**Report of the Investigation**  
**into an engine room fire on**  
**mv *Pride of Le Havre***  
**on 18 March 1999**  
**off the Isle of Wight**

**Extract from**  
**The Merchant Shipping**  
**(Accident Reporting and Investigation)**  
**Regulations 1994**

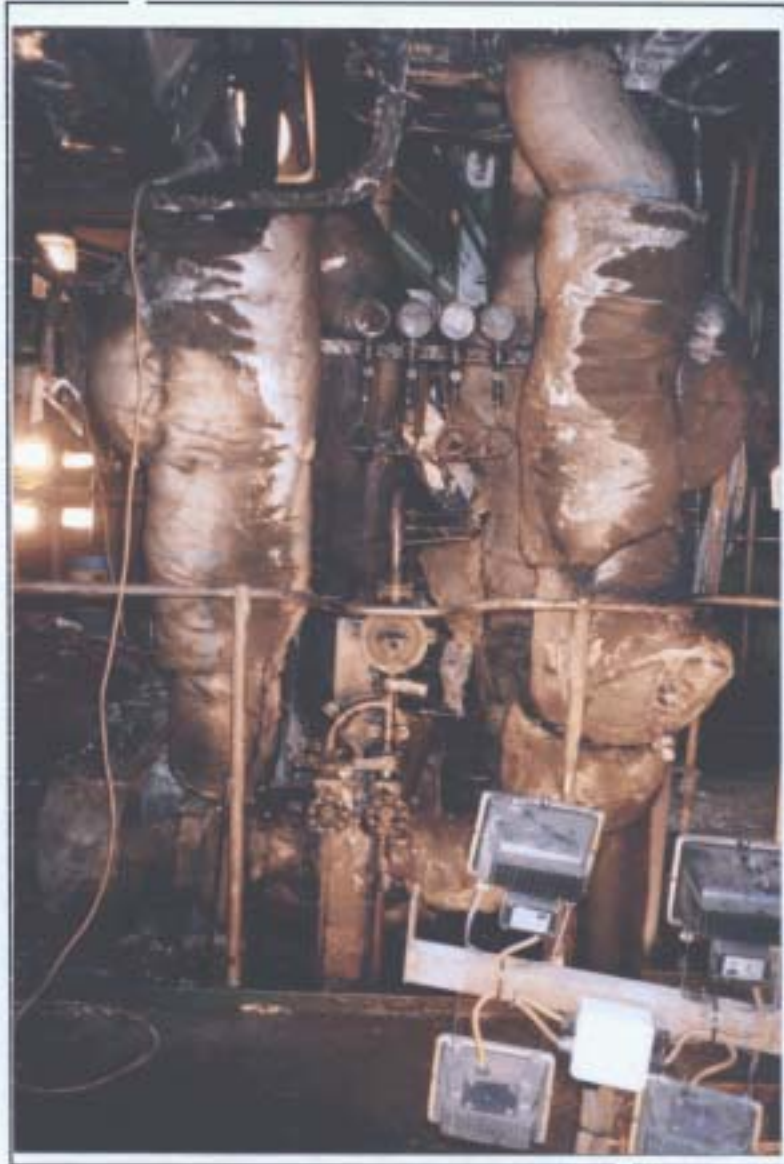
Fig 1      General view of No 2 Thermal Oil Pump.  
Return lines the right, discharge lines on the left.

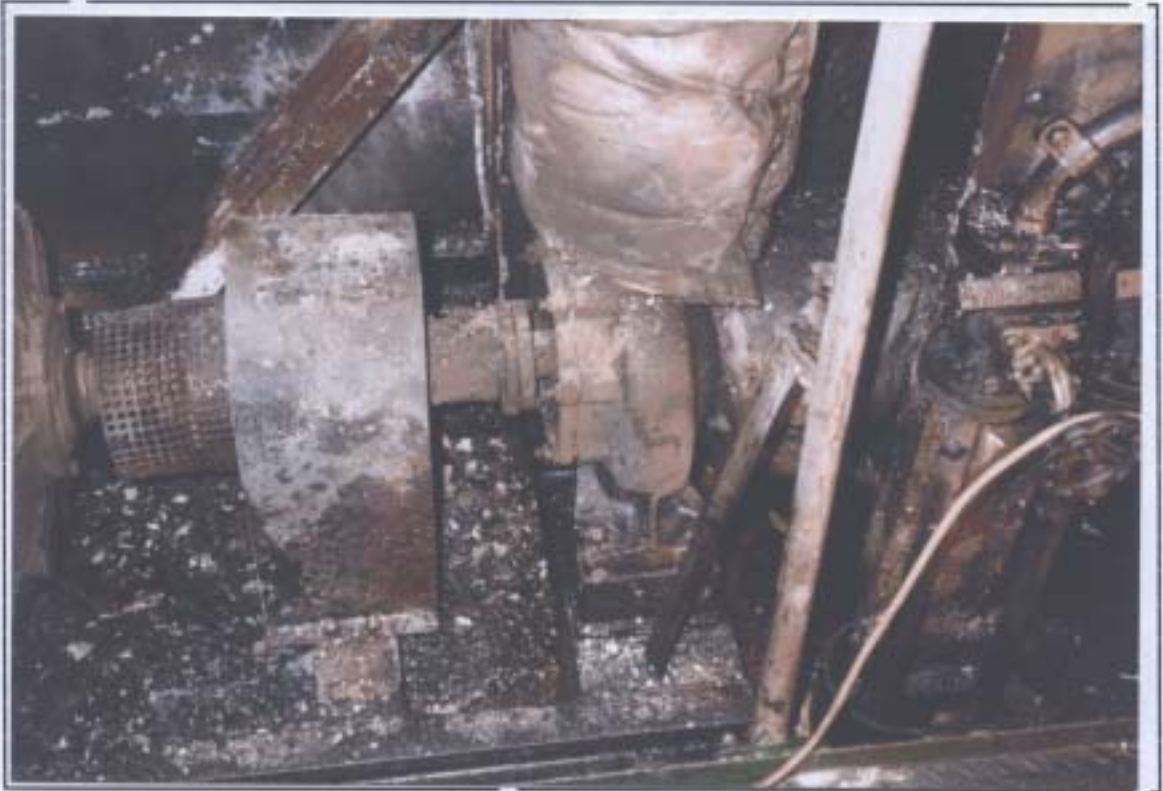
Fig 2 Close-up view of No 2 starboard thermal oil pump showing shrouded coupling and bearing bracket.

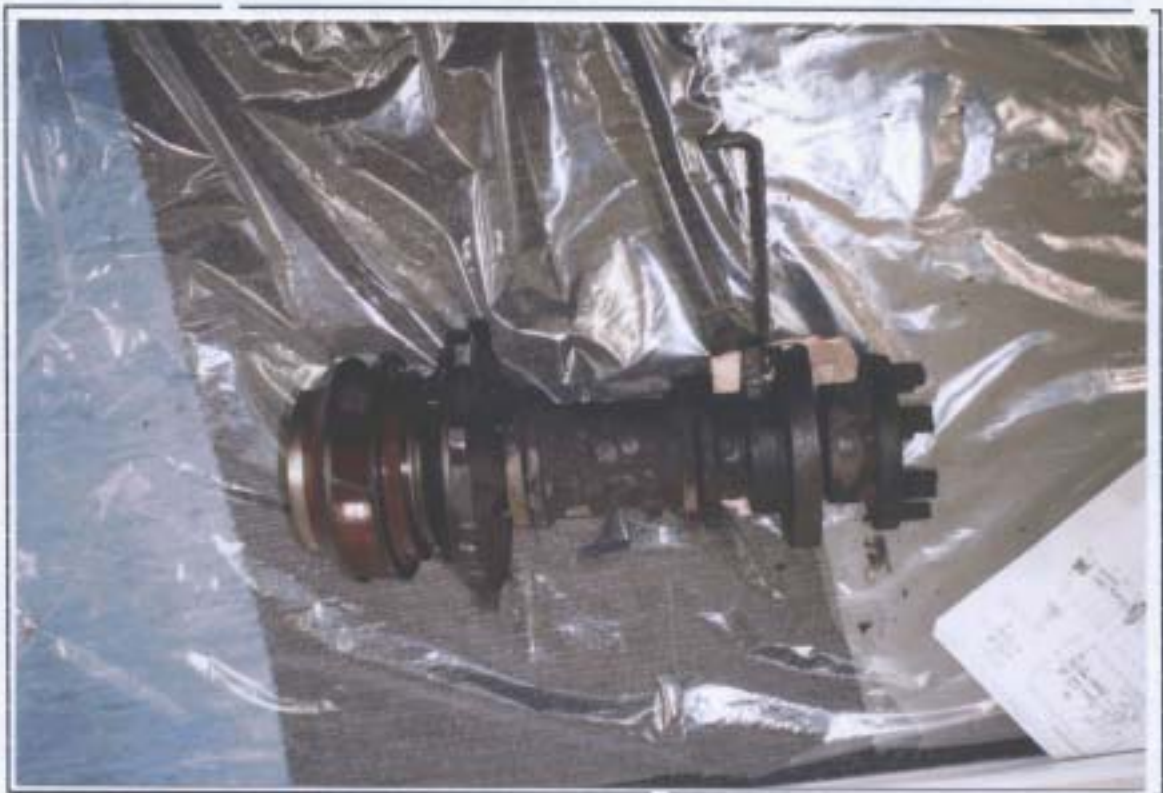
Fig 3 General view of shaft, impeller, bearing bracket, and drive coupling before being stripped for inspection.

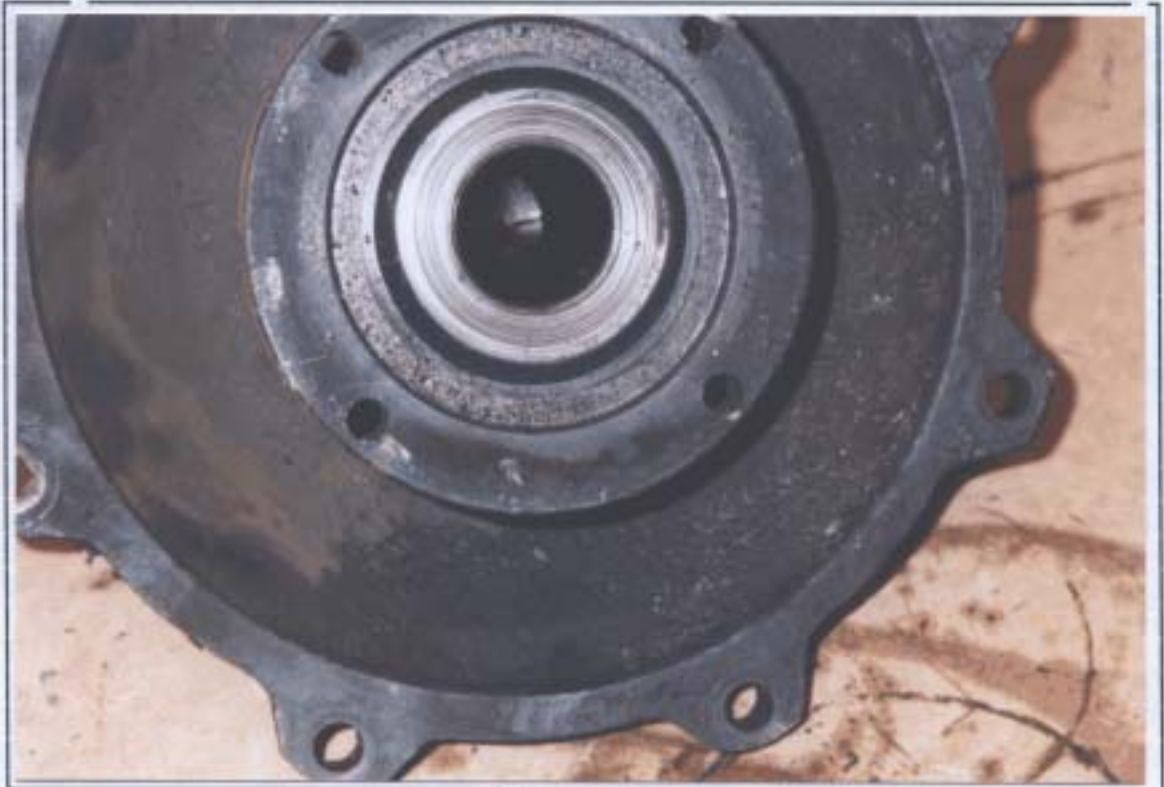
The likely sequence of events was that the collapse of the ball-bearing initiated the mechanical seal failure. Damage to the face of the thrower supports this scenario, suggesting that the ball race broke up, the shaft moved forward, leading to mis-alignment of the mechanical seal and loss of thermal fluid.

- 3.1.9    An examination of No 2 pump (starboard) showed heavy contact wear between thrower and discharge cover, together with damage to the deep groove ball race on the drive end of the shaft.  
(Ref: 1.7.2)

Fig 4 Close-up view of discharge cover showing heavy face plate wear caused by movement of shaft forward and contact between thrower and discharge cover.

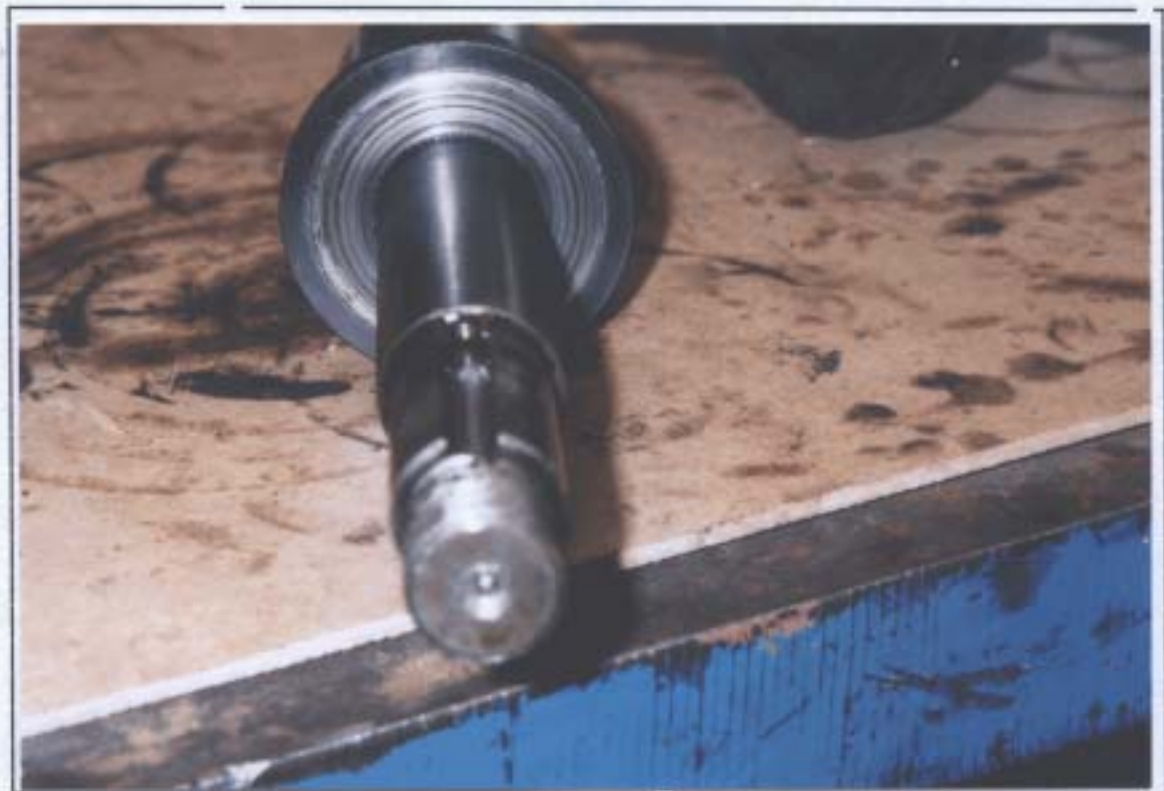
Fig 5 Close-up of impeller shaft thrower showing corresponding wear pattern.

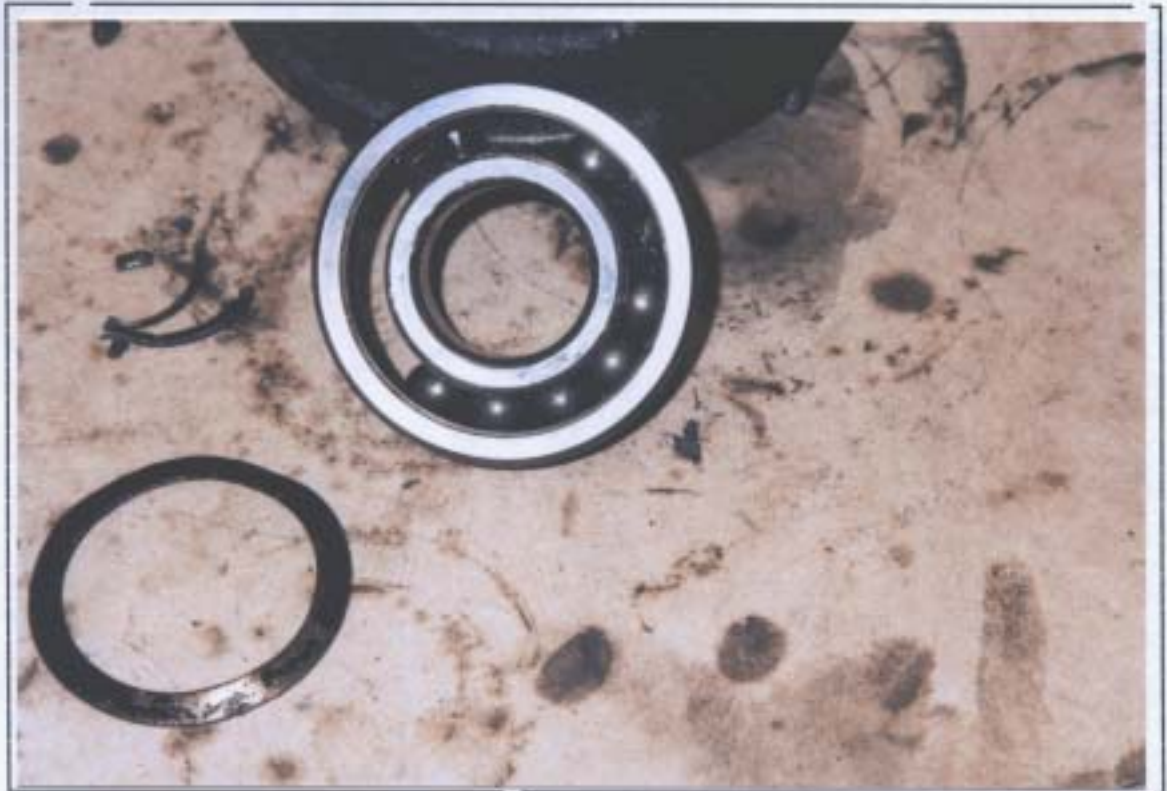
- a) Control air dryer unit to be renewed and surveyed by 30.04.99.
  - b) Buckled deck plating and support beams above thermal oil circulating pumps to be renewed as necessary by 31.03.2000.
- 1.7.2 An examination of the starboard thermal oil pump (No 2) showed heavy contact wear between the thrower and the discharge cover, indicating that the impeller shaft had moved forward, away from the drive motor. The deep groove ball race on the drive end of the shaft had suffered damage with some

of the balls missing and the cage broken up. No obvious damage was seen on the mechanical seal components, but with failure of the ball-bearing and the subsequent movement of the shaft, some misalignment probably occurred.

While it has not been possible to identify positively the ignition source of a leakage of hot thermal oil through thermal oil pump aft bearing, debris from the collapsed deep groove ball-bearing might have provided local “hot spots” which could have raised the temperature of the already hot oil, and led to ignition of the resultant thermal oil vapour.

The collapse of the aft deep groove ball-bearing race allowed mis-alignment to develop in the faces of the mechanical seal of the thermal oil pump and resulted in a leakage of hot thermal oil out of the bearing bracket, into the bearing housing, and then out along the impeller shaft.

Fig 6 View of Deep Groove ball bearing showing damaged ball race and cage.

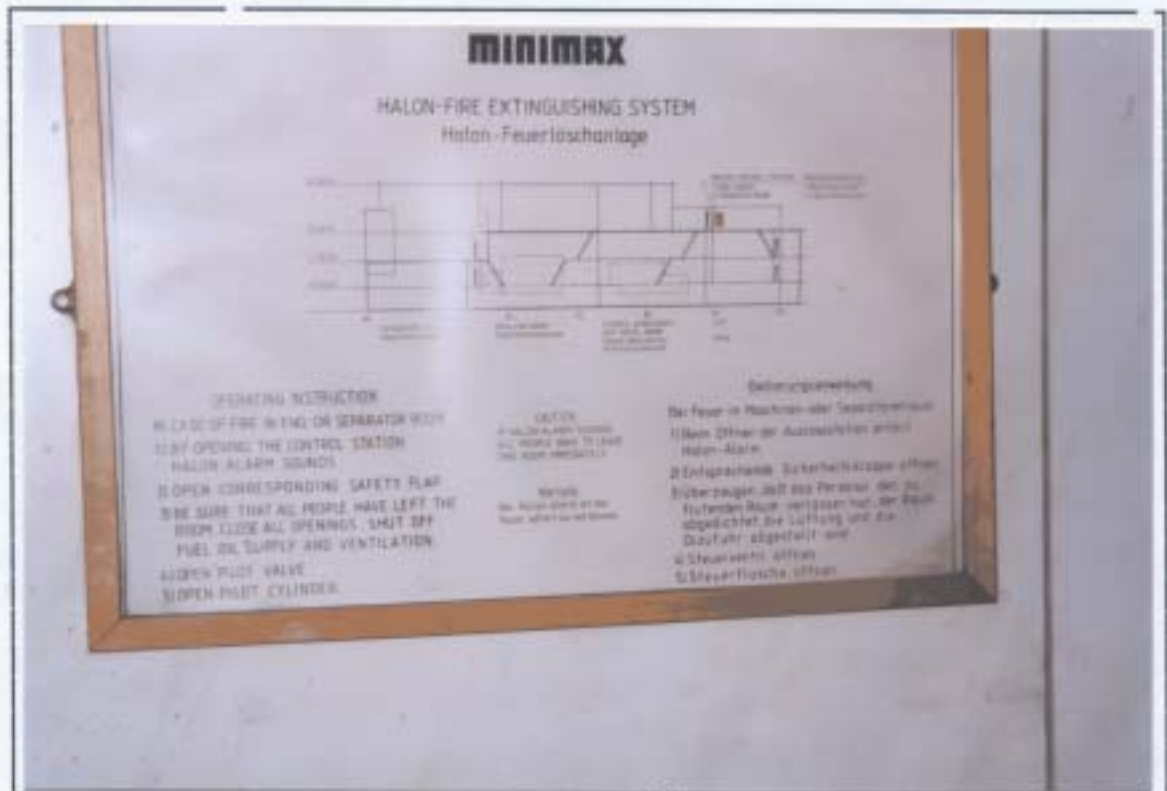
Fig 7 Close-up of Halon system drawing mounted on bulkhead outside Halon Control Station on deck 3.

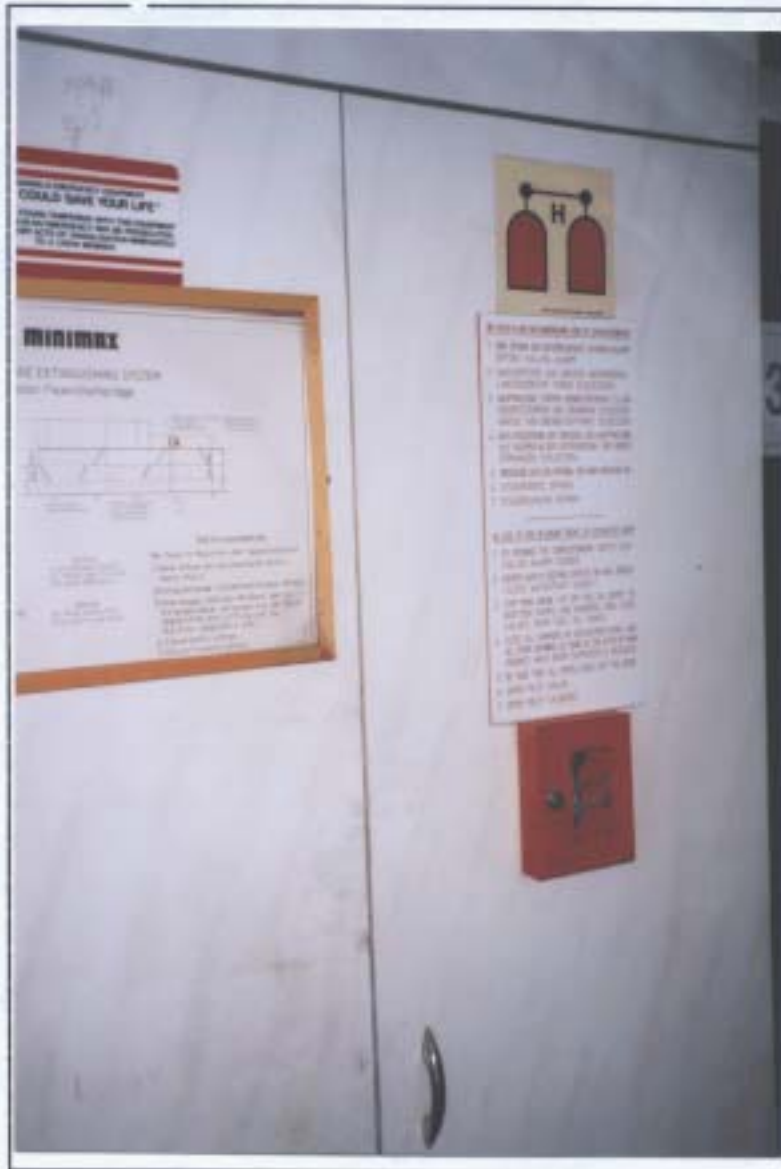
Fig 8 General view of Halon Control Station on deck 3. Note instructions and locked key box.
