Report on the investigation of
the grounding of
the class VI passenger vessel
Pride of the Dart
on Mew Stone rocks
near the entrance to the River Dart
on 28 June 2002

Marine Accident Investigation Branch
First Floor
Carlton House
Carlton Place
Southampton
United Kingdom
SO15 2DZ

Report No 12/2003
April 2003

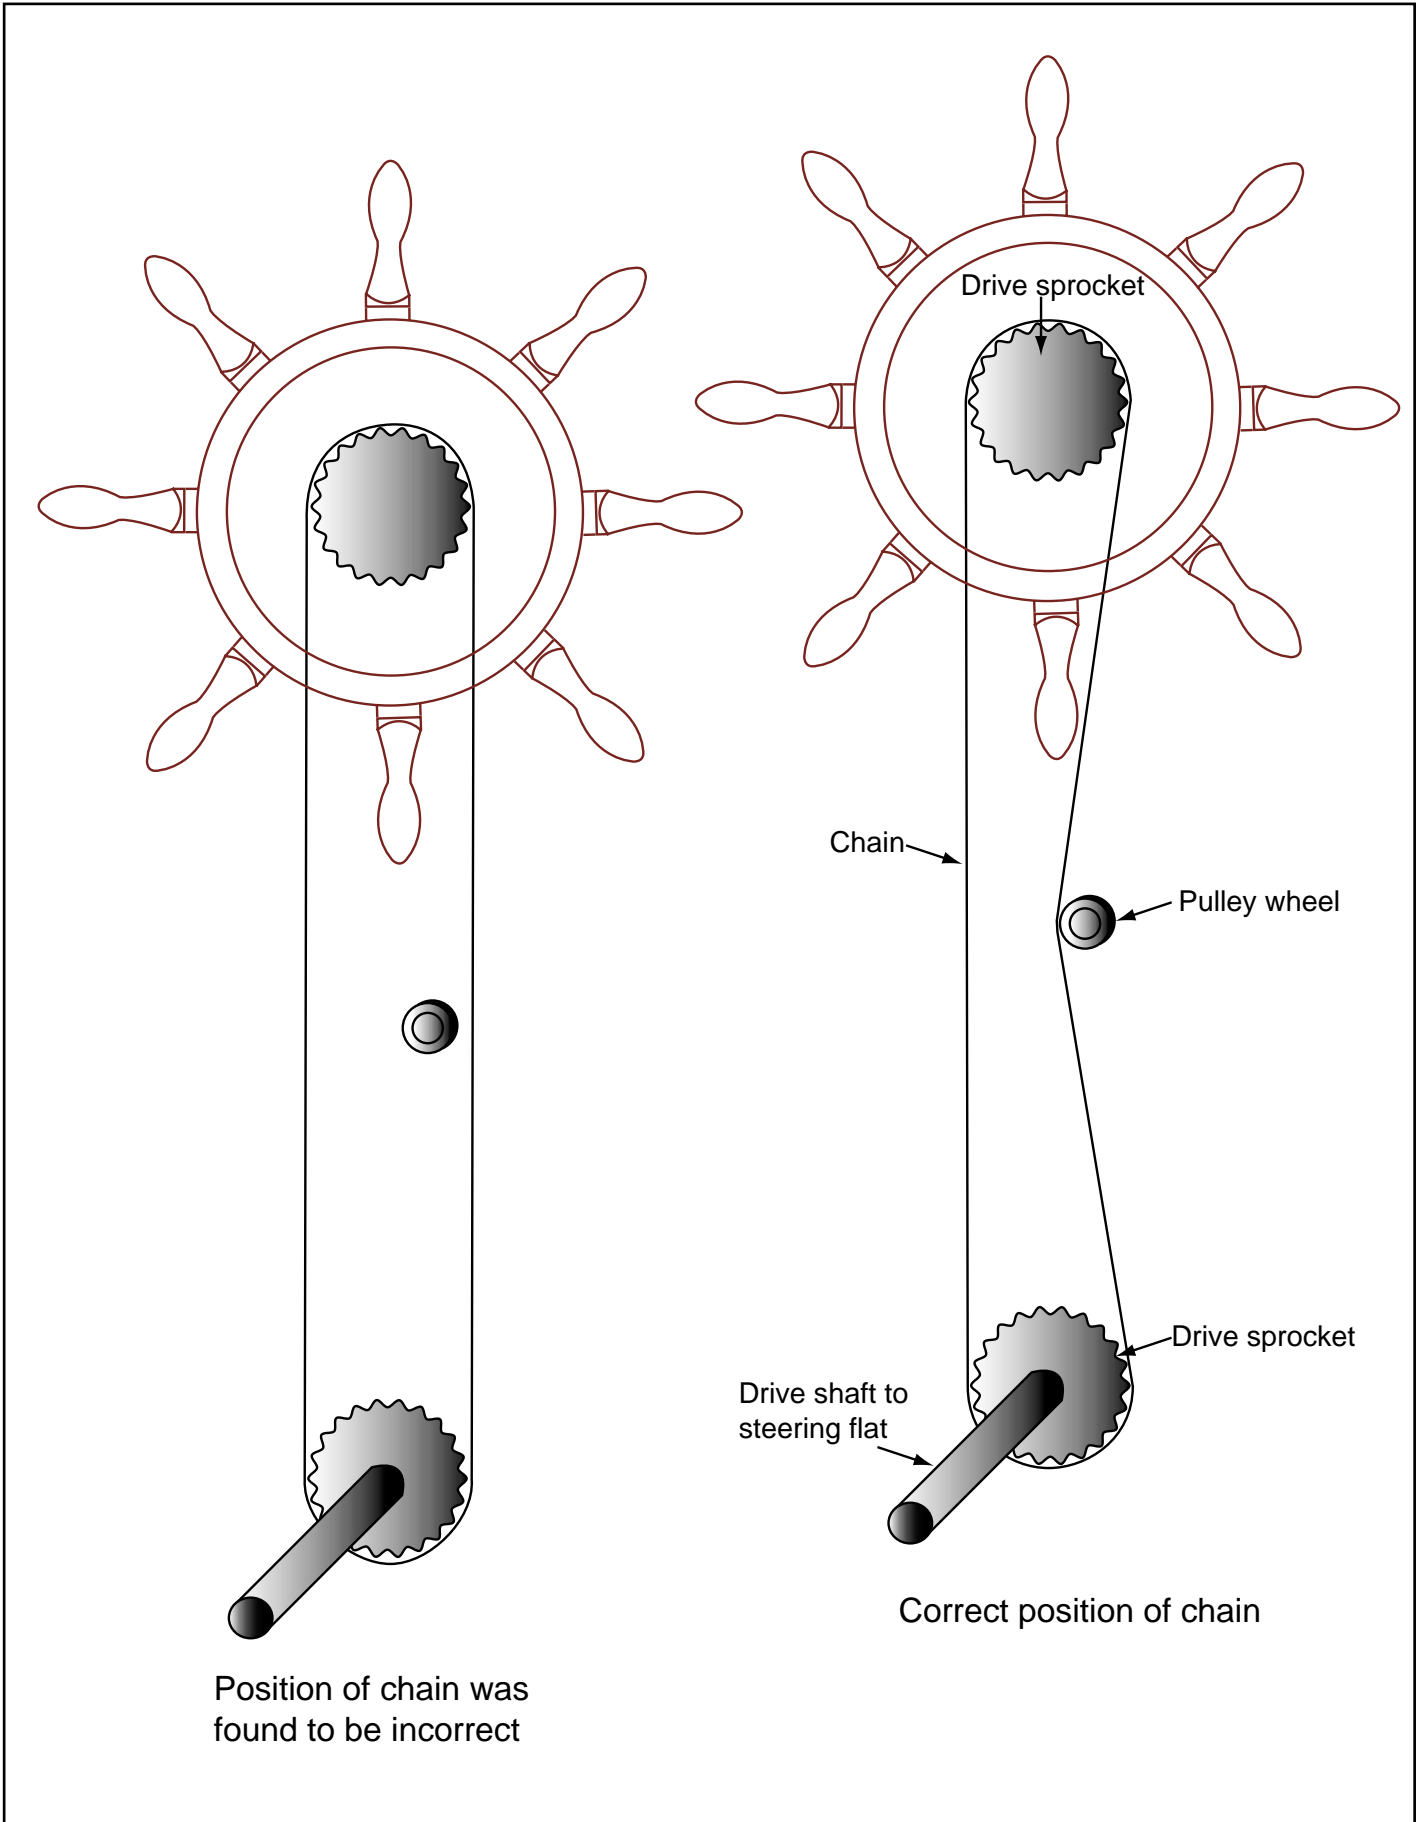
Diagram of the steering system

After the accident, the front panel beneath the steering wheel was removed to reveal the chain and, about half way down, a round pulley wheel. The chain was found to be to the starboard of, and away from, the round pulley wheel. The purpose of the round pulley wheel was to provide a guide and tensioning to the chain (**diagram 1**).

The chain was placed to the port side and around the round pulley wheel. The steering was then tested and it was found to be working satisfactory. The chain was put back to starboard of, and away from, the round pulley wheel as revealed when the panel was removed. Again, the steering was moved and in doing so noises were heard. The wheel could not be moved to port.

When the chain was found to be off the tensioning pulley, the wheel could not be turned to port but it could be turned to starboard. The section of the vertical chain to port (when looking forward) was tight and, therefore, on the tension side, so that when the wheel was turned to starboard, the drive shaft could be turned as normal.

However, the section of the vertical chain on the right side, which should have passed around the pulley, was slack, so that when the wheel was turned to port the chain slipped over the teeth of the sprocket of the drive shaft.

The reason why the chain had suddenly slipped off the tensioning pulley was possibly due, in part, to gradual wear on the chain, giving excessive fore and aft movement. There was no mechanism to keep the slack chain on the tension pulley. Inspection, during routine maintenance, might have identified the potential problem, and measures could then have been taken to prevent it.

1. Possibly due, in part, to gradual wear, the chain between the steering wheel and the drive shaft had slipped off the tensioning pulley allowing only steering to starboard but not to port. [2.2]

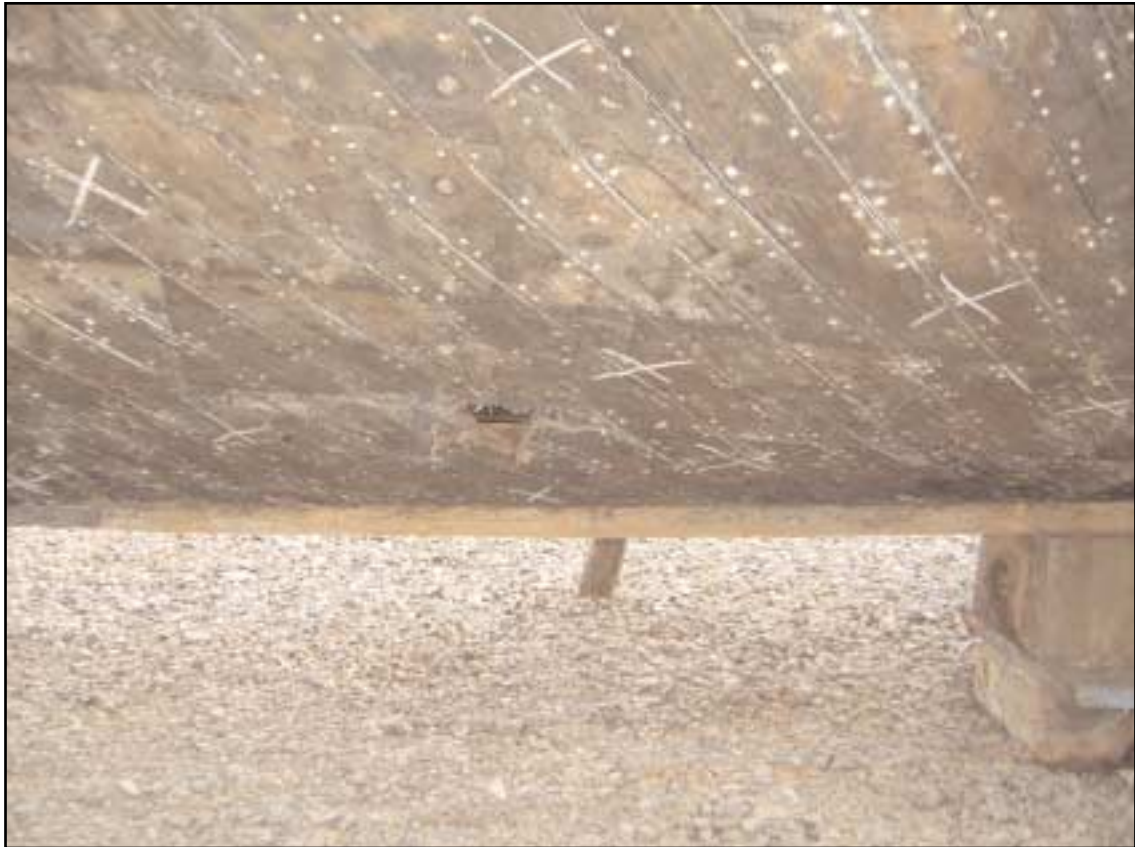
Photograph 2

1.4.5 Damage (**Photographs 2 and 3**)

A number of wooden hull planks were pushed up and split over a length of about 8.4 metres between the keel and the turn of the bilge on the port side, starting from just aft of the stem to nearly amidships. There was one small hole in way of the bar/buffet space (**see diagram 2**).

A hole in the port side of the hull in way of the bar/buffet space

Damage extended along three spaces: the forepeak, bar/buffet and engine room. The penetration to the hull and, therefore, the main flooding, was in way of the bar/buffet space. There was limited flooding through the gaps between the planks, which had been pushed up in the grounding.

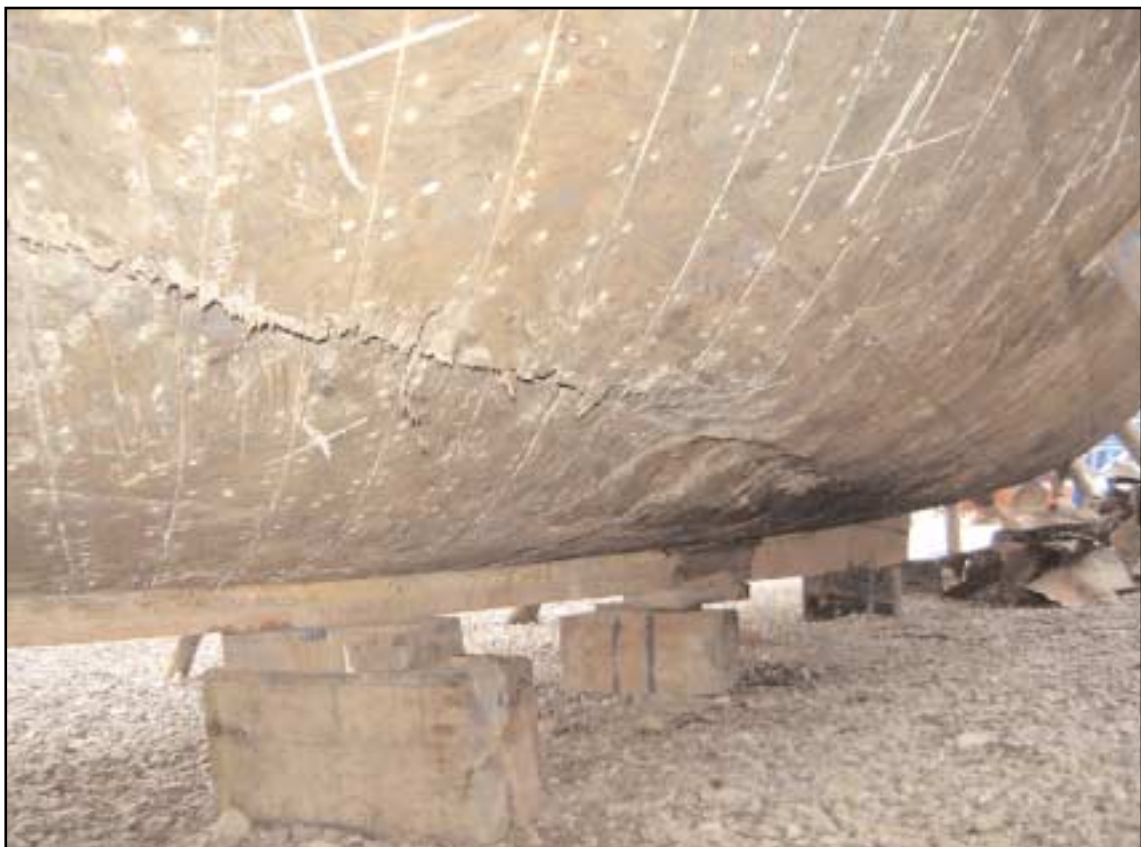
Photograph 3

A view of the damage of the port side looking aft showing a longitudinal tear

Total flooding of more than one compartment would have resulted in the vessel foundering. However, the flooding into the three spaces was not sufficient for her to founder, and the vessel was able to remain afloat until she was beached. In view of the extent of damage, and the rate of flooding, beaching was a wise option.
