Report on the investigation
of the loss overboard of a fisherman
from the fishing vessel
Van Dijck
while fishing 30 miles
south-west of Guernsey
on 16 April 2001

Marine Accident Investigation Branch
First Floor, Carlton House
Carlton Place
Southampton
SO15 2DZ
Report No 35/2001
October 2001

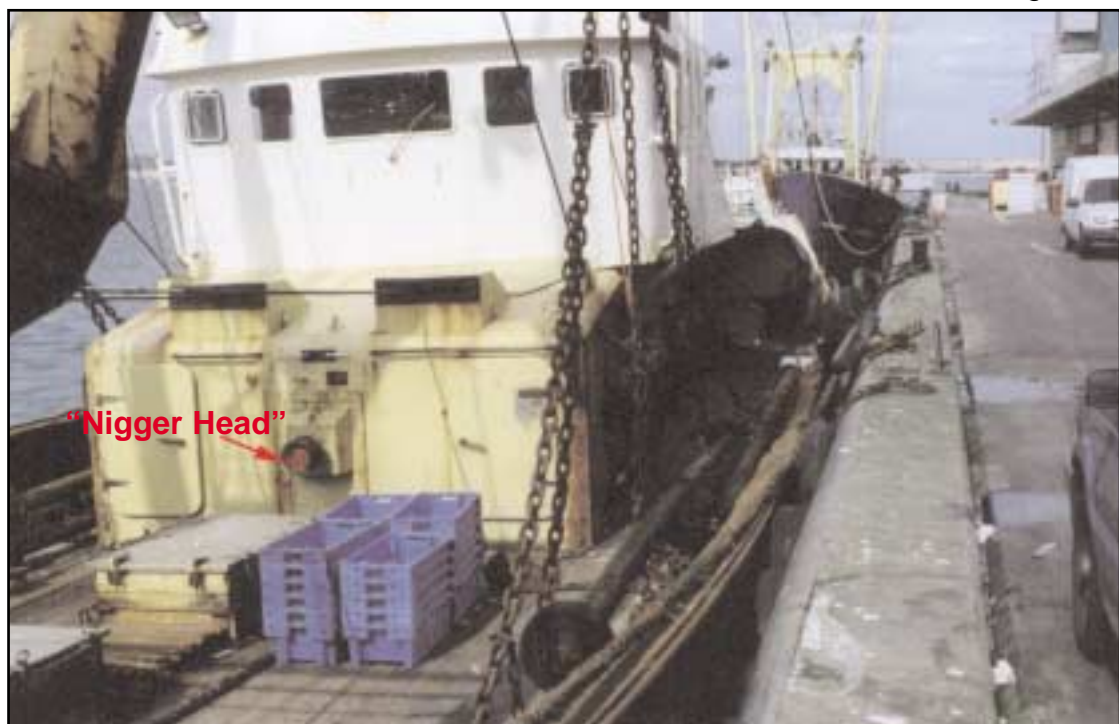
Figure 1

At 2240 the gear was hauled again; Mark operating the "nigger head" to swing the dredges inboard, while Francis stood in a safe position behind him (**Figure 1**). Once inboard, it was obvious that more repair work would be necessary before the dredges could be reshot. Once the dredges had been emptied on to the deck, the skipper carried out further welding work. This was completed at 2335 and the gear reshot. Once it was over the side, Mark and Francis returned to sorting out the debris as before.

General view of wheelhouse and winch house.
Note central position of "Nigger Head" (painted red).

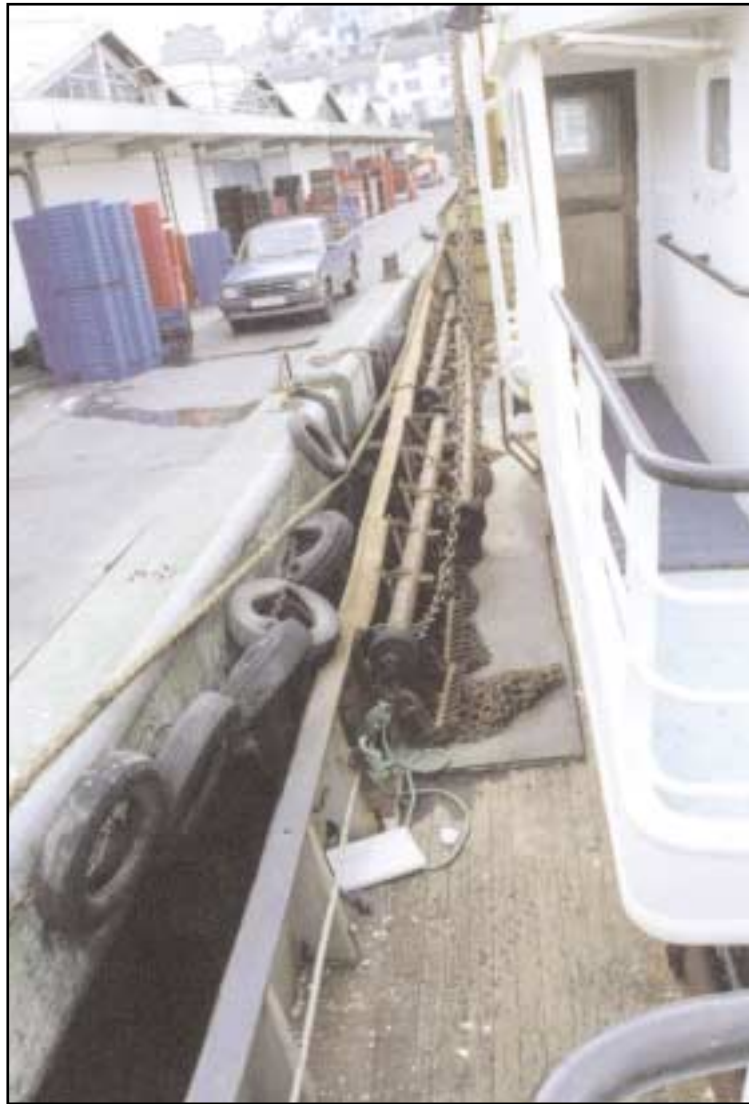
Figure 2

View of port side of *Van Dijck* showing area where Francis was working at the time of his disappearance

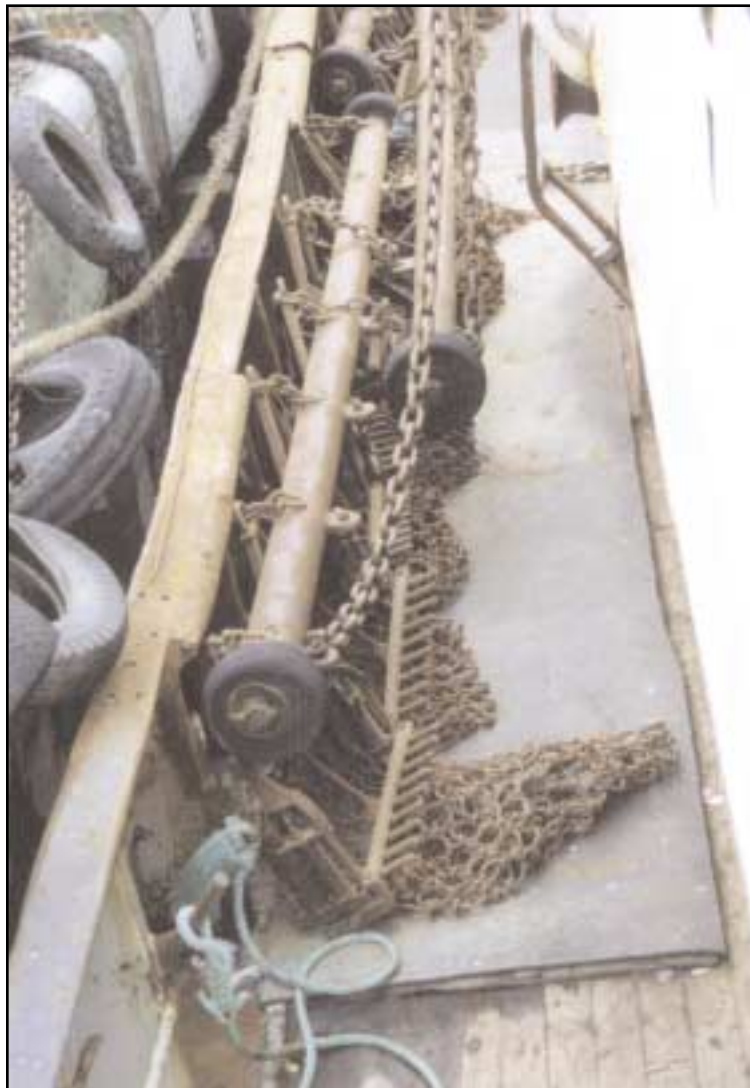
Figure 3

All areas of the main deck are fitted with wooden sheathing. Steel deck protection plates, about 1 metre wide, are fitted on both sides of the vessel, over the wooden sheathing, from the break of the forecastle aft to a position just short of the entrance to the accommodation block (**Figure 3**).

General view of port side, main deck showing dredges and steel deck protection plate

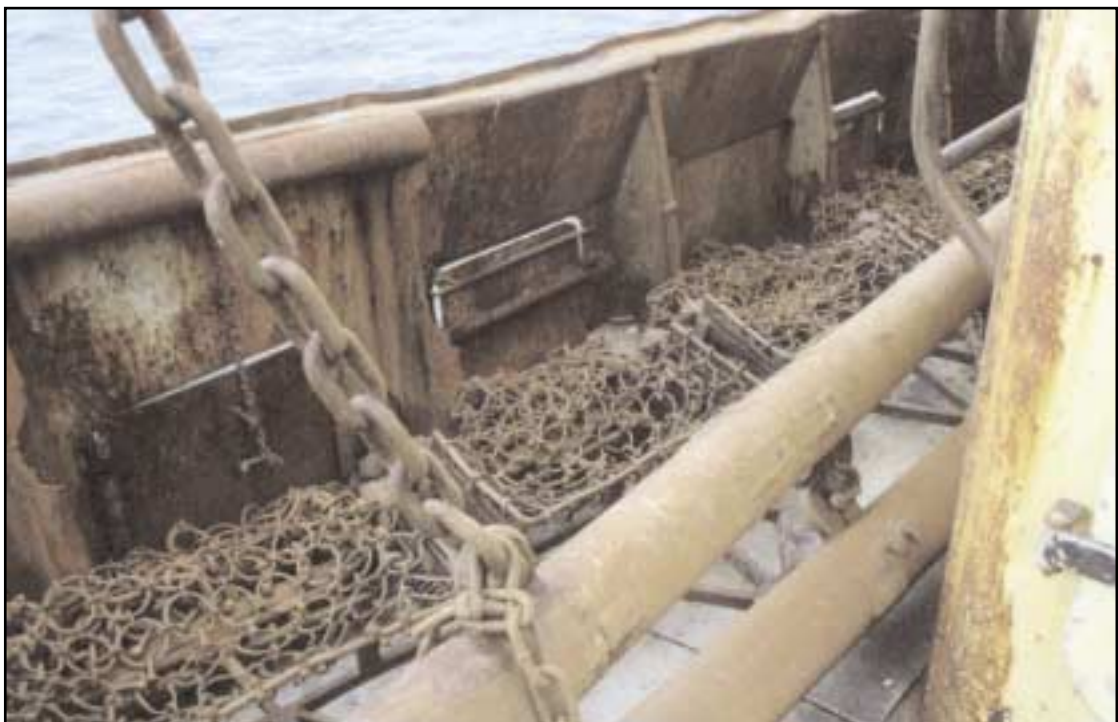
Figure 4

View of scupper doors in position

During the last two periods when Francis was engaged in sorting the debris, the scupper doors were all left in place, just wedged three-quarters open as he had been shown. When it was realised that Francis was missing, the search showed that one of the scupper doors had been removed. None of the crew recall seeing Francis removing the doors or finding the doors removed before this

3. During the last two periods when Francis was engaged in sorting the debris, all the scupper doors were left in place, just wedged three-quarters open as he had been shown. When it was realised that Francis was missing, the search showed that one of the scupper doors had been removed. The fact that the scupper door had been carefully stowed in the adjacent frame space indicates that the removal was deliberate and that he had cleared the space for a particular reason.
[Ref: 2.2.2]
