Report on the investigation of the loss of

***Vertrauen (BF 450)***

19 July 2001

**Report No 29/2002  
August 2002**

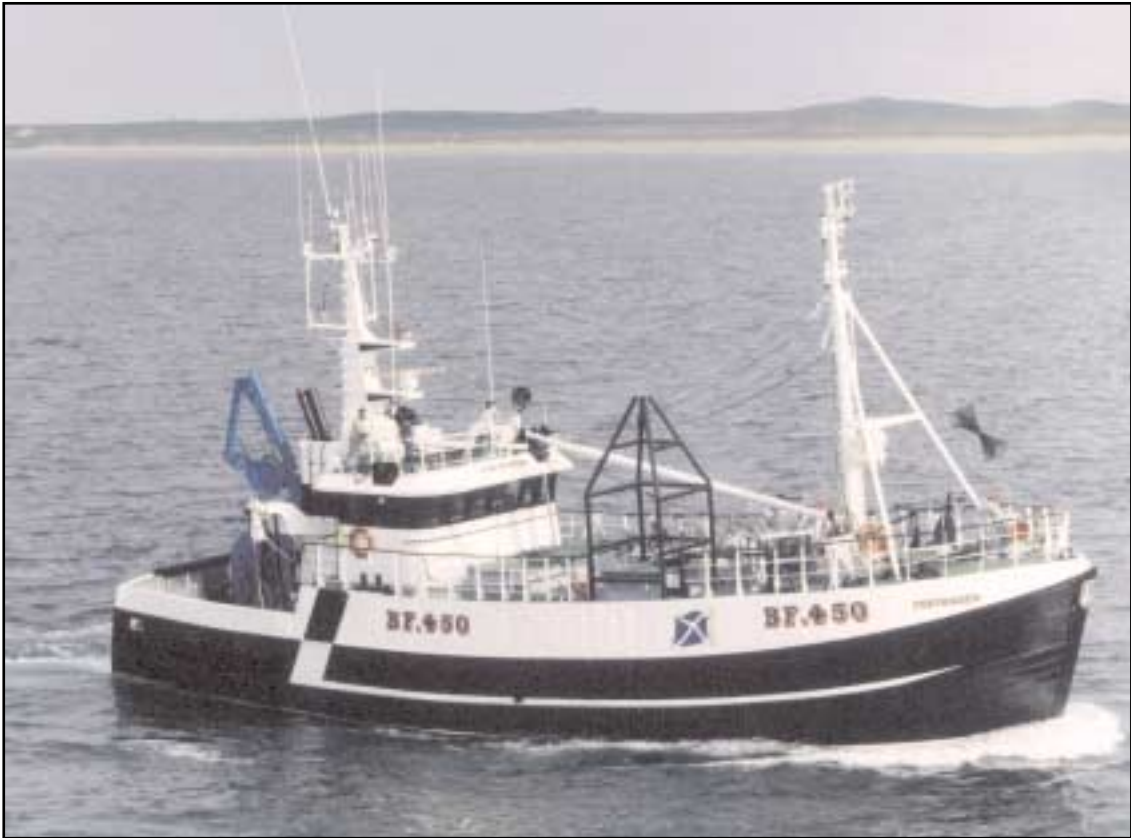
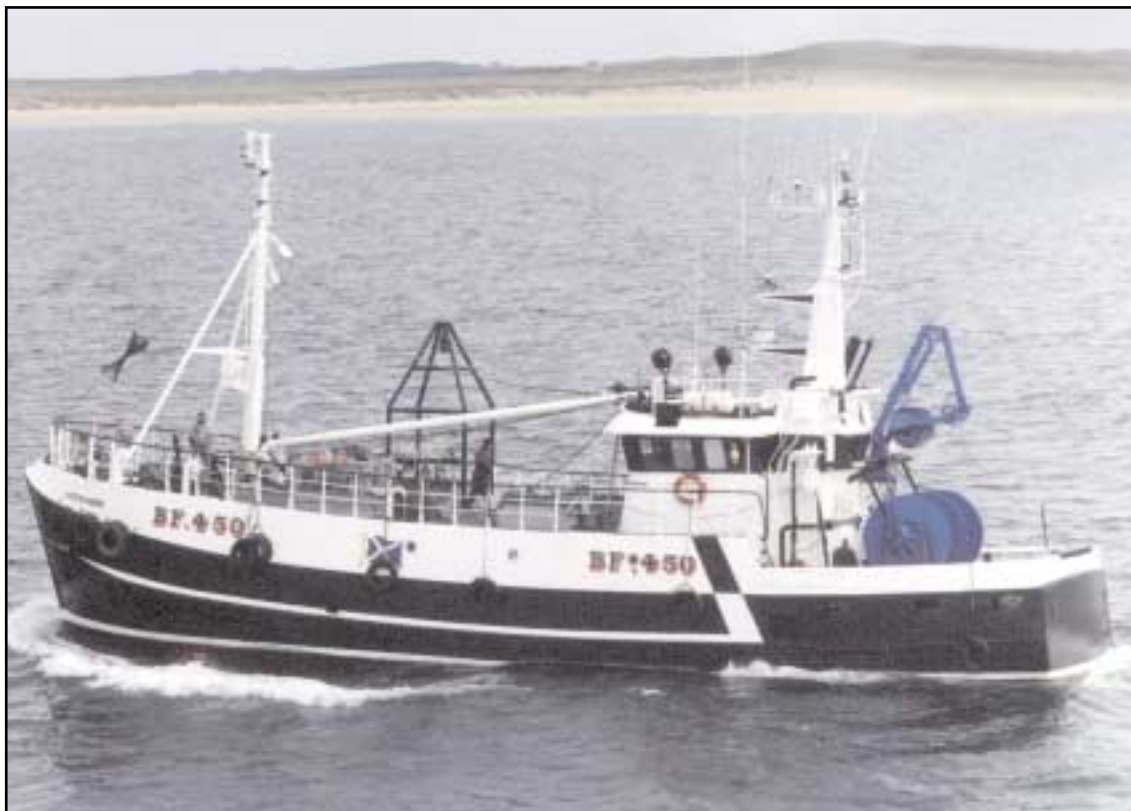
Figures 1 & 2 - *Vertrauen*

General views of *Vertrauen* are shown in **(Figures 1 & 2)**. A general arrangement drawing can be seen in **(Figure 3)**

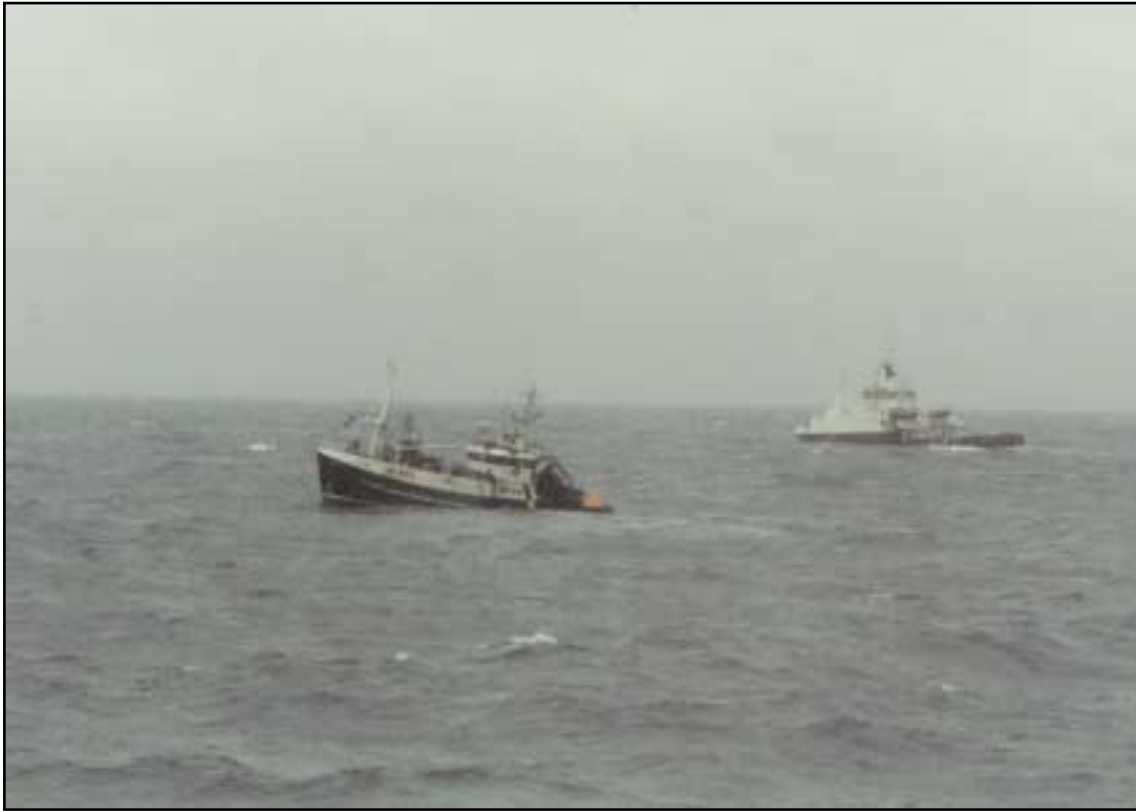
Figure 4

At first, the crew waited for the FRC on the aft deck, but when waves started to break over the bulwarks they went up on to the shelter (**Figure 4**). The FRC came to the port side (**Figure 5**), and the crew were able to step across, because by that time *Vertrauen* was listing to port. The abandonment was accomplished seconds before the stern sank. Before and during the evacuation, the crew were able to keep predominantly dry. The bow stayed above the surface for about another 5 to 10 minutes (**Figures 6 & 7**) before she disappeared completely at 1609. The weather was worsening at the time, so this probably hastened her loss. The FRC returned to *Scott Guardian*.

The stand-by vessel *Scott Protector* recovered the inflated liferafts after *Vertrauen* had sunk, and took photographs (**see Figures 4 - 7**).

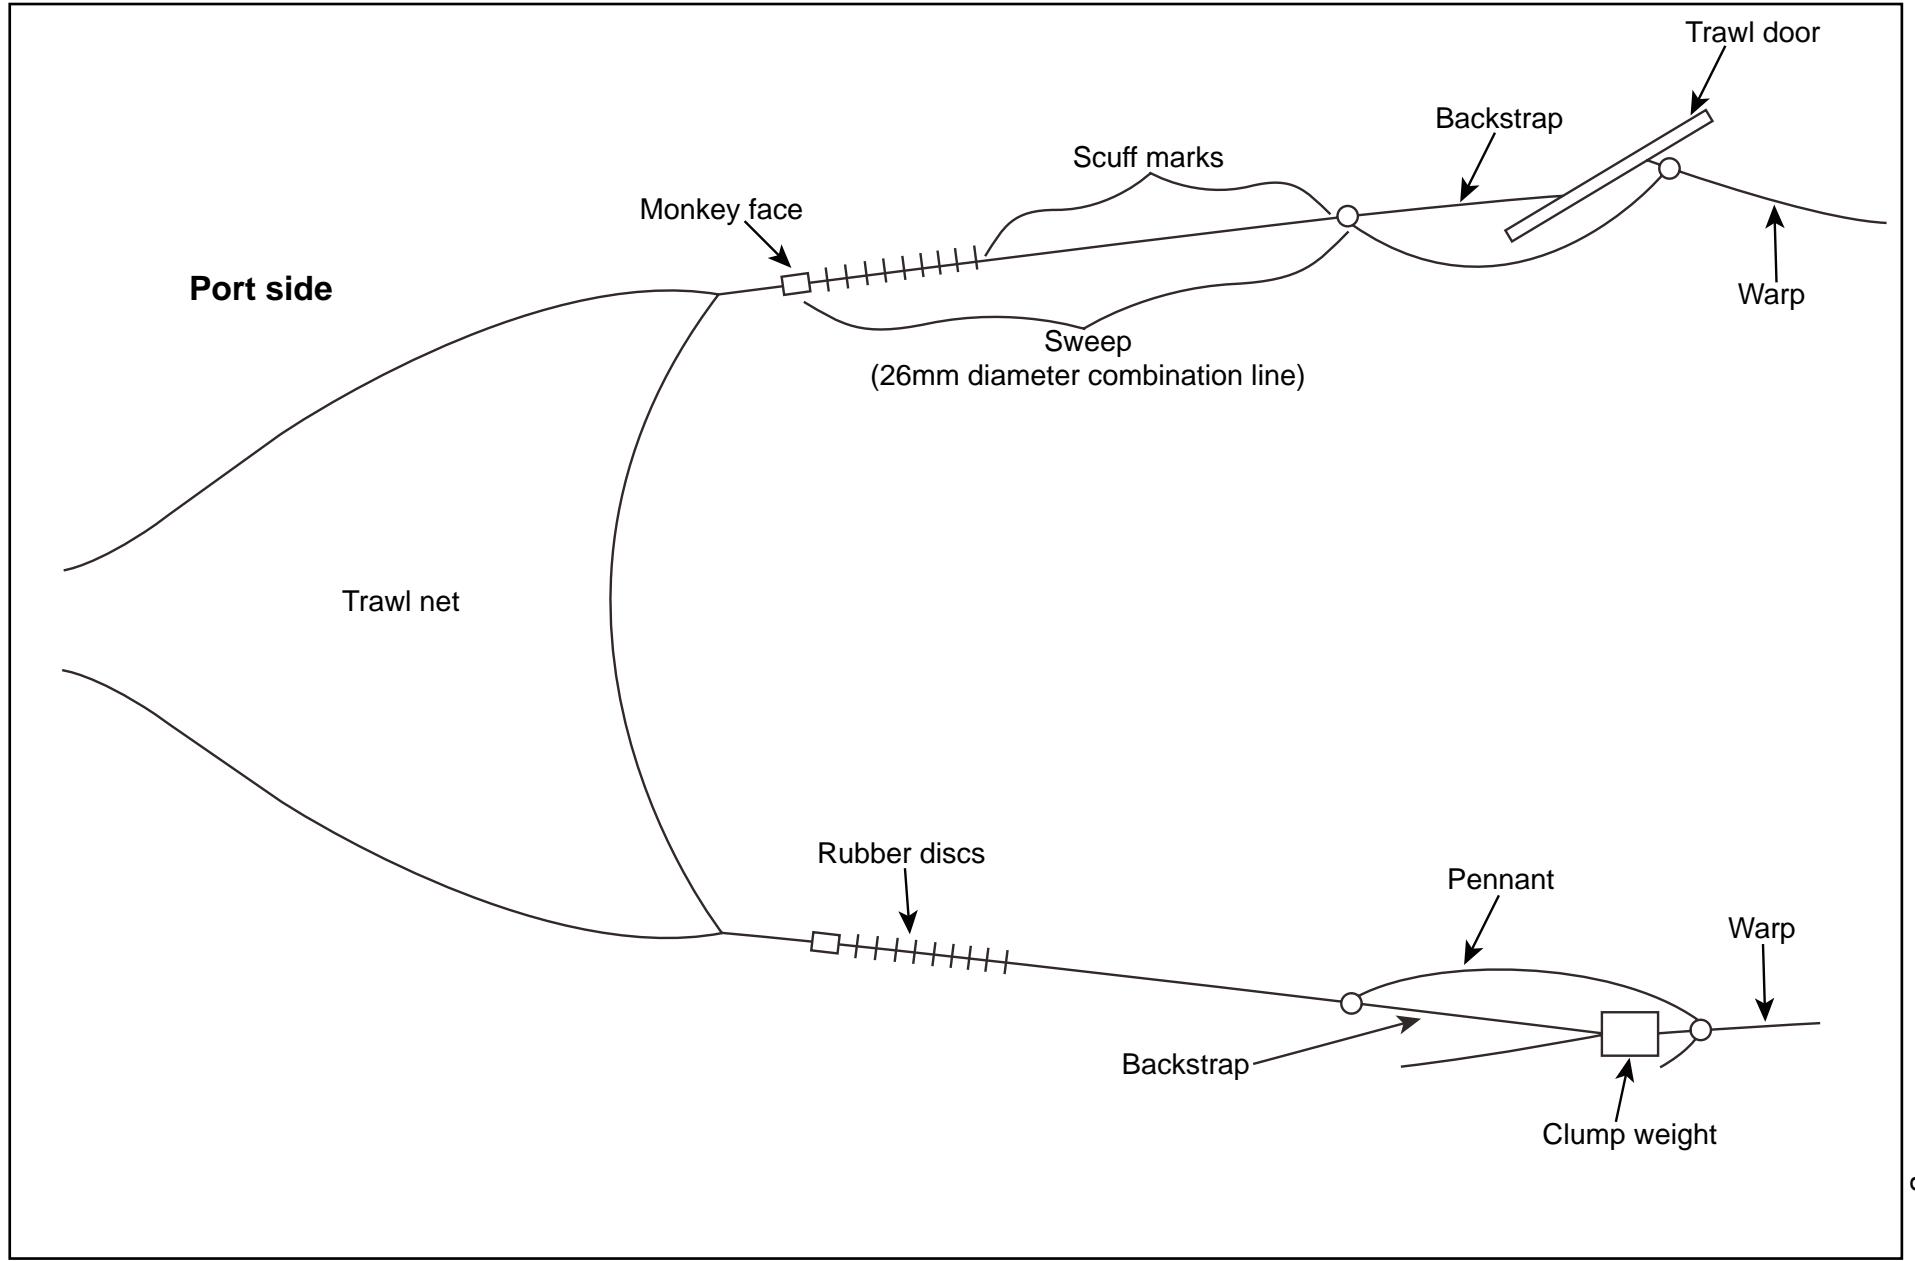
Diagram of the port half of the fishing gear

The port sweep of the port net (**Figure 9**) had scuff marks on it, indicating that it had been caught on the fastener. The scuff marks covered most of the sweep where no rubber discs were fitted. Because *Vertrauen* was making some way when the gear became snagged, the fastener was probably a heavy weight which was being dragged along the seabed.
