**Report on the investigation of
an accident to the
skipper of the fishing vessel
Wakil II (BW 147)
3.5 miles south-west of St Bees Head
on 10 April 2000**

Marine Accident Investigation Branch
First Floor, Carlton House
Carlton Place
Southampton
United Kingdom
SO15 2DZ

Report No 40/2000

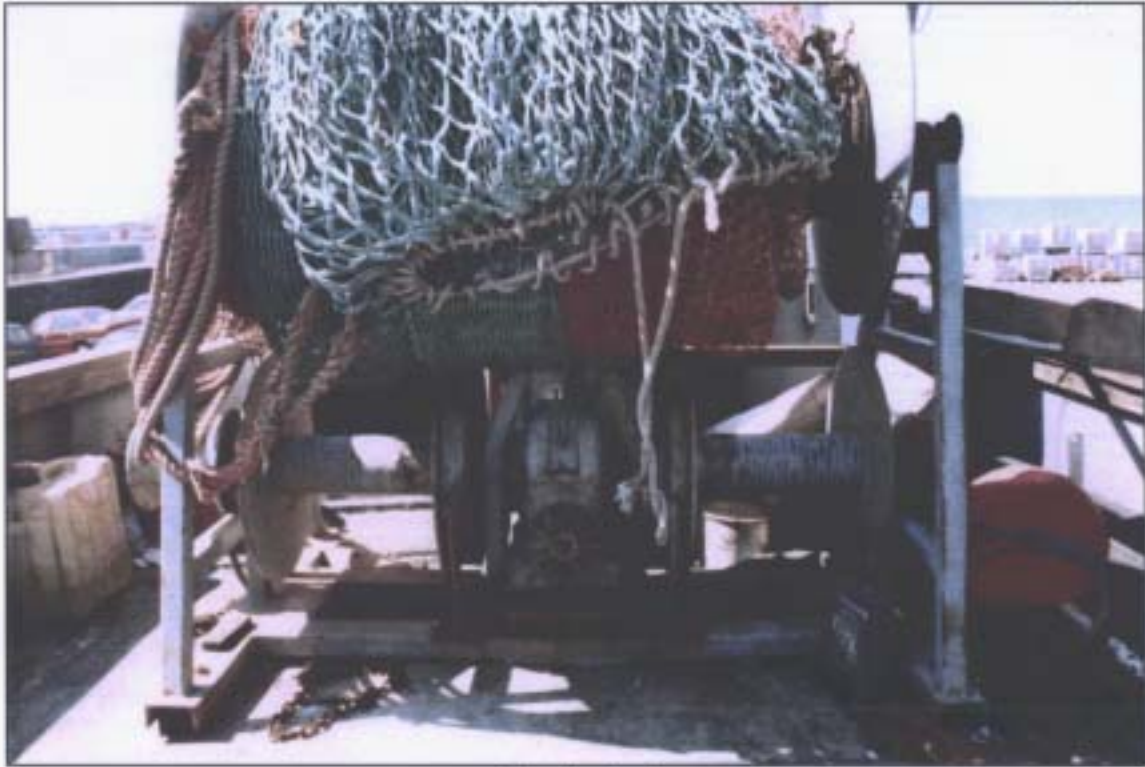
Figure 3

The hydraulic trawl winch was powered independently from the main engine by a 9kW, twin cylinder Petter diesel. The operating control lever for the winch was situated on the forward side. The winch was not fitted with a dead man's handle.

Trawl winch

Back on deck, while the gear was being heaved up, the skipper continued grading prawns from the previous haul into the boxes. While in a position near to the port winch barrel, he lost his footing and fell on to the port trawl warp as it was being heaved on to the winch.

He fell awkwardly, and the sleeve of his oilskin jacket caught on a shackle connecting the heavy warp to the light warp. He was dragged on to the port barrel of the winch. The sleeve of his jacket became trapped in the winch from the cuff to the neck, pinning him to the deck underneath the winch barrel.

The winch was not fitted with a dead man's handle, a device requiring the operator to apply pressure to the control lever during operation. Because of this, it was possible for the skipper to leave the winch while it was heaving.

Had a device, such as a dead man's handle, been fitted to the winch control, the skipper would not have been where he was, with the winch running, when the accident occurred.

2. Consider carrying out a risk assessment.
3. Consider fitting a dead man's handle to the winch control on board his vessel.

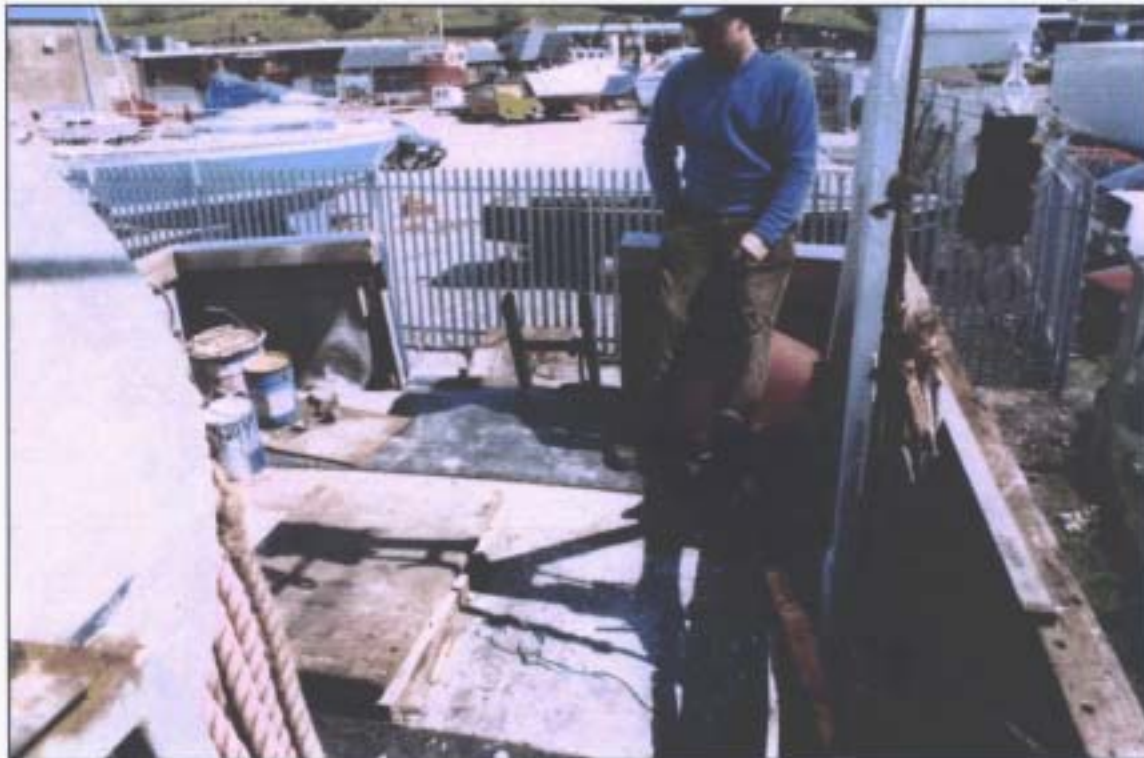
Figure 4

Working deck

It was normal practice for the skipper to clear the working deck of any obstructions before hauling. However, on this occasion, because not all the catch had been graded from the previous haul, an unnecessary hazard was created by the six fish boxes on the small working deck aft.

Had the working deck been cleared before commencing the hauling operation, in accordance with the skipper's normal practice and the advice given in *Fishermen and Safety*, the hazard would not have existed, and the accident might have been avoided.
