Report on the investigation of
the collision between

Amenity and Tor Dania

South of Grimsby Middle, the River Humber, UK

**Report No 20/2005
November 2005**

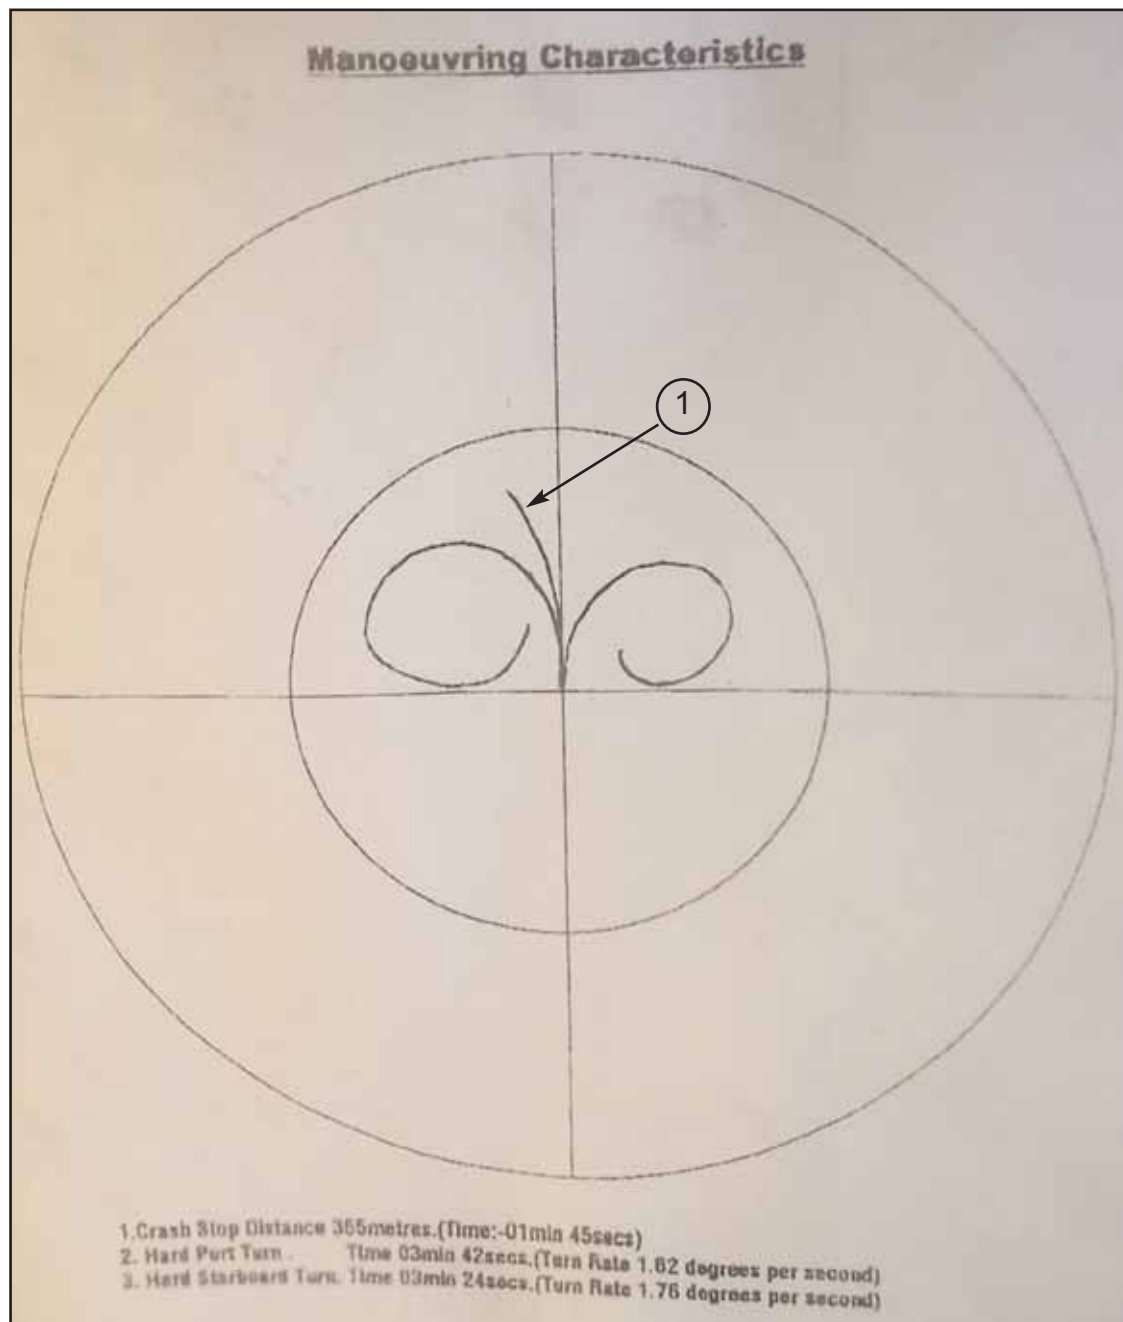
Figure 3

① Crash stop, full ahead to full astern wheel midships

The vessel could maintain steerage down to a speed of 2-3 knots. She had a left-handed fixed pitch propeller, meaning that the bow would swing to port when the propeller was going astern (**Figure 3**).

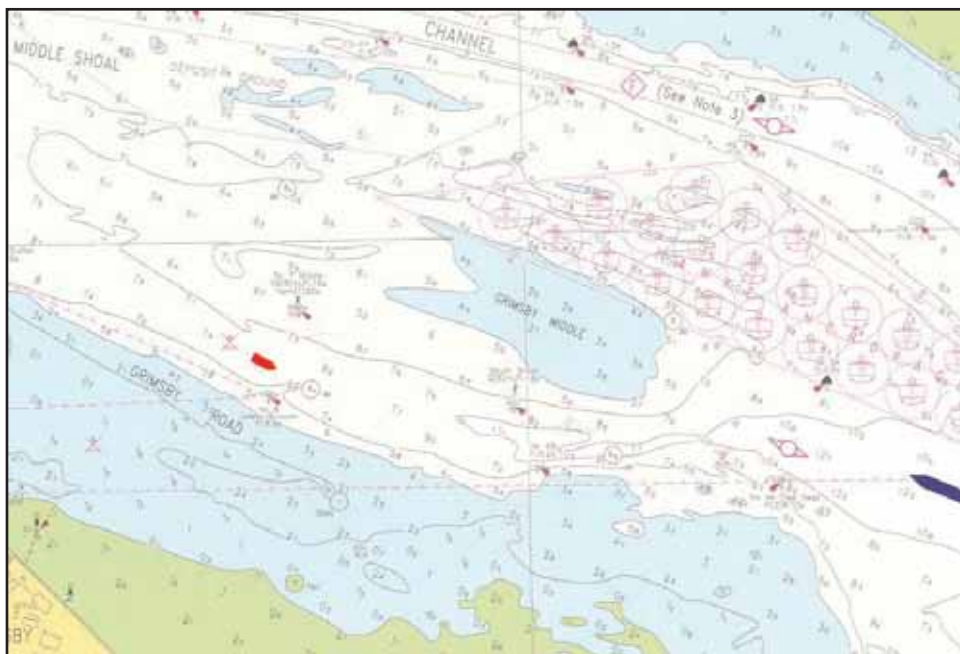
Figure 6 - 0400

At 0400 (**Figure 6**), *Amenity*'s master saw an inbound vessel, displaying a red sidelight fine on the port bow at 3 miles. This was *Tor Dania*. At this time both vessels were navigating in approximately the centre of the buoyed channel.

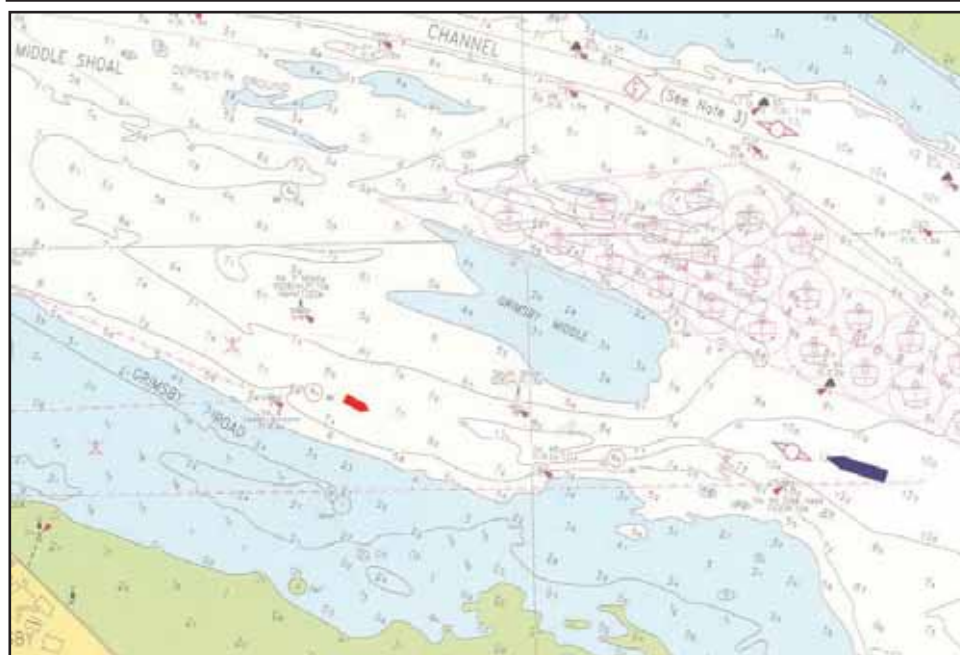
Figure 7 - 0403

Tor Dania's master reported to VTS when the vessel was passing abeam of Clee Ness No.4A light float at 0403 (**Figure 7**). At this time, he advised VTS that he was reducing speed to ensure his arrival at Immingham coincided with a break in the traffic there. He then reduced speed from 17 to 14 knots. *Amenity*'s master heard this and was, therefore, aware of the name of the inbound vessel.

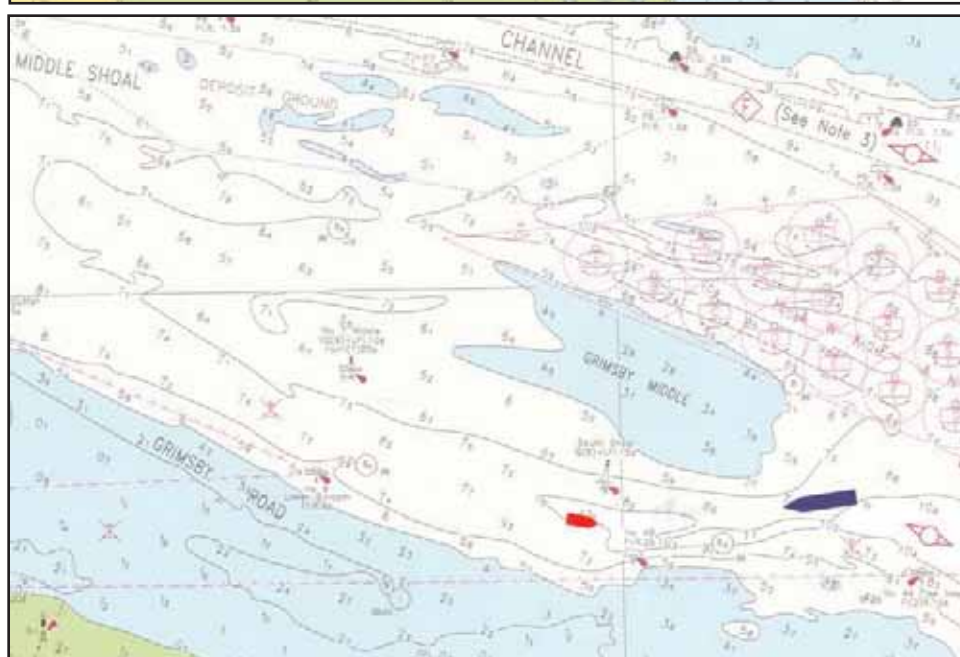
Figure 8 - 0406

At 0406 (**Figure 8**), *Tor Dania*'s master altered course to port to clear South Shoal buoy. *Tor Dania* overshot the turn fractionally, coming round to about 264° before adjusting course a little to starboard to pass close to the south of the South Shoal buoy. The vessel was to the north side of the channel, making good 14 knots. A snapshot taken from the vessel's ECS display is shown in **Figure 11a**.

Amenity's master expected to see *Tor Dania*'s green sidelight as she made her turn for South Shoal buoy. However, when he saw *Tor Dania* make her turn at about 0406, he interpreted what he saw as the vessel altering course to between 220° and 240°. As a laden tanker, he considered *Amenity* to be restricted to navigating within the buoyed channel. Therefore, faced with what he perceived as a vessel coming round across his bow with a closing speed of about 25 knots, he put his propulsion full astern. Aware that *Amenity* had a left-hand propeller, and that this manoeuvre would push the bow to port, he steered hard to starboard to counter the effect. However, as soon as *Amenity*'s propeller started to turn astern, the bow began to swing to port.

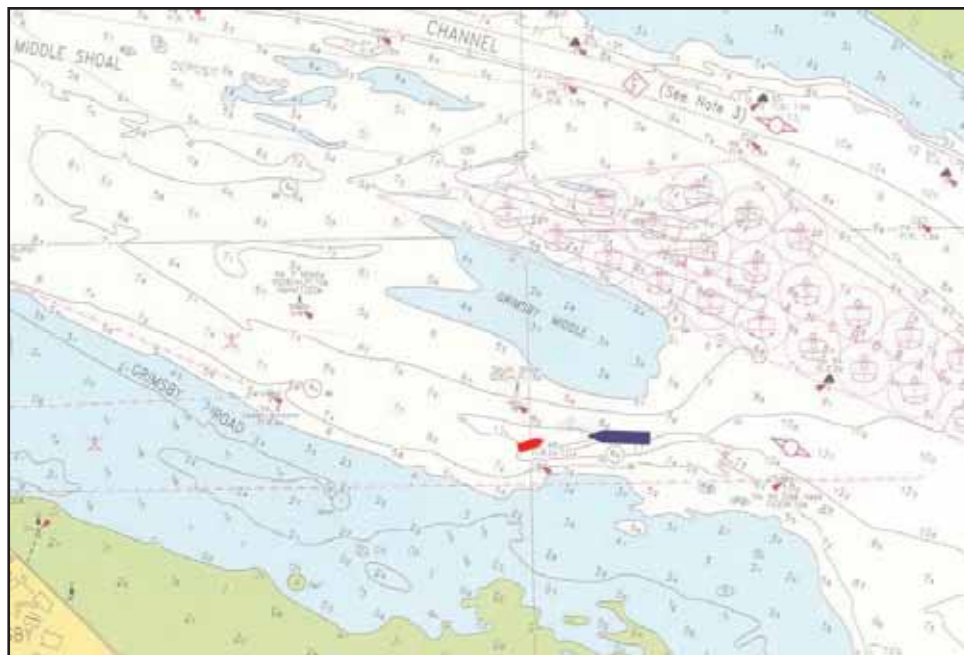
Figure 9 - 0407

At 0407 (**Figure 9**), the master of *Tor Dania* noticed *Amenity* starting to alter course to port, and initially he thought that she was making her turn for the No.4B buoy. However, when the vessel continued to alter course, he realised that a collision was inevitable, and ordered the helm hard to starboard to reduce the angle of impact. The collision occurred about 30 seconds later (**Figure 10**), and at 0407 50 *Tor Dania*'s master reported the collision to VTS.

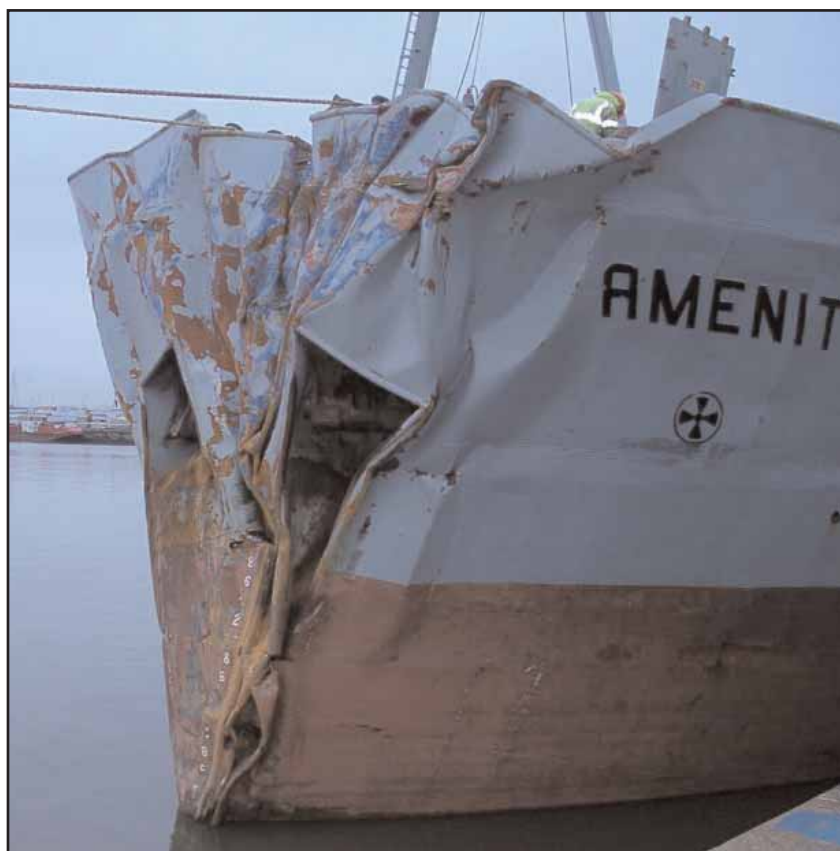
Figure 13

Damage to *Amenity*

The damage to *Amenity* was limited to her bow, as shown in **Figure 13**, and she was able to return to IOT under her own power. The forward collision bulkhead was not penetrated.

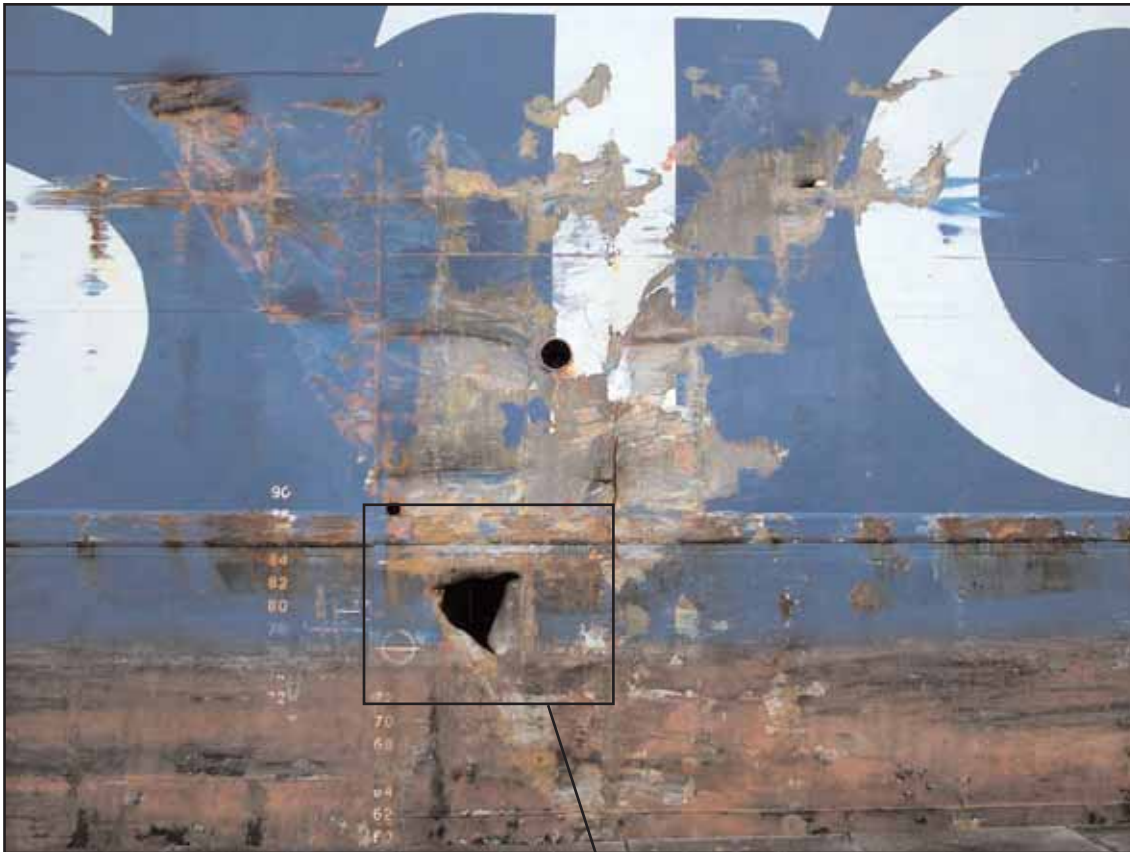
Figure 14

Tor Dania was holed in way of a bunker tank as shown in **Figures 14 and 15**. Fortunately, the hole was about 1 metre above both the waterline and the level of the bunkers in the tank. There was no pollution.

Damage to *Tor Dania*

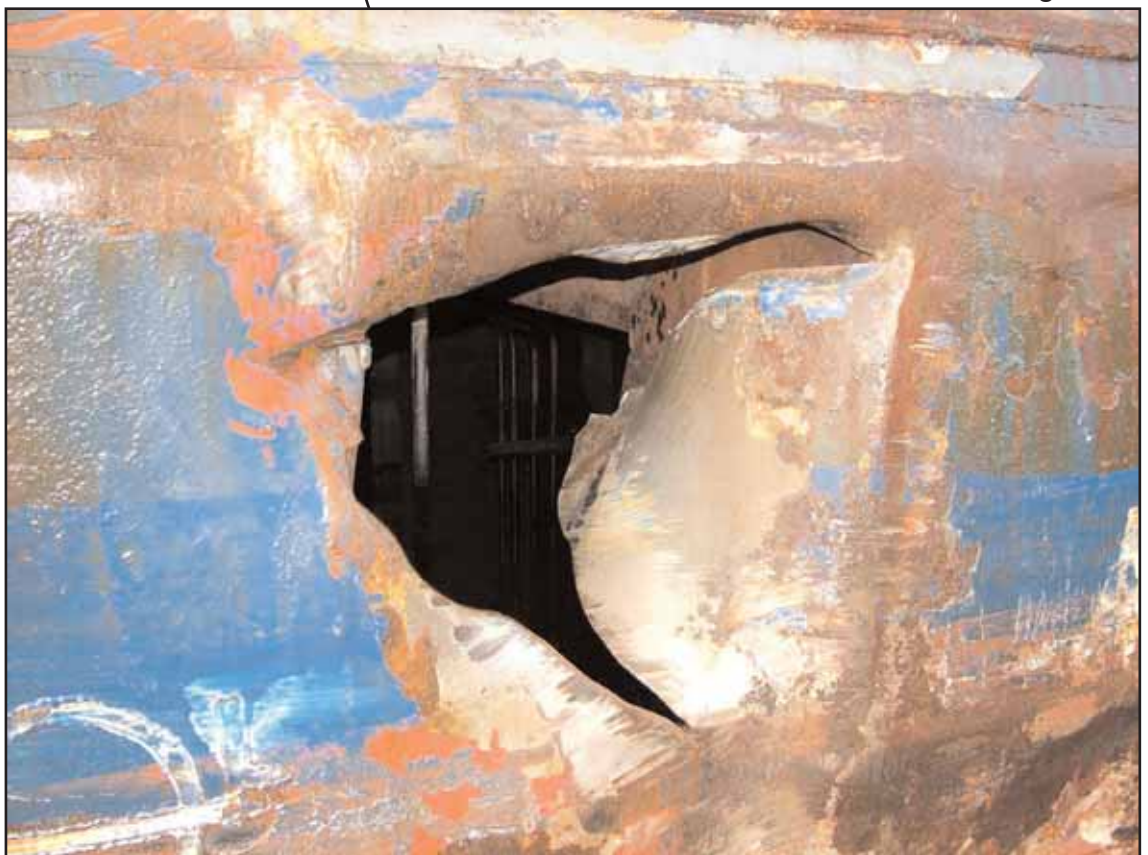
Figure 15

Close-up of damage to *Tor Dania*
