# MASTER'S PRE-SAILING CHECKLIST

M/V BEN-MY-CHREE

## SITE REPORT

### ***BEN-MY-CHREE*: COLLAPSE OF THE PASSENGER WALKWAY DUE TO UNINTENDED ENGINE MOVEMENT IN PORT**

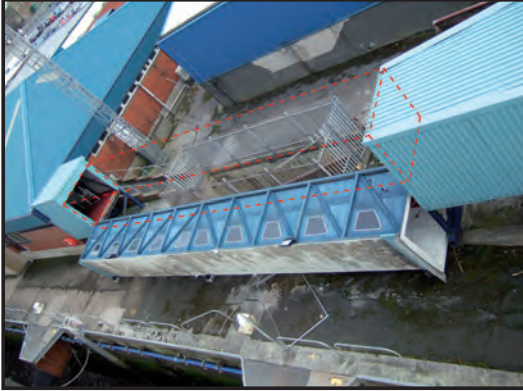
After 3 weeks in dry dock, the Isle of Man registered passenger vehicle ferry, *Ben-My-Chree*, undocked on 25 March 2010. Once refloated it was discovered that neither of the two bow thrusters could be started as their main circuit breakers were defective. The crew carried out some temporary repairs to get one bow thruster working and the vessel sailed to her home port of Douglas, Isle of Man and re-entered service.

The chief engineer was monitoring two shore technicians who had boarded the vessel at Heysham to repair the bow thrusters' defective main circuit breakers. The ship was also taking bunkers and the operation, monitored by the third engineer, was nearing completion. The starboard main engine was started by the second engineer at 1338, with the master's permission, in order to run the shaft generator to test the bow thrusters' main circuit breakers. At 1357, the chief officer requested the third engineer for bridge control of main engines as he wished to test controls prior to departure. (The normal practice on board for testing engines was to activate the pitch control levers before the engines were started and observe the pitch response).

The third engineer, who had previously been concentrating on bunkering, transferred controls to the bridge, and the chief officer, not observing that the starboard engine was running, put both engines' pitch control levers to the full ahead position. Within a few seconds, the vessel surged ahead, causing serious damage to the passenger access structure. The foot-passenger walkway detached at both ends and collapsed onto the quayside, and the gangway fell from the vessel's side shell door and was left hanging on a single rope. Fortunately, there were no injuries. Eight passengers were trapped in the gangway compartment of the shore structure and had to be rescued by the fire service.

1. Running main propulsion engines while a vessel is alongside is an extremely hazardous activity and must be controlled carefully. Several accidents in the past have resulted from failure of controllable pitch propeller (CPP) control systems resulting in propeller blades being inadvertently set to ahead or astern pitch. Sufficient safeguards must be put in place to mitigate the consequences if the CPP system fails to maintain the neutral position of the propeller blades and, specifically, to uncouple the hazards of engine operation from passenger or vehicle operations.

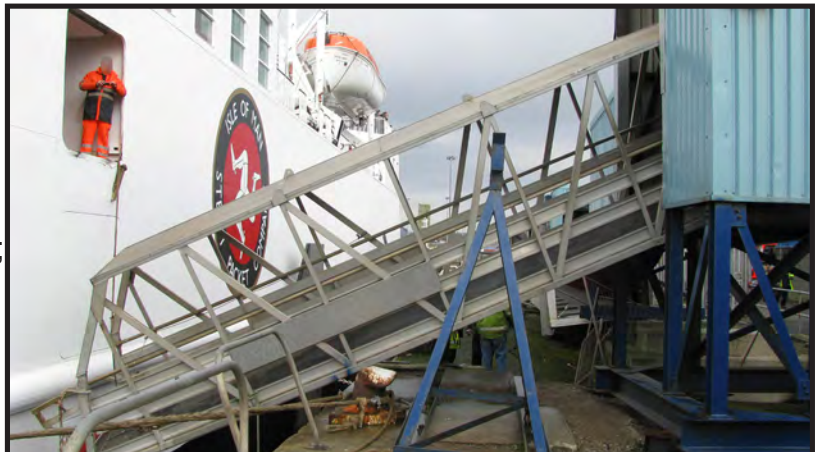
The Health & Safety Executive (HSE) completed an investigation into the failure of the passenger access structure. The investigation identified that the quay on which the passenger access structure was built had suffered considerable settlement over the years; the walkway was secured to the rest of the structure with only two small bolts at either end; and there were no records of inspections or maintenance

- *An inspection regime, similar to that for bridges, should be adopted with the findings of the inspection recorded and any remedial work identified should be carried out within an appropriate timescale. Particular attention should be given to safety critical parts of the structure. The inspection should be carried out by a competent person.*
- *For the procurement, operation and maintenance of ship to shore structures, reference should be made to the guidance provided in CIRIA Report C518, Safety in Ports, ship to shore linkspans and walkways.*

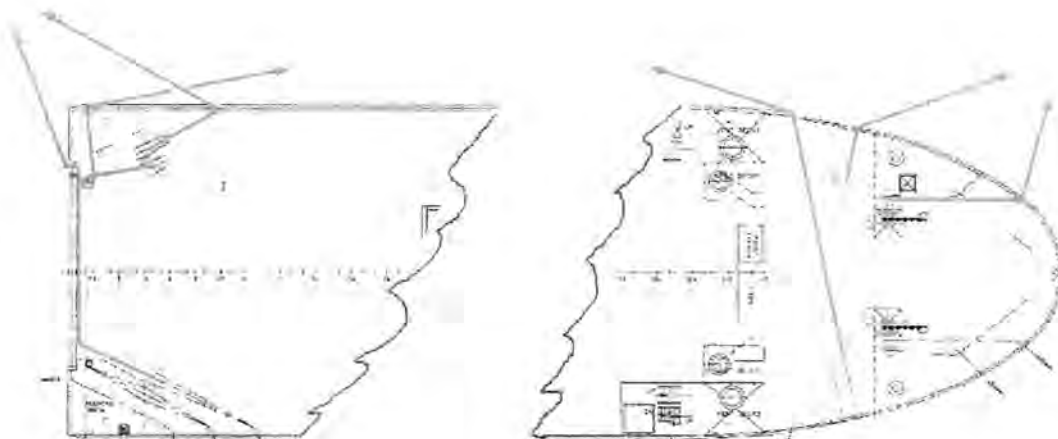
In normal conditions (i.e. moderate weather and tidal state, with little perceived risk of ranging) the vessel is moored with two headlines, two sternlines, a forward backspring and an after backspring, all led to tension winches as indicated in the plan below and set at 25% with the exception of the after backspring, which is held on the winch brake.

All ropes are 64mm 6 strand X-lay Atlas (breaking strain 81 tonnes) fitted with 44mm Dynex tails (breaking strain 148 tonnes) to assist handling. Both types of rope are stated by the manufacturers to have an elasticity to breaking point of about 4% - 6%.
