Collision between tug *CHRISTOS XXII* and its tow, *EMSSTROM*, Hope's Nose, Tor Bay, England 13 January 2013

SUMMARY

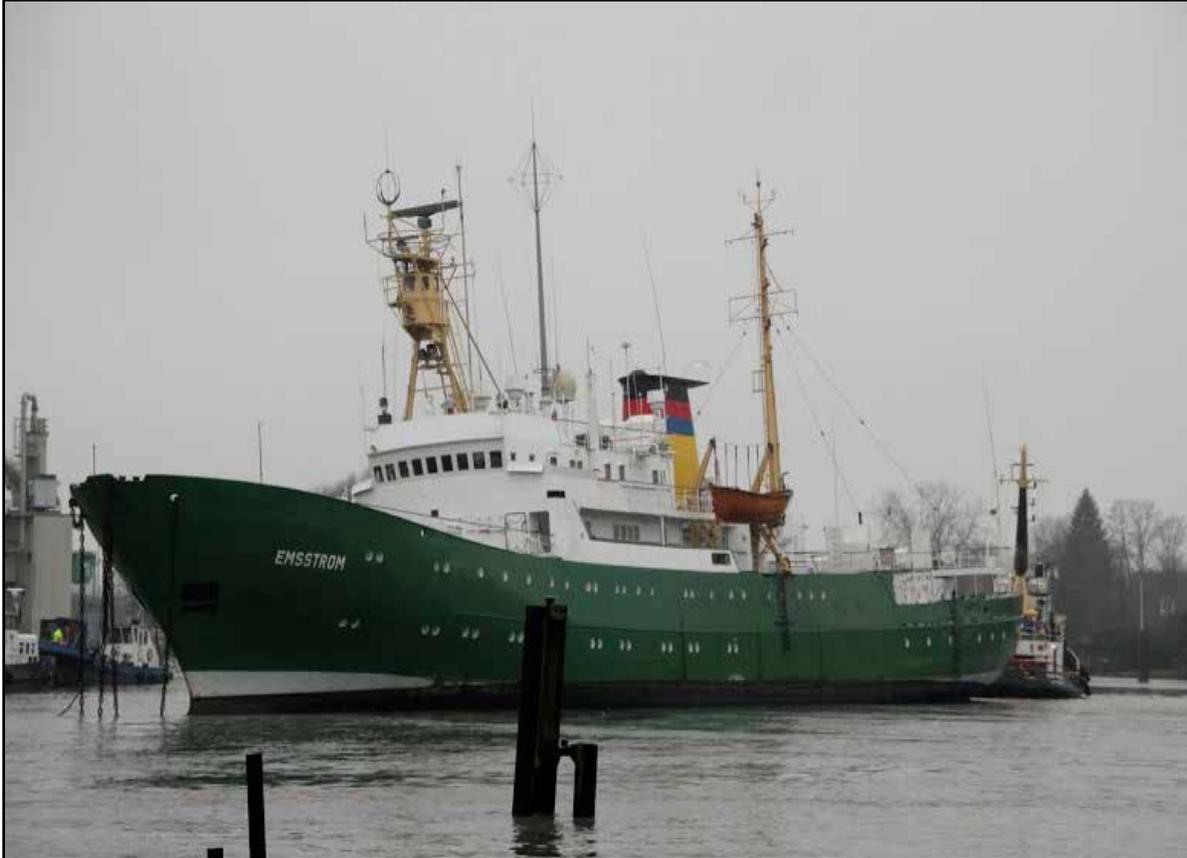
At 1030 on 9 January, *Emsstrom* was pulled clear of the berth at Leer by river tugs. It had been sitting on the bottom at the berth and, once clear, developed a list of 5-10° to starboard. *Emsstrom* arrived at Emden at about 1200 the next day. However, on seeing the list, *Christos XXII*'s master refused to accept the tow and *Emsstrom* was moored alongside the quay to enable Avalon Maritiem staff to correct the list. This was achieved by transferring ballast water using a salvage pump from *Christos XXII*, which formed part of the equipment kept on board *Emsstrom* in accordance with the towage plan.

Figure 2: *Emsstrom* showing list to starboard

At 1700 on 12 January, *Christos XXII* was in deeper water and the scope of the tow was increased to 480m. The following morning, at 1100, the tug was in the English Channel when *Emsstrom* was seen to have developed a list of about 10° to port. The master informed the tug's managers, Christos XXII Spanopoulos Tugs, and then called MRCC² Brixham by VHF³ to request permission to enter Tor Bay to seek shelter and investigate the cause of the list. In preparation for this, he reduced the scope of the tow to 200m and altered course towards Tor Bay.

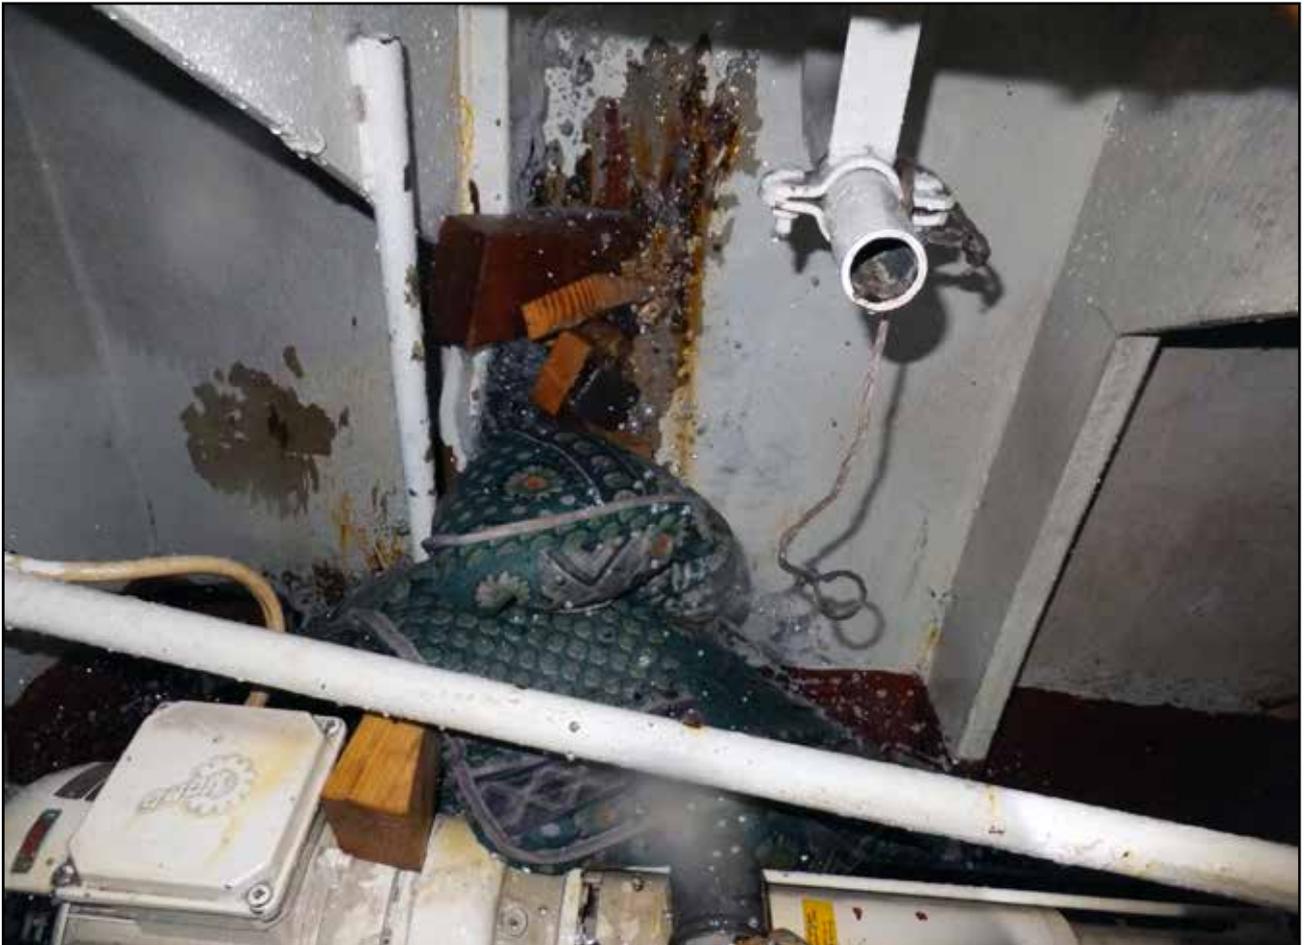
The master immediately put the bow thruster to starboard, the starboard engine full ahead and the port engine full astern in an attempt to move *Christos XXII* sideways away from *Emsstrom* and avoid a collision. However, at 2058, *Emsstrom* struck *Christos XXII* just aft of midships on the port side.

As the master attempted to manoeuvre clear, the motorman called the bridge from the engine room by telephone, informing him that there was major water ingress to the engine room. It was found that *Emsstrom*'s bow had penetrated *Christos XXII*'s shell plating below the waterline in way of the hydraulic motors in the engine room.

Figure 3: Damage to shell plating in engine room

When the master ordered the release of *Christos XXII's* port anchor, the tug was downtime of *Emsstrom*. The anchoring had the effect of pivoting *Christos XXII* to port, stopping it in the water, side-on to the tide and in the path of *Emsstrom*, which maintained its momentum, leading to the collision.

2014/112 Develop a crisis response management cell and associated procedures to provide support to ships' staff in crisis situations.

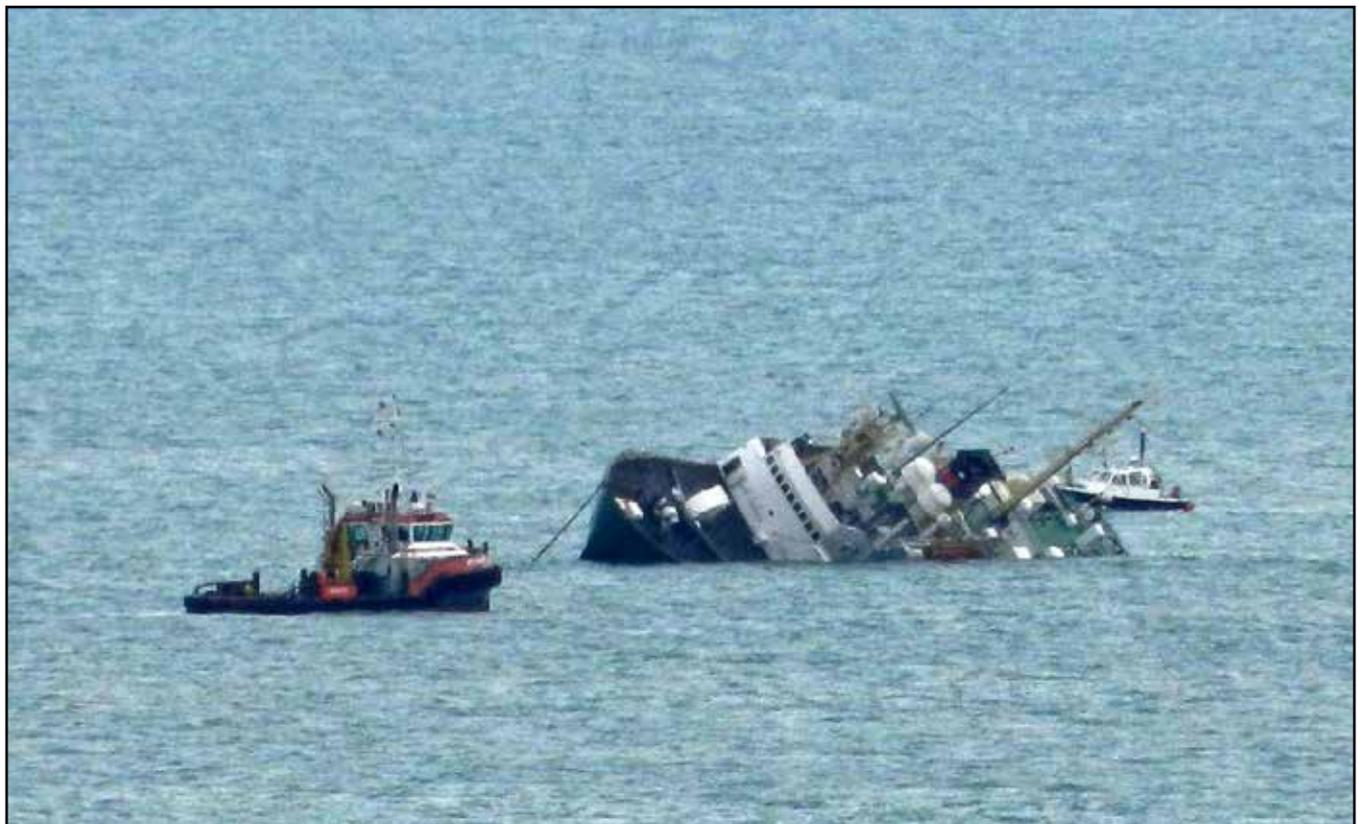
Emsstrom's position had been monitored throughout, and attempts were made by one of the other vessels that responded to the "Mayday", to tow the vessel. However, *Emsstrom* sank in 25m of water at 1326 on 14 January.

Figure 4: *Emsstrom* sinking
