Report on the investigation of the  
capsize of an un-named

**Haitian sloop**

***Sea Quest***

**Report No 17/2007**  
**August 2007**

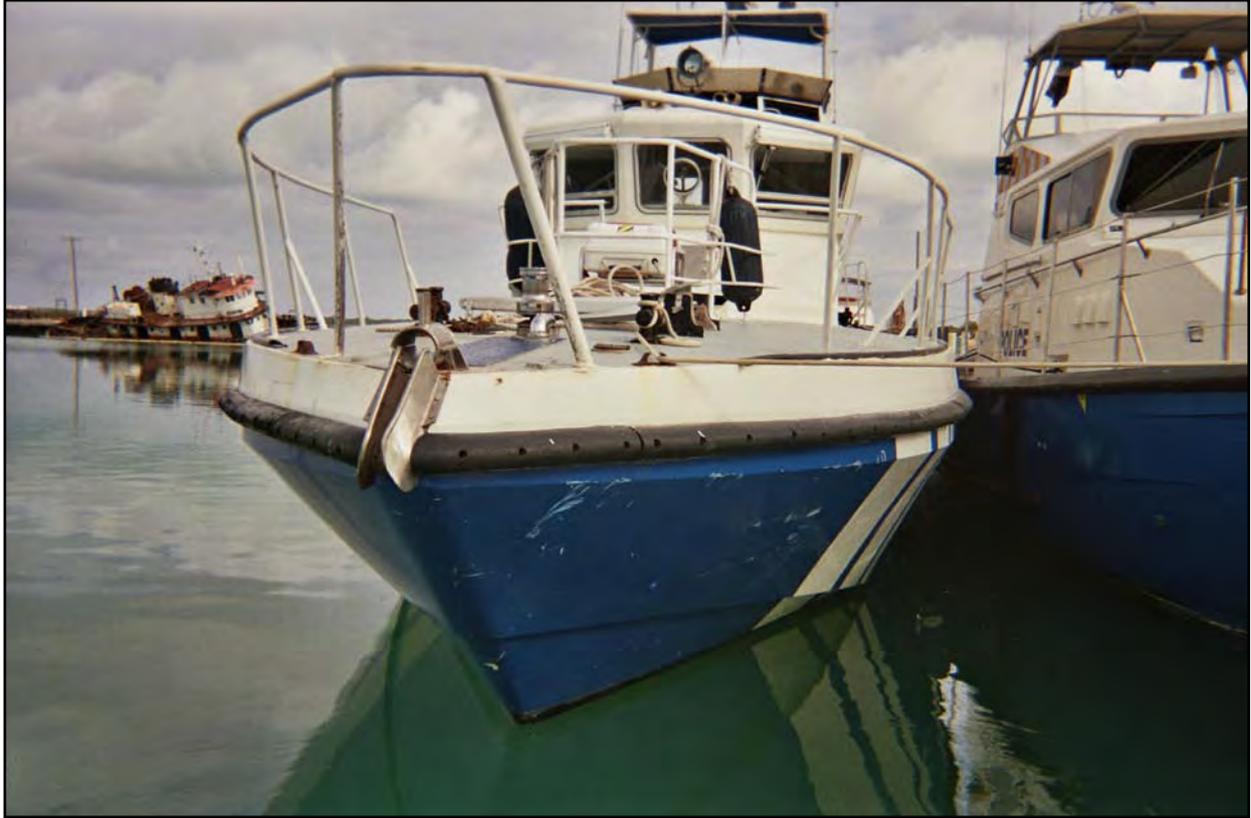
Figure 1

*Sea Quest*

The hull was in generally good condition, with some scuffing around the sides. The port bow had some scratching in the gel coat, and some light blue paint from another source had adhered to the hull in that area (see **Figure 1**). There was no damage to the stern, nor evidence of any recent repairs to the hull.

A few witnesses claimed that the sloop capsized following a collision with, or ramming by, *Sea Quest*. However, close inspection of both vessels revealed no signs of collision damage. A small quantity of light blue paint, similar to that on the sloop, was found on *Sea Quest's* port bow, and this was considered consistent with the captain's description of his initial coming alongside and bumping the sloop.

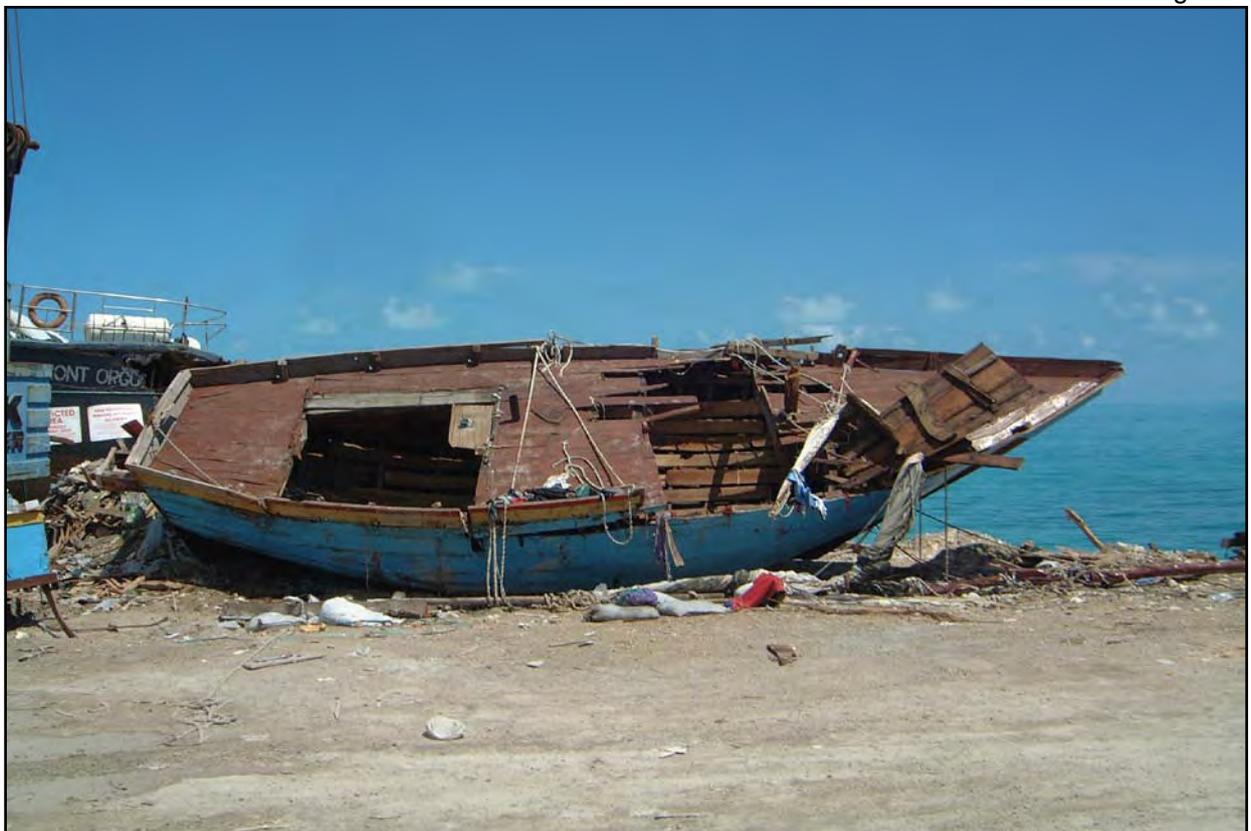
Figure 2

Haitian Sloop - after recovery

To remove the bodies, it was necessary to remove the cabin structure, and to make cuts into, and to lift, part of the main deck (**see Figure 2**). This activity and the ensuing damage to the vessel were photographed, and these photographs were available to the investigators during their examination of the wreck. Twelve bodies were removed in total, ten from the hold, and two that were trapped in the rigging on the upper deck.

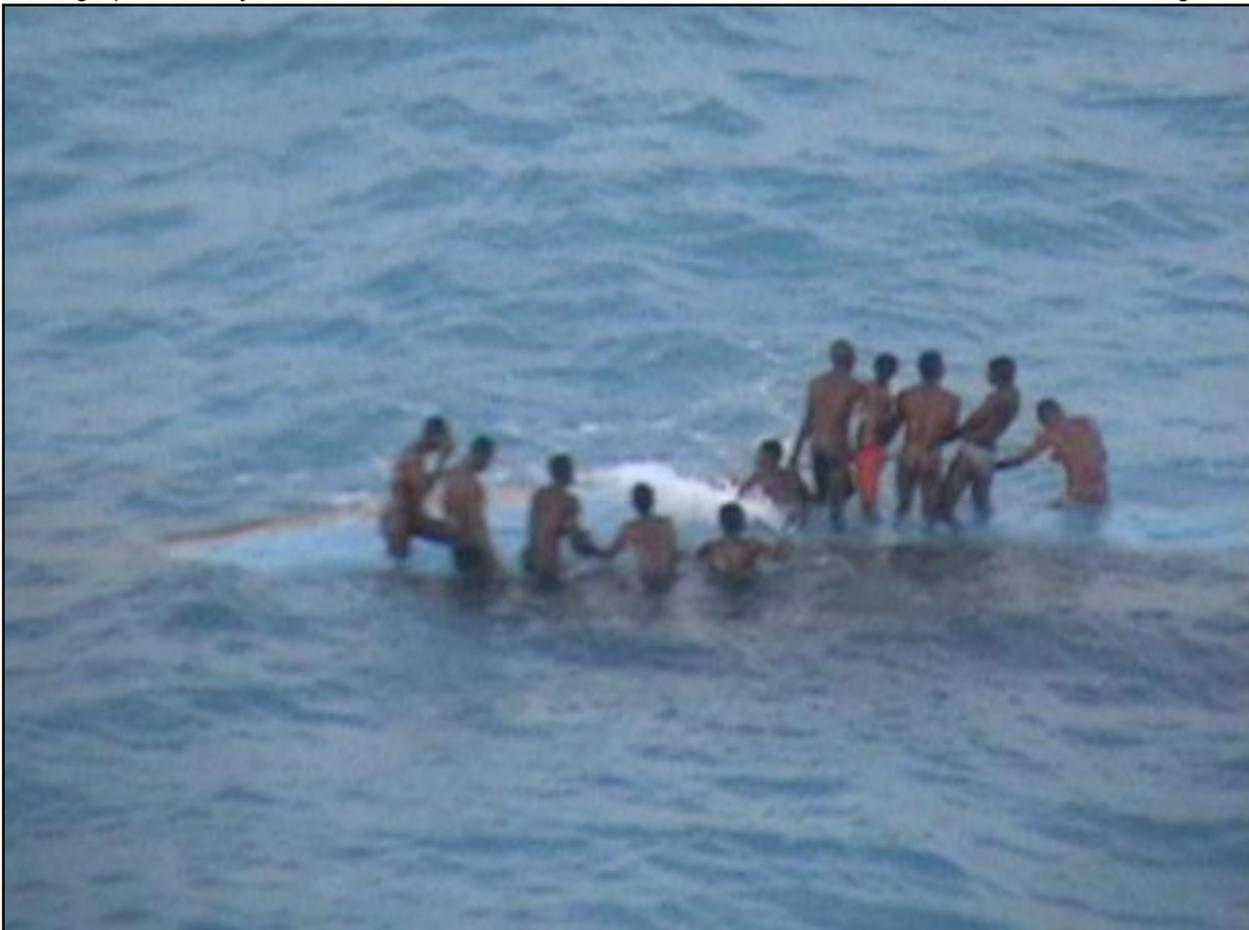
Figure 4

Survivors standing on hull of sloop

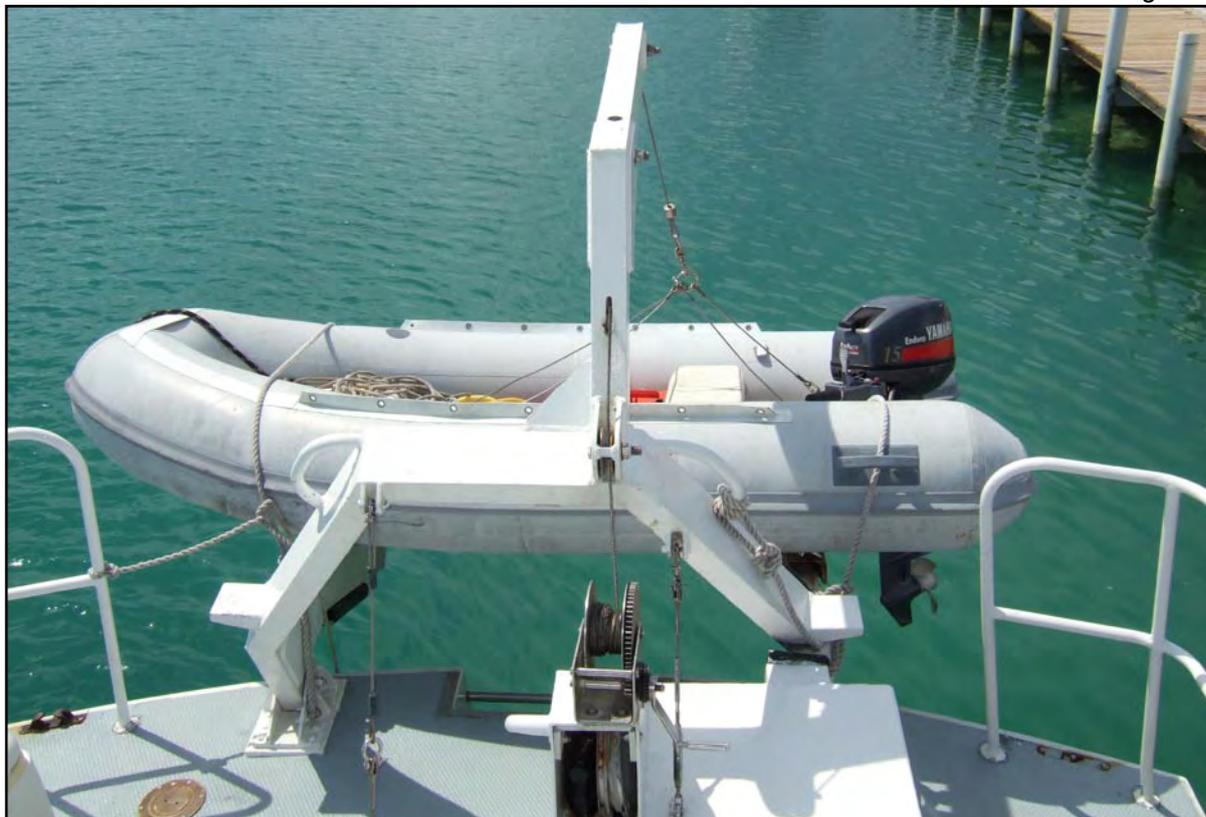
Search and rescue was not the vessel's primary task, and it was not therefore designed or equipped for such activities. The high freeboard to port and starboard made difficult the recovery of people from the sea, and the absence of guard rails, portable or fixed, along the sides presented a hazard to personnel recovering people in those areas. While the rescue boat boarding ladder set in the transom provided one method of boarding, this was close to both propellers and would have restricted the vessel's manoeuvrability while it was being used.

Sea Quest - rescue craft

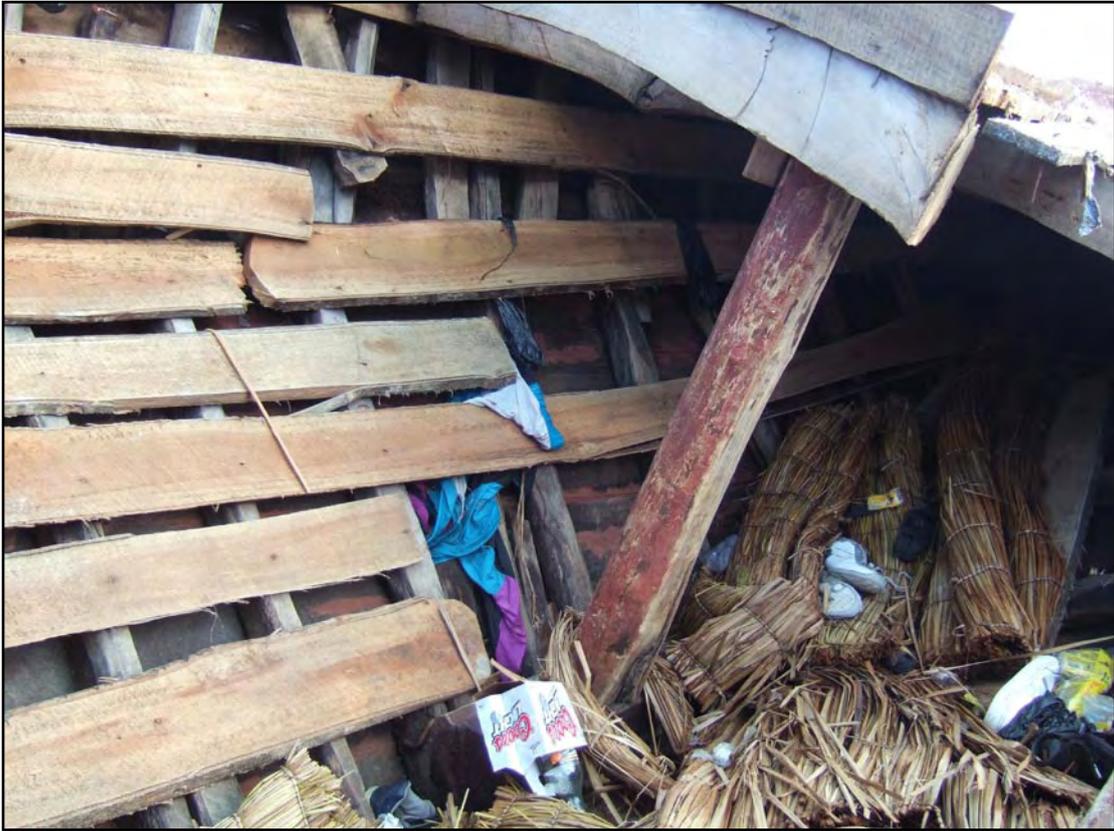
Figure 10

Internally the wooden frames and hull were protected by longitudinal spar ceiling (**Figure 10**). Personal possessions were littered inside the hull, and a number of small plastic bags were found tied to the spar ceiling and beams; these had been used to hold potable water. Similar bags had been used to dispose of human waste.

Internal view of Haitian sloop

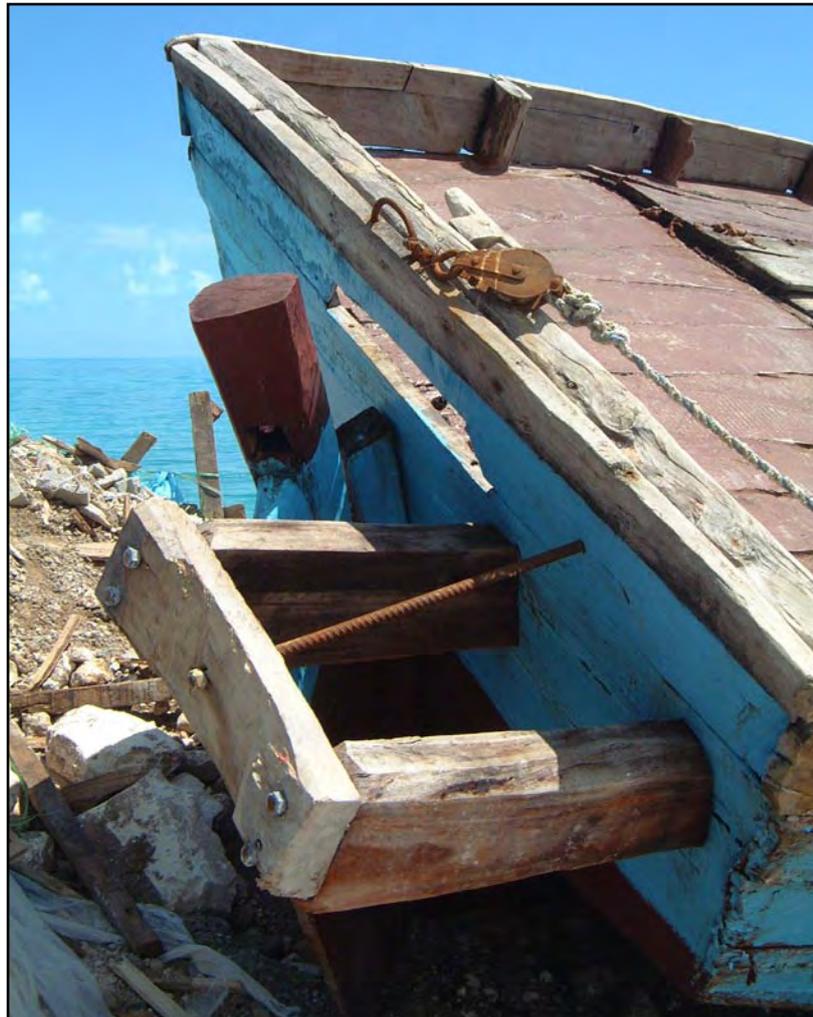
Figure 11

A substantial outboard motor bracket was fitted to the transom stern, its wooden construction showed signs of previous use (**Figure 11**). Although no outboard motor was recovered with the sloop, *Sea Quest's* engineer had noticed that an outboard motor had been lying on the aft deck when the vessel was intercepted. Evidence from one of the survivors indicates the outboard motor was a 35 HP Mariner engine. A white plastic 15 gallon drum was found inside the sloop when it was examined ashore. The drum contained less than 1 gallon of liquid, and interviews with the passengers confirmed that it had been stowed below deck and had provided fuel for the outboard motor.

Outboard bracket

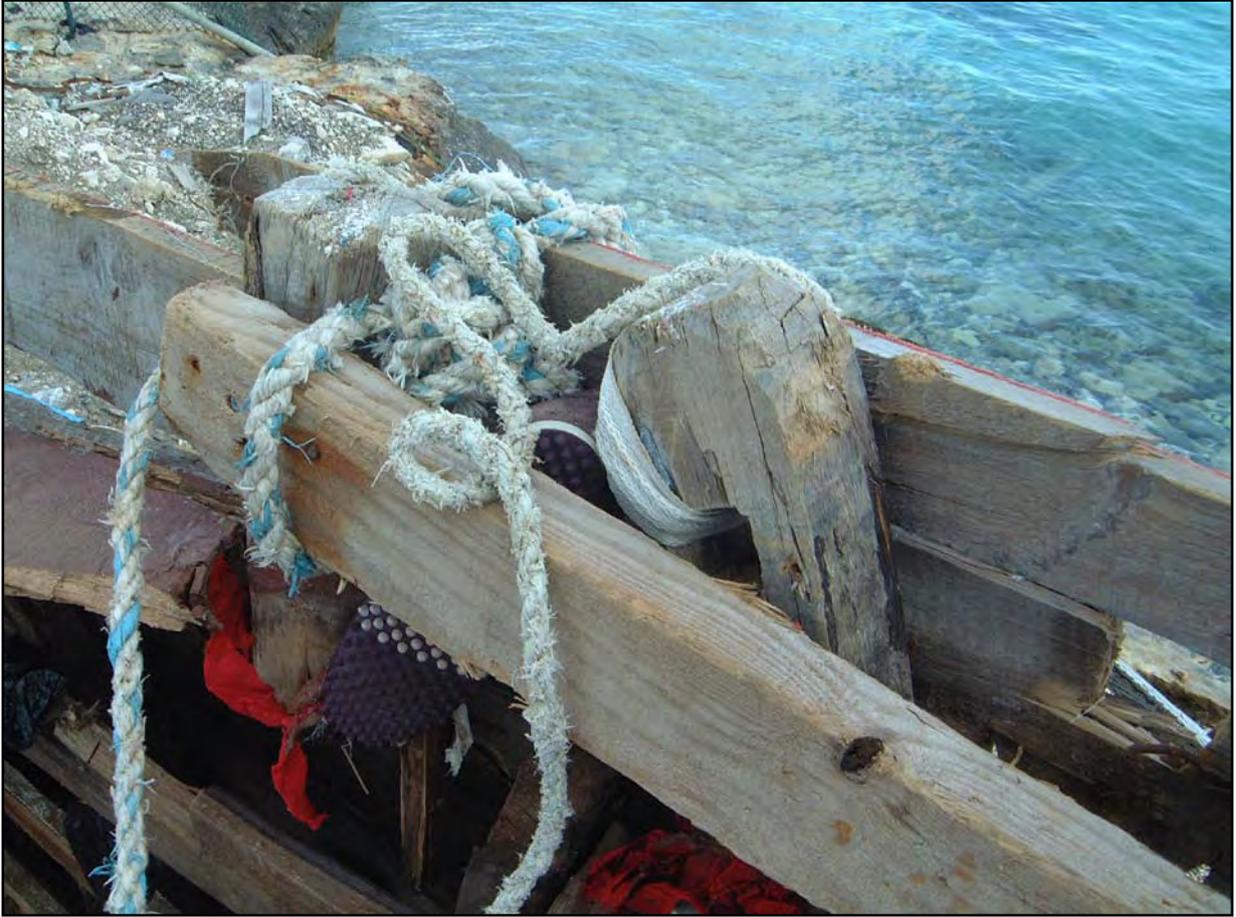
Figure 12

Main mast shroud lashings attached to extended frame

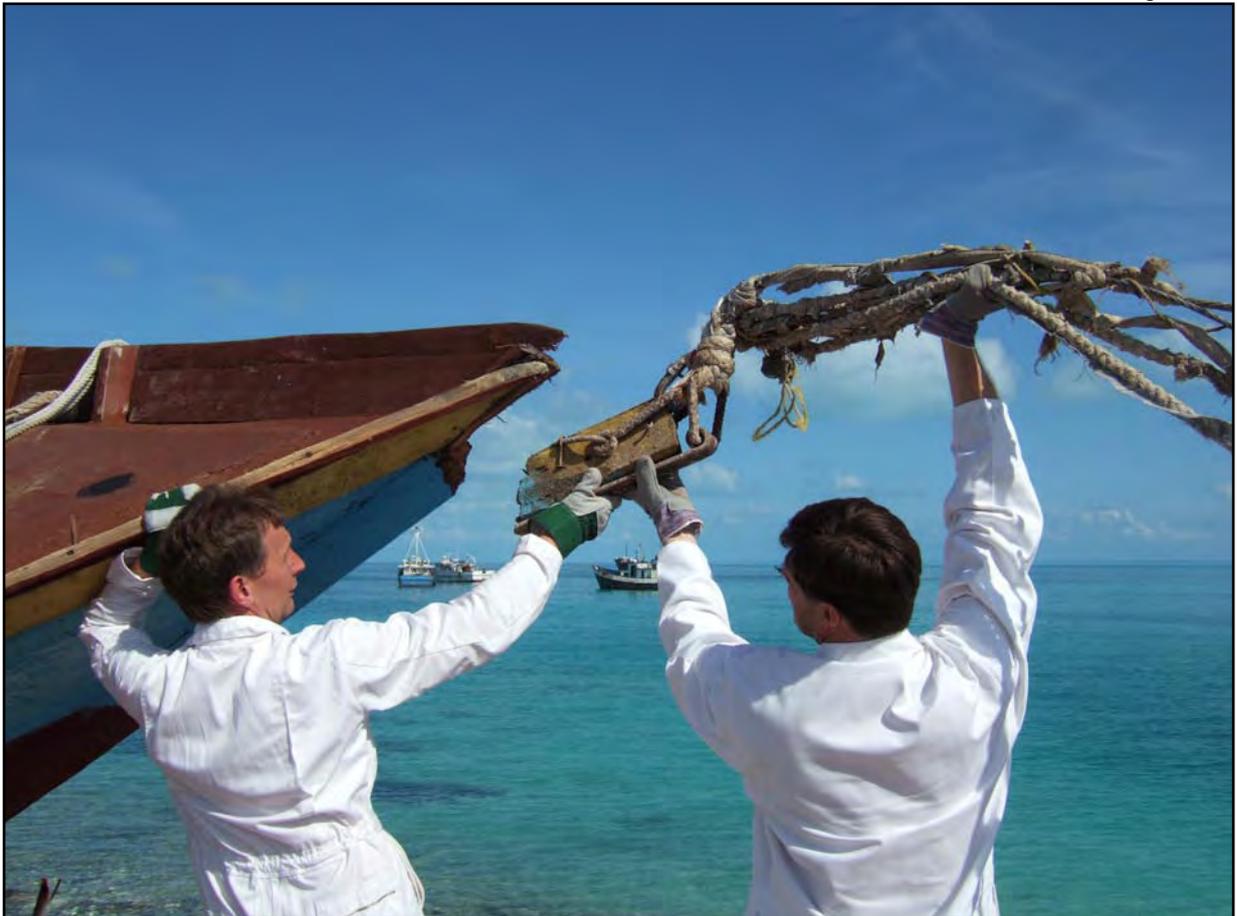
Figure 13

Forestays attached to broken stem head

The wooden stem head had broken off below its metal reinforcement (**Figures 13 and 17**), and this was independently examined to determine how it had failed. The examination determined that the stem head had fractured under a load of approximately 1.5 tonnes, and it had failed downwards and backwards, consistent with a pulling force along the sloop's starboard deck edge.

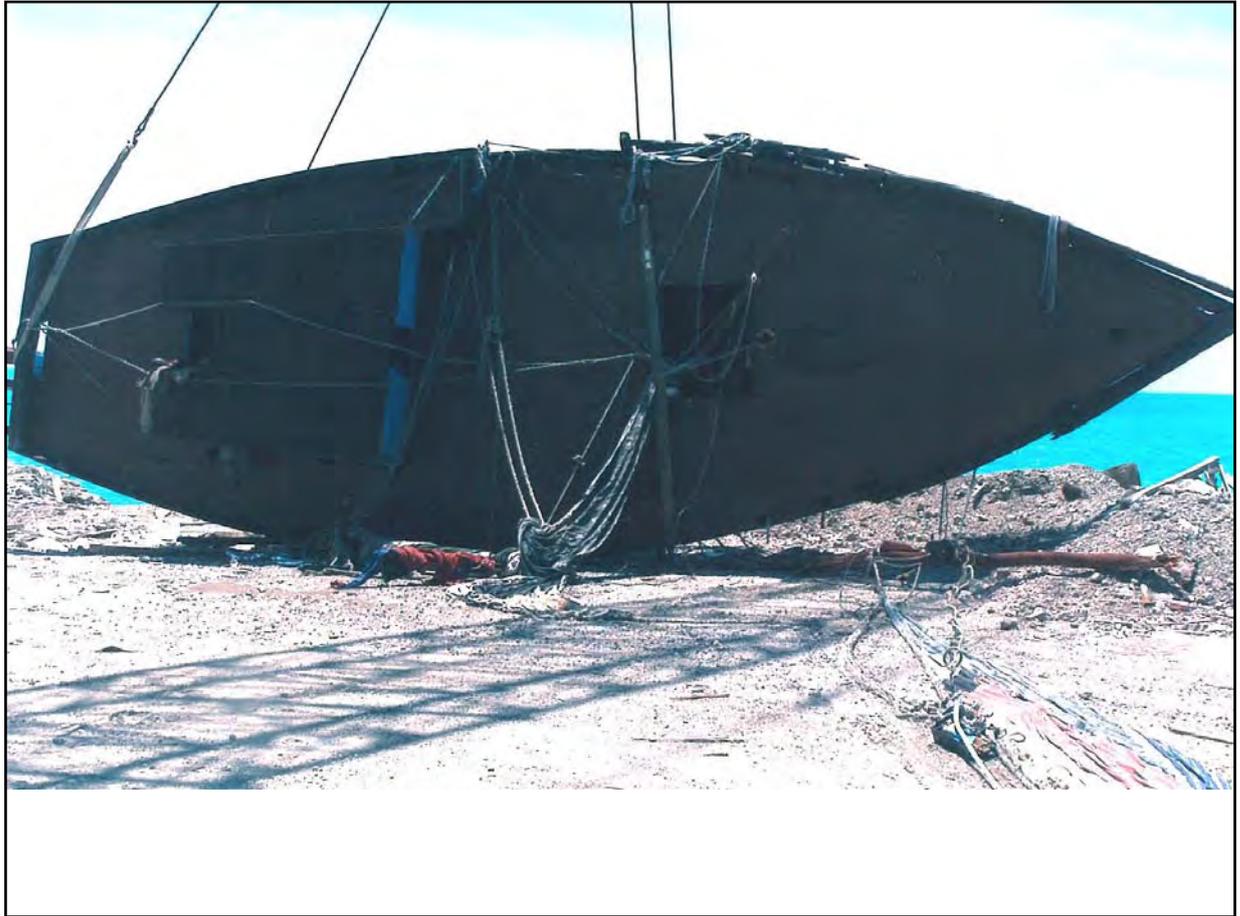
Overall, the hull showed little signs of damage. A few planks were loose at their ends and some caulking had become dislodged. However, there were no impact marks, and photographic evidence indicates that the hull flexed considerably when it was lifted ashore, giving this as the likely source of the damage (**Figure 15**).

Flexing of hull as sloop lifted ashore

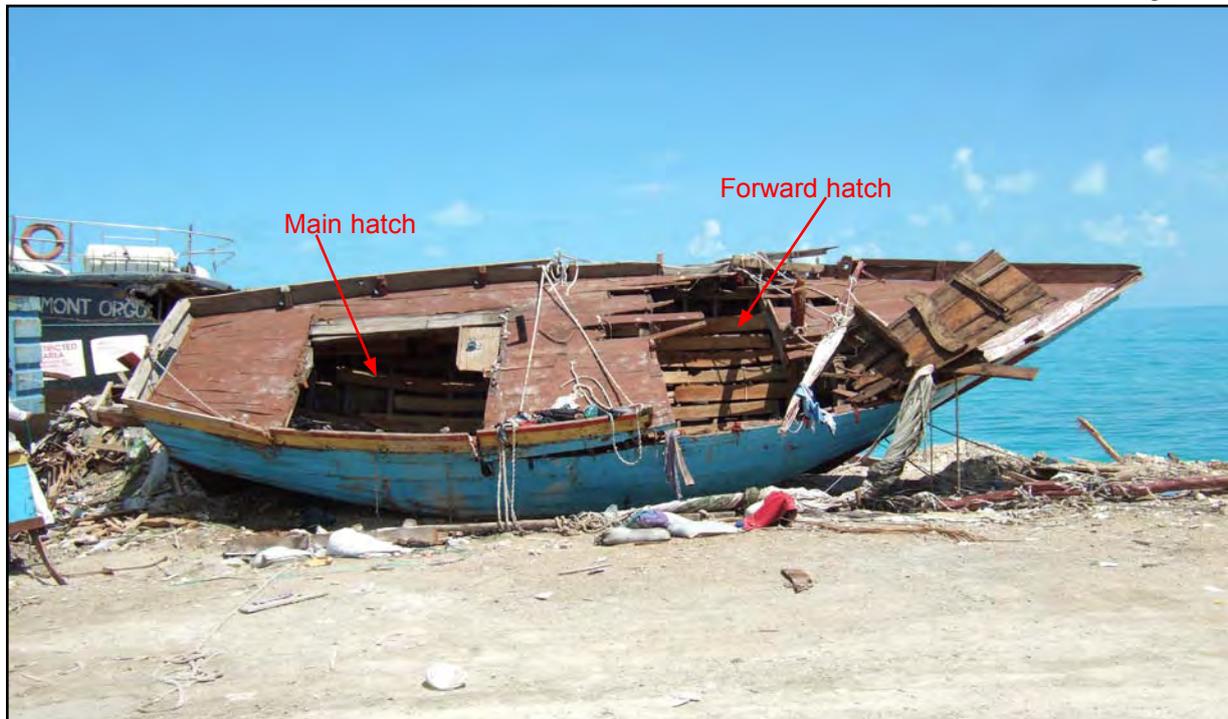
During the operation to recover the bodies from the wreck, the coach roof covering the aft hatch was removed; a deck section on the starboard side, adjacent to the main aft hatch was cut off; and a deck section athwartships, in way of the forward hatch (**Figure 16**), was cut off. Some of the gunnels were broken, but photographs of the lifting of the sloop ashore indicate that this was likely caused by the compression of the lifting slings.

Sloop with deck areas removed

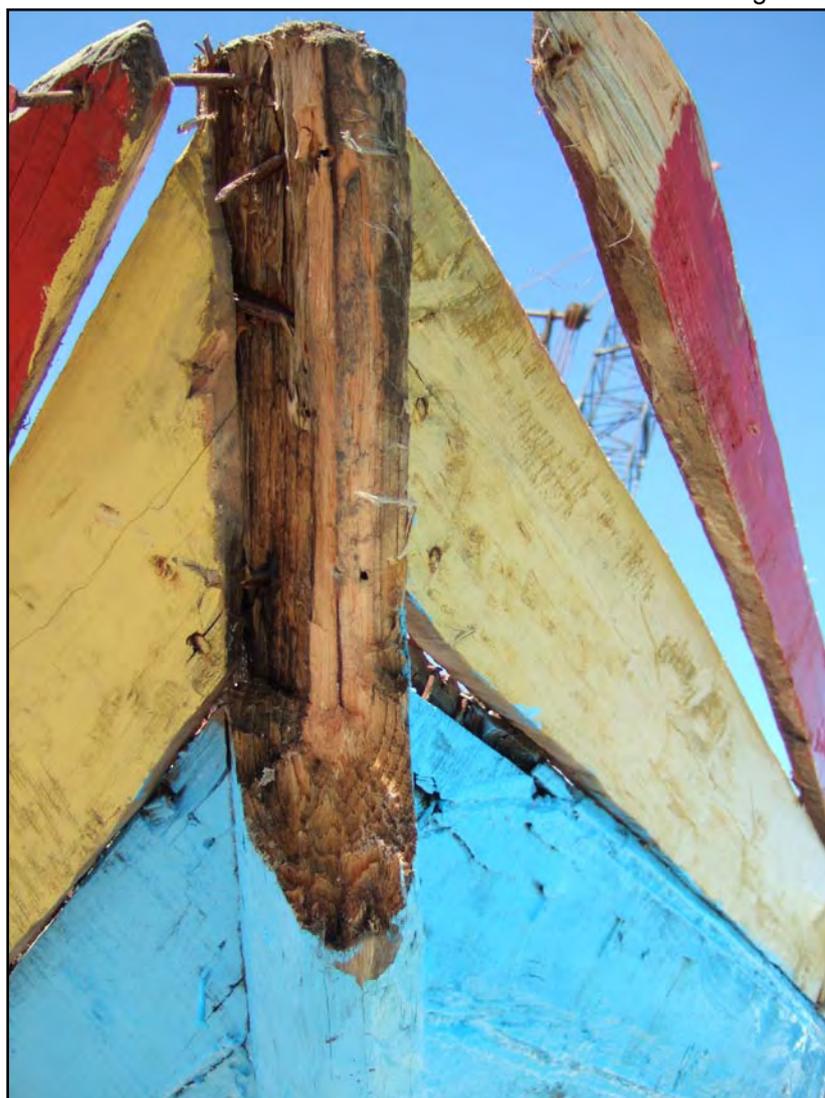
Figure 17

Sloop bow showing area of damage where stem head fractured

Given a capsize to port while under tow at 5 knots, it is possible to explain the force required to turn the sloop to lie on its starboard side, and the fracture to the stem head. Perhaps the only credible theory is that, as the sloop capsized to port, the sail, which had been bundled up on that side (the leeward side) when it was lowered, acted as a drogue on hitting the water. The force of the sail pulling astern would have dragged the sloop's bow to port. Also, this drag, acting through the halyard, probably fractured the mast. As the sloop continued to roll to port and the mast hit the water, the mast was forced backwards and upwards, i.e. to starboard. This action would have caused the stem head fitting to fracture in the direction suggested by analysis. With the point of towing effort now transferred (via the forestay to the mast top) to the wire shrouds, the continued pull of *Sea Quest* as she slowed down would likely have been sufficient to continue the rotation of the sloop until the hull lay on its starboard side. A violent capsize of this nature would also explain why two of the passengers perished, trapped against the deck by the rigging.
