Failure of the controllable pitch propeller of the chemical tanker *Key Bora*, resulting in heavy contact with the jetty in the port of Hull 20 December 2013

SUMMARY

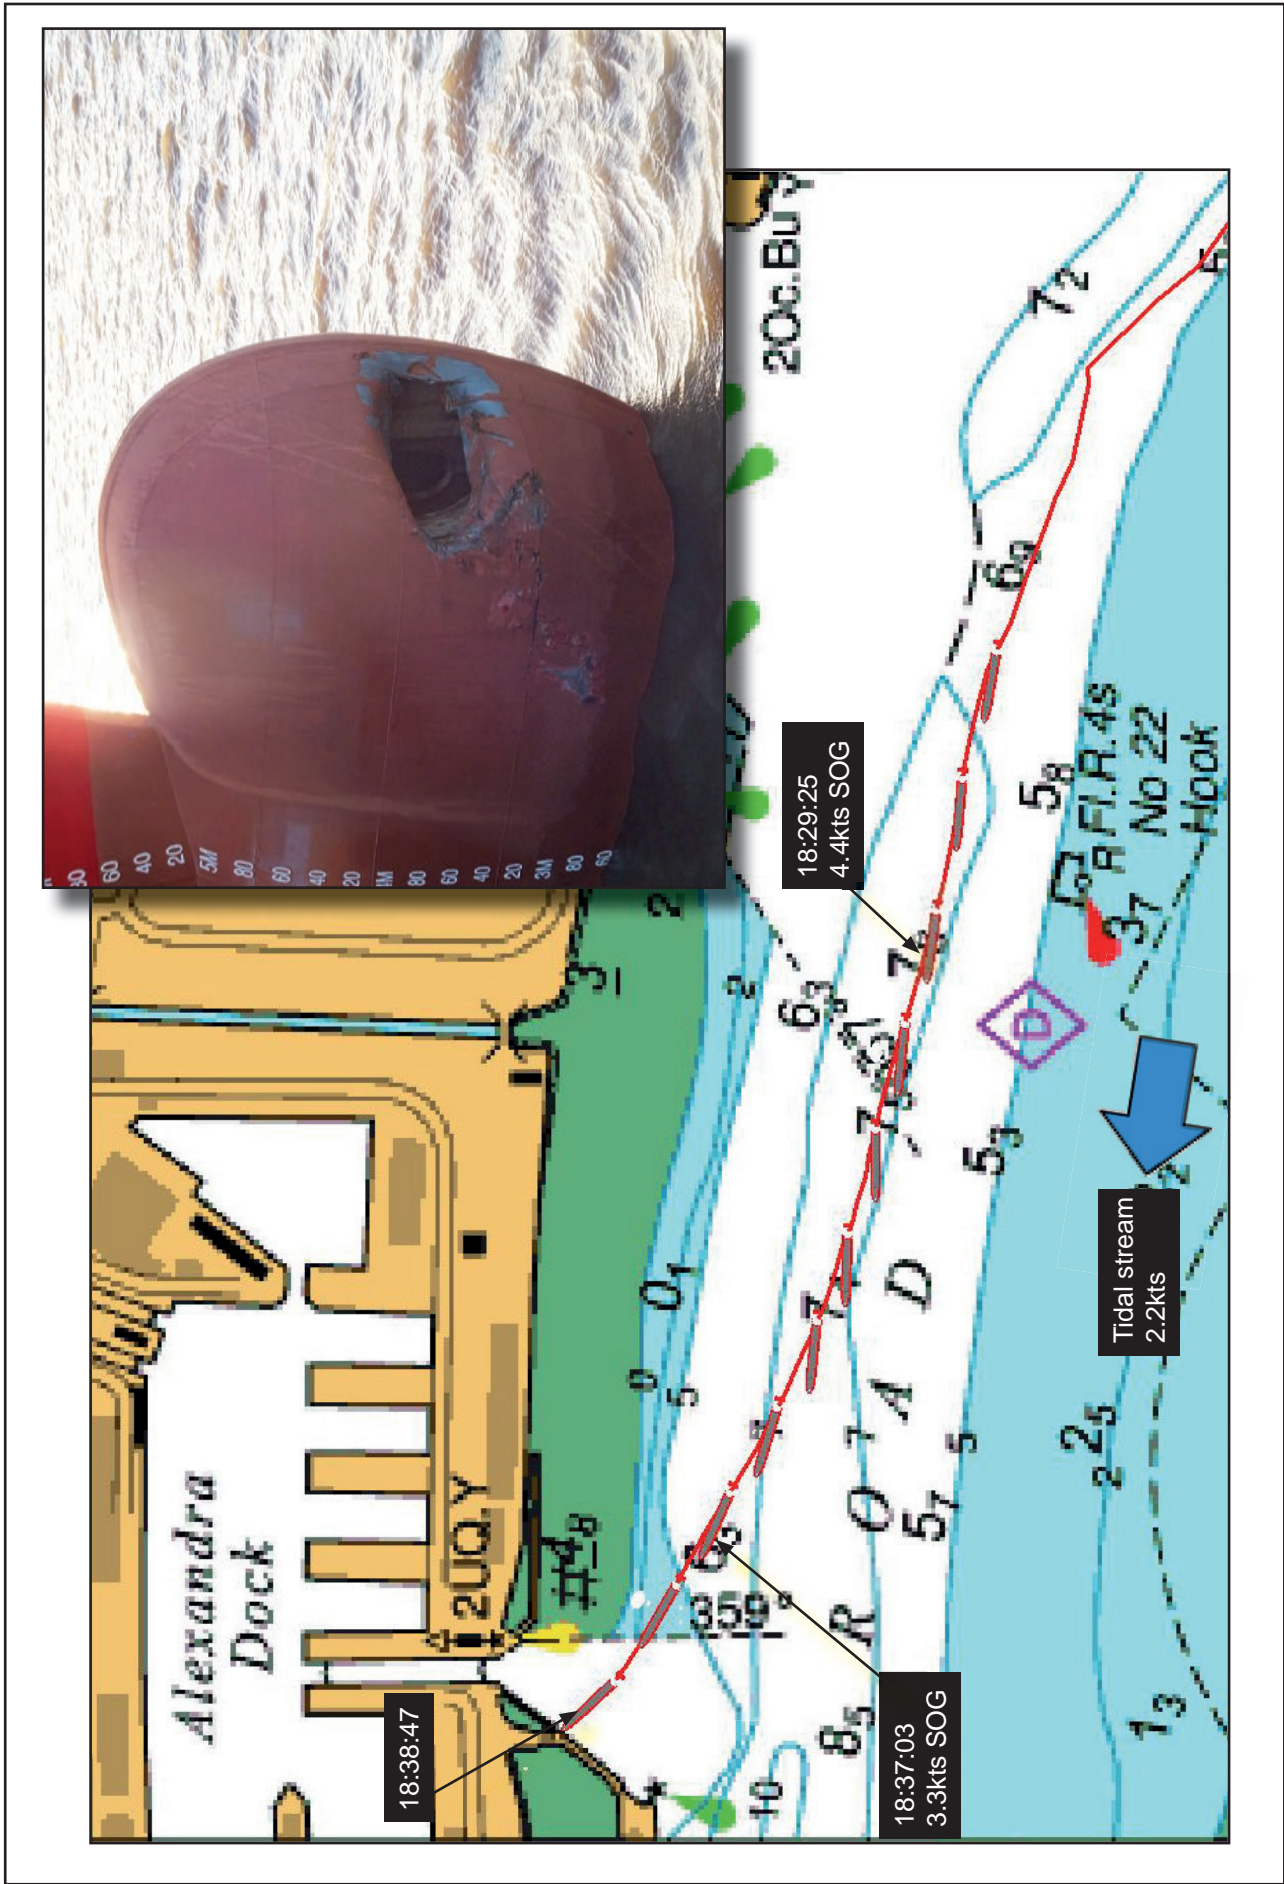
Figure 1: Approach to Alexandra Docks, showing Key Bora's position, speed and tidal stream

As part of the subsequent master/pilot exchange the pilot agreed with the master that, to compensate for the slow astern response, he would stop the vessel immediately after passing the Hook Buoy (**Figure 1**), and asked for the anchors to be made ready.

The impact caused a hole, approximately 90cm in diameter, in the bulbous bow 1m above the waterline (**Figure 1 inset**). There was no pollution but the jetty suffered damage to the wooden fenders and piling on the west lead-in section.

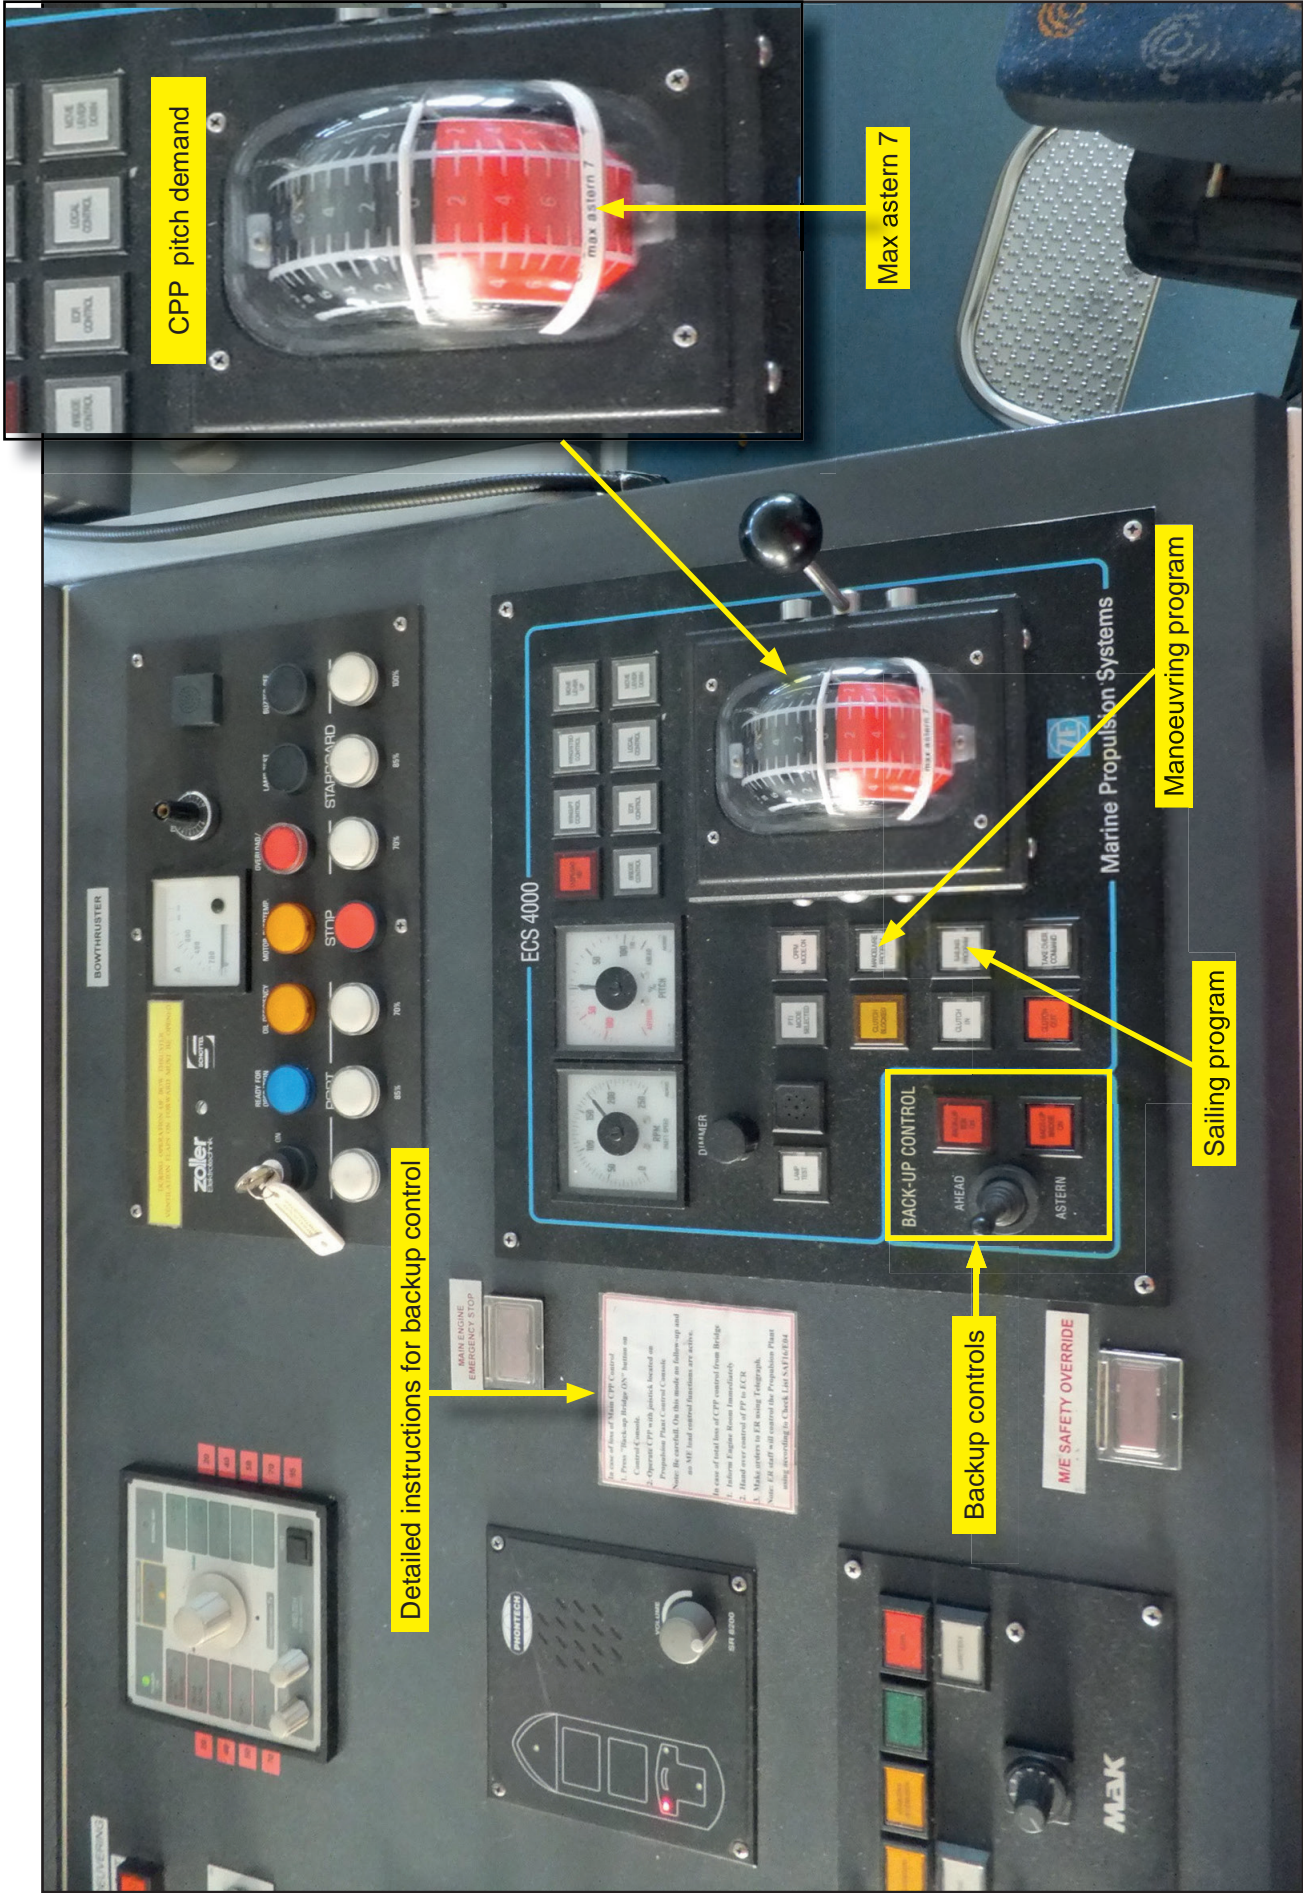
Figure 2: Bridge central control unit

The CPP control system was an ECS 4000 supplied by NORIS⁹. It consisted of a central unit that integrated the signals from all the sub-systems including the bridge controls (**Figure 2**), engine control room control and the local emergency control, and a PLC¹⁰ that translated the pitch demand into electrical signals for ahead and astern pitch solenoid valves. These in turn controlled the flow of high pressure hydraulic oil to the CPP pitch actuator. This actuation was controlled by the PLC through a closed loop feedback system. An LCD¹¹ touch-screen provided a user interface to the central unit and was used to set the PLC's control parameters.

In the event of a malfunction, the feedback system could be bypassed by activating one of the backup control buttons, located at the central console on the bridge and in the engine control room, enabling direct joystick control of the solenoid valves. A notice containing detailed instructions for operating in the backup control mode was displayed at the central console on the bridge. The pitch control levers at the central console and the bridge wings had labels pasted on the astern sections of the graduated scales stating *max astern 7* (**Figure 2 inset**).

A notice containing detailed instructions on the use of the backup system control was displayed prominently on the central console on the bridge (**Figure 2**). Had the master been familiar with this control mode, he would have known that a faster, more effective response could have been achieved by using it. However, the vessel's safety management system contained no requirement for deck officers to familiarise themselves with this mode of control or to conduct propulsion failure drills, and no such drills or familiarisation had been completed.

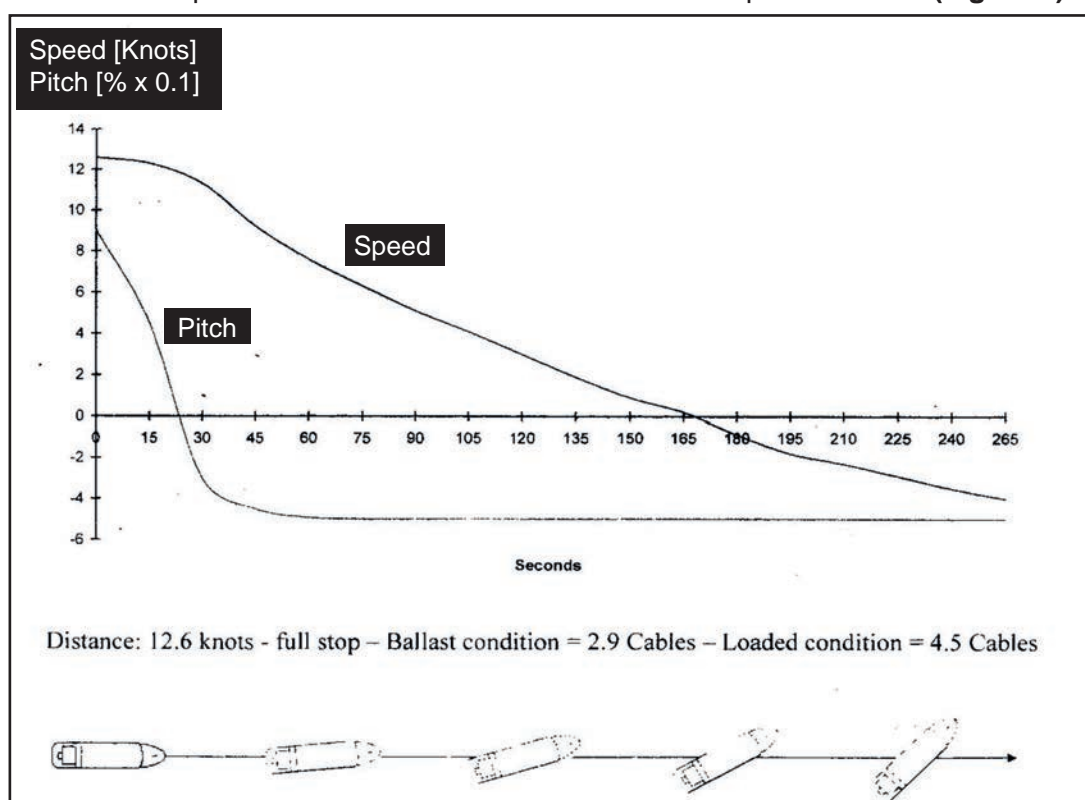
Figure 3: Crash stop tests (as displayed on the bridge of *Key Bora*)

During the investigation, an undated record of a crash stop test was found on board the vessel. BV was unable to confirm when this data was acquired and there were no other records available on board or with BV regarding any other crash stop tests carried out on *Key Bora*. The time taken for the pitch to change from full ahead to stop was recorded as 19.6 seconds, and from stop to full astern as 14 seconds. The full ahead pitch was indicated as 90% and full astern pitch as -50% (**Figure 3**).

The crash stop test was most probably carried out during the sea trials in 2005, as there were no other records of further sea trials or tests on the CPP system. Full astern pitch was recorded as -50% in the crash stop trial, demonstrating that the vessel was unable to achieve an astern pitch larger than 50% (**Figure 3**). It is highly likely that the statement regarding astern response in the 'Master/Pilot Exchange of Information' document was derived from this crash stop test.
