FLYER TO FISHING INDUSTRY

Our Boy Andrew: Fatal Accident to Skipper

Marine Accident Investigation Branch
17 November 2011

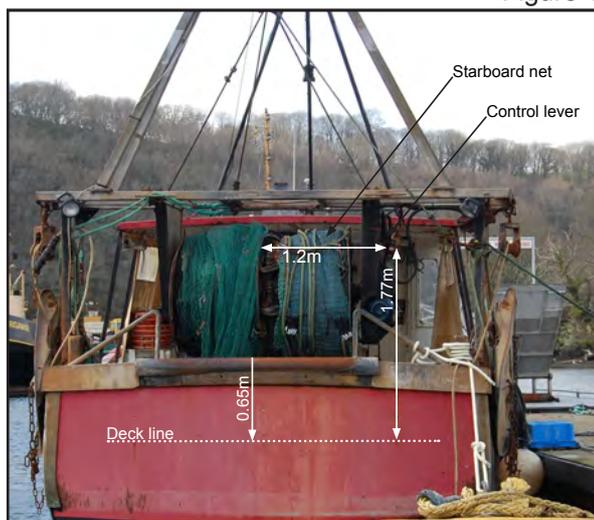
Figure 1

Our Boy Andrew, a UK registered fishing vessel, departed Looe early on the 24 March 2011 and headed south-easterly to her fishing grounds north of Eddystone Rocks. The skipper was the only person on board. At 0710, he shot the port net (**Figure 1**) and then towed it east-south-easterly until 1140, at which time he decided to haul the gear. This would have required him to haul the warps and secure the trawl doors. At about 1200, he turned the vessel onto a south-westerly heading and prepared to haul the port net. It is believed that he set the net drum control lever to the 'haul' position and then stood between the net drum and stern bulwark (**Figure 2**) so that he could manually guide the net onto the drum.

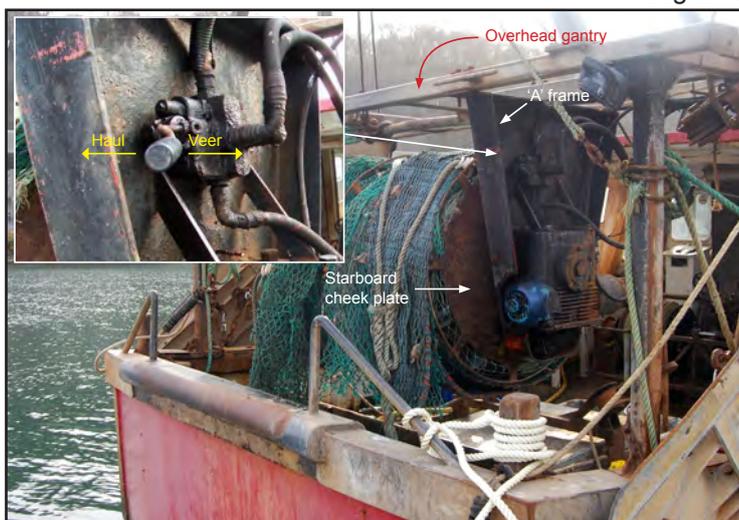
Figure 2

1. The equipment and process used on *Our Boy Andrew* to haul in her fishing gear compromised safety for a single-handed fisherman because:
 - It was necessary to manually feed the net onto the net drum, and this exposed the fisherman to the hazard of being snagged by the net and dragged onto the drum.

- The fisherman was required to move away from the winch controls to feed the net onto the drum.
 - There were no emergency stop controls fitted to the system.

- There was no one available to stop the net drum if the fisherman became entangled.
2. Had the skipper conducted a sufficiently comprehensive risk assessment following his decision to operate the vessel single-handedly he may have identified and mitigated the hazard of being dragged onto the rotating net drum. Independent advice might also have helped him identify the hazards.

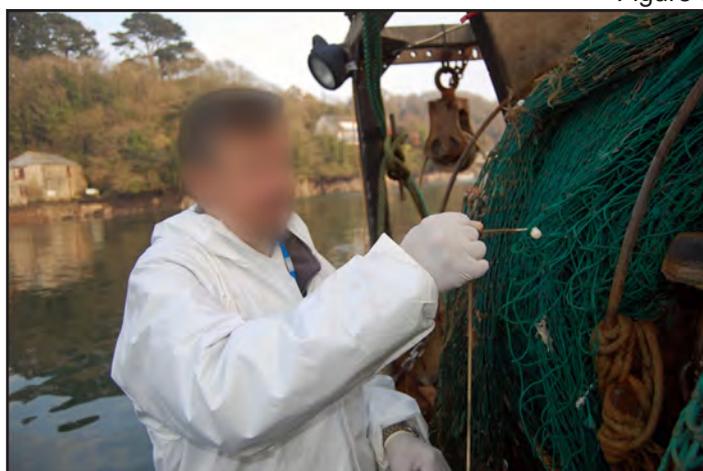
Figure 3

A drawstring toggle on the left-hand side of the stormhood on the skipper's jacket became entangled in the net (**Figure 3**) when the cod end was about 10 metres from the net drum. This would have caused the skipper to be pulled towards the rotating drum. Evidence indicates that he then reached towards the operating lever to stop the motor but was unsuccessful. The net drum stopped rotating when the cod end became wedged between the net drum and the overhead gantry. The skipper died as a result of injuries to his upper body.

3. Although it would have been preferable for the skipper not to have had to work in close proximity to the moving net, the risk of an accident within the confined area adjacent to the net drum could have been lowered by ensuring that any snag hazards on the clothing he was wearing were reduced to a minimum.
