Fire on board the fishing vessel **ONWARD**

**60nm off the north coast of Scotland
resulting in the loss of the vessel
11 April 2012**

SUMMARY

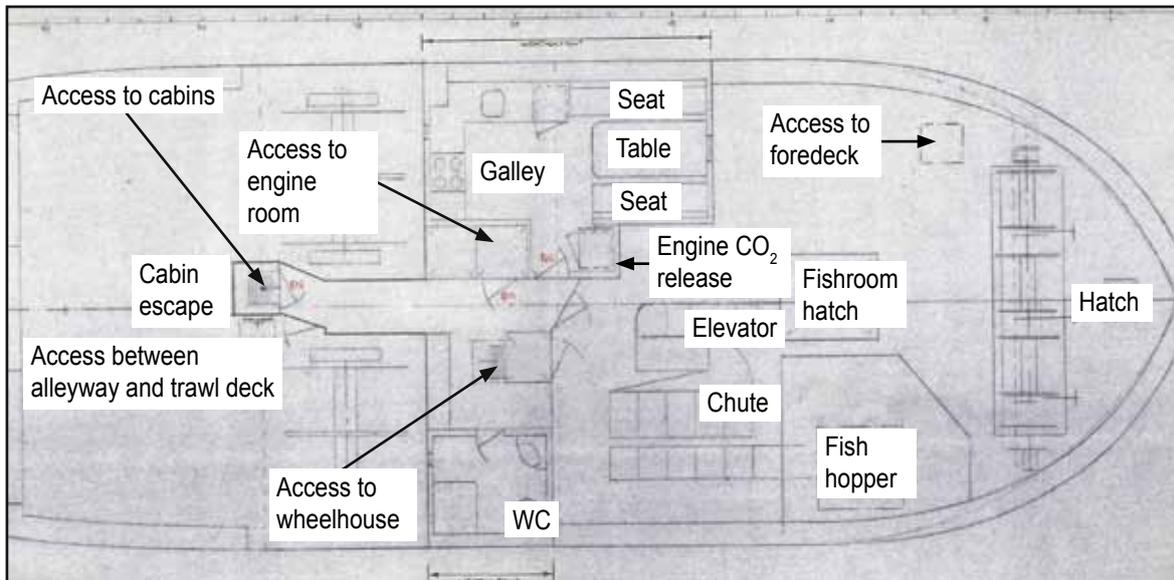
Figure 2: General arrangement (Accommodation deck)

The vessel's skipper, mate, engineer and two deckhands were on board. Between 0300 and 0900, the wheelhouse watches were shared between the skipper (0300-0500), the engineer (0500-0700) and one of the deckhands (0700-0900). The engineer visited the engine room during his watch and found that the main engine and the auxiliary machinery systems were operating normally. When not on watch, the crew slept in separate cabins in the accommodation area aft (**Figure 2**).

Access to the engine room was via a door sited next to the galley door on the port side of the main alleyway (Figures 2 and 4). The compartment's bulkheads, deckhead and access door had a fire insulation rating of B15¹. The engine room access door was kept closed when the vessel was at sea, but it did not provide a tight seal. The engine room had a single exhaust fan leading to a vent to port of the wheelhouse (Figure 5). A closed circuit television (CCTV) system enabled the engine room and trawl deck to be monitored from the wheelhouse.

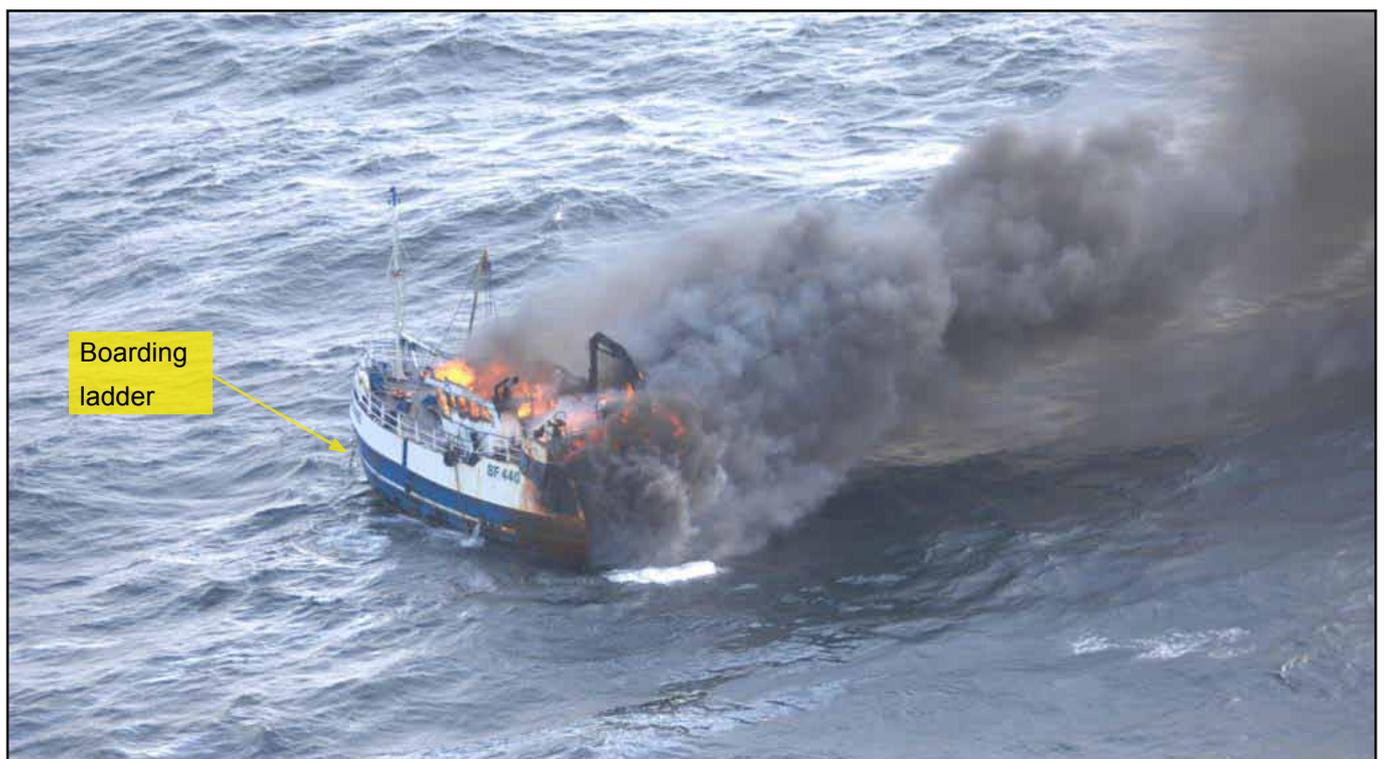
Figure 3: *Onward* on fire

In view of the intensity of the fire (**Figure 3**) and the vessel's wooden construction, *Onward* would have continued to burn until foundering. The proximity of the underwater obstruction discovered in June 2012 to the vessel's last known position, and the positions of the EPIRB on 12 April 2012 (**Figure 1**), suggests that the obstruction could be the wreck of *Onward*.

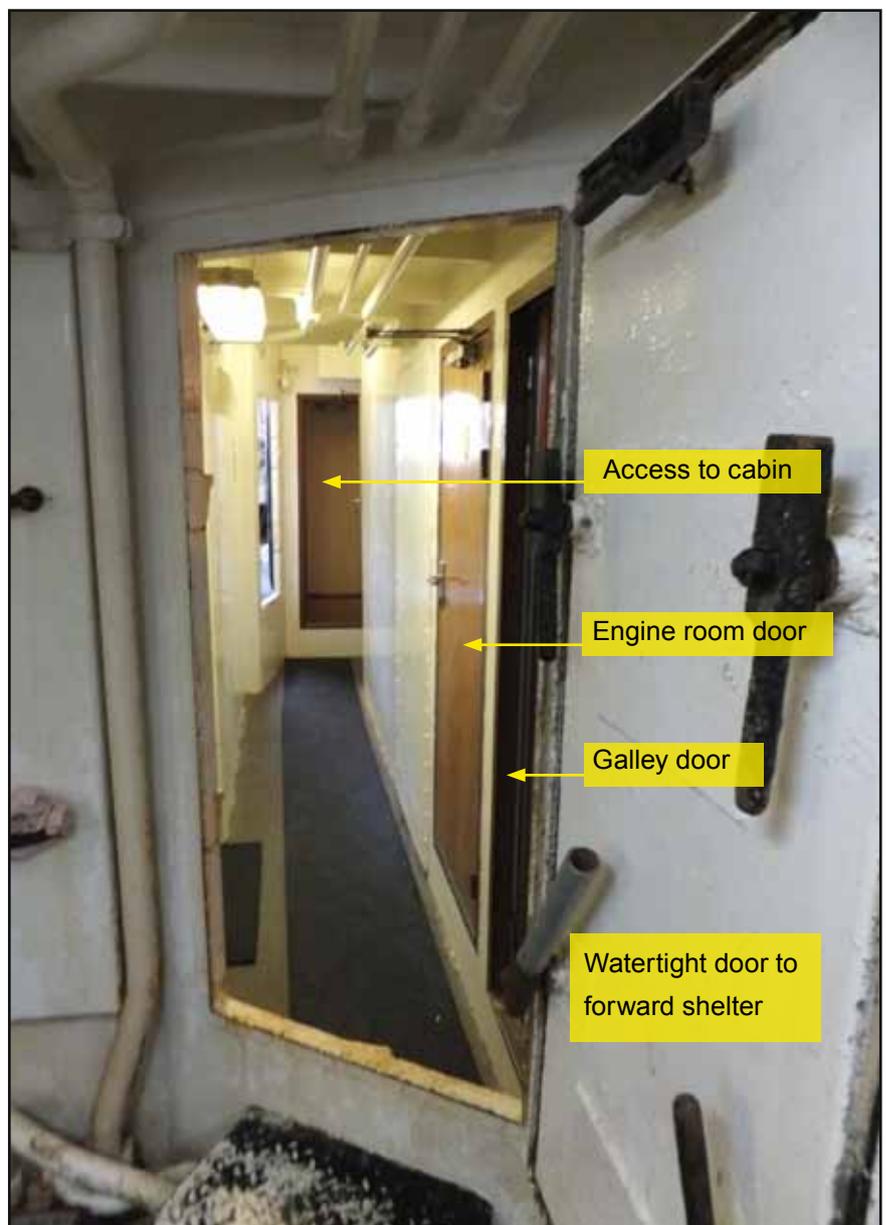
Figure 4: Access to the engine room via a door sited on the port side of the main alleyway (*Ocean Challenge*)

Once an oil-based fire was established in the engine room, large quantities of black smoke would have escaped into the alleyway through the gaps between the engine room door and its frame. It is highly likely that the rapid development and spread

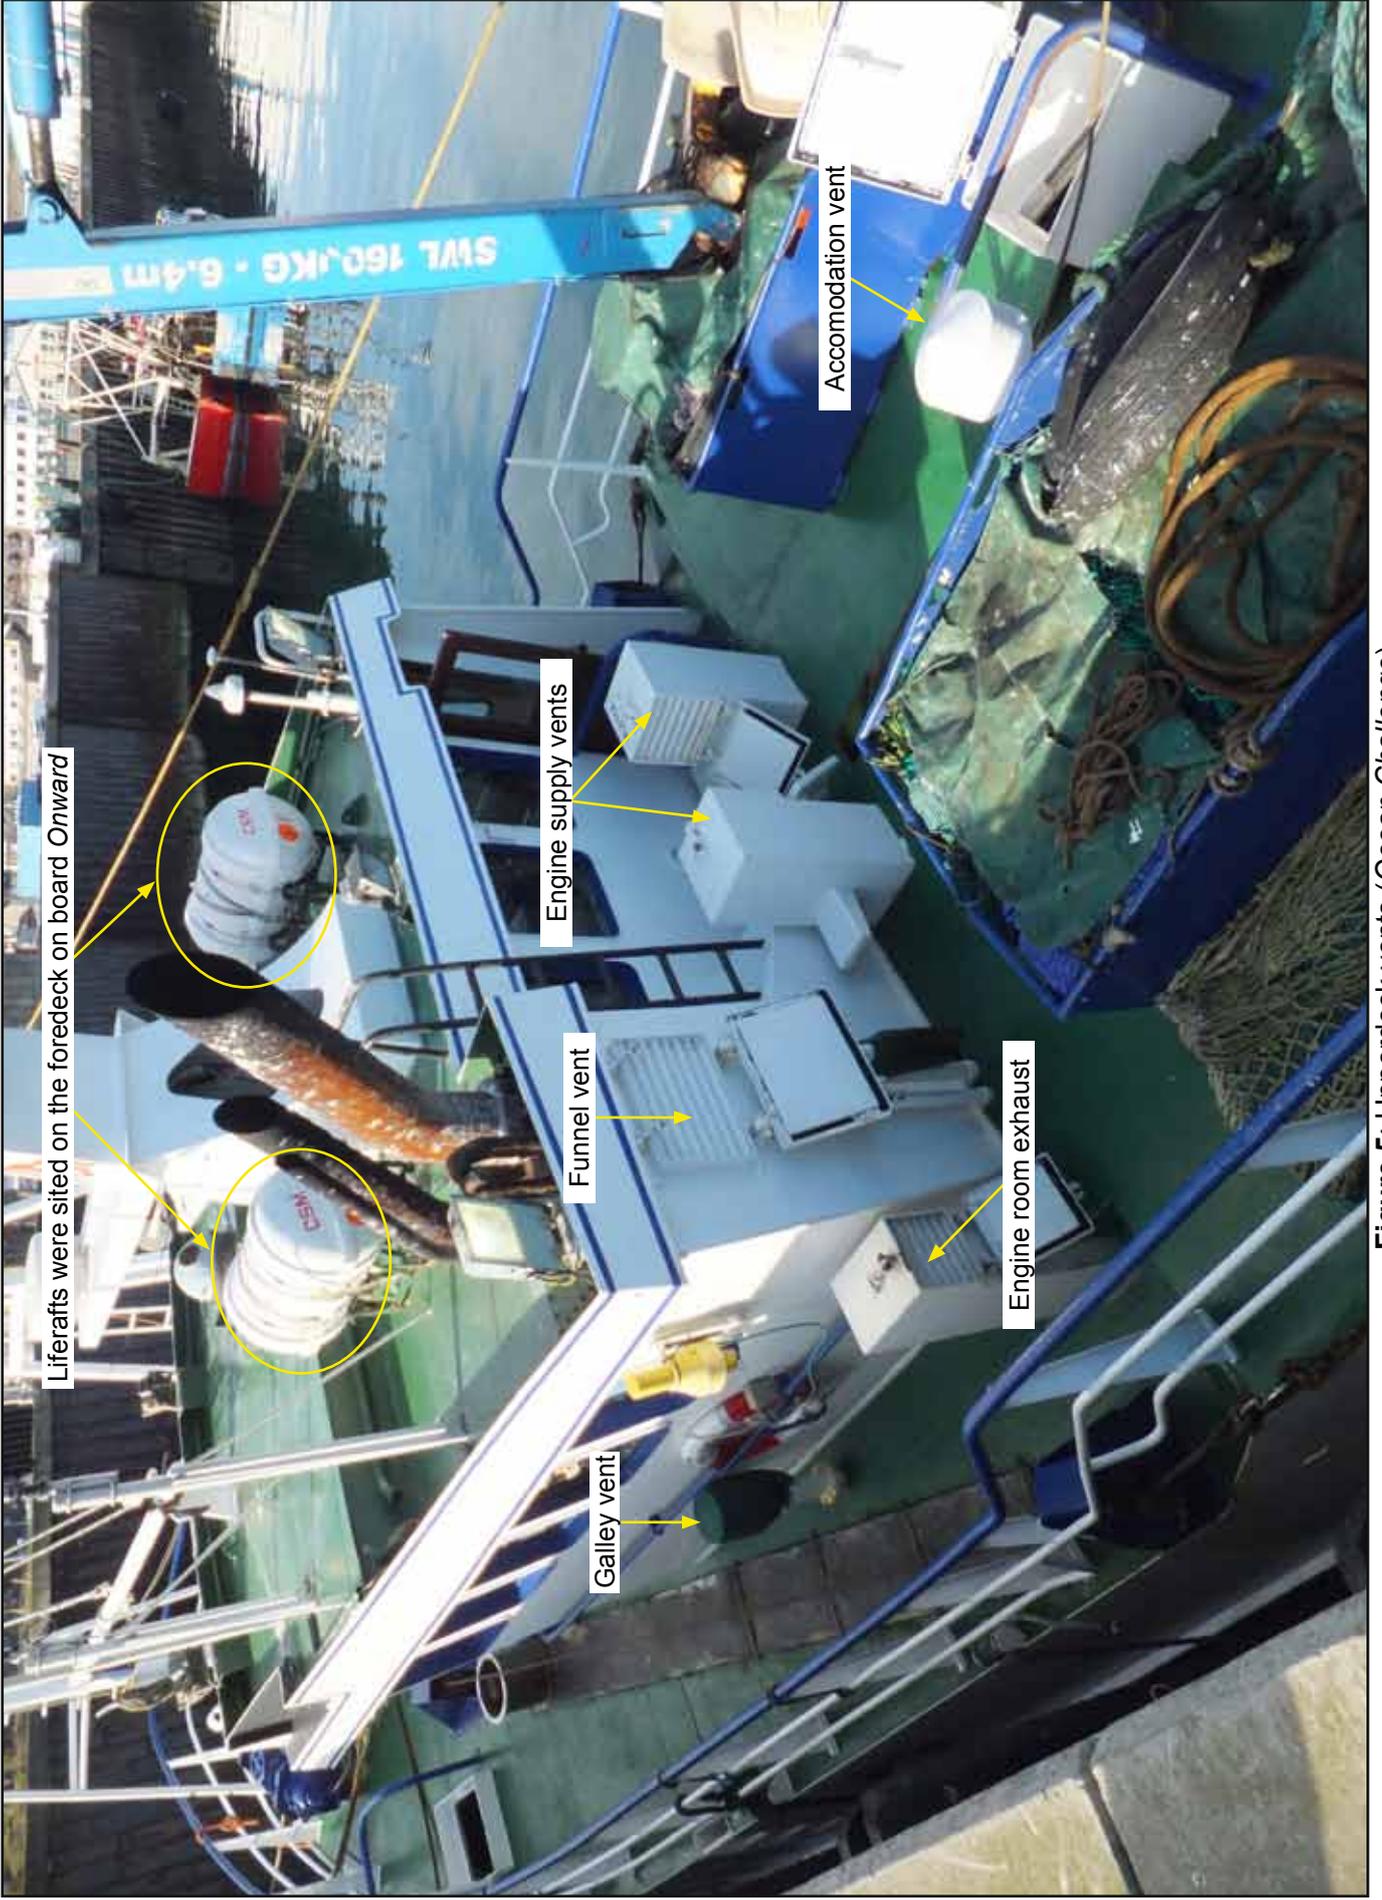
Figure 5: Upperdeck vents (Ocean Challenge)

- The closing of the vents on the upper deck was uncoordinated and incomplete.

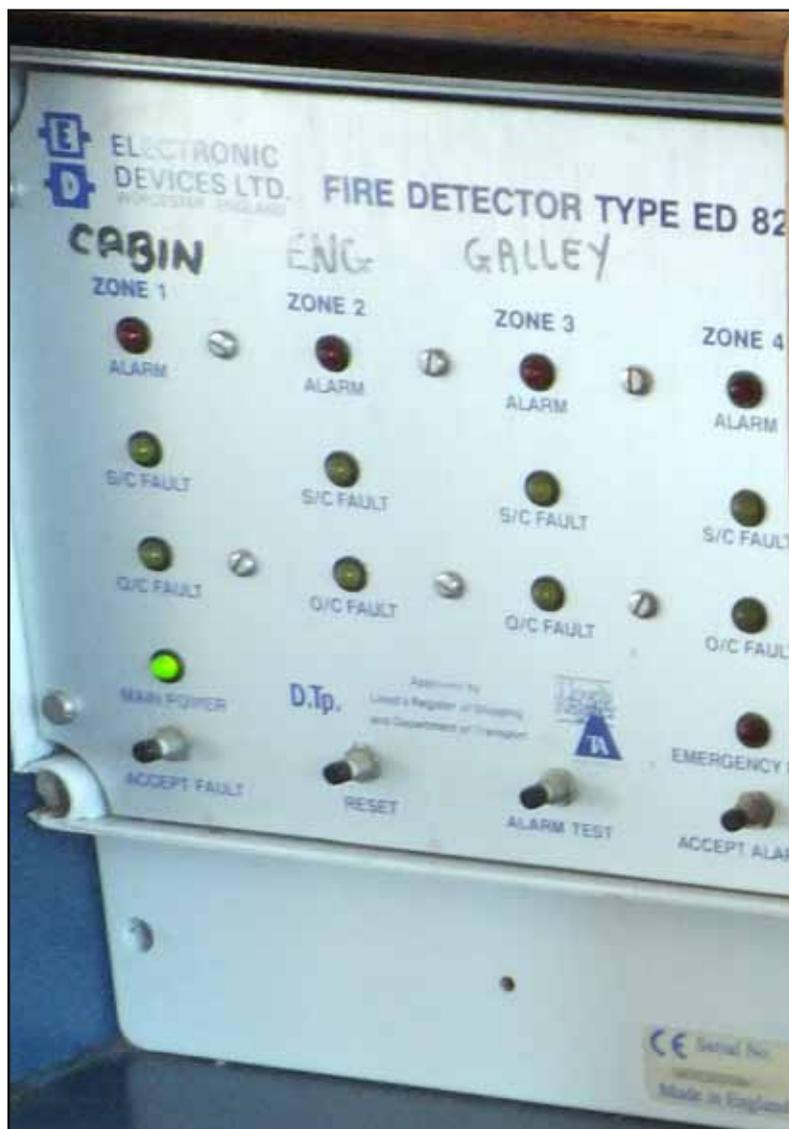
Figure 6: Fire detection system control panel (*Ocean Challenge*)

The first indication that a fire had broken out was when the skipper smelled smoke in the wheelhouse that had come up from the deck below. Given that both smoke and heat sensors were fitted in the engine room, galley, alleyway and the cabins, and that no alarms were heard by the skipper in the wheelhouse or by the rest of the crew when they were in their cabins, it can be concluded that the fire detection system was either unserviceable or was not switched on.

Although the fire detection system fitted on board *Onward* met the design and performance standards required by LR, it was not tested regularly. Indeed, it is possible that the system had not been thoroughly tested since the vessel's last survey in 2009. In such circumstances, the probability of some of the system's sensors not functioning as intended, particularly those in high-risk spaces such as engine rooms, which were continuously exposed to high levels of heat, dirt and vibration, was increased considerably. It is possible that system faults were indicated on the control panel in the wheelhouse, but they had either not been noticed or their significance had not been recognised by any of the crew.
