Report on the investigation of heavy weather  
encountered by the cruise ship

***Pacific Sun***

on 30 July 2008

**Report No 14/2009**  
**June 2009**

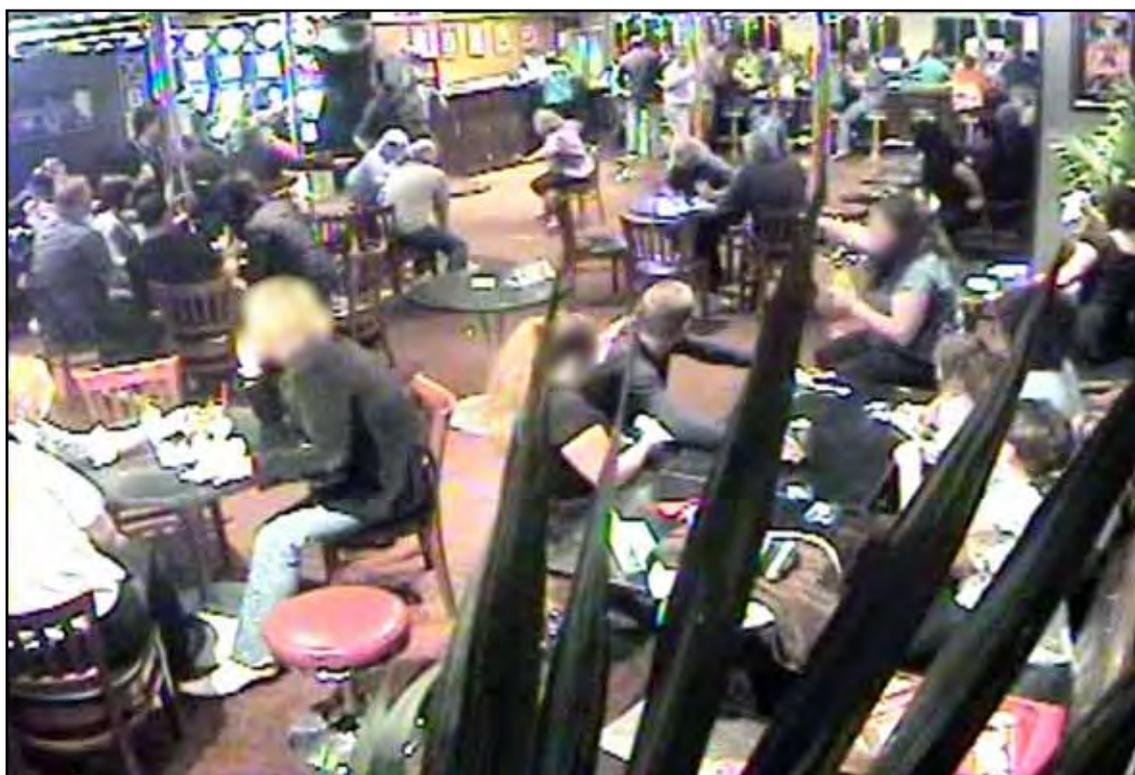
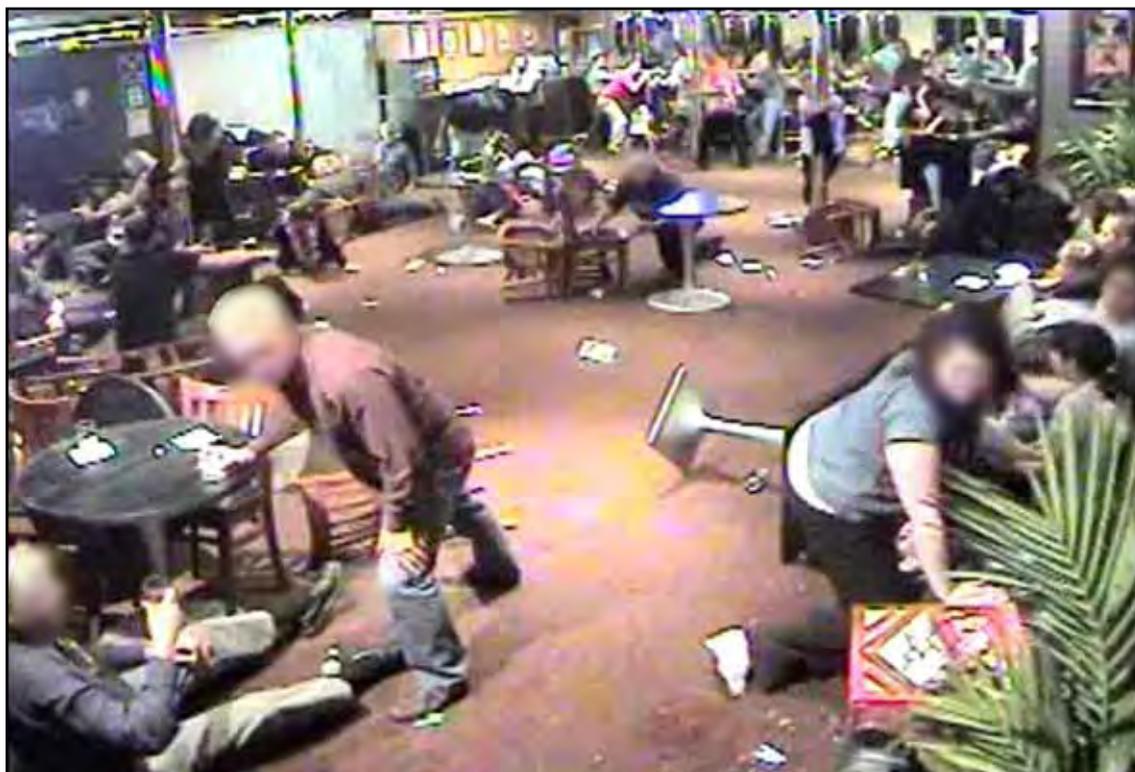
The effect of the roll is shown in the sequence from the CCTV footage in **(Figure 4)**.

Legends Bar, Deck 9, prior to the three large rolls

Legends Bar, Deck 9, following the three large rolls

In the Legends Bar, where bar service was being provided, the effect of the roll can be seen in the 'before' and 'after' pictures at **Figure 4**. The settees, tables and chairs were all able to move freely, and the CCTV footage showed passengers attempting to regain their balance by grabbing at heavy unsecured tables and other unsecured furnishings as they were thrown and fell across the deck. The broken glass, liquids and fallen plant pots added to the hazards the passengers and crew faced, and at least seven injuries were reported from this area.

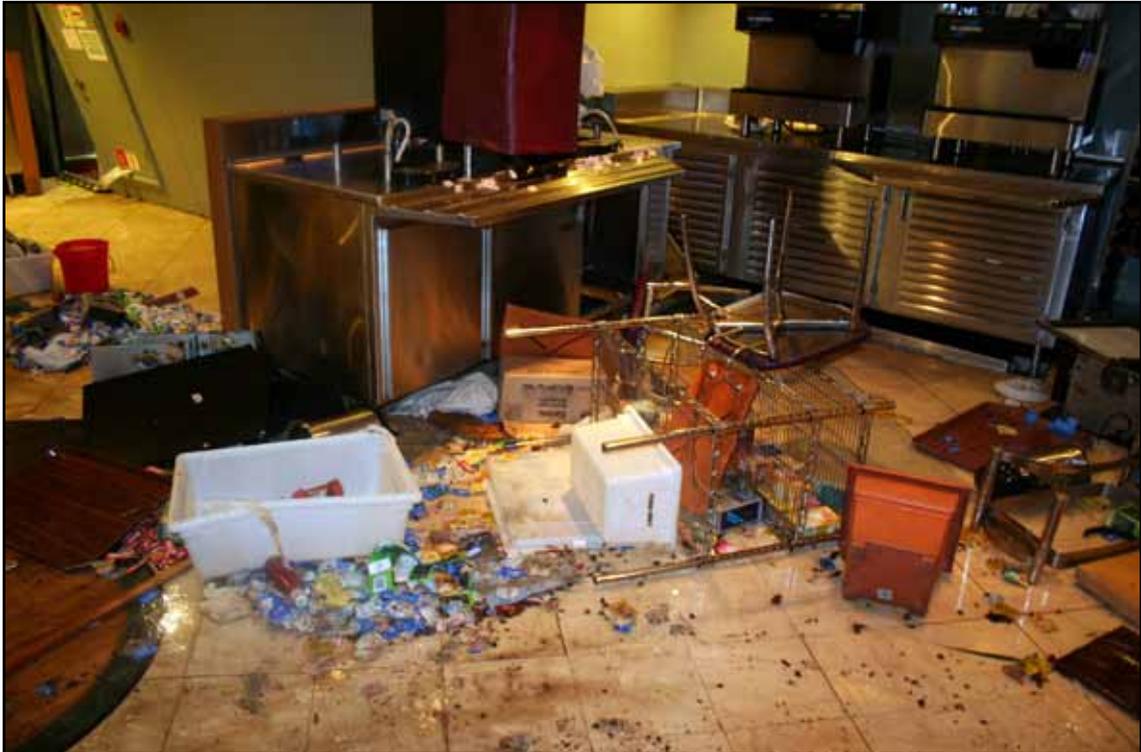
Figure 5a

Public rooms condition following the accident - Outlook Bar and Grill,  
Deck 10, Muster Station C

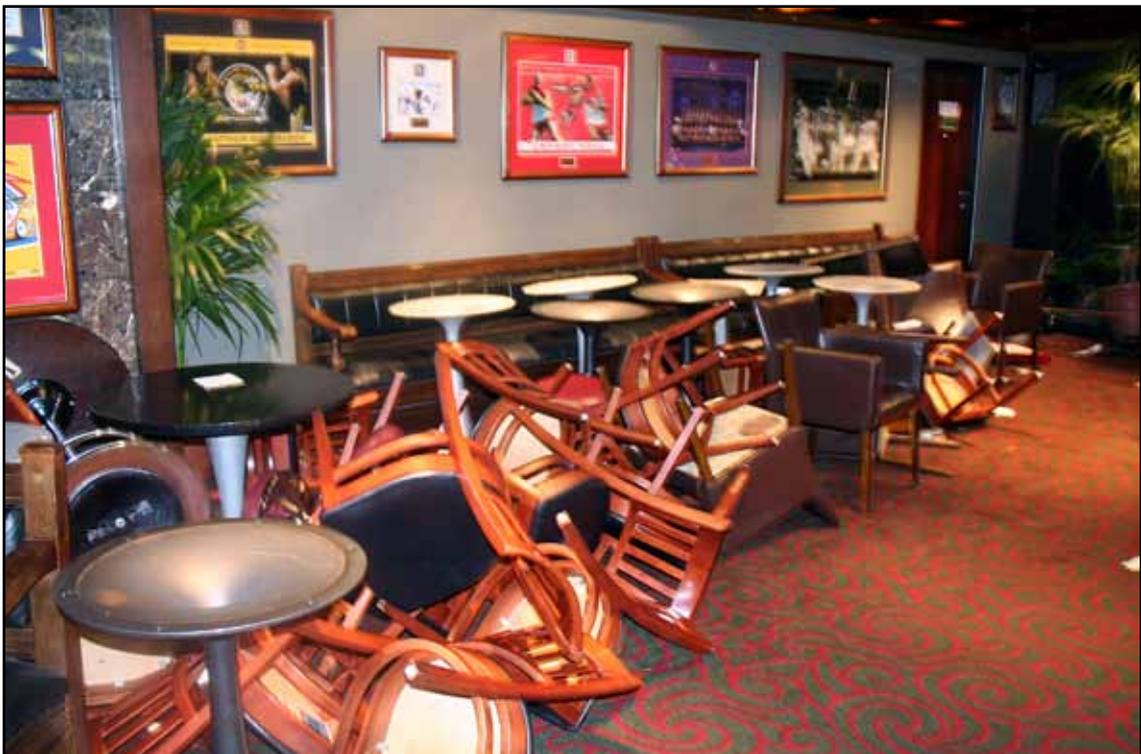
Figure 5b

Legends Bar, Deck 9, Muster Station B

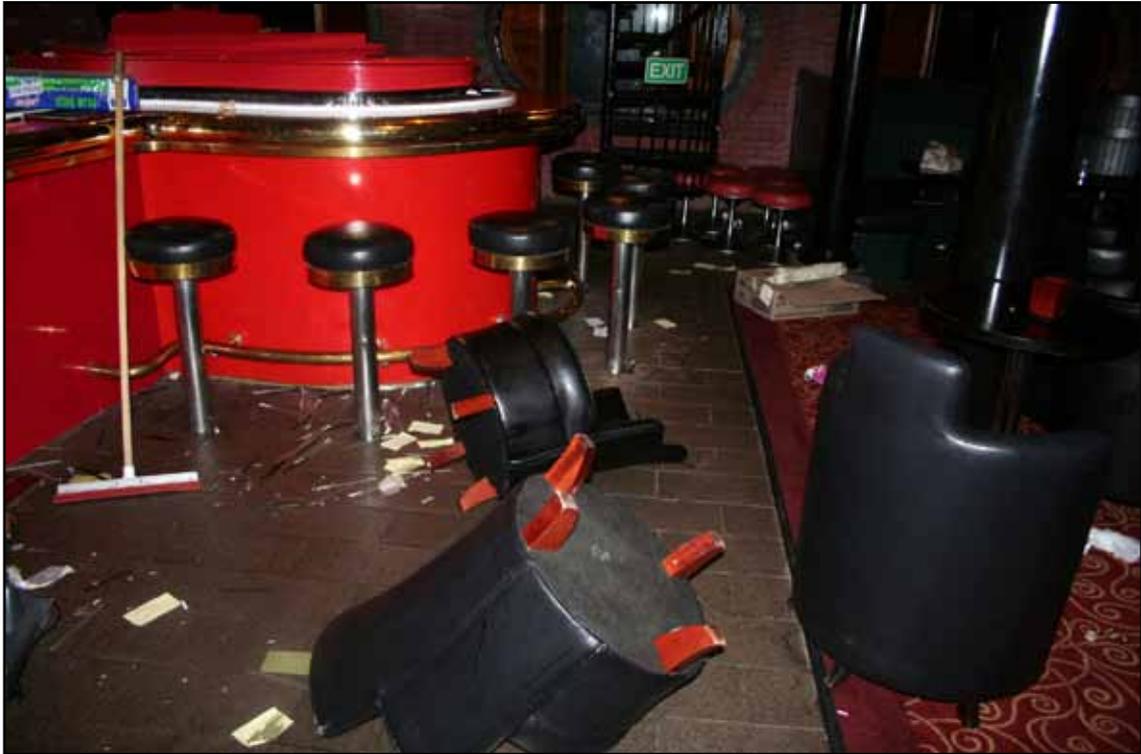
Figure 5c

Speak Easy Piano Bar, Deck 8

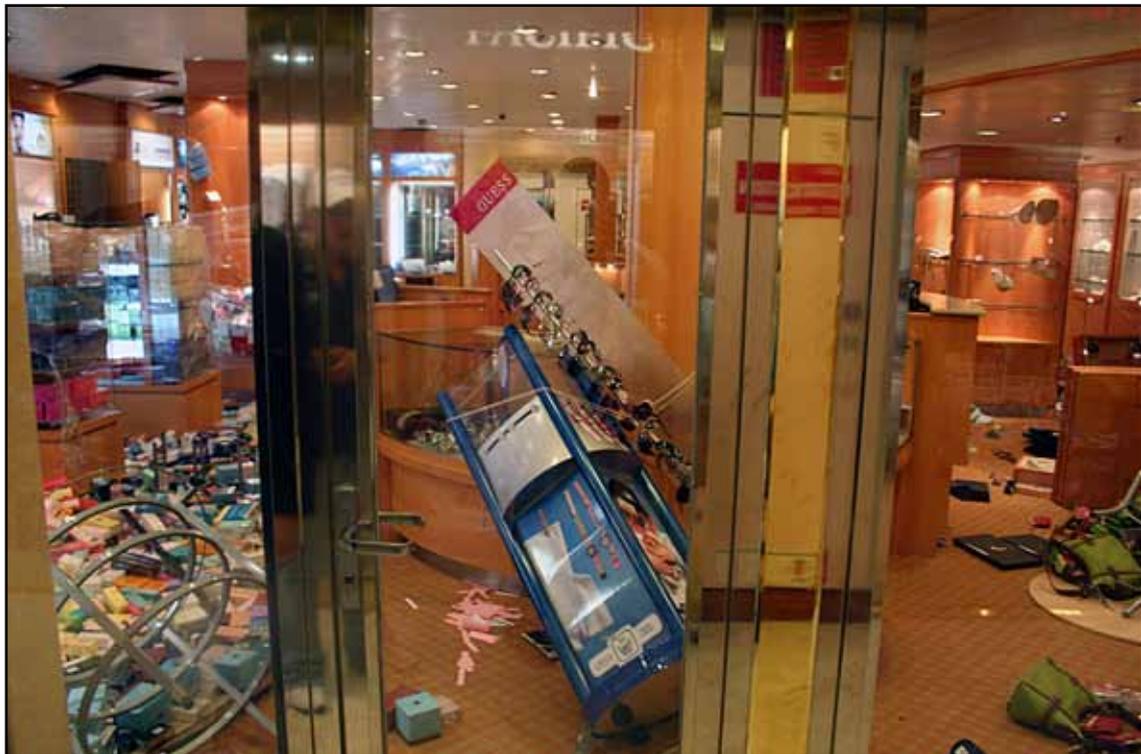
Figure 5d

Duty-free shop, Deck 8

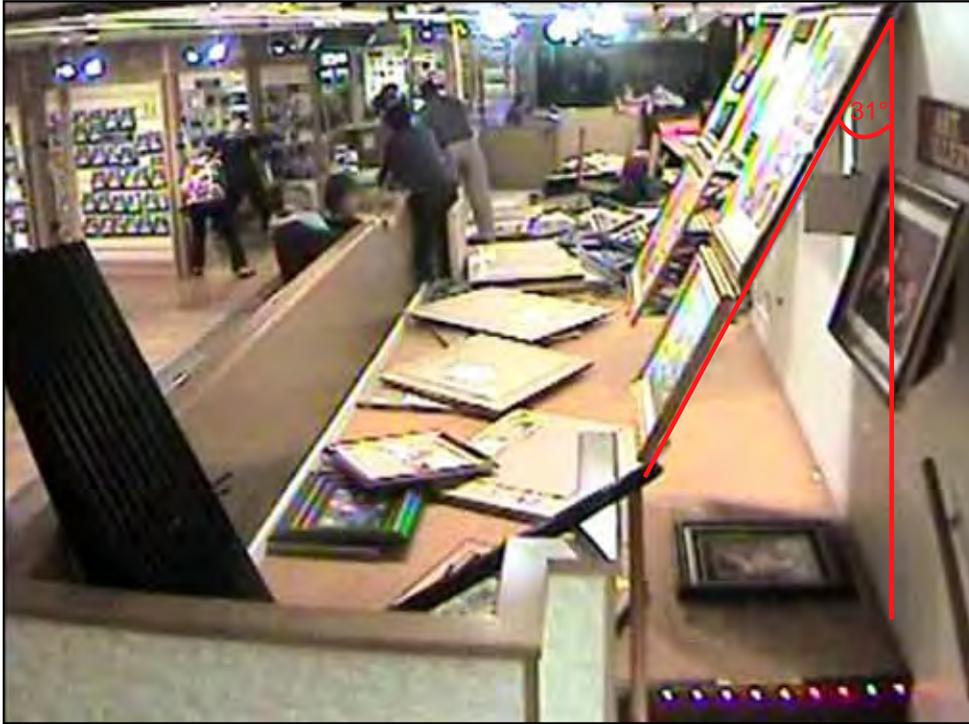
Art Gallery and Photo Gallery, Deck 9, at the largest recorded roll angle

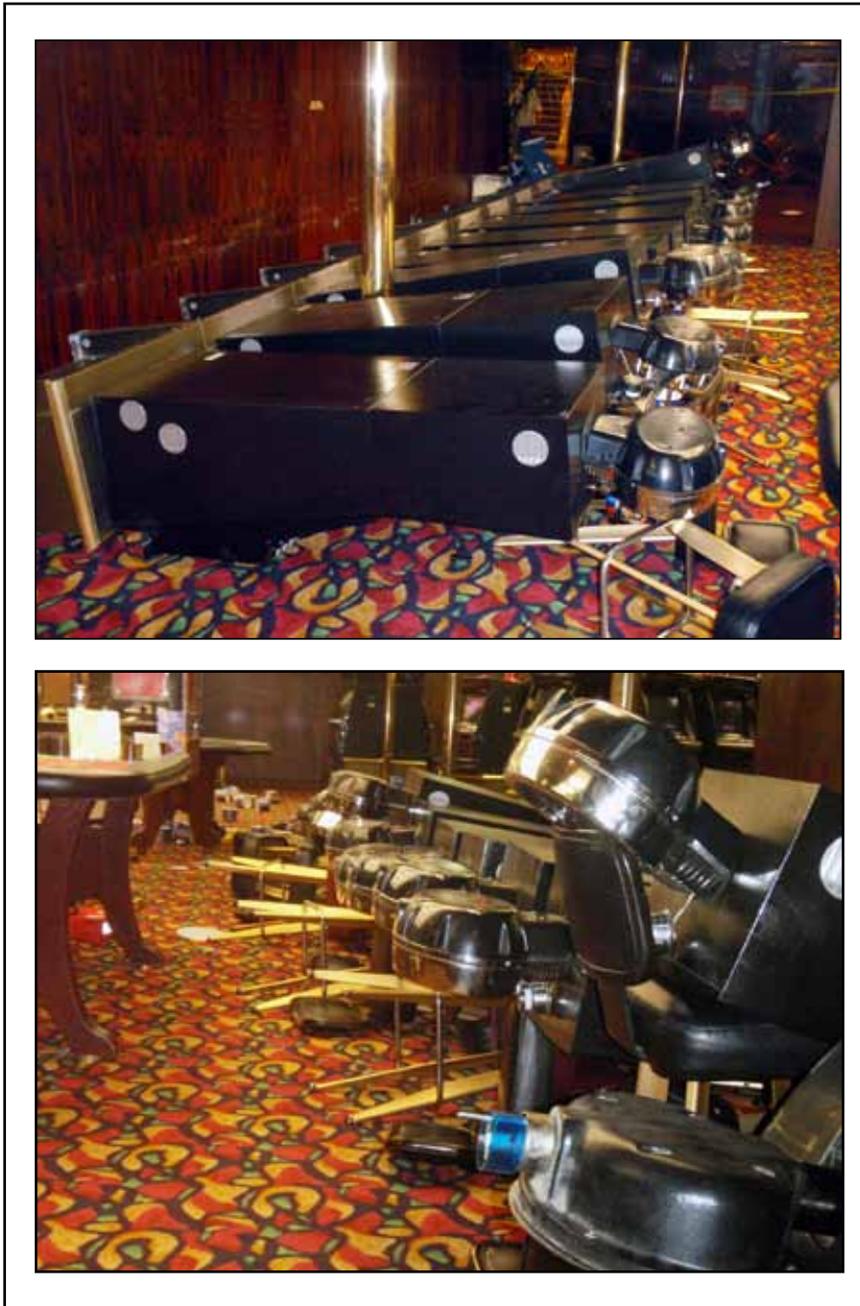
Figure 9

This muster station combined two areas of deck 9. The effect of the rolling in the casino area caused large secured items to move, including a bank of gaming machines to fall from the bulkhead (**Figure 9**). Some passengers only avoided injury because the adjacent chairs prevented the gaming machines from collapsing directly on to the deck. The electronic poker machine (**Figure 10**) came adrift and travelled across the casino deck, causing several reported injuries.

Collapsed casino gaming machines, Casino, Deck 9

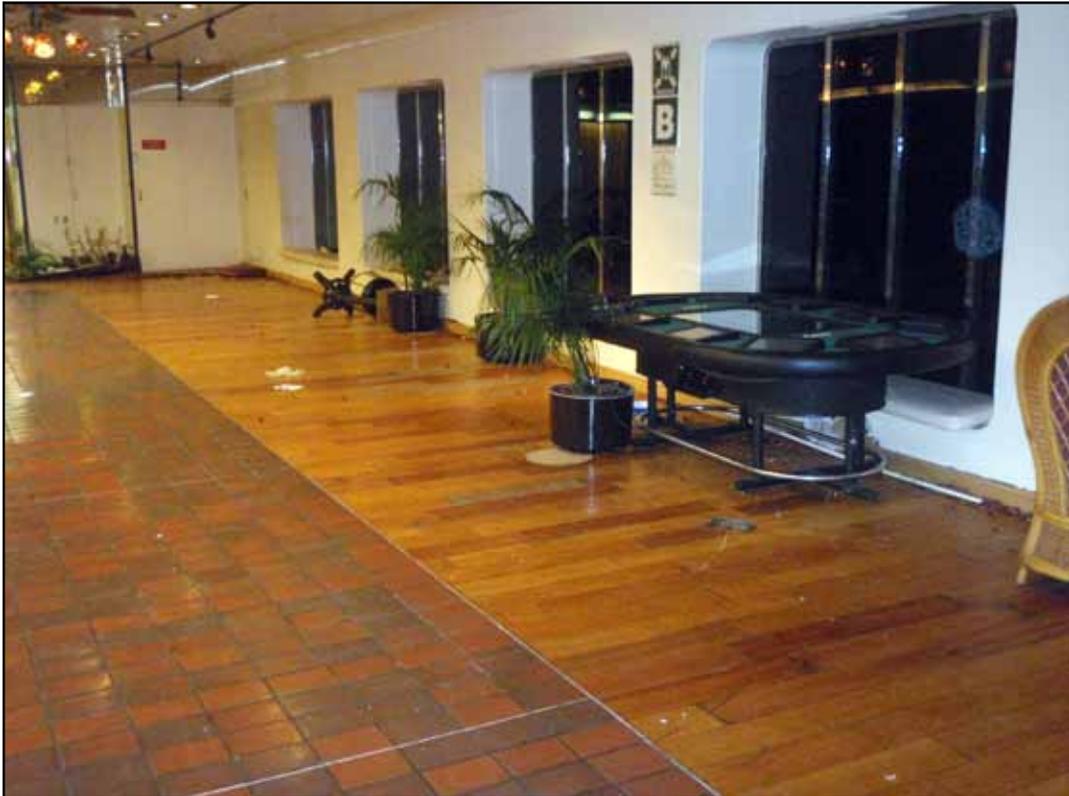
Poker Pro machine, released from mountings, Deck 9

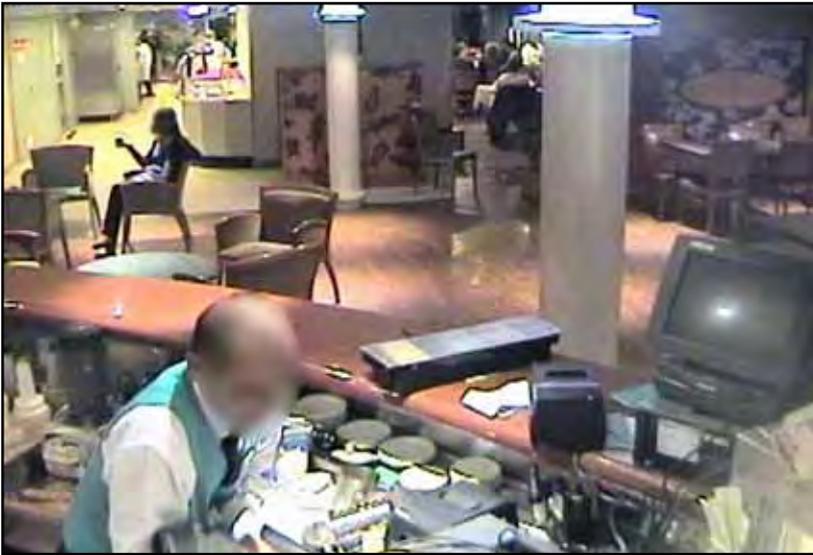
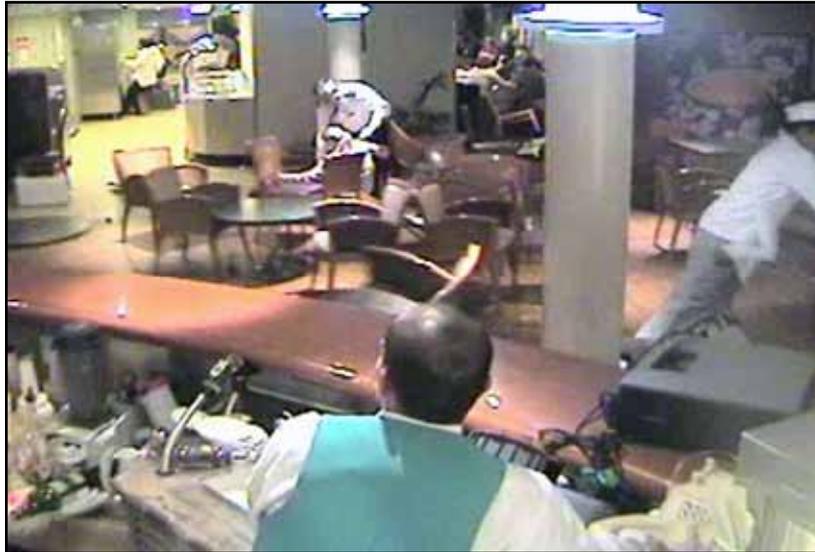
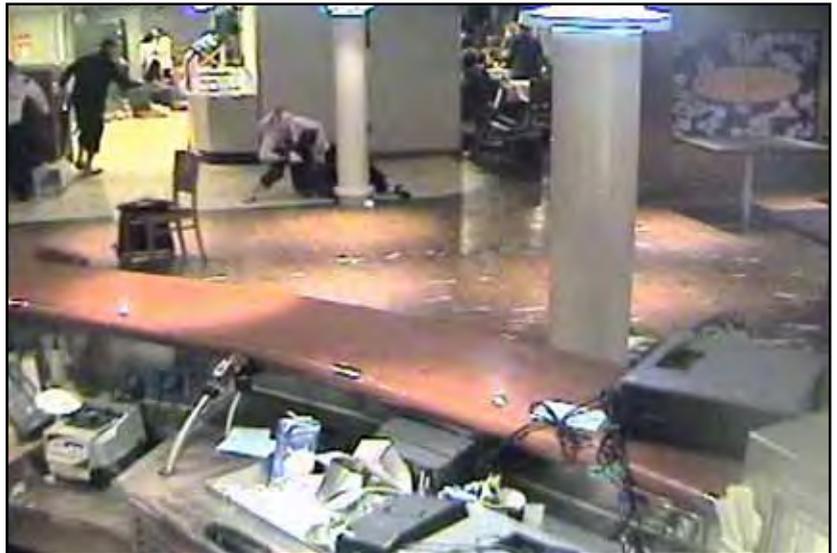
Outlook Bar and Grill - Deck 10, Muster Station C, during the large rolls

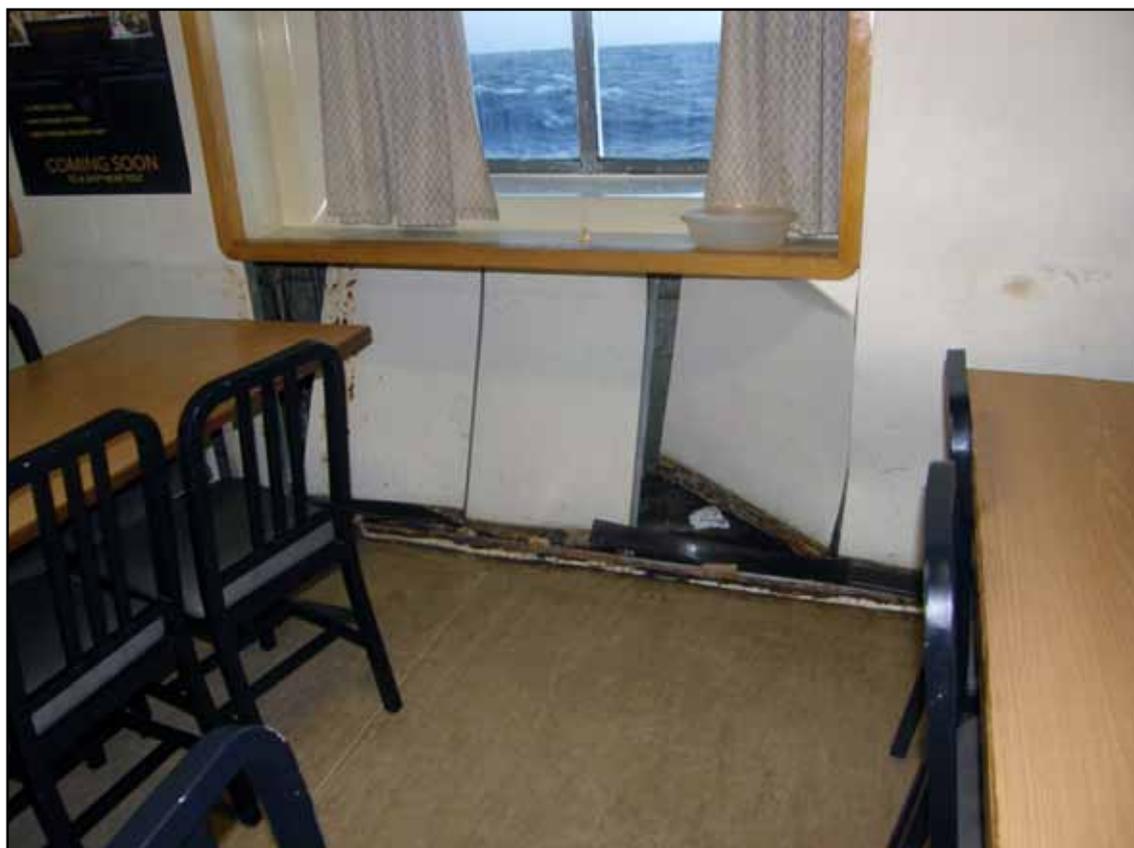
Figure 12

In the officers, staff and crew mess rooms (**Figure 12**), all of which were in use at the time of the accident, no tables or chairs were secured to the deck and all of these moved as the ship rolled.

Damage to crew mess room, Deck 3

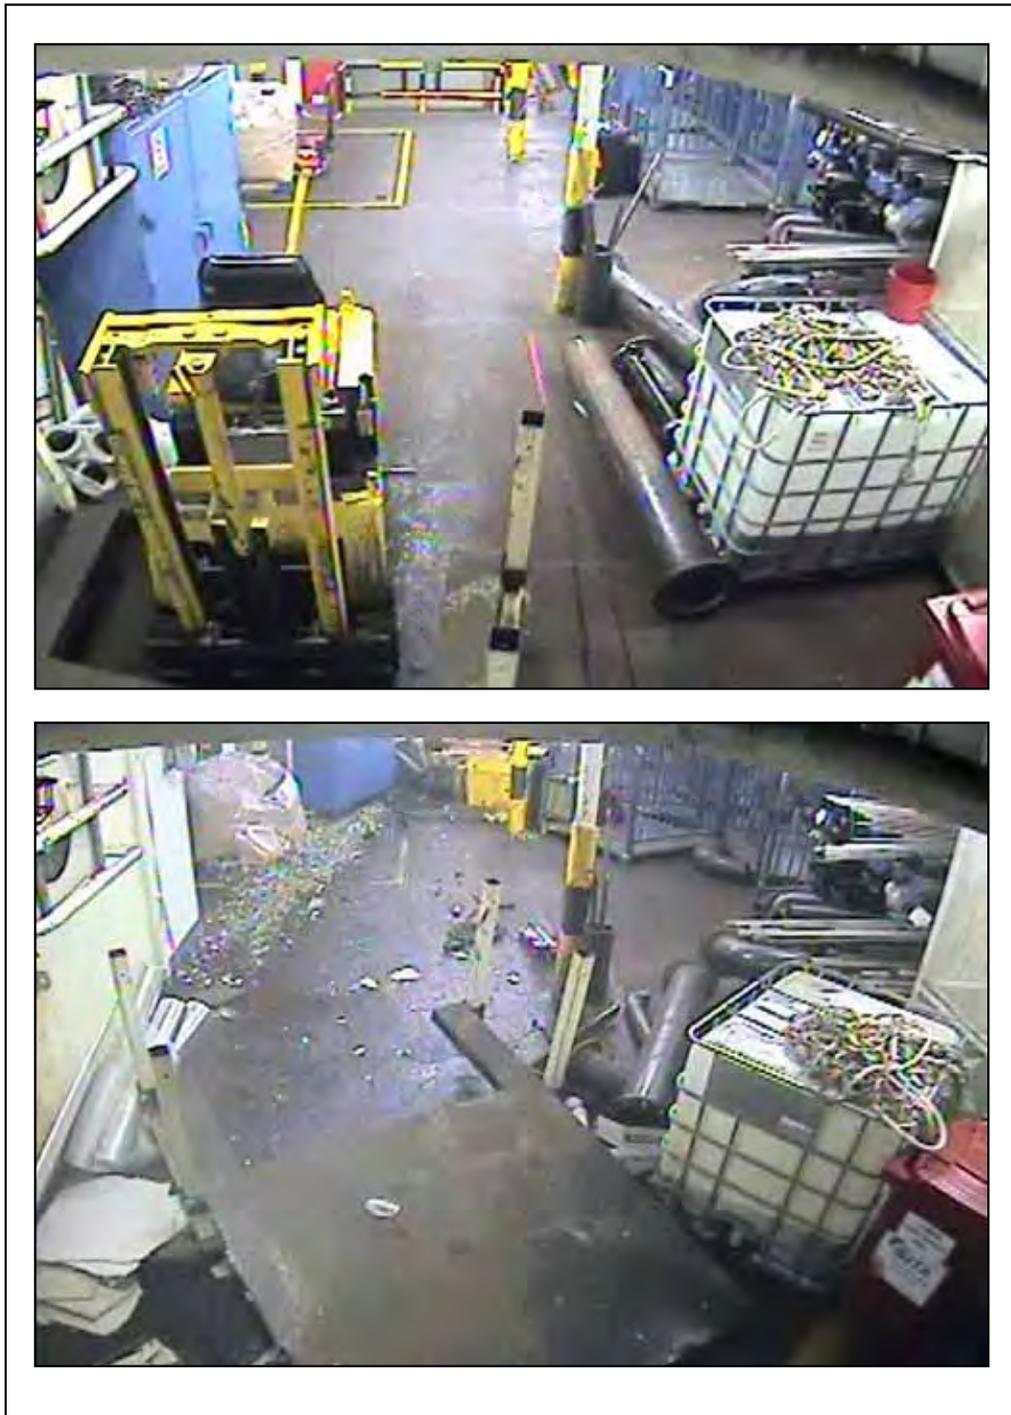
Figure 13

The stores handling area on deck 3 was a busy thoroughfare and served as a storage area for engineering equipment and baggage handling cages. As the ship rolled, a forklift truck which was stowed in this area, several heavy pipes and a number of storage boxes were able to move across the full width of the deck (**Figure 13**). In addition, at the extremities of the rolls the deck 3 shell doors were partly submerged and, as these were not watertight, seawater entered the deck, making it slippery.

Deck 3 handling area and crew main access, before and after the large rolls

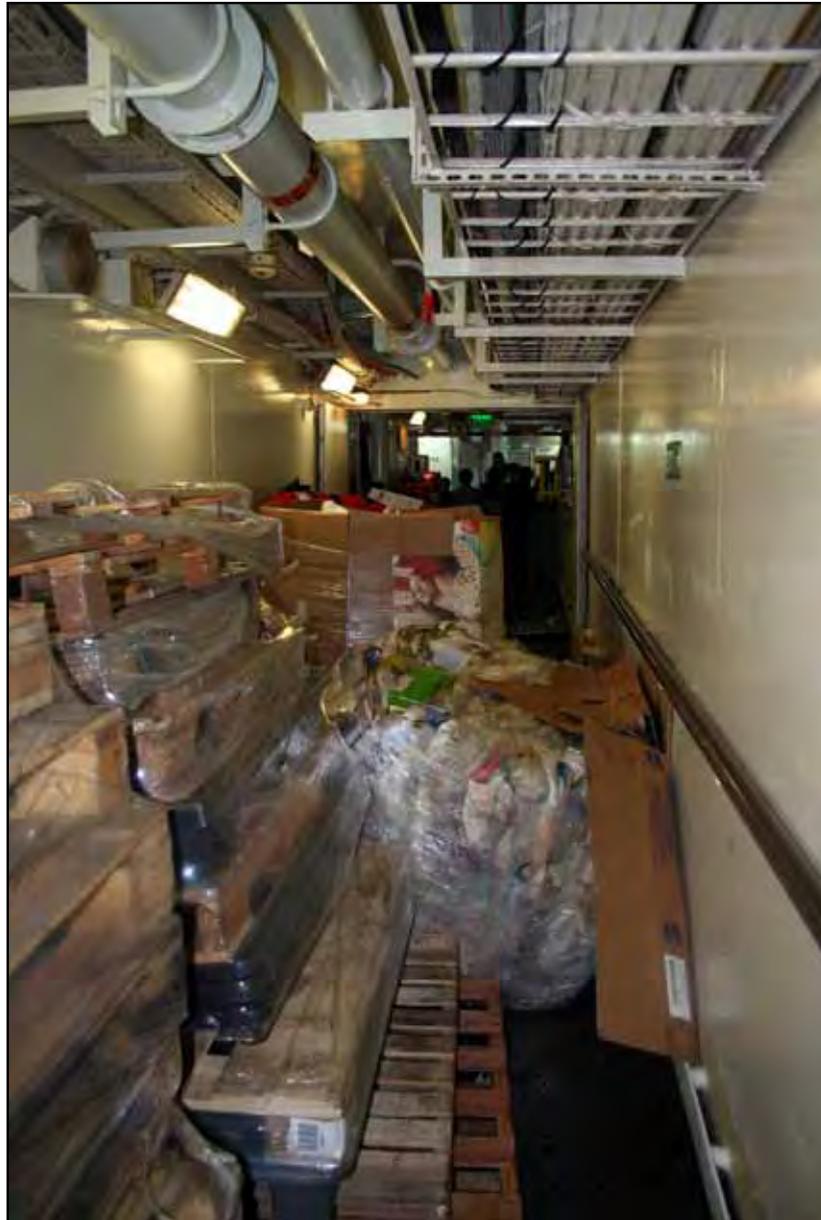
Figure 14

In preparation for arrival in Auckland the next day, the crew had started to place on deck 3 the garbage and other equipment for landing, and some of these stows collapsed, blocking alleyways (**Figure 14**).

Deck 3 - main crew alleyway after accident

Under normal conditions, the preferred route to the medical centre from the forward part of the ship for stretcher parties was via the main crew alleyway. However, the obstructions in the store handling area and main crew alleyway on deck 3, along with the wet decks, made passage through this area extremely difficult.

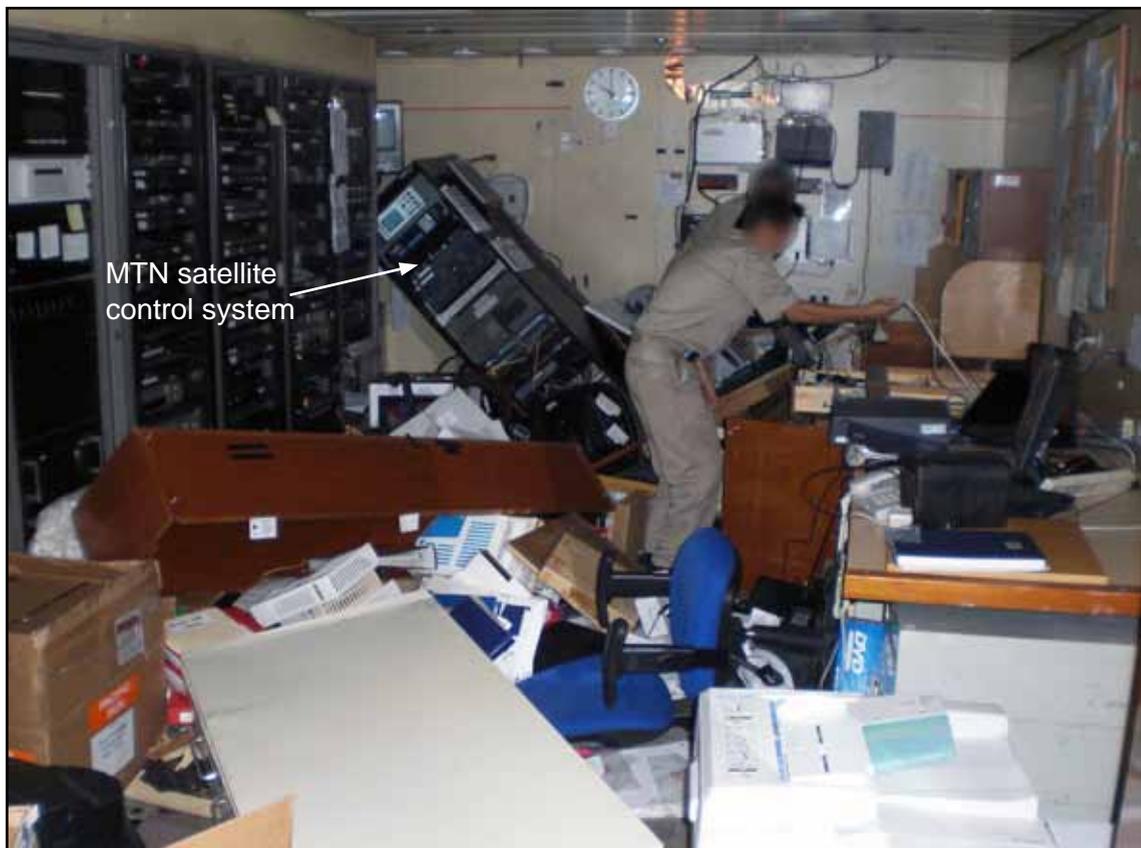
Figure 15

As the vessel rolled, the MTN<sup>4</sup> satellite communications system in the communications office on deck 11 ripped from its securing arrangement and fell over, tearing out connections and disabling the unit (**Figure 15**).

Electro Technical Office after the accident
