Report on the investigation into the contact
made by the tanker
Vallermosa,
with the tankers
Navion Fennia and ***BW Orinoco***
at the Fawley Marine Terminal
on 25 February 2009

Marine Accident Investigation Branch
Mountbatten House
Grosvenor Square
Southampton
United Kingdom
SO15 2JU
Report No 23/2009
November 2009

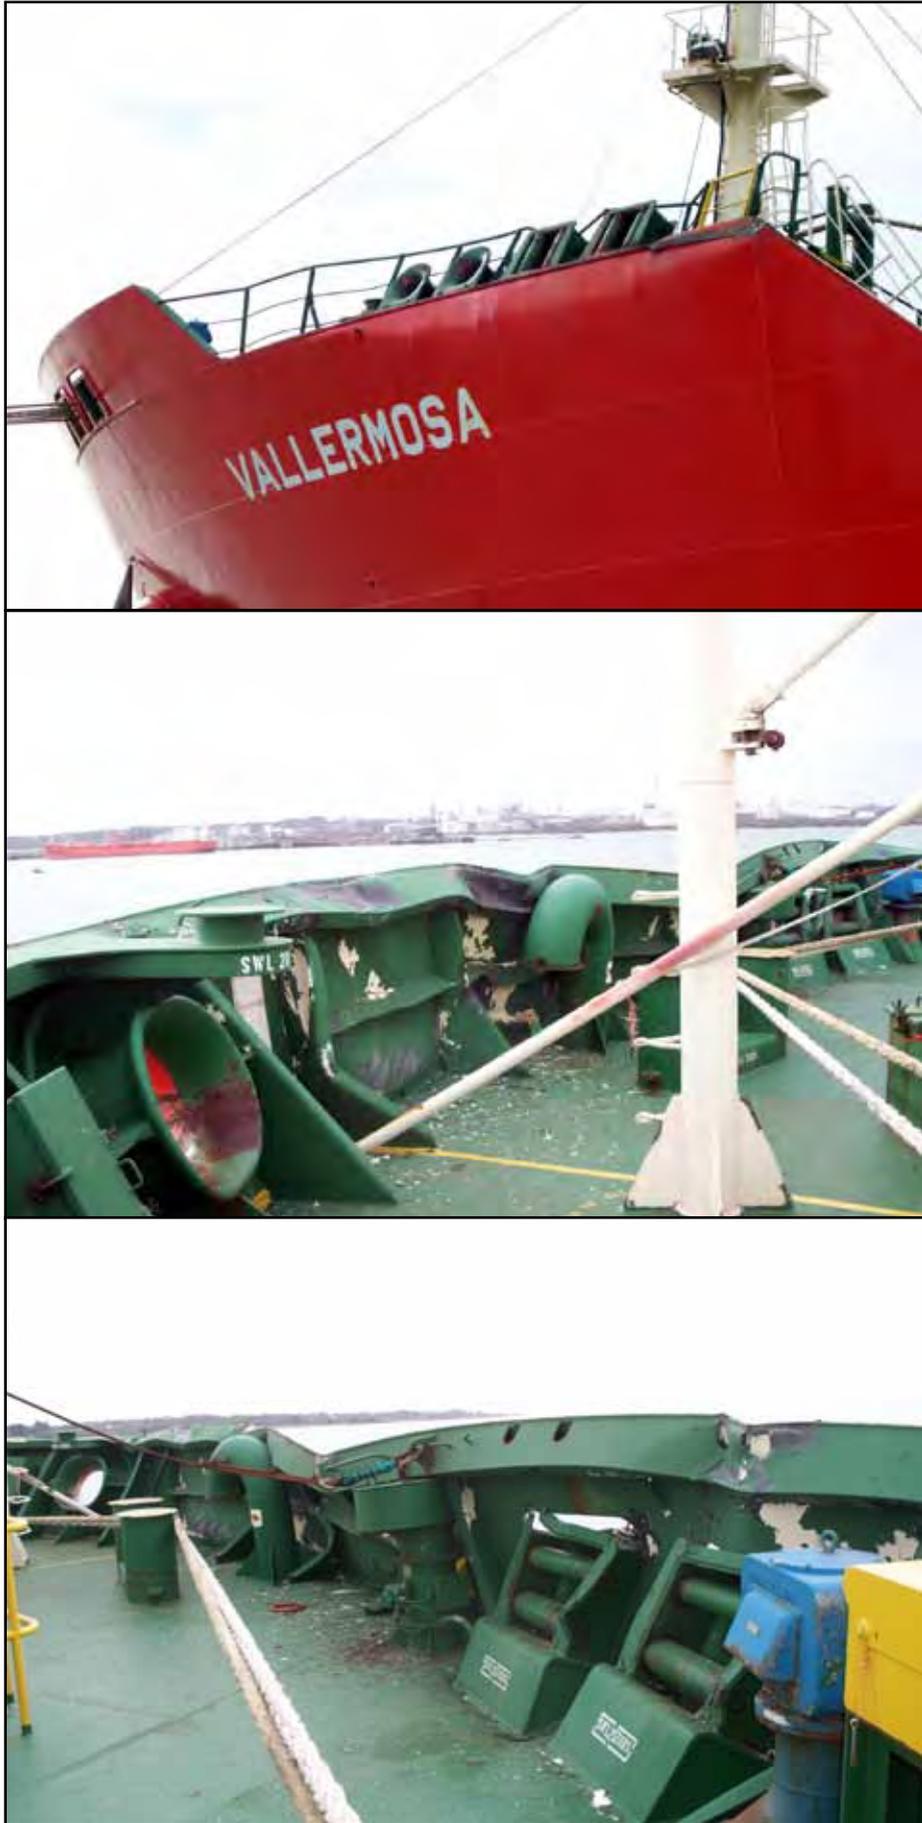
Figure 6

Vallermosa sustained damage (**Figure 6**) to the port and starboard side forecastle bulwark and connecting brackets, the forecastle deck was heavily buckled over a 15m length. Two fairleads on the port side and two on the starboard side were damaged along with the ventilation trunking to the forward store. Following discharge of her cargo, the vessel proceeded to Portland, where temporary repairs were effected. Permanent repairs were subsequently carried out in Flushing (**Figure 7**).

Damage sustained by *Vallermosa*

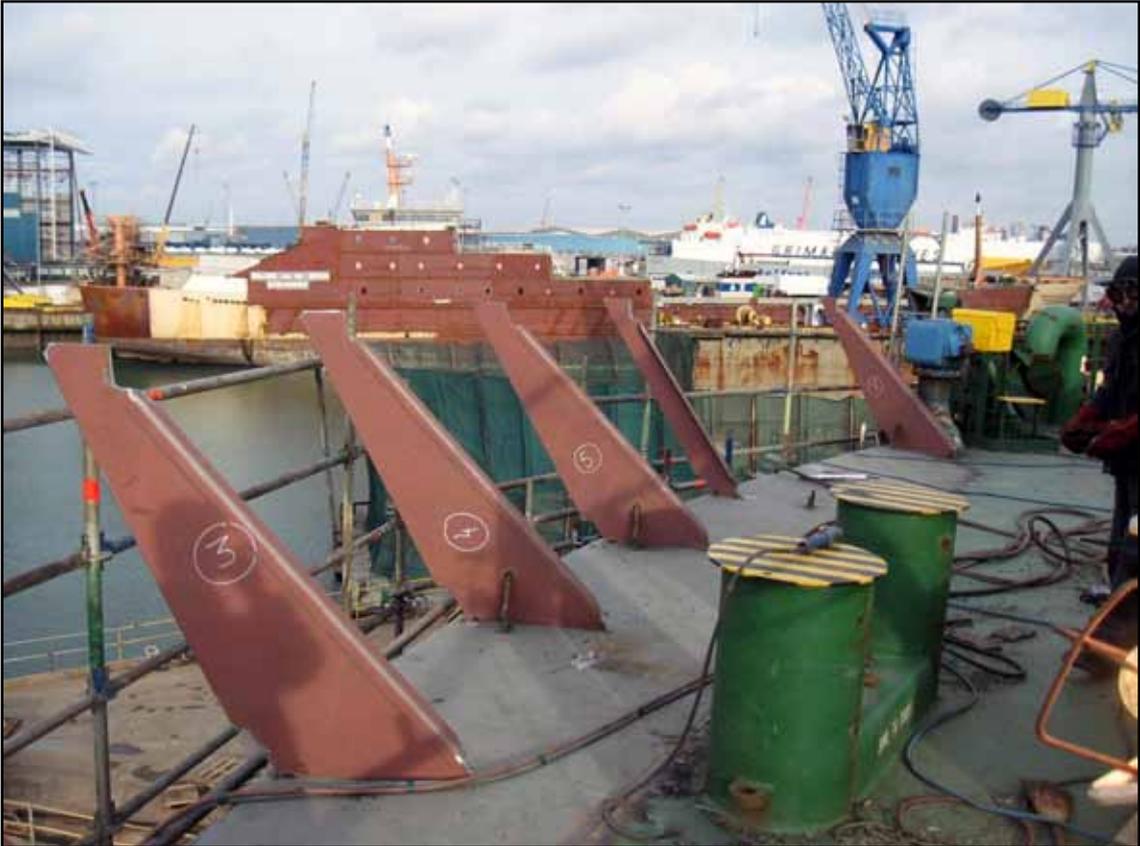
Figure 7

Vallermosa undergoing repairs in Flushing

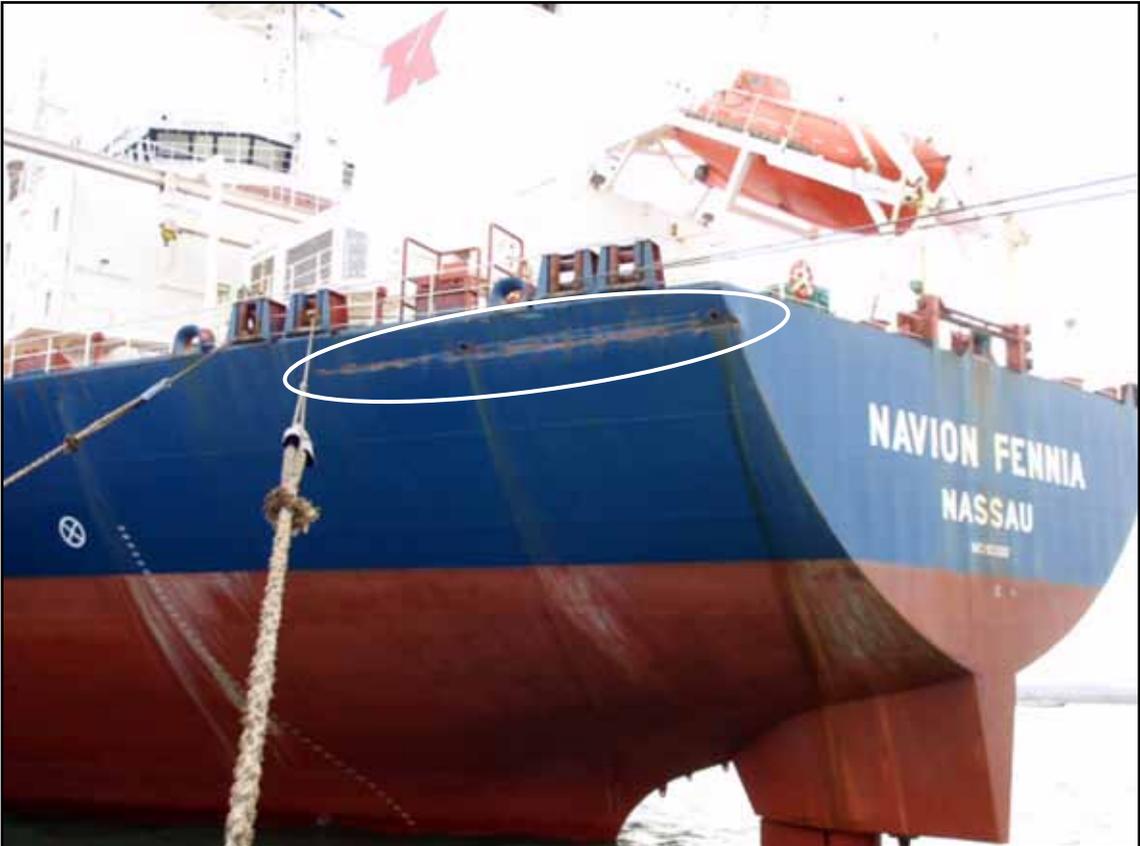
Figure 8

Navion Fennia, which was starboard side alongside Fawley Marine Terminal berth 5, sustained damage to her port quarter (**Figure 8**). This consisted of torn and indented plating with buckling of associated stiffeners. Temporary repairs were effected before the vessel left the Solent, allowing permanent repairs to be deferred until her next docking period.

Damage sustained by Navion Fennia

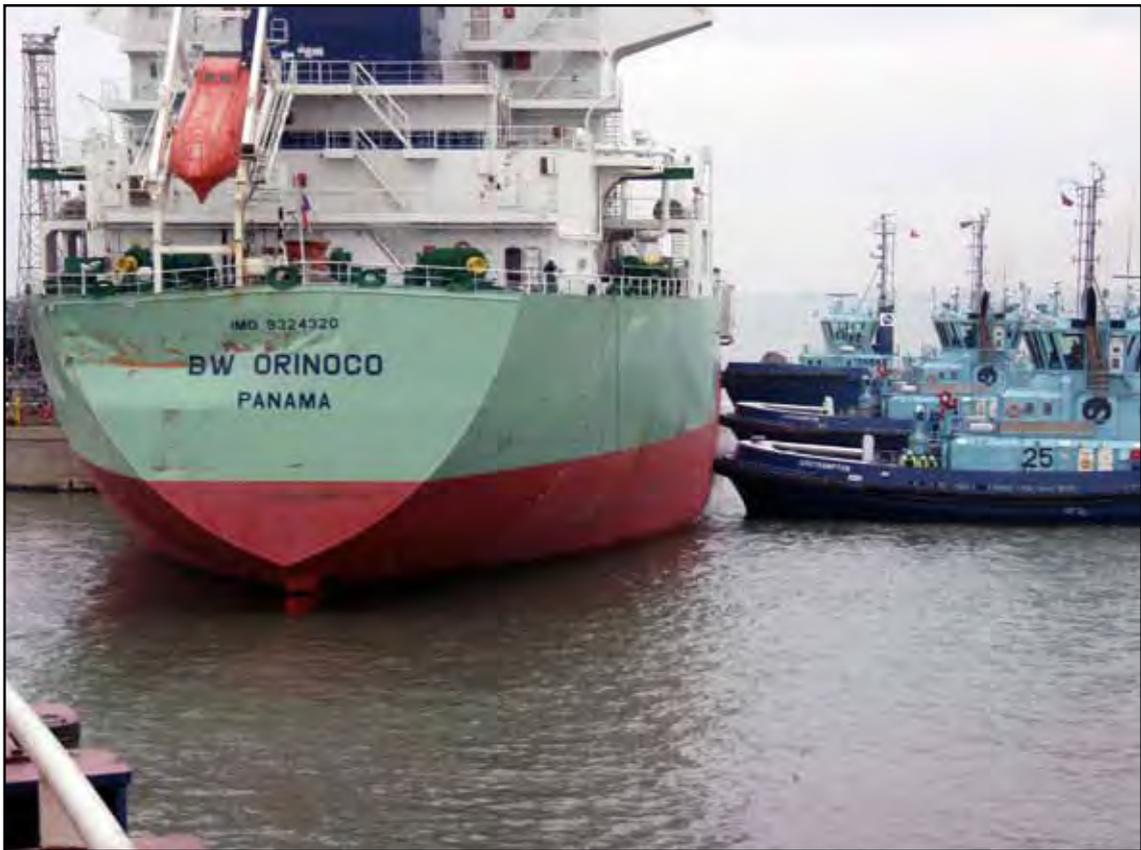
Figure 9

BW Orinoco, port side alongside Fawley Marine Terminal berth 4, sustained extensive damage to her port quarter, stern structure, poop deck and steering gear (**Figure 9**). The vessel required steelwork replacement (**Figure 10**), and repairs were also required to the freefall lifeboat davit before she could leave the Solent.

Damage sustained by *BW Orinoco*

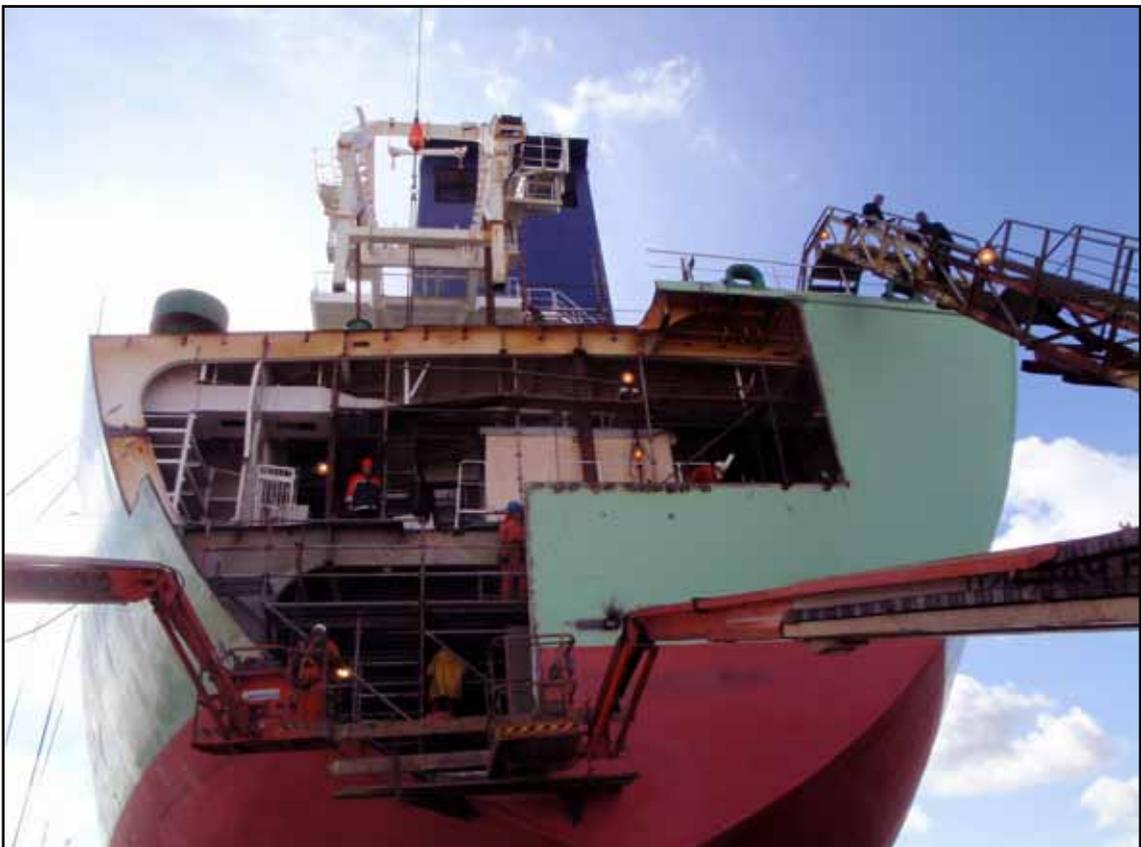
Figure 10

Repair work to *BW Orinoco*

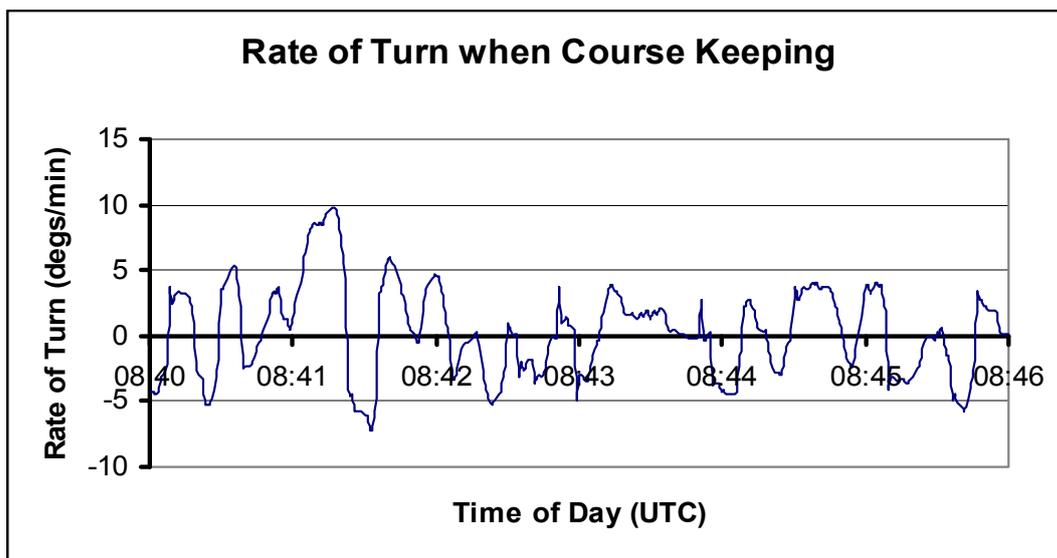
Figure 4: Vallermosa Measured Rate of Turn while on a Steady Course

It is seen that the rate of turn is hardly ever steady or close to zero, as one might have expected on a day when the winds were light and the sea slight. The plot in Figure 4 was made from data sampled every second, so the undulations, whose periodicity is well in excess of the sampling period, cannot be ascribed to noise in

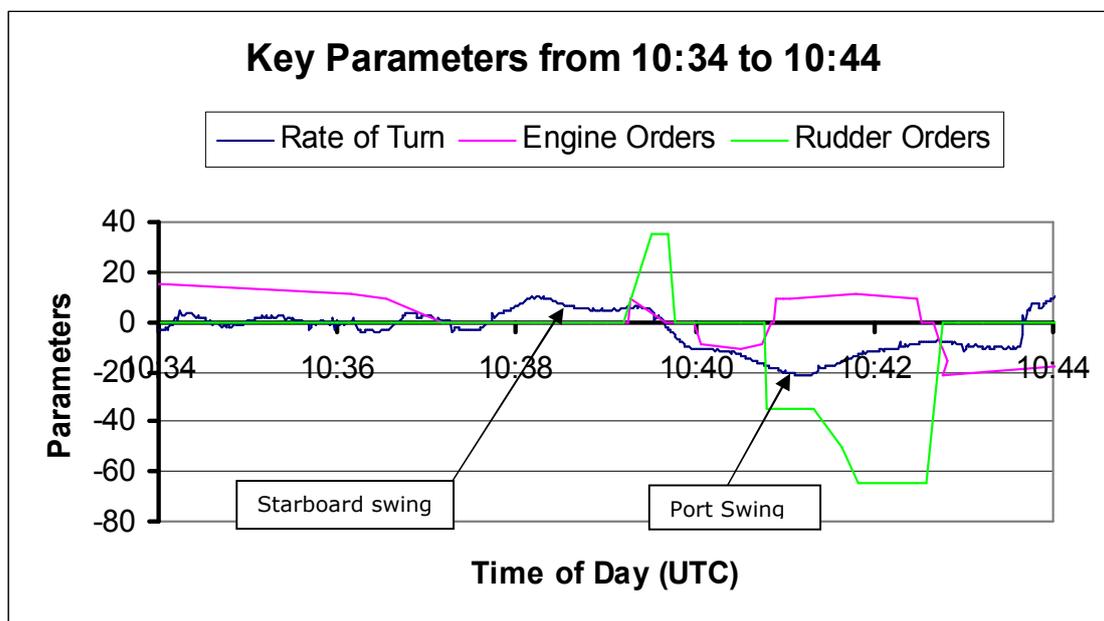
At 10:34 the ship was making about 11.5 knots over the ground with the engines on half ahead, having been reduced from full ahead. Figure 8 indicates the turn rate, rudder commands and engine orders over this last period.

Figure 8: Measured Parameters in Period Leading to Collision
