Extracts from Hawkins & Associates Ltd's Fire Investigation Report – C69/45210  
dated 2 September 2010

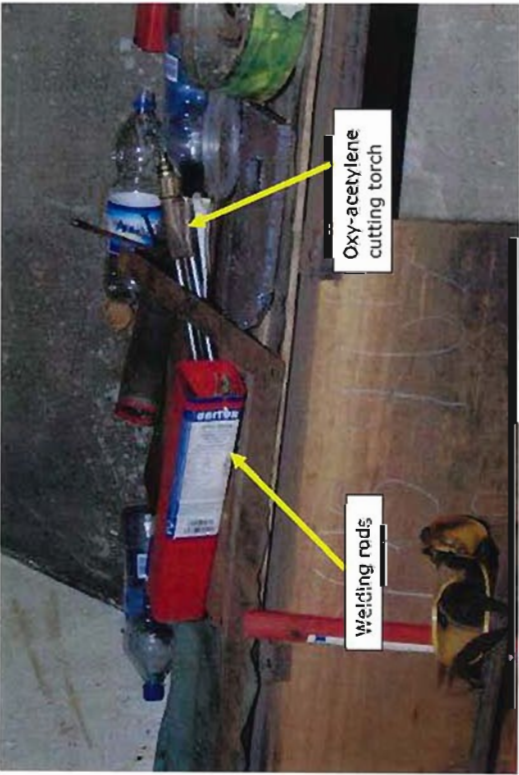
3.2.1 The inspection of the Yeoman Bontrup started in the Bosun's Store at the bow, working aft. There were large amounts of stores in the Bosun's Store including rubber belts for the conveyors; drums of oil and a work bench with welding and cutting equipment, (see **Photograph 1**).

**Photograph 1**  
The welding and cutting equipment in the Bosun's Store

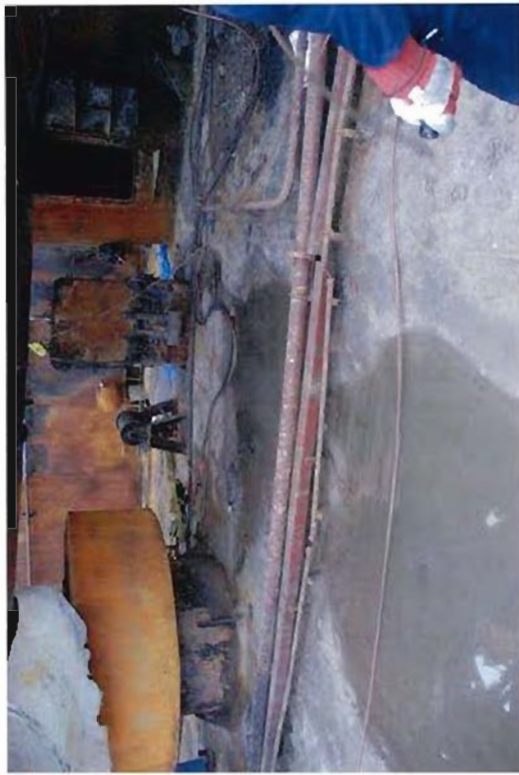
- 3.2.3 Returning on-deck and moving aft, there was some blackening of the cargo at the aft edge of hold 5. The front of the accommodation had high levels of soot deposits to port and the deck aft of hold 5 was buckled severely (see **Photograph 3**). Three large round ventilator stacks were immediately ahead of the accommodation and served to ventilate the conveyor tunnels. The centre and port vents were fire damaged severely. The starboard vent was undamaged (see **Photograph 4**).

**Photograph 3**  
Buckling in deck plating between Hold 5 and the accommodation

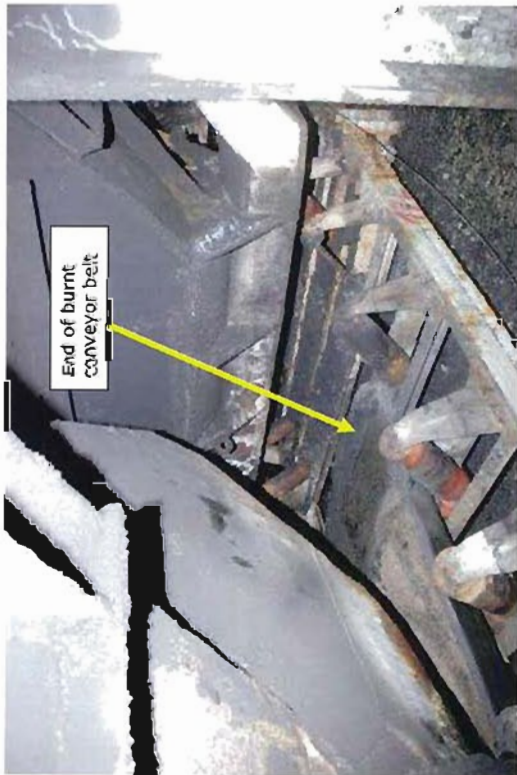
3.2.2 Descending to the tank top at the forward end of the hold, there was no smoke damage, although some water was lying on the tank top at the forward end. Working aft, a layer of smoke deposits was present at frame 179 aft. At frame 167 the conveyor belt on the starboard side had burnt away (see **Photograph 2**). The hot layer build-up was sufficient to melt light fittings and cause drop down of the services.

**Photograph 2**  
The burnt away conveyor belt at Frame 167

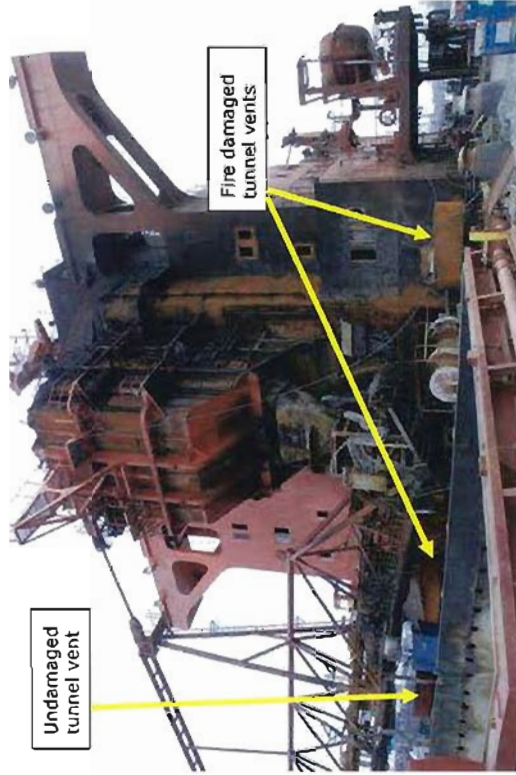
**Photograph 4**  
Fire damage to the vents from the conveyor tunnels

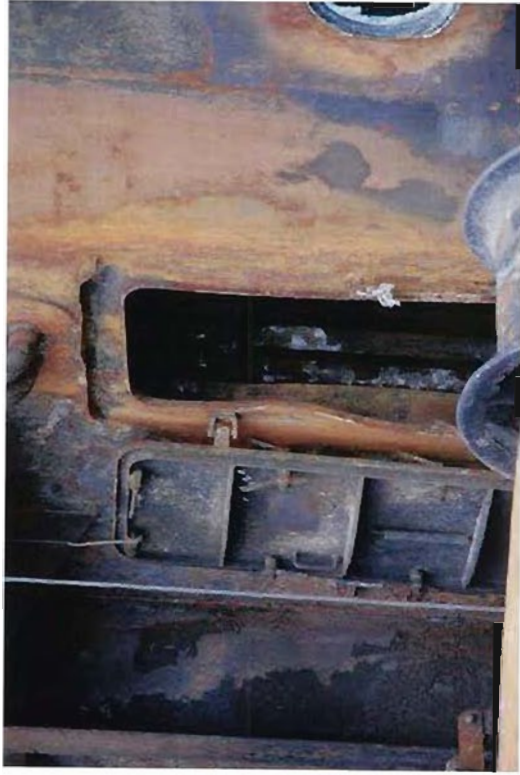
- 3.2.5 At the front of the accommodation tower, the access door to port of the conveyor tower was open at the time of the fire (see **Photograph 5**), as was the internal door into the conveyor tower itself. The door to the starboard side of the conveyor tower was closed during the fire.

**Photograph 5**  
Open door on the front of the accommodation, to port of the lift conveyor casing

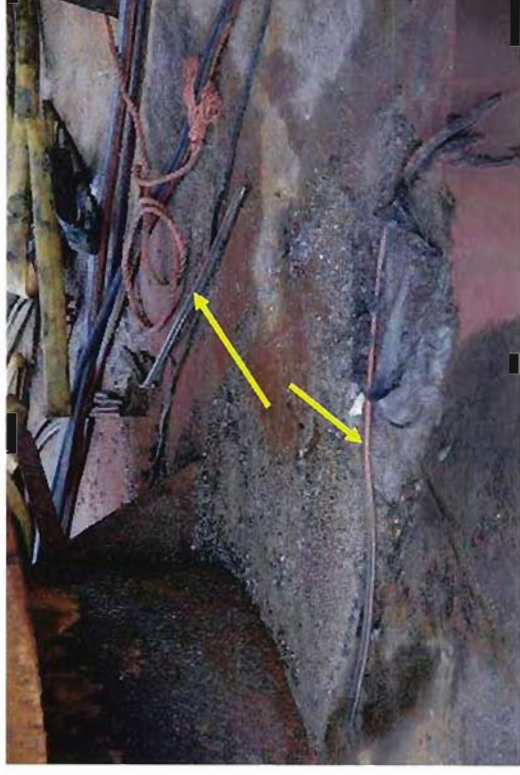
- 3.2.7 Amongst the debris in front of the accommodation were the remains of oxy-acetylene hoses (see **Photograph 7**) and a high expansion foam generator.

**Photograph 7**  
The remains of oxy-acetylene hoses in the debris in front of the accommodation

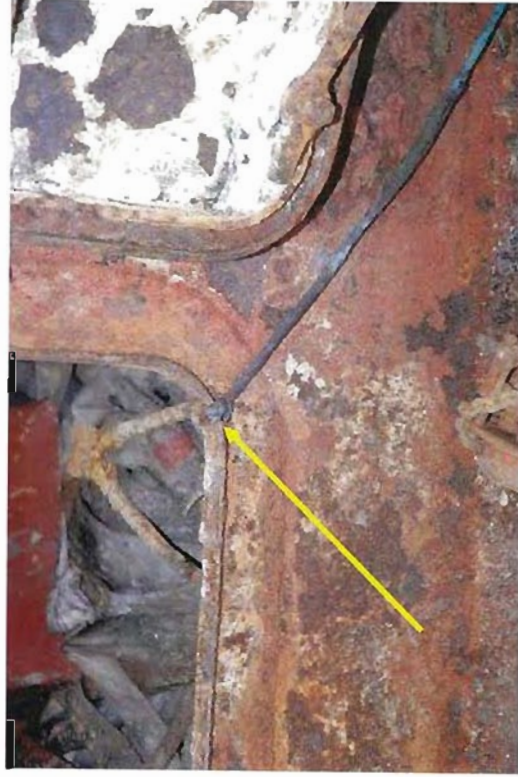
- 3.2.6 The access doors to the accommodation were closed on the port side, but two of the three doors on the starboard side of the accommodation were open at the time of the fire. The forward access door to the CO<sub>2</sub> room was closed; however, the doors from the deck to the accommodation and the Deck Workshop were open at the time of the fire. The remains of an arc welding cable were lying through the open doorway to the Deck Workshop (see **Photograph 6**).

**Photograph 6**  
The remains of a welding cable through the door of the Deck Workshop

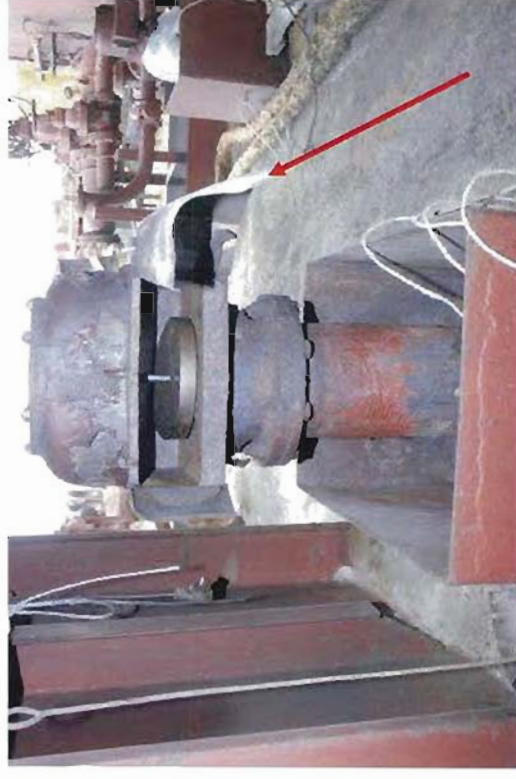
- 3.2.8 The fuel oil tank (FOT) vents on the port side were blown open, indicating that the tank had experienced an internal over-pressure; however, there was little associated fire damage to the vents themselves (see **Photograph 8**). The FOT vents on the starboard side were not blown open but were all fire damaged severely.

**Photograph 8**  
The "blown" Port FOT vents.

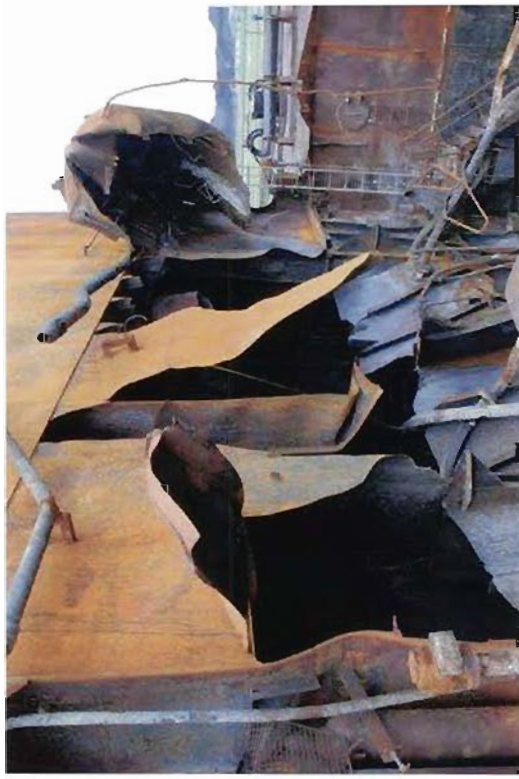
3.2.9 The aft deck of the Yeoman Bontrup was mostly blown off. The deck to the port and starboard sides of the exposed Steering Gear Room had remained in place. However, the inner edges of the plating on the top of the tanks outboard of the Steering Gear Room had been torn from the bulkheads. The Steering Gear Room was open with the rudder head and steering gear exposed. The aft edge of the accommodation tower was fractured; with the bulkhead plating bent outwards from the Engine Room (see **Photograph 9**).

**Photograph 9**  
The damage to the aft bulkhead of the Engine Room

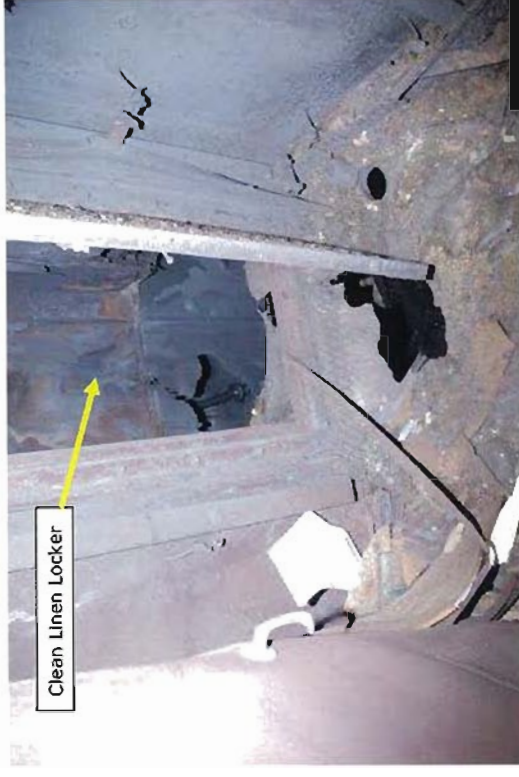
3.2.11 A large hole existed in the deck plating in the Laundry and Clean Linen Locker on the main deck inside the accommodation tower. This was approximately over the Diesel Oil Service Tank in the Engine Room. The steel deck plating was burnt or melted away over an area of approximately 4 m<sup>2</sup> (see **Photograph 11**). The remaining accommodation was fire damaged severely throughout; however, the bridge had sustained little in the way of fire damage.

**Photograph 11**  
The damage to the deck plating in the Laundry and Clean Linen Locker

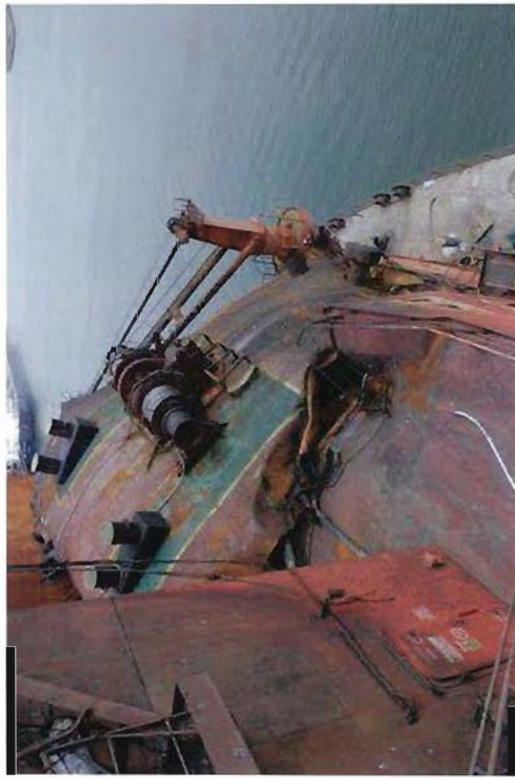
3.2.10 The stern deck lay on the port side of the accommodation tower. The underside of the deck section had heavy soot deposits. Paint remained on the top surface of the aft deck and the deck was relatively undamaged by fire (see **Photograph 10**).

**Photograph 10**  
The section of the stern deck lying on the port side of the accommodation.

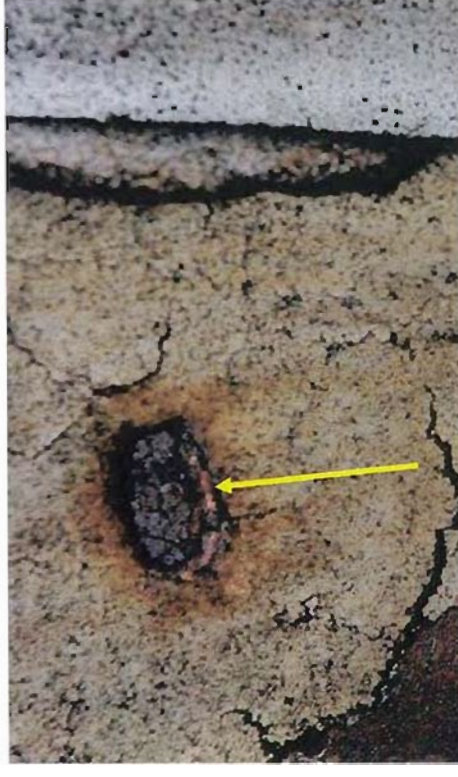
3.2.12 External doors of the lift conveyor casing were open above main deck level and numerous tools, including welding rods, remained in the stairwells. The lift conveyor chute or 'trousers' had numerous welded patches and oxyacetylene holes cut in it (see **Photograph 12**).

**Photograph 12**  
A hole cut in the "trousers" in the lift conveyor casing.

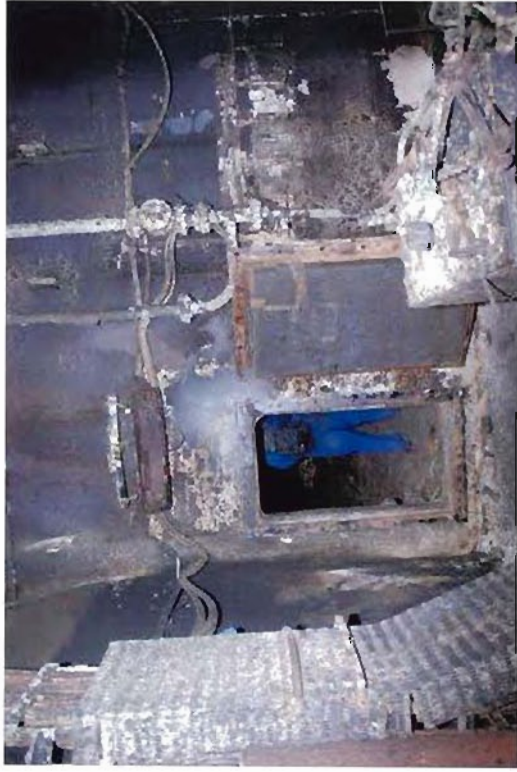
3.2.13 The Power Pack Room at the base of the lift conveyor casing was fire damaged severely. It contained the remains of oil drums, welding and cutting equipment. There was no clear evidence of failed hydraulic lines in this area. The remains of a work bench were to port. Witness marks revealed that the access way between the

Power Pack Room and the Engine Room Workshop on the port side was open at the time of the fire (see **Photograph 13**).

**Photograph 13**  
The access door between the Power Pack Room and the Engine Room Workshop.

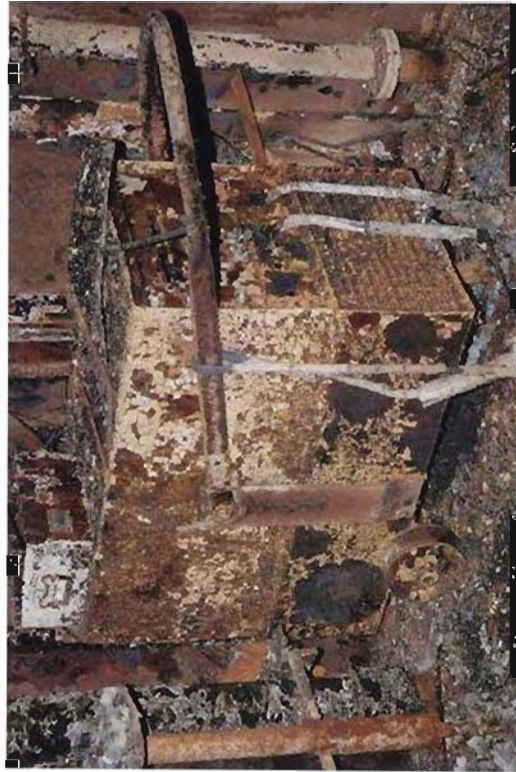
3.2.14 The Engine Room Workshop was fire damaged severely. A welding area to port had oxy-acetylene and arc welding equipment (see **Photograph 14**). Doors on the starboard side of to the Engine Room were distorted inwards (see **Photograph 15**). The aft door of the workshop had been open during the fire (see **Photograph 16**). The overhead gantries in the Engine Room had collapsed and there was severe distortion to the top of the steel columns. The forward starboard corner of the second deck around the engine opening had sustained severe fire damage to the Diesel Oil Service Tank. Numerous steel pipes had burnt away and deck beams and deck plating overhead were burnt or melted and had re-solidified on the deck plating below (see **Photograph 17**). Sight "glasses" in the Diesel Oil Service Tank had melted or burnt away.

**Photograph 14**  
Welding equipment in the engine room.

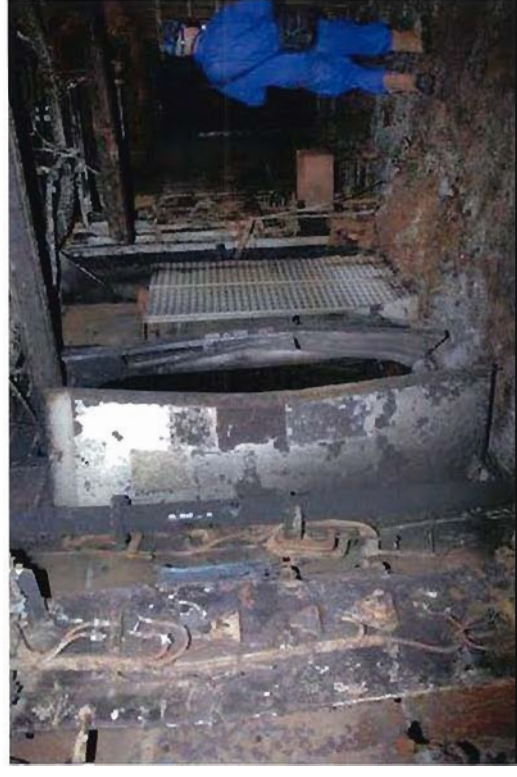
**Photograph 15**  
The doors on the starboard side of the Engine Room

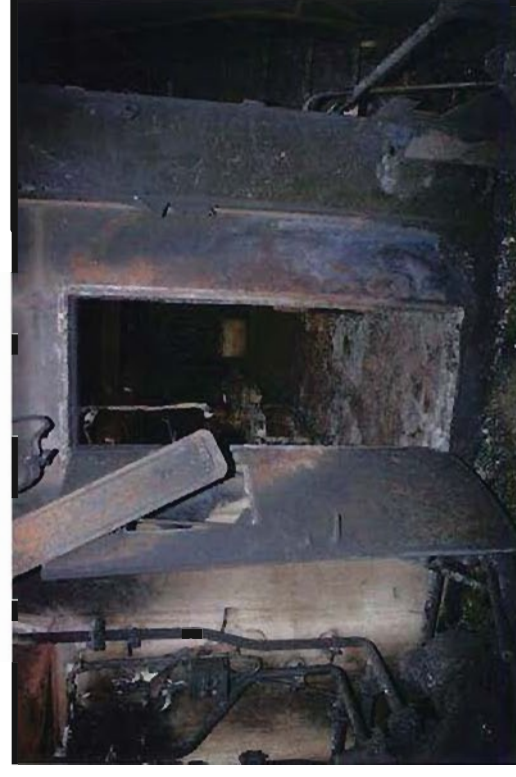
- 3.4.5 There was severe distortion to double doors from the Engine Room Workshop to the Engine Room; however the aft door from the workshop to the Engine Room was in the 'open' position at the time of the fire. The glass in the window of this door was broken and lying in the debris outside the workshop.

**Photograph 16**  
The aft door to the Engine Room Workshop

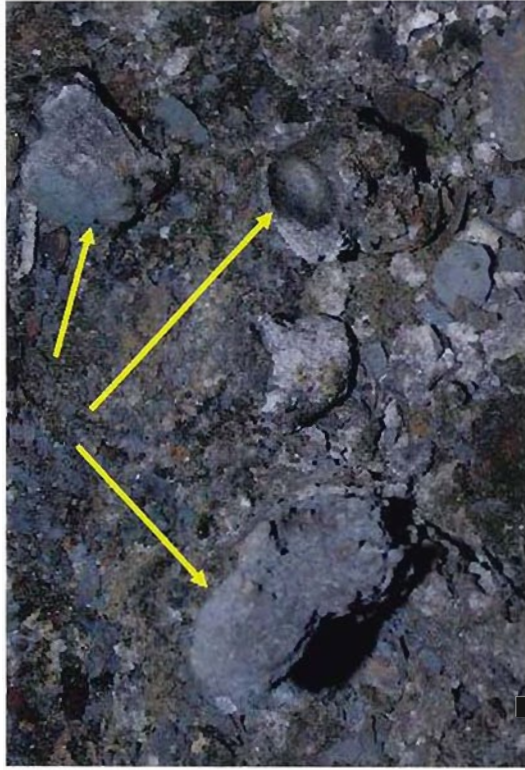
**Photograph 17**  
Resolidified melted steel adjacent to the Diesel Oil Service Tank

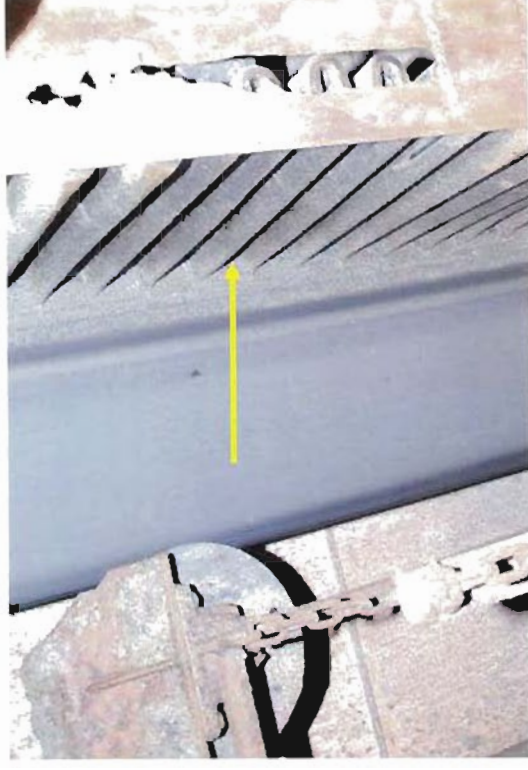
**Photograph 19**  
The flexible rubber side on the lift conveyor belt

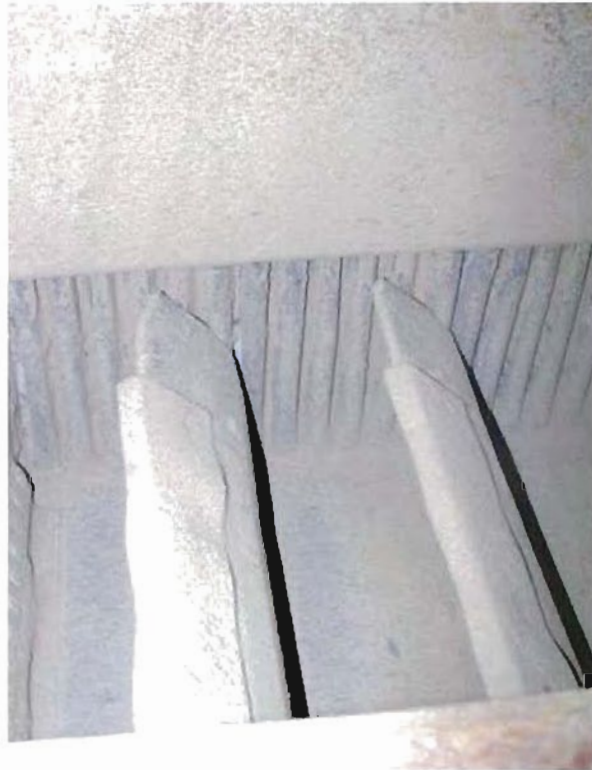
**Photograph 18**  
The view of the ascending conveyor belt buckets from the platform below the third deck.

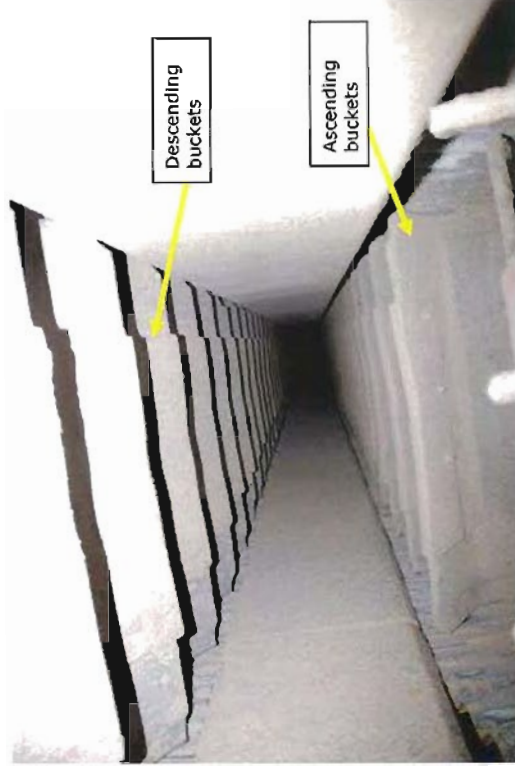
3.3.3 I viewed the lift conveyor belt from the platform below the Power Pack Room on the third deck from where the Second Engineer on the Yeoman Bontrup reported having seen the fire initially. There was a clear view of the ascending buckets on the belt (see **Photograph 18**). The flexible rubber sides to the belt were clearly visible in the lift conveyor tower (see **Photograph 19**). A view down the tower showed the buckets in the rising and falling belt (see **Photograph 20**).

**Photograph 20**  
The view down the lift conveyor tower with the ascending and descending buckets

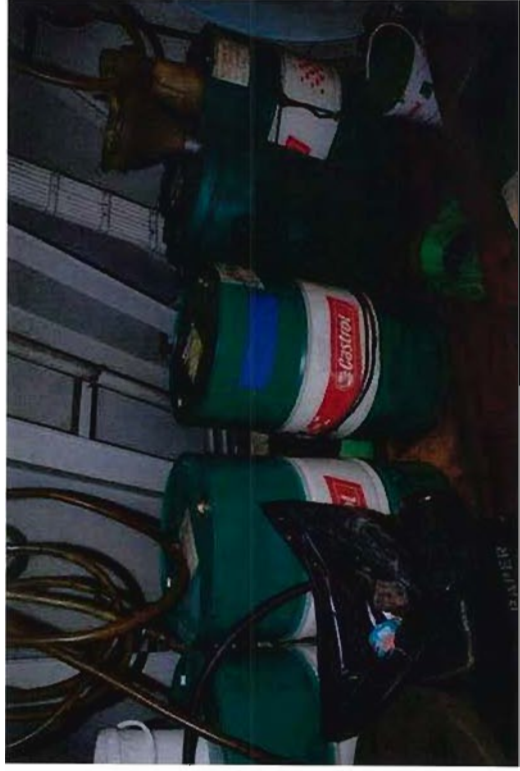
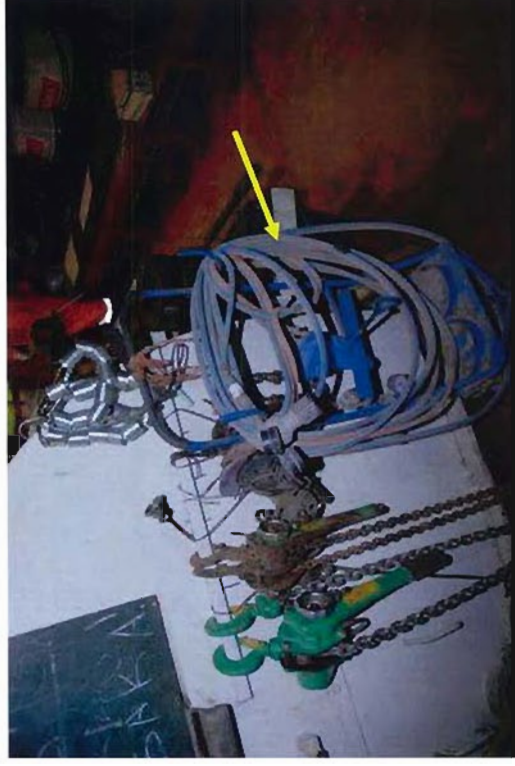
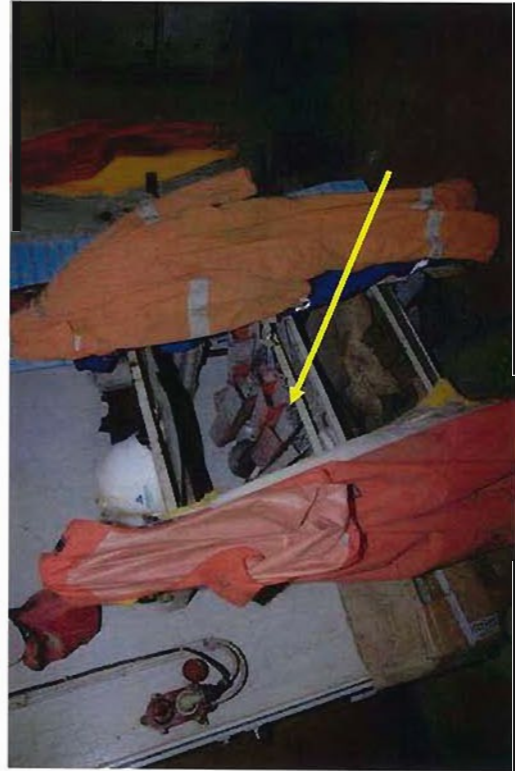
3.3.4 The Power Pack Room contained a work bench; oil drums, welding rods and cutting equipment (see **Photographs 21 to 23**). The adjoining door to the Engine Room was shut, but witness marks indicated it had been used regularly. There were no locking dogs and it was bolted shut. A retaining stud welded to the bulkhead adjacent to the door could be used to hold the door open at sea (see **Photograph 24**).

**Photograph 21**  
Oil drums in the Power Pack Room

**Photograph 23**  
Portable cutting equipment in the Power Pack Room

**Photograph 22**  
Welding rods in the Power Pack Room

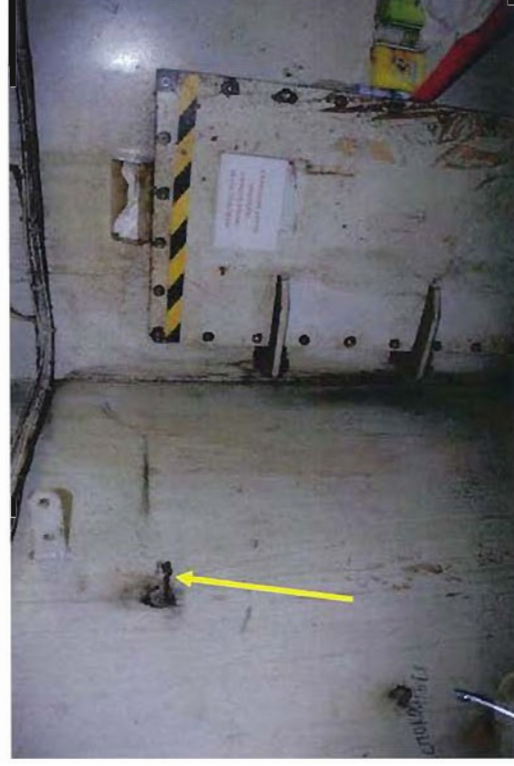
**Photograph 24**  
The retaining bolt on the bulkhead to keep the access door to the Engine Room Workshop open at sea

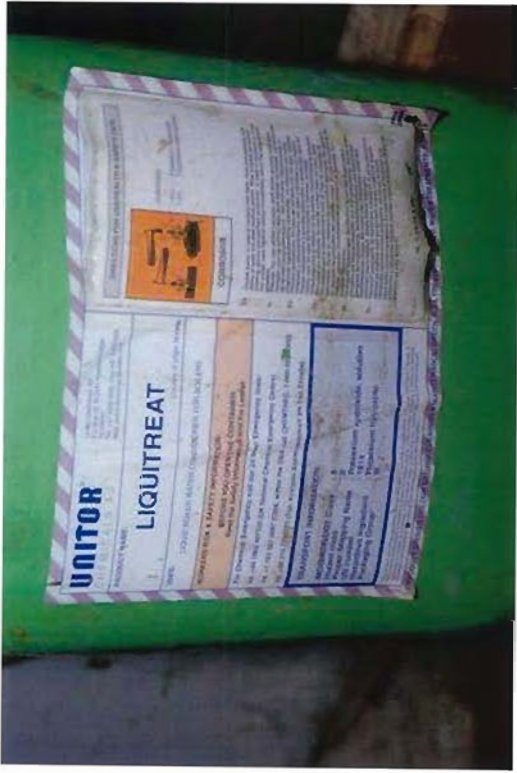
3.3.5 There were corrosive liquids stored beside the oil drums (see **Photograph 25**). In general, below decks, all available spaces and corridors were used for general storage, including storage of flammable liquids (see **Photographs 26 and 27**). The 'trousers' in the lift conveyor tower had numerous oxy-acetylene cut holes and welded patches on the outside of the chute (see **Photograph 28**) and nuts retaining the hardox tiles were rusted severely (see **Photograph 29**).

**Photograph 25**  
The corrosive liquids in the Power Pack Room

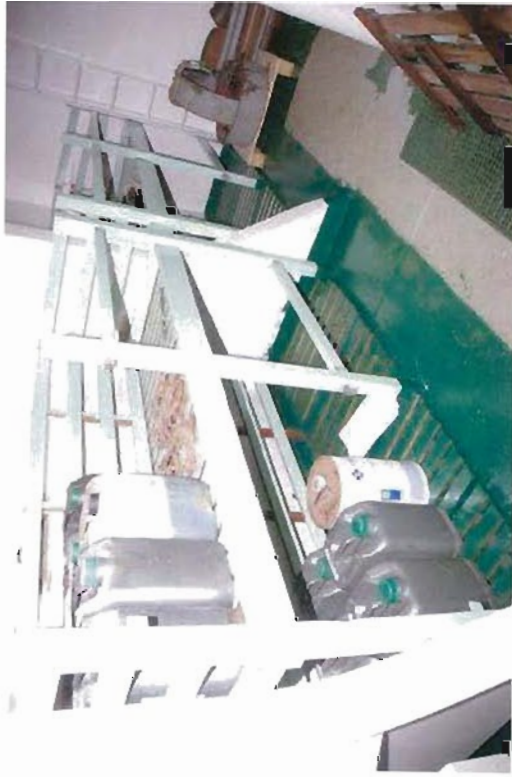
**Photograph 26**  
The now empty racking across the transom previously used for chemical storage

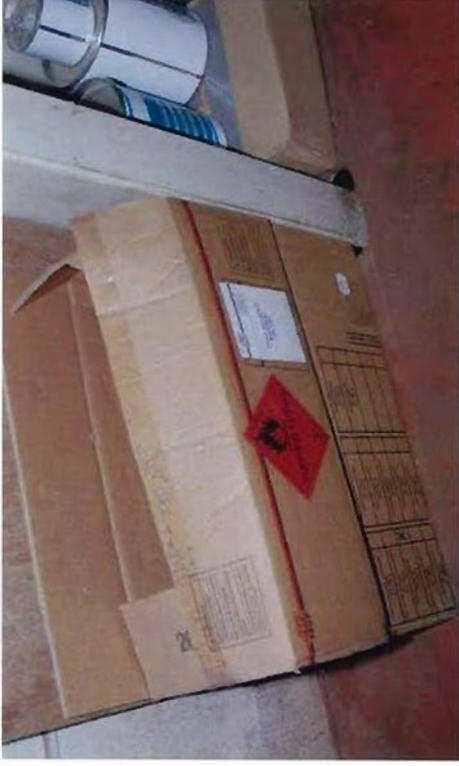
**Photograph 27**  
The flammable liquids stored in a passageway

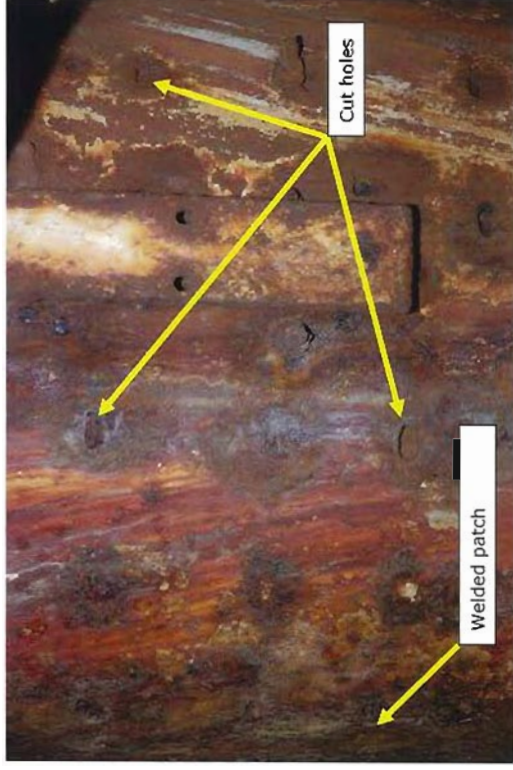
**Photograph 28**  
The welded patches and holes cut in the "trousers" in the lift conveyor tower

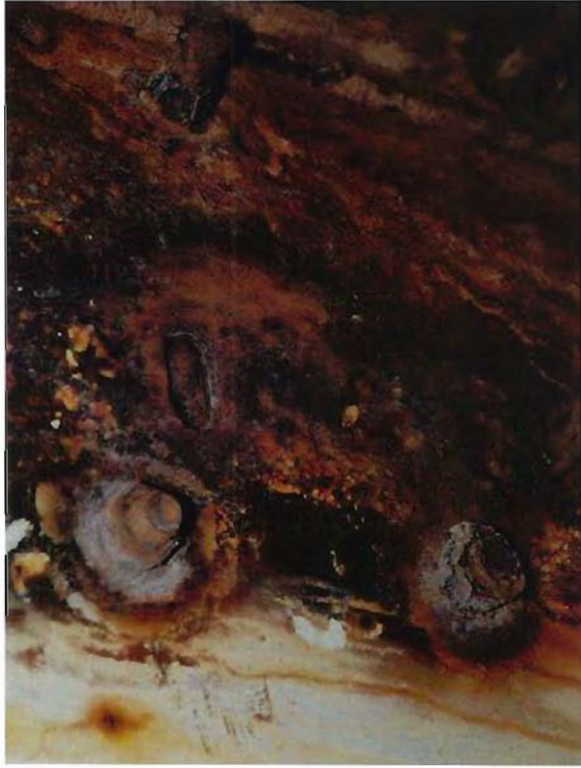
**Photograph 29**  
The severely rusted nuts on the retaining bolts for the "Hardox" tiles

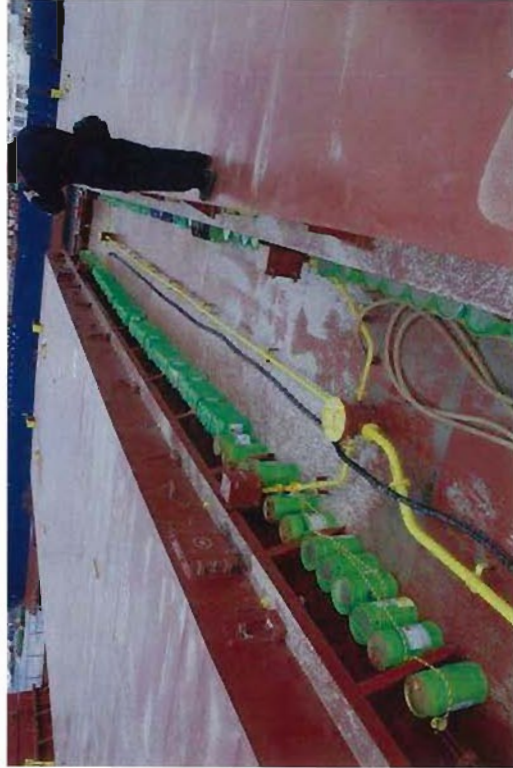
3.3.6 On deck, there were numerous drums of chemicals stored between holds 4 and 5 (see **Photograph 30**). These were reported to have been stored in racks across the transom in the Steering Gear Room. The chemicals included alkyl benzenes, sodium nitrite, acids, potassium hydroxide, sodium hypochlorite and hydrazine hydrate.

**Photograph 30**  
The chemicals stored between Hold 4 and Hold 5

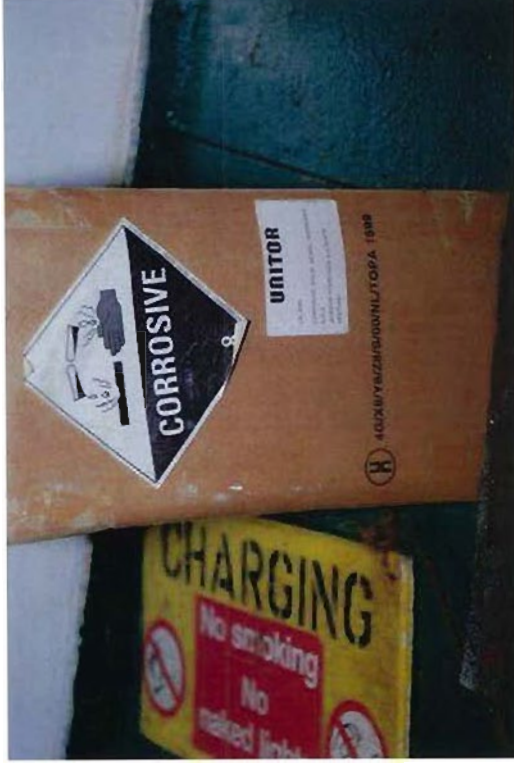
However, some corrosive chemicals remained in the Steering Gear Room (see **Photograph 31**) including chlorinating tablets (see **Photograph 32**).

**Photograph 31**  
The corrosive chemicals in the Steering Gear Room

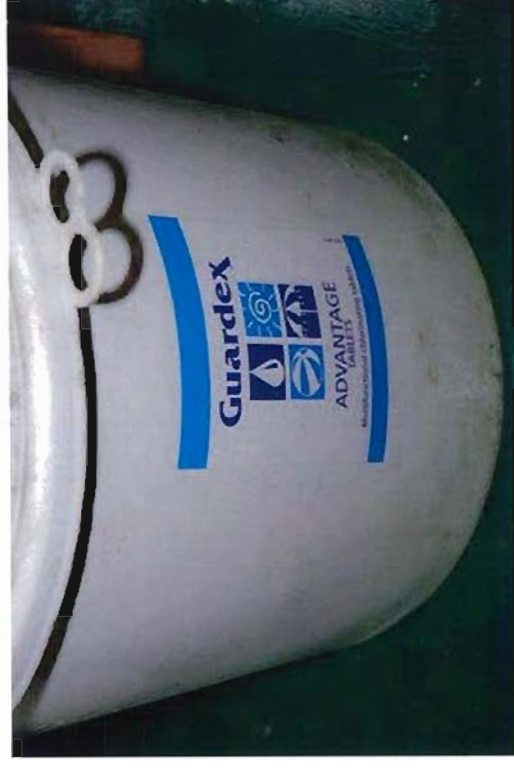
**Photograph 32**  
The chlorinating tablets in the Steering Gear Room

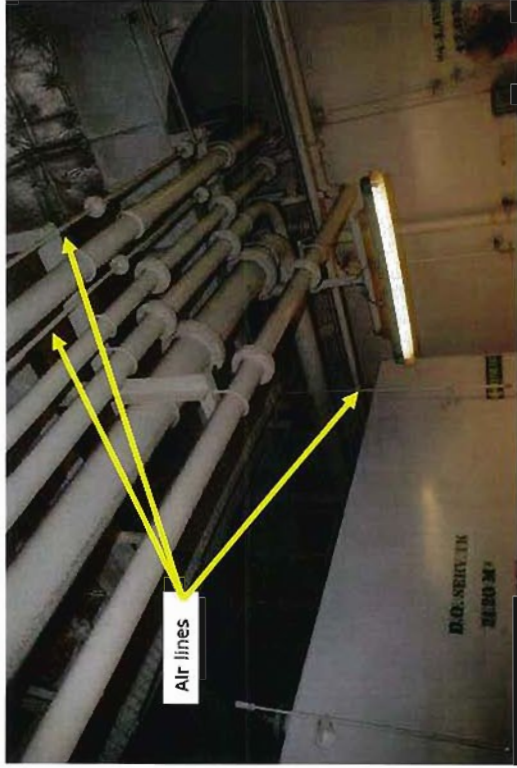
3.3.7 In the Engine Room, air control pipes routed to the emergency shut down cylinders on the Diesel Oil Service Tank valve were disconnected from the valve. The air lines ran across the deck head adjacent to the Diesel Oil Service Tank (see **Photograph 33**). This was in a similar location to the burnt steel and deck beams on the Yeoman Bontrup. All sight glasses for the Diesel Oil Service Tank, vented oil tank and heavy fuel oil were made of plastic and not glass (see **Photographs 34** and **35**).

**Photograph 33**  
The air lines above the Diesel Oil Service Tank

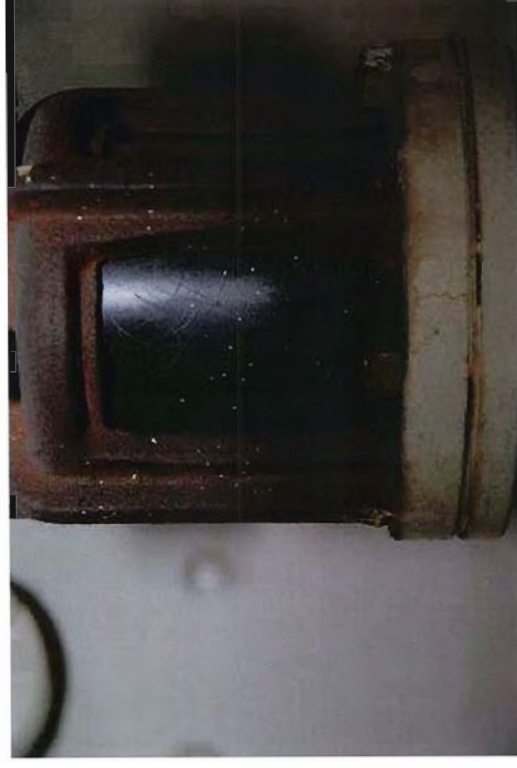
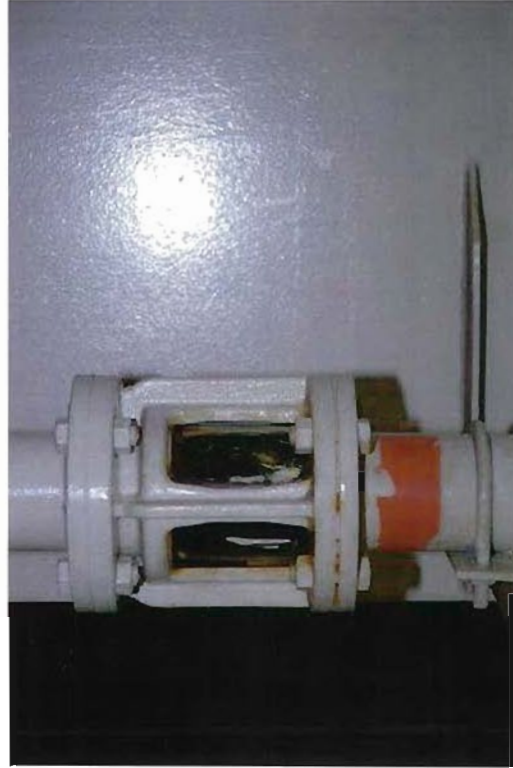
**Photograph 35**  
The plastic sight glass in the Heavy FOT fuel line

**Photograph 34**  
The plastic sight glass in the Diesel Oil Service Tank fuel line

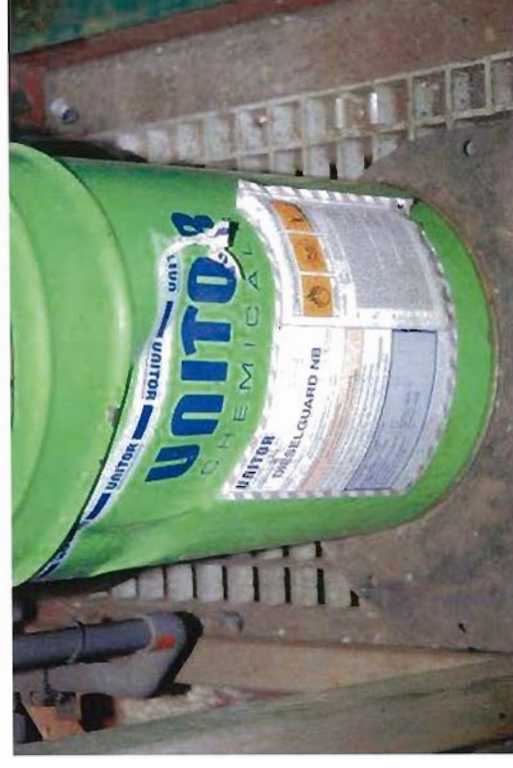
3.3.8 There were drums of the oxidising agent Dieselguard NB in the Engine Room outside the workshop (see **Photograph 36**). The two emergency shutdown control valves for the oil tanks were in the fire control room, one of the two valves shut the valve for the Diesel Oil Service Tank. The other valve closed all the remaining fuel supply valves in the Engine Room.

- 4.8 There was a container of Dieselguard NB (sodium nitrite) outside the Engine Room Workshop doors on the Yeoman Bridge. Sodium nitrite is a powerful oxidising agent and if it was also present outside the workshop doors on the Yeoman Bontrup it would assist in a rapid development of the fire in this area and could possibly initiate an explosion. This would be consistent with the damage to the workshop and storeroom doors. The lack of over-pressure damage to the Engine Control Room above the storeroom suggests that the over-pressure outside the workshop did not occur until after the Engine Control Room windows had melted. The lack of damage to the Purifier Room doors and windows suggests that the over-pressure outside the

**Photograph 36**  
The drum of Dieselguard NB outside the Engine Room Workshop door

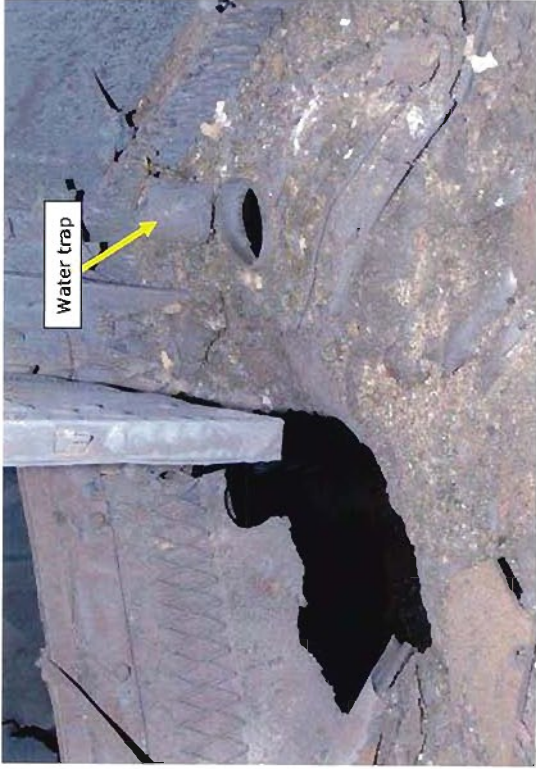
3.4.2 The fire damage in the Laundry and Clean Linen Locker was most severe in the Clean Linen Locker with a small hole in the Laundry and most of the Clean Linen Locker floor burnt away. The ceramic tiles in the laundry remained in place, except at the hole in the floor. The drain pipe in the laundry floor directly over the Diesel

Oil Service Tank was intact, but the water trap lay upside down on clean tiles and stuck in debris beside the drain, see **Photograph 37**.

**Photograph 37**  
The water trap for the Laundry drain in the fire debris.

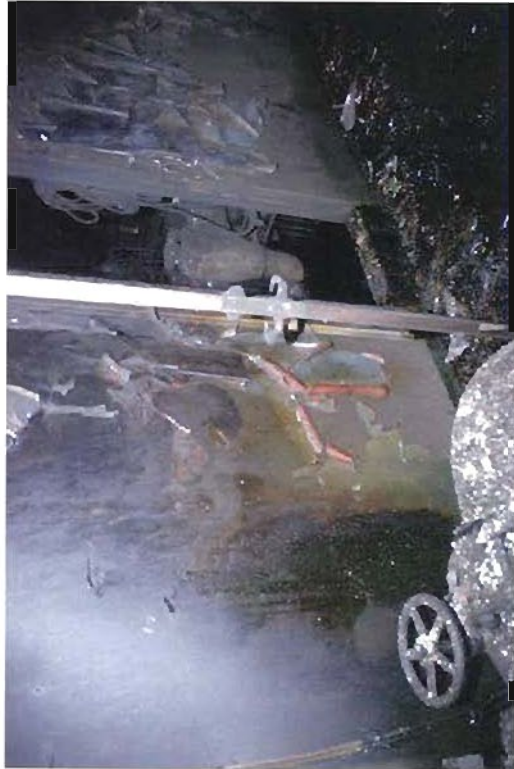
- 3.4.6 The forward door to the Purifier Room on the starboard side of the Engine Room was open at the time of the fire, see **Photograph 38**. There were the remains of a piece of rope attached to the handle on the outside of the door. The edges of the rear door to the Purifier Room were free of soot, indicating that it was closed at the time of the fire. Glass in the Purifier Room doors was undamaged.

**Photograph 38**  
The starboard door to the Purifier room

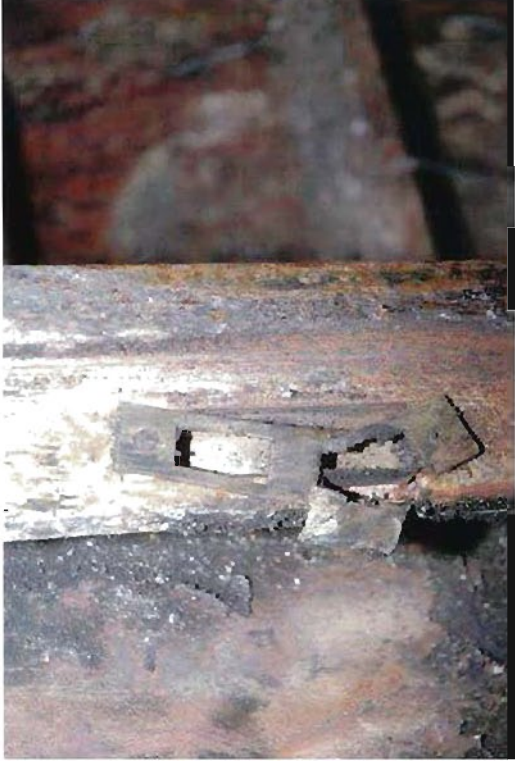
- 3.4.7 The door from the Engine Room to the Engine Store over the Engine Room Workshop was blown into the storeroom. The door was buckled around the lock and the striker plate on the door jamb was broken, see **Photograph 39**. The windows of the Engine Control Room over the storeroom had re-solidified at the bottom of

**Photograph 39**  
The damage to the striker plate for the door to the Engine Store

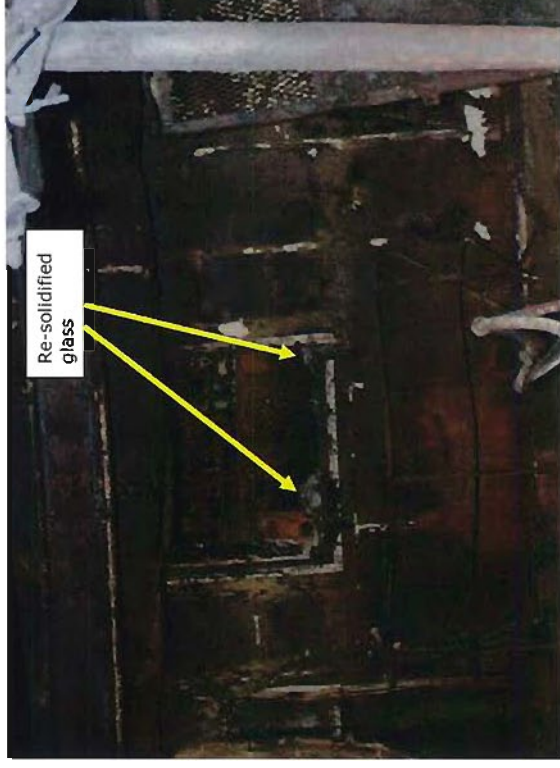
their frames and had not shattered, see **Photograph 40**. The door to the Engine Control Room was in place and fire damaged, but not buckled and the glass in the door had re-solidified at the base of the frame, see **Photograph 41**.

**Photograph 40**  
The re-solidified glass in the windows of the Engine Control Room

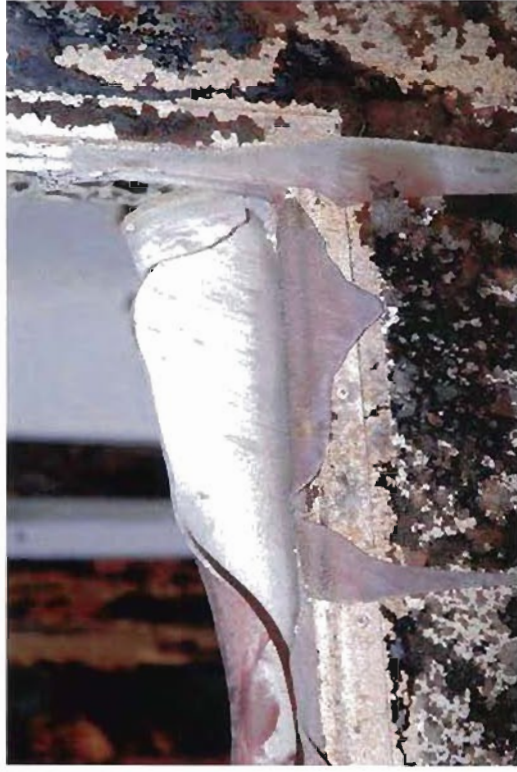
**Photograph 41**  
The resolidified glass in the window of the door to the Engine Control Room

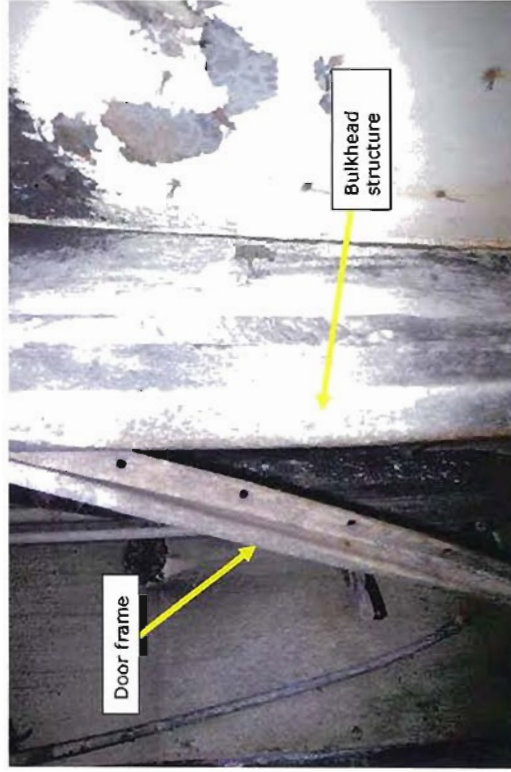
3.4.8 There was no significant fire damage at low levels in the Engine Room, although there was light heat damage to plastic materials at the third deck level. The door to the escape trunking at the aft end of the Engine Room at the lowest deck was buckled severely. The door was lying in the Engine Room and the door frame bent into the Engine Room, see **Photograph 42**.

**Photograph 42**  
The damage to the door frame for the emergency escape trunk at the aft end of the Engine Room

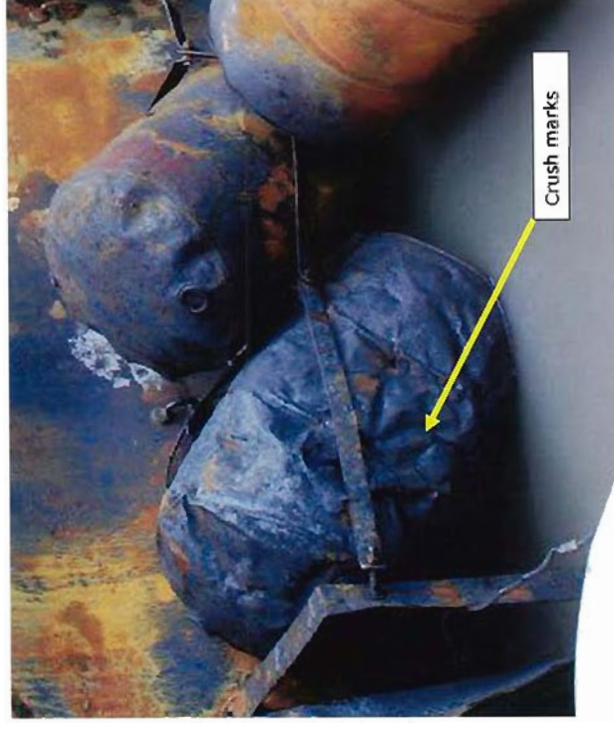
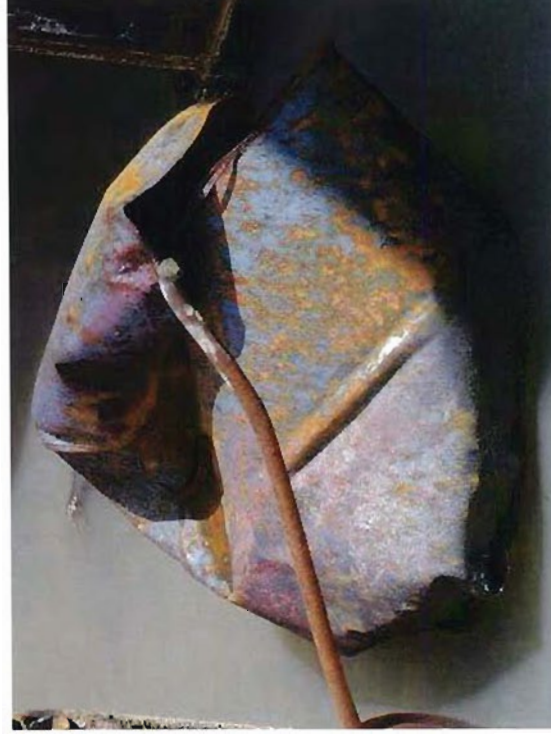
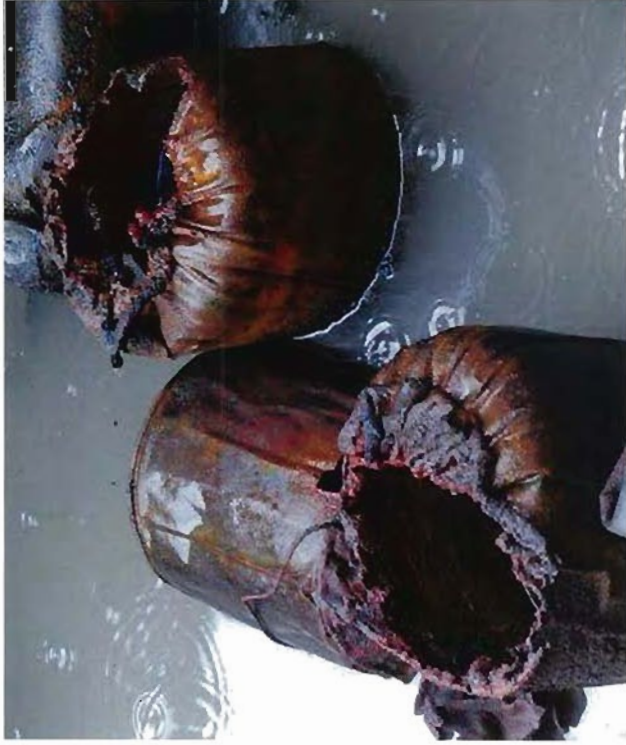
3.4.9 The Steering Gear Room was exposed due to the explosion removing the stern deck. The damage to the components in the Steering Gear Room is shown in **Figure 12**. It contained over expanded 200 litre drums (see **Photograph 43**), crushed 200 litre drums (**Photograph 44**) and burnt 25 litre drums (see **Photograph 45**).

**Photograph 43**  
An over expanded 200 litre drum (right) and one that has been previously crushed (left) in the Steering Gear Room

**Photograph 44**  
A crushed 200 litre drum in the Steering Gear Room

**Photograph 45**  
The burnt 25 litre drums in the Steering Gear Room
