Extracts from Hawkins & Associates Ltd's Fire Investigation Report – C69/45210  
dated 2 September 2010

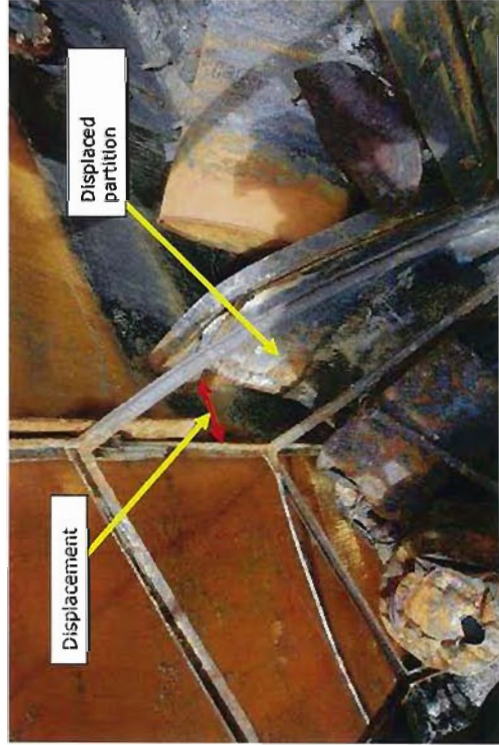
3.4.10 The aft bulkhead of the Rope Store on the port side of the Steering Gear Room had moved approximately 100 mm forwards, (see **Photograph 46**). Drums stored aft of the Rope Store were crushed, (see **Photograph 47**). The drums stowed to starboard of the Rope Store had over-pressurised in the fire (**Photograph 48**). The metal cabinets on the port side of the Steering Gear Room were displaced forward of their mountings while those on the starboard side were bent forward, but remained in place (see **Photographs 49 & 50**).

- 4.14 The crush damage to hydraulic tanks and electrical connection boxes is limited to those closest to the stern and the displacement of the Rope Store bulkhead suggests that a localised detonation occurred towards the stern of the vessel. The lack of crush damage to the electrical connection boxes forward of the stern gear indicates that the high over-pressures did not propagate further forward and that there was a rapid decrease in over-pressure. This is consistent with a small localised detonation in the area and subsequent rapid pressure decay. The drums appear to have been crushed then re-expanded when their contents boiled. The crush marks and subsequent expansion of 200 litre drums suggests that the explosion that removed the stern deck occurred before the entire space heated to the boiling points of the contents of the drums.

**Photograph 46**  
The aft partition of the Rope Store

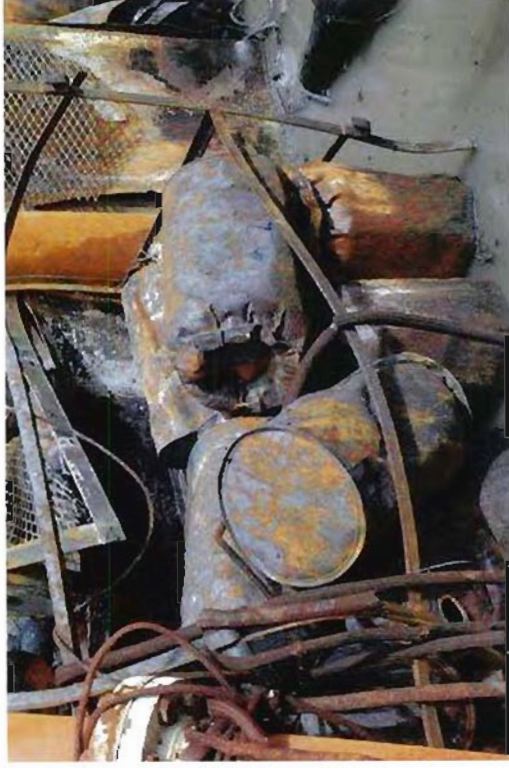
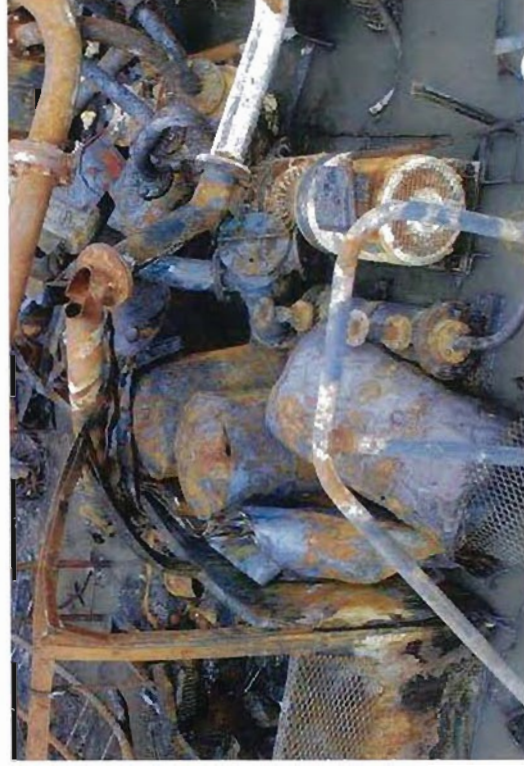
**Photograph 47**  
The crushed 25 litre drums aft of the Rope Store

**Photograph 48**  
Over pressurised 200 litre drums to starboard of the Rope Store

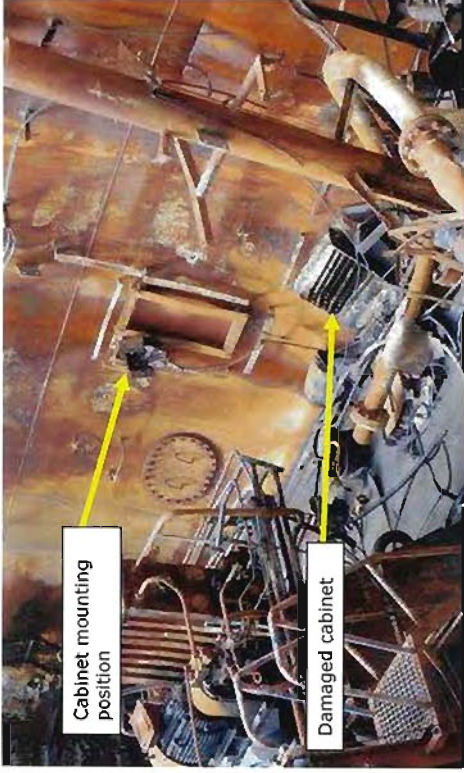
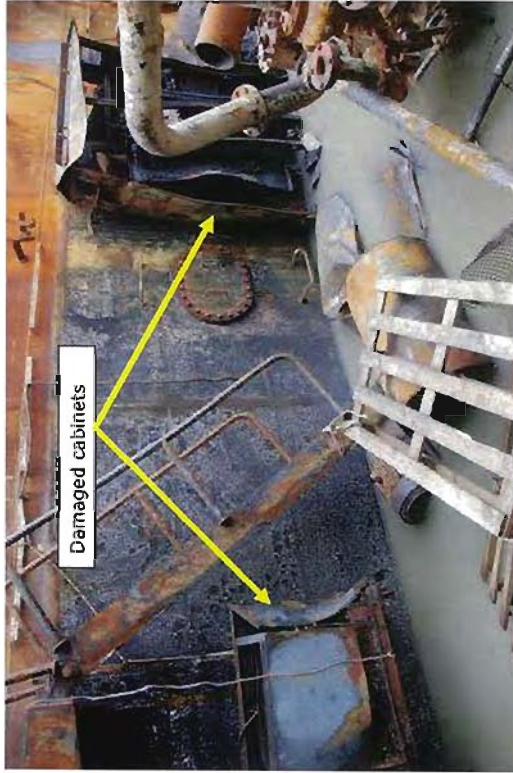
**Photograph 49**  
The remains of cabinets on the port side of the Steering Gear room

**Photograph 50**  
The damaged cabinets on the starboard side of the Steering Gear room

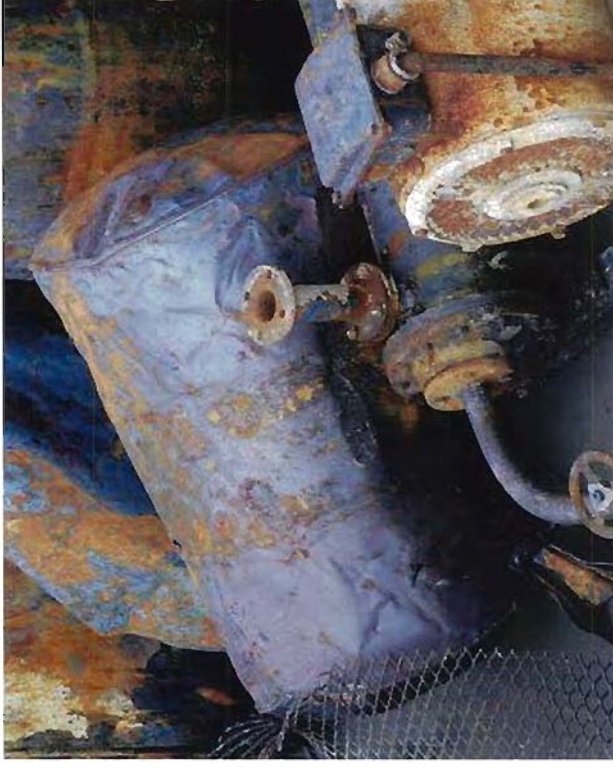
3.4.11 There were numerous 200 litre drums with crease marks in their sides, which had subsequently over-expanded, see an example in **Photograph 51**. The hydraulic tanks for the steering gear were squashed slightly and electrical connection boxes on top of the motors for the hydraulic system on the steering gear were crushed, see **Photograph 52**. A matching connection box on electric motors forward of the steering gear was not crushed in the same manner.

**Photograph 51**  
A 200 litre drum with creased sides which has subsequently over-expanded

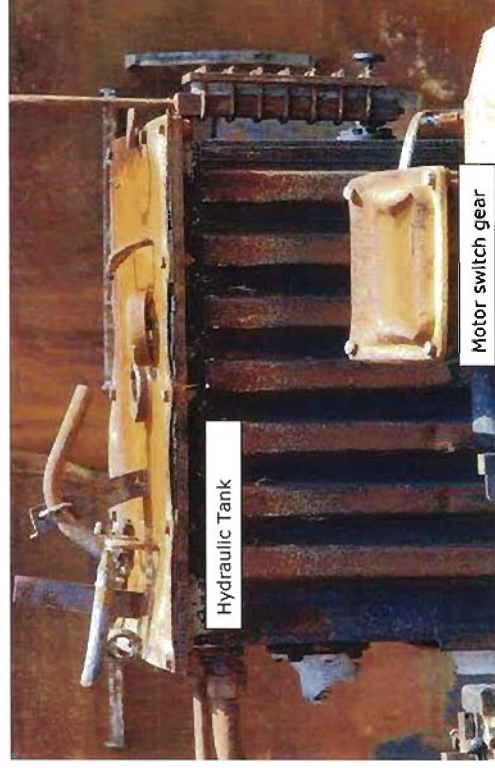
**Photograph 52**  
The crush damage to the top of the hydraulic tanks and motor switch gear

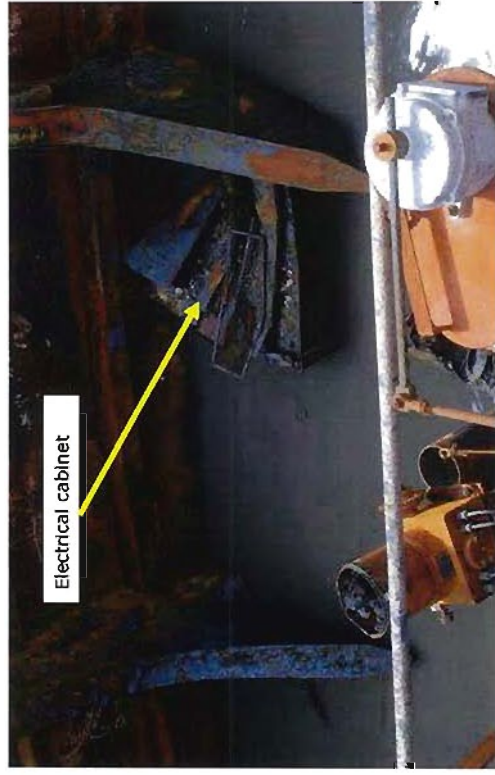
**Photograph 53**  
The collapsed electrical cabinet to starboard of the centreline frame at the transom

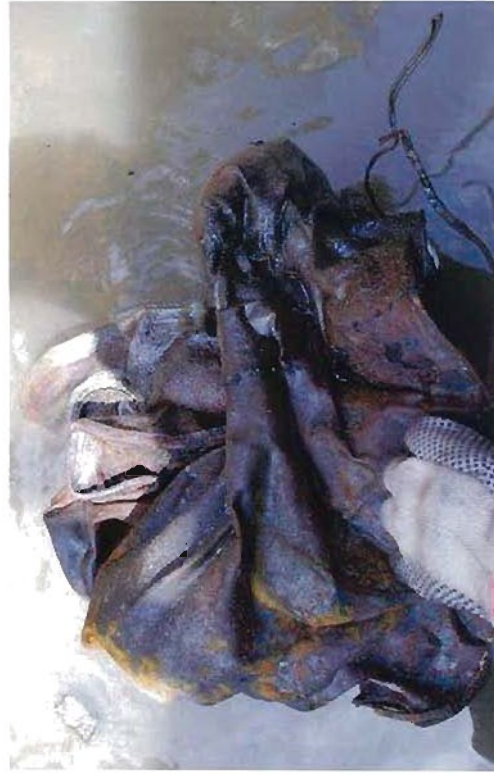
- 4.15 It is likely that a local detonation occurred at the transom creating drum shrapnel and causing the severe crush damage to the 200 litre and 25 litre drums in the immediate vicinity and displacing them from their original positions. Drums further from the seat of the detonation sustained crushing damage, but were not shredded into pieces of shrapnel. This localised detonation might have opened the Steering Gear Room to the atmosphere and allowed air to rapidly mix with the fuel rich atmosphere in the Steering Gear Room, causing the explosion that removed the stern deck.

**Photograph 54**  
The remains of a severely crushed 200 litre drum between the rudder head and the transom
