# MAIB

## FLYER TO SHIPPING INDUSTRY

### **YEOMAN BONTRUP: RADIATION HAZARD IDENTIFIED FOLLOWING A FIRE**

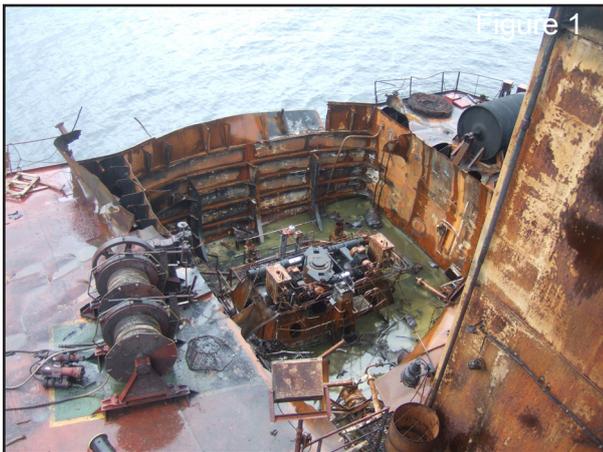
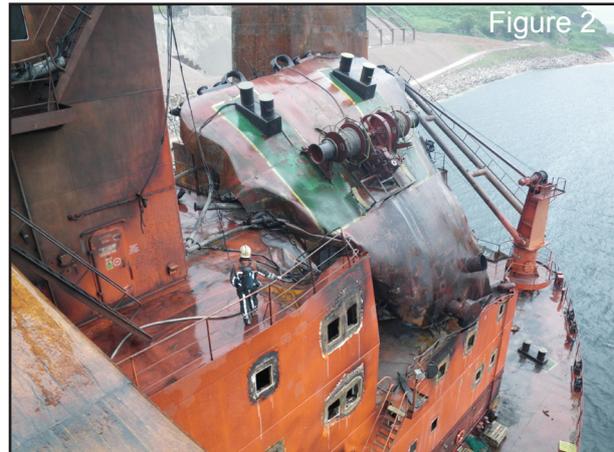
On 2 July 2010, a fire was discovered on the vertical cargo conveyor belt of the self-unloading bulk carrier *Yeoman Bontrup* while the cargo hopper was being repaired. The crew tackled the fire from the conveyor tunnels under the holds, but it quickly spread throughout the cargo handling area and into the accommodation. The fire also spread into the engine room by heat transfer through the bulkheads and via an open connecting door, and then to the steering gear compartment which contained a number of hydraulic systems as well as stocks of oils, greases, and ship's-use chemicals. There, the fire caused a large explosion that blasted the entire poop deck into the air and onto the funnel deck (**Figures 1 & 2**). Fortunately, there were only minor smoke inhalation and bruising injuries.

The fire was most likely caused by hotwork repair debris falling from the cargo hopper at the top of the tower into the flammable side curtain of the vertical conveyor belt.

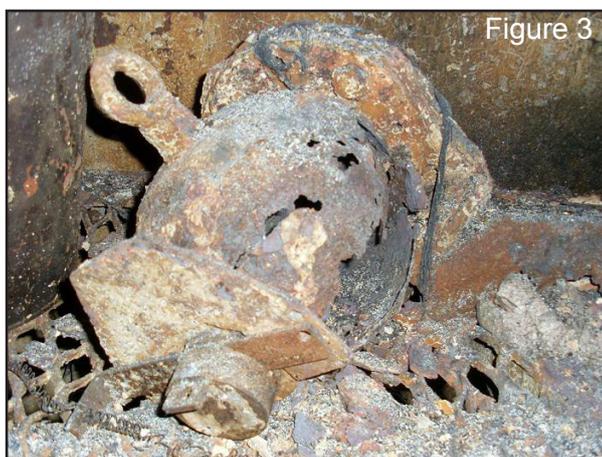
Silometer devices, containing radioactive Cobalt 60 isotopes, were fitted to the cargo hopper to detect excessive build up of cargo in the self-unloading system. The silometers had not been used for 10 years, and the outer shells of the source containers were in an extremely poor condition. However, the radioactive isotopes inside them were still active. During the fire, the lead shielding around one of the radioactive source containers melted, exposing the radioactive source container itself (**Figure 3**).

The onboard risk assessments did not include the risk of exposure to gamma ray radiation, and the Safety Management System did not provide any guidance on inspecting the silometers or safety precautions to be taken. Consequently: welding operations regularly took place in the hopper area without any precautions being taken to warn or protect the personnel involved; when the fire broke out none of the firefighters or salvors was warned of the potential hazard; and inspectors and surveyors investigating the cause of the fire were consequently exposed to low levels of radiation when they inspected the cargo hopper area. Fortunately, the source containers were not breached; had this occurred the fire could have spread radioactive particles throughout the surrounding area, generating a severe risk to health.

- Where appropriate, ship owners and managers should ensure their Safety Management Systems provide comprehensive guidance for the control, use, inspection, maintenance and disposal of radiation sources fitted to their vessels to ensure that risks of exposure to radiation are minimised.
- Such guidance should include the potential risk to health from exposure to radiation resulting from an accident such as a fire or collision.
- Emergency plans should ensure that the presence of radiation sources is brought to the attention of attending emergency services (eg. Fire and Rescue Service) so that the radiation risk is given due consideration.
