**Report on the Investigation of  
the Foundering of  
mfv *AMBER ROSE* (B417)  
off the Isle of Man  
with the Loss of One Life  
on 15 October 1998**

Marine Accident Investigation Branch  
First Floor, Carlton House  
Carlton Place  
Southampton  
SO15 2DZ

**Report No 24/2000**

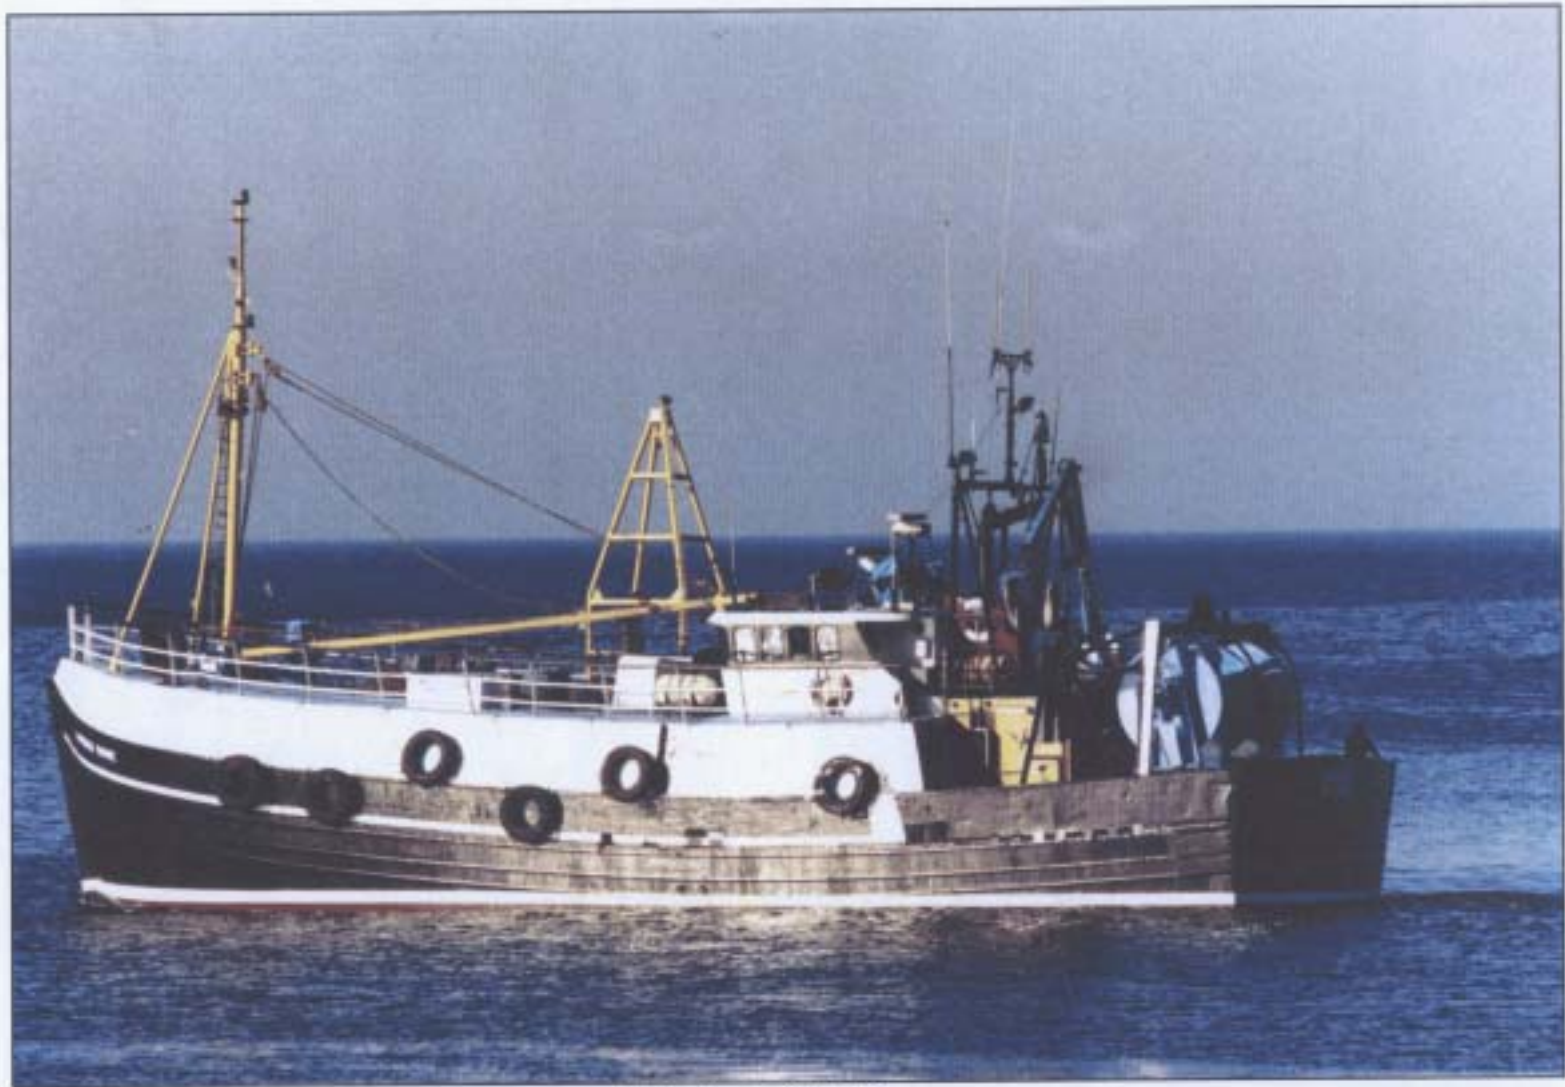
Figure 1

*Amber Rose* after refit  
(photograph courtesy of Buckie Shipyard)

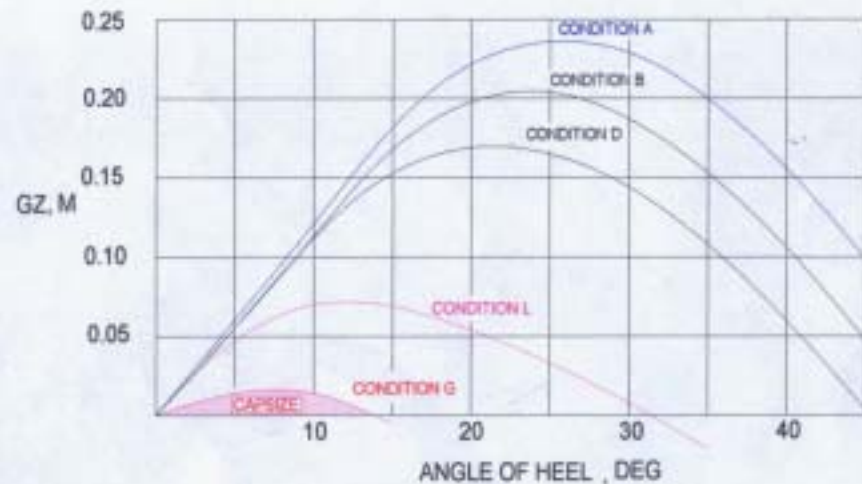
## STABILITY CURVES FOR VARIOUS CONDITIONS OF LOADING

The net result was that when *Amber Rose* left Buckie shipyard she did not comply with the minimum stability criteria set out in her trim and stability booklet for the loading condition with a full catch (**Figure 3, curve B**). With all three extended RSW tanks filled to the tops of their hatch coamings, *Amber Rose's* stability was substantially below the requirements (**Figure 3, curve D and Annex 3**) - this is the vessel's estimated stability after stowing her catch on 15 October 1998.

The model tests showed that this reduction in the vessel's stability, in itself, would not have caused the vessel to capsize in the prevailing sea conditions.

CONDITION A - DEPART GROUNDS CONDITION IN APPROVED TRIM AND STABILITY BOOKLET

CONDITION B - DEPART GROUNDS CONDITION FOLLOWING THE RE-FIT IN BUCKLE

CONDITION D - AS CONDITION B WITH ALL 3 RSW TANKS COMPLETELY FULL

CONDITION G - AS CONDITION D WITH 89 TONNES OF FLOODING IN FWD SPACES

CONDITION L - AS CONDITION A WITH 89 TONNES OF FLOODING IN FWD SPACES

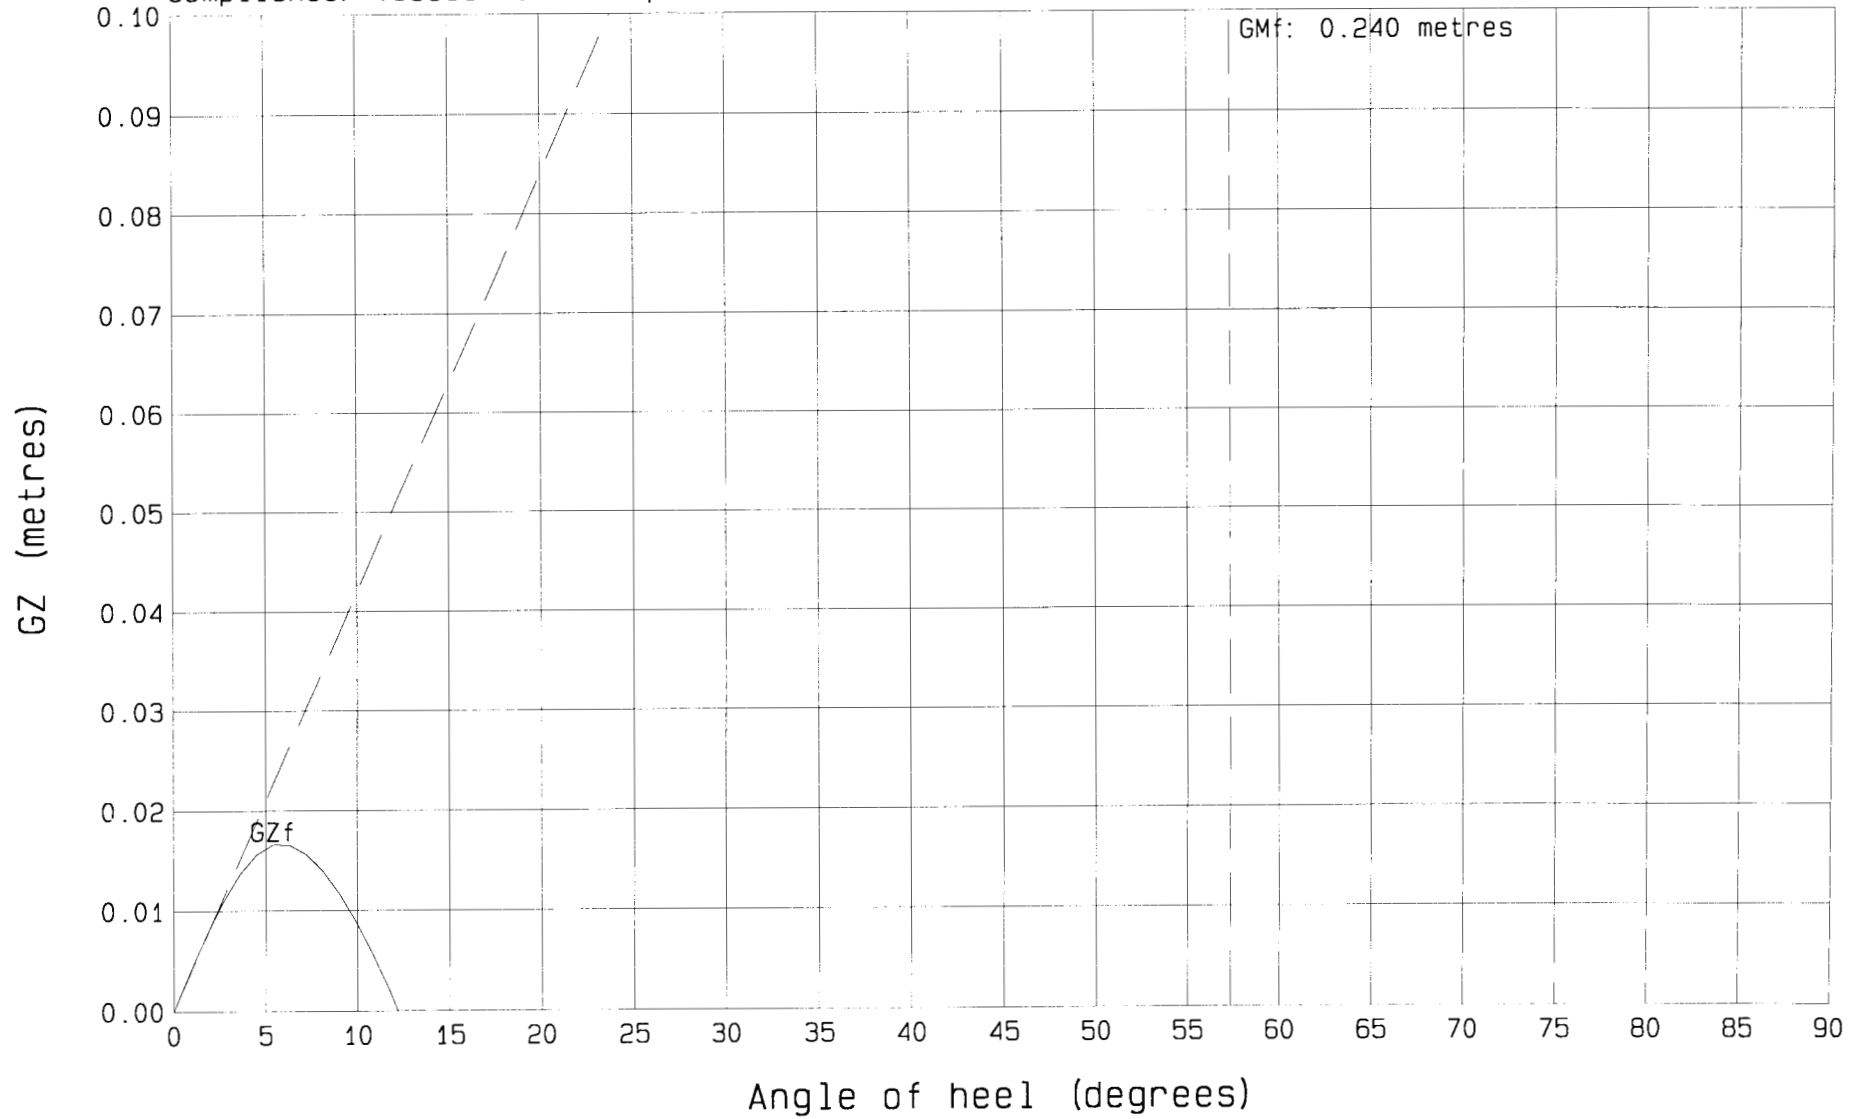
***Amber Rose* - Flooding of the refrigeration machinery space and the RSW tank space -  
Condition G.**

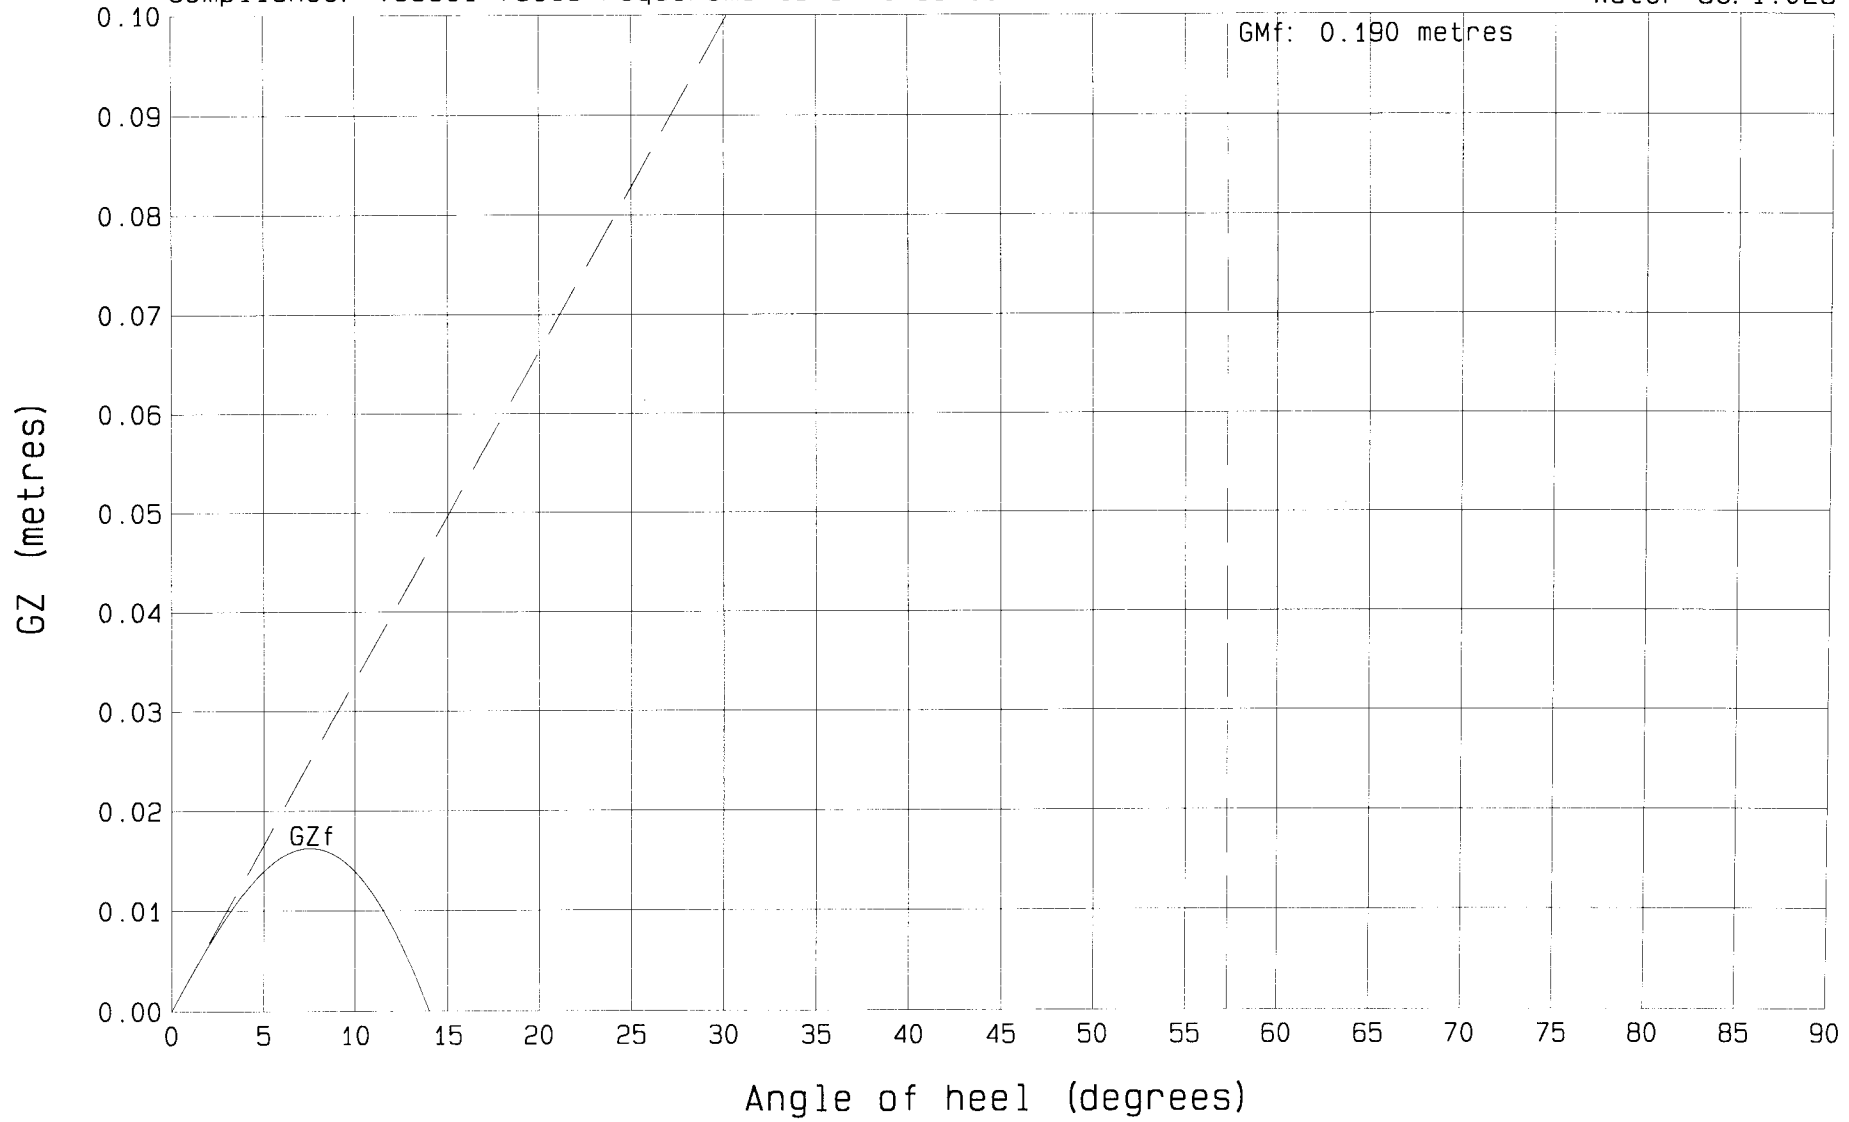
It is believed *Amber Rose* capsized when the refrigeration machinery space and the RSW tank space became flooded with 69 tonnes of water. Had she not been overloaded and at her approved maximum displacement of 324 tonnes, 69 tonnes of floodwater would not have capsized her (**Annex 6 - condition L**) in the prevailing conditions. It would have taken about 91 tonnes to capsize her (**Annex 6 - condition M**) - about 30% more. So however long she took to flood with 69 tonnes of water she would probably have taken at least 30% longer to flood with 91 tonnes.

***Amber Rose* - Flooding of the refrigeration machinery space and the RSW tank space with the vessel at her approved maximum displacement:**

- a) with 69 tonnes of floodwater - Condition L.
- b) with 91 tonnes of floodwater - Condition M.
