Steel fabricator's design calculations

Concerns keel of Maxfun 35 by order of Breehorn.
 Strength calculation of the fin profile at the insert in the hull of the boat.

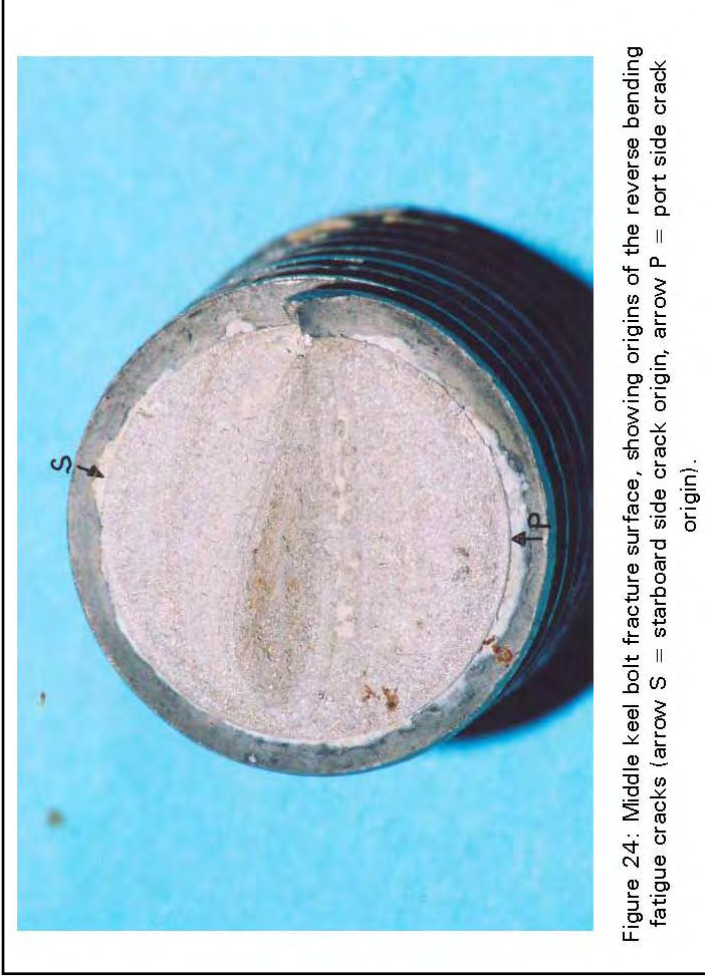
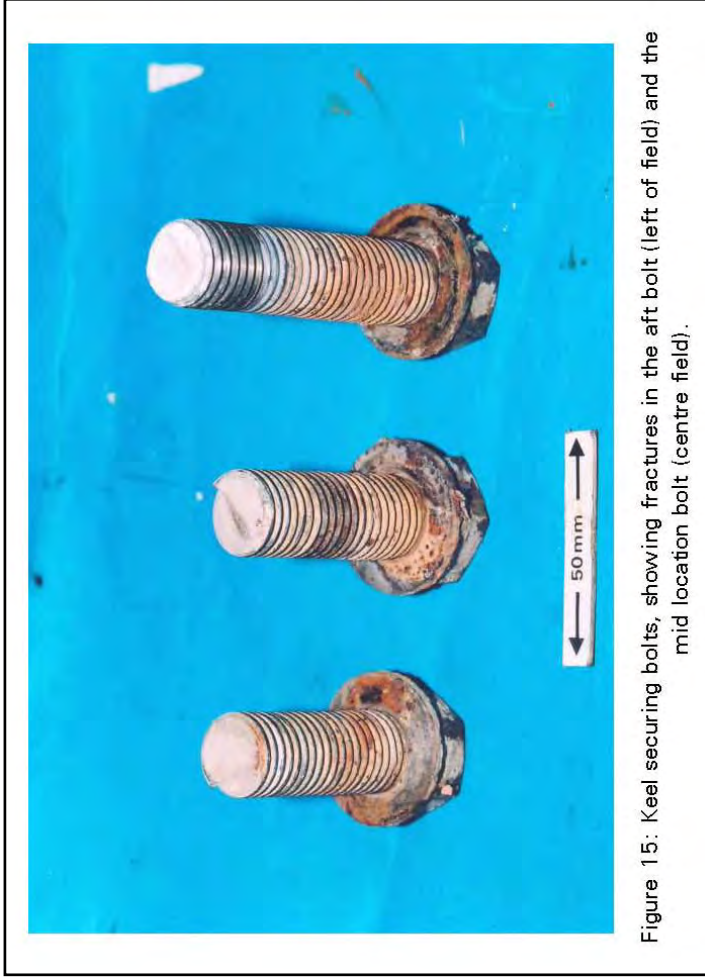
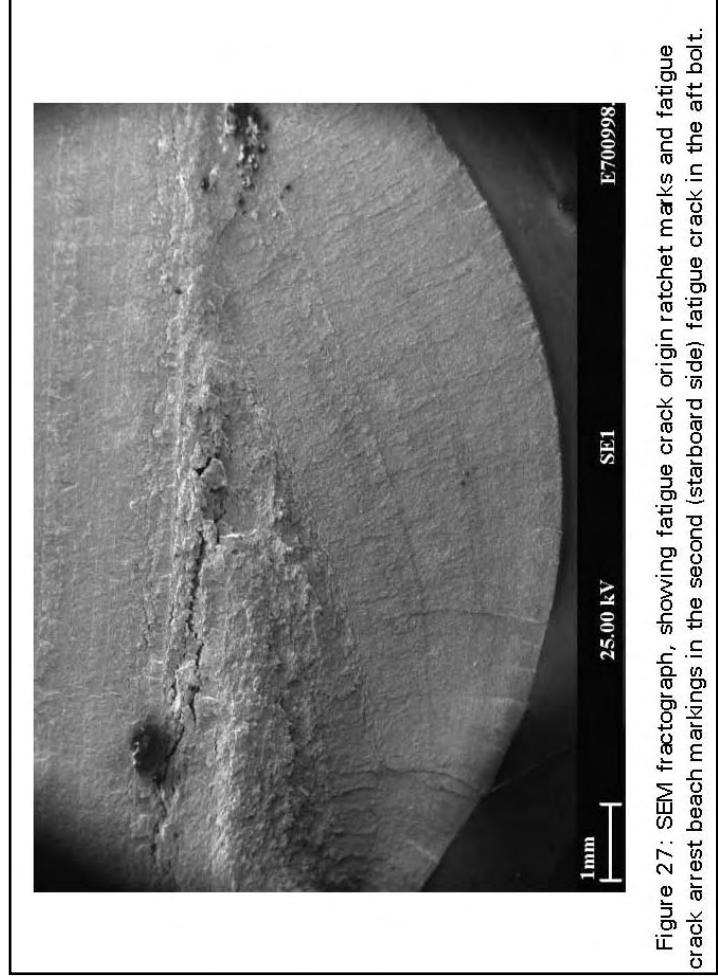
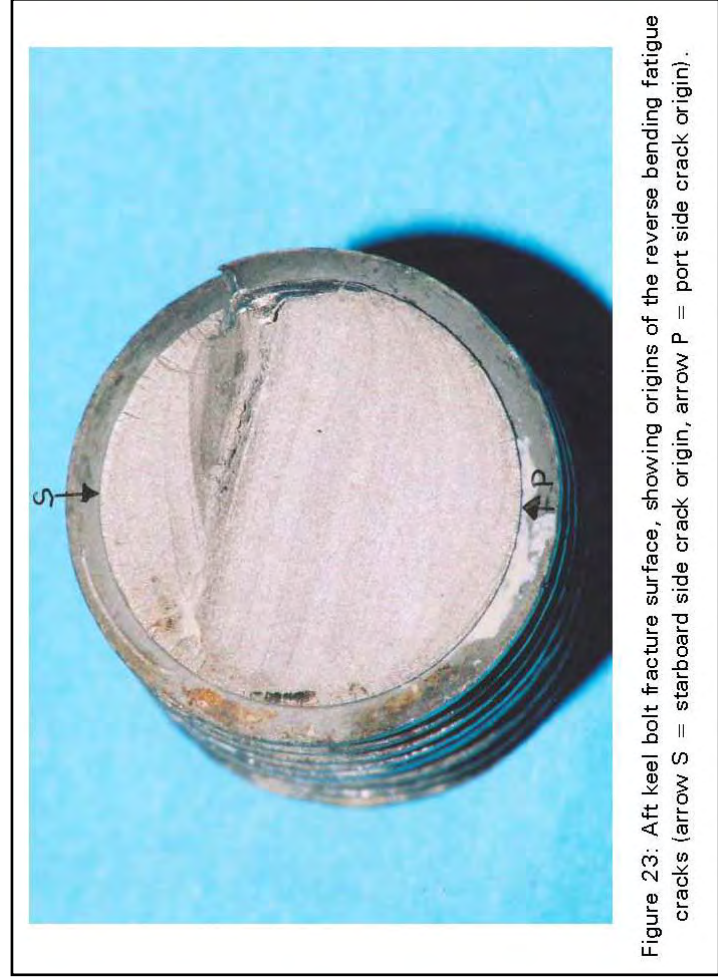
Director and Head of Laboratory

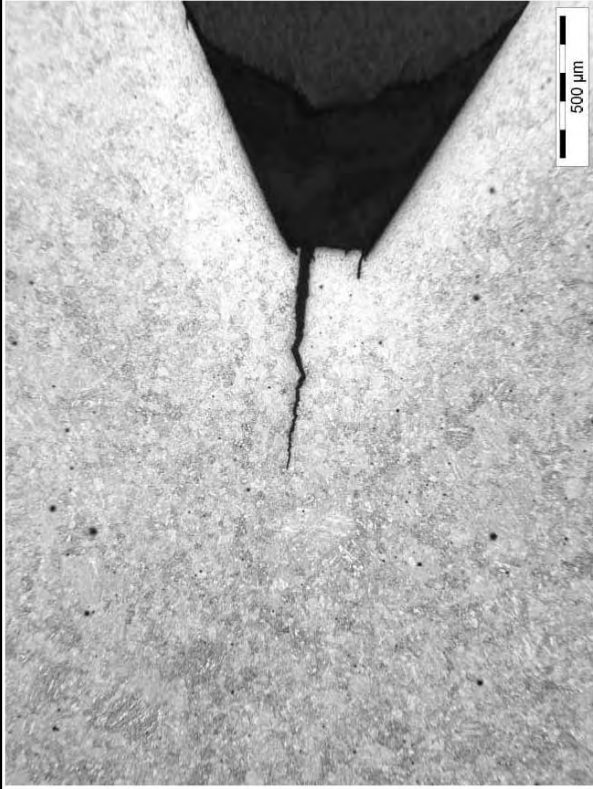
Figure 39: Micrograph (original image captured at X50), specimen etched in Nital. Longitudinal section from the middle bolt, showing detail of a secondary fatigue crack with intergranular cracking in its tip region.

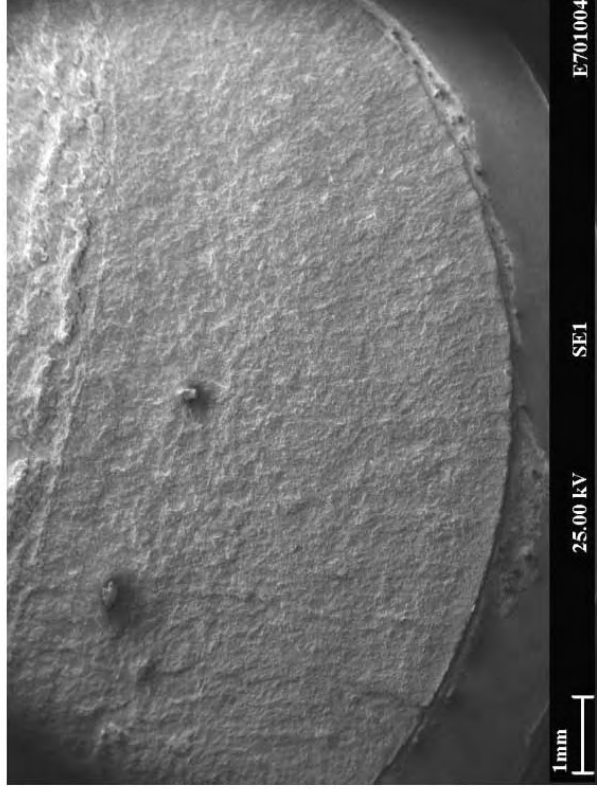
Figure 30: SEM fractograph, showing starboard side fatigue crack in the middle bolt.

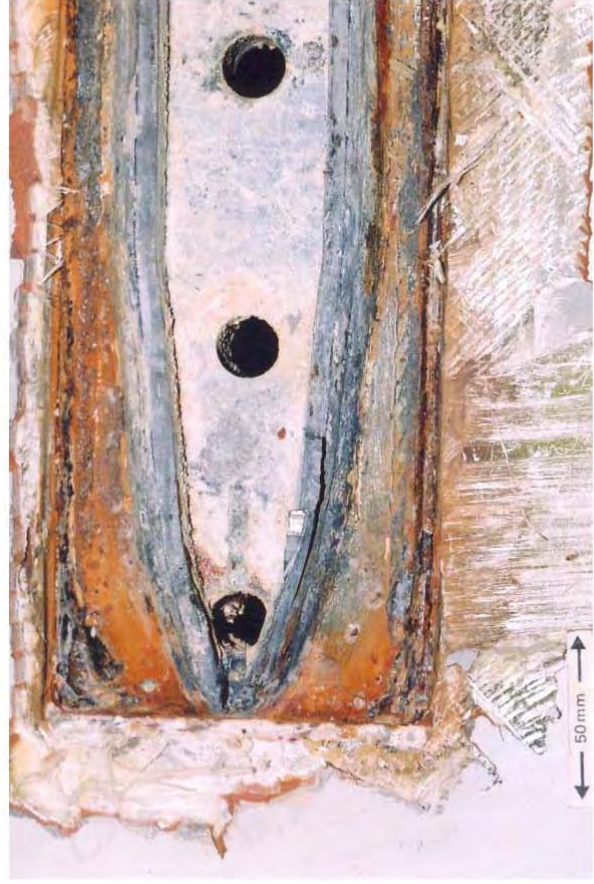
Figure 50: Forward end of the upper keel box fabrication, exposed by chiselling away the resin and paint finish to the hull underside.

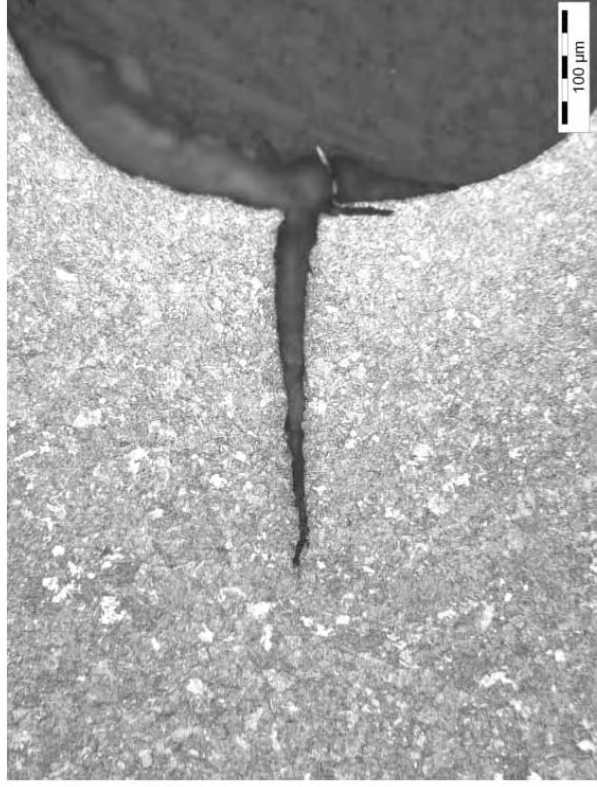
Figure 37: Micrograph (original image captured at X200), specimen etched in Nital. Longitudinal section from the aft bolt, showing detail of a secondary fatigue crack.

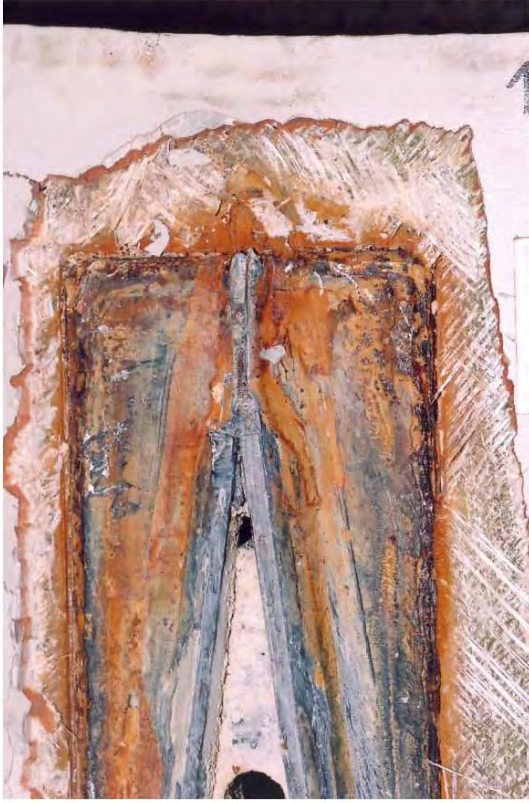
Figure 51: Aft end of the upper keel box fabrication, exposed by chiselling away the resin and paint finish to the hull underside.

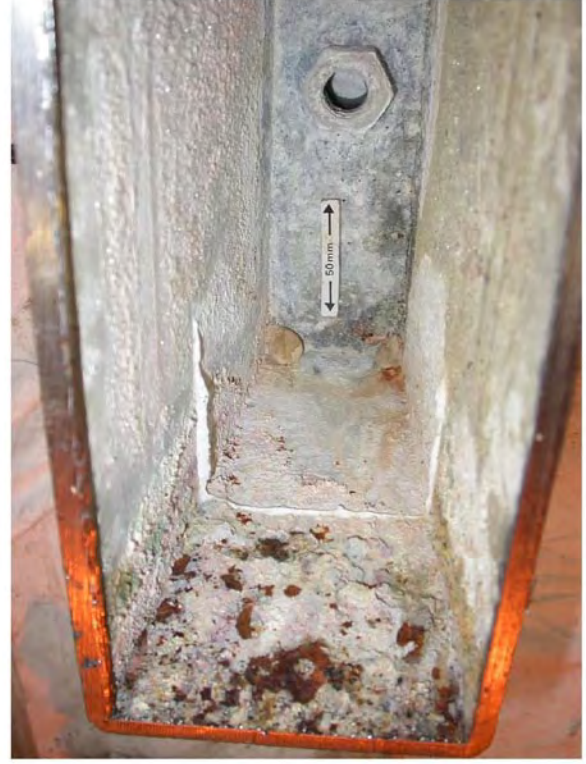
Figure 56: Detail of the internal water mark and long standing corrosion which had exposed areas of the steel substrate.

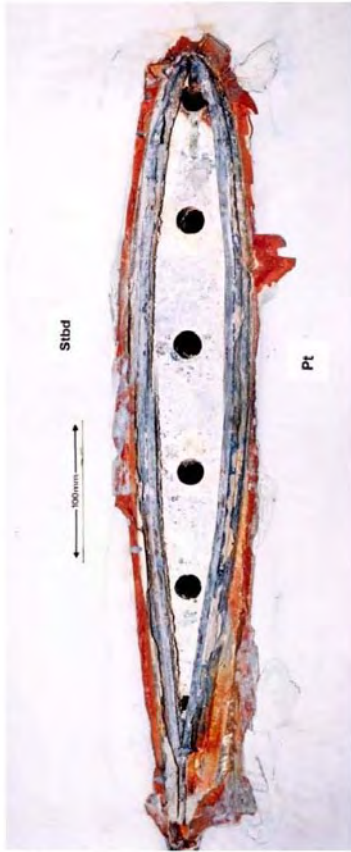
Figure 57: Keel blade fracture site, which was coincident with the toes of the fillet welds joining the keel blade to the face of the fabricated upper tapered box.

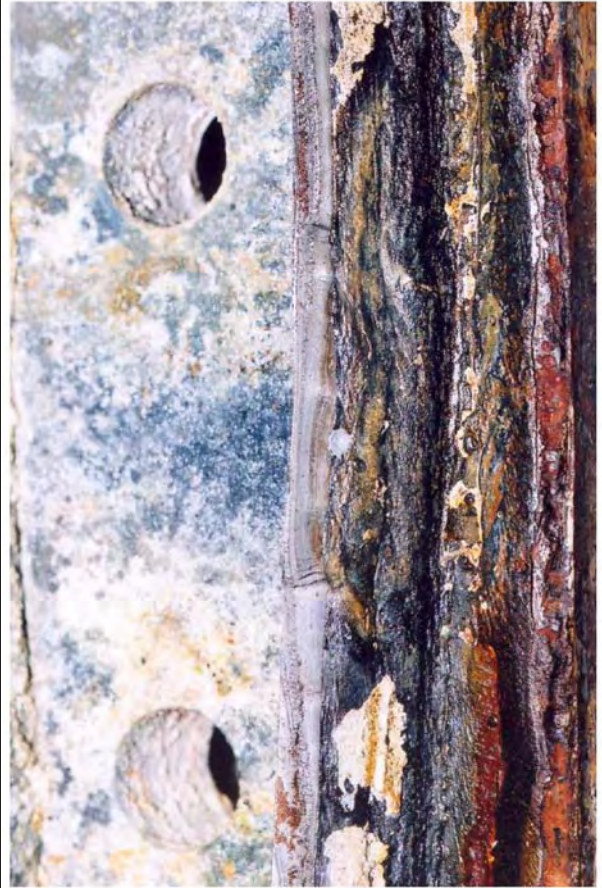
Figure 59: A region of the port side keel blade fracture, showing association of fatigue crack initiation sites with stress concentrations arising from aspects of weld toe profile.

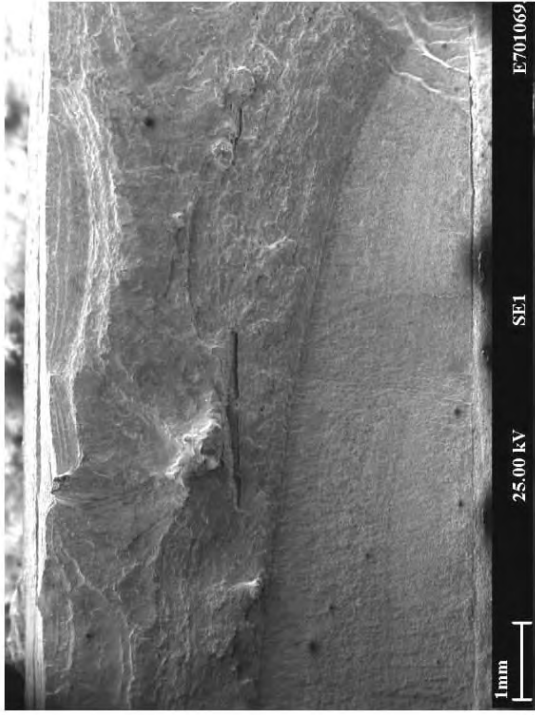
Figure 63: SEM fractograph, showing deep principal fatigue crack (lower field), shallow secondary fatigue cracks (upper field) and ductile terminal fracture between the two crack fronts - starboard side keel blade fracture.

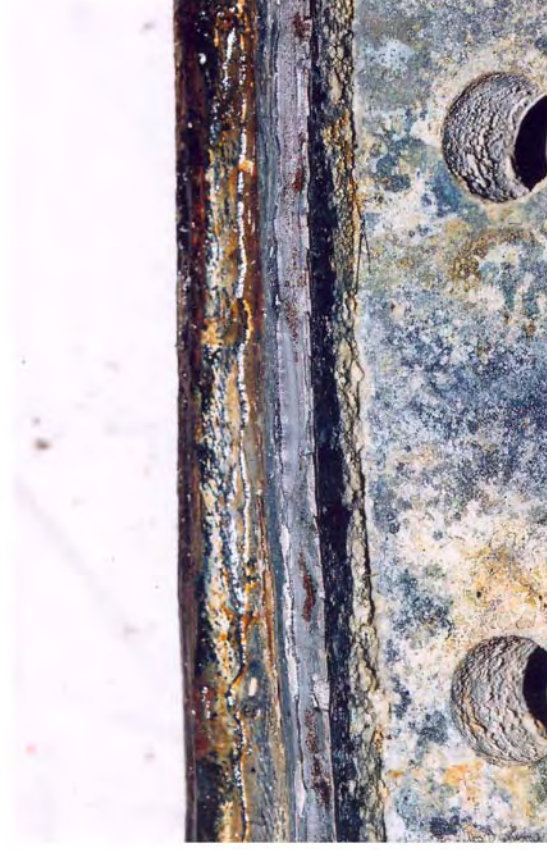
Figure 60: A region of the starboard side keel blade fracture, showing association of fatigue crack initiation sites with stress concentrations arising from aspects of weld toe profile.

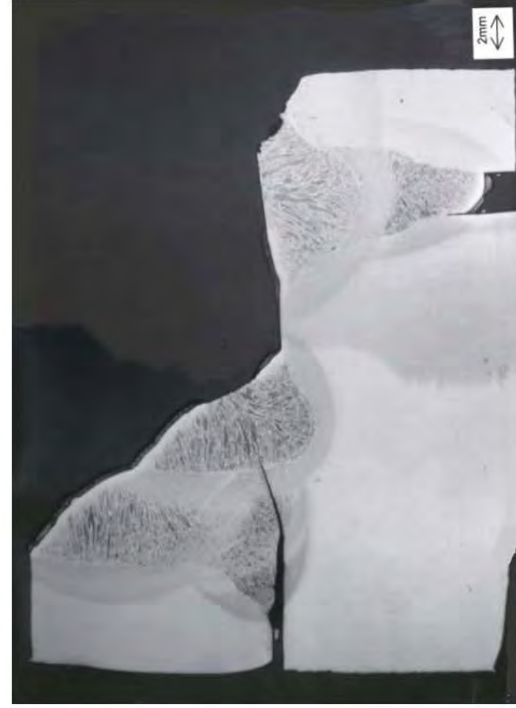
Figure 65: Macrograph (original image captured at X4), specimen etched in Nital. Cross section from fracture in port side of keel blade, showing fatigue fracture top of field, and secondary fatigue crack originating from the blade to box weld root. The figure also shows lack of root fusion and penetration in the taper box construction weld (lower right field).

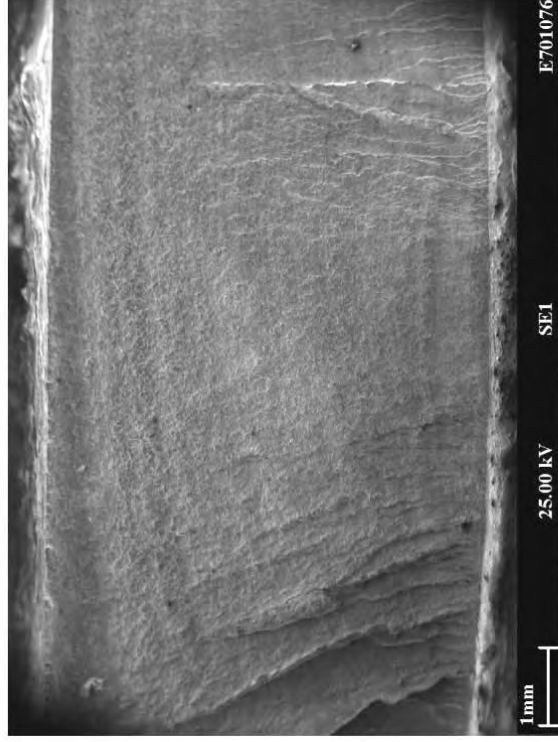
Figure 61: SEM fractograph, showing through plate fatigue crack in the port side of the keel blade. The figure also shows ratchet marks at the crack origin side and a number of relatively indistinct beach markings.

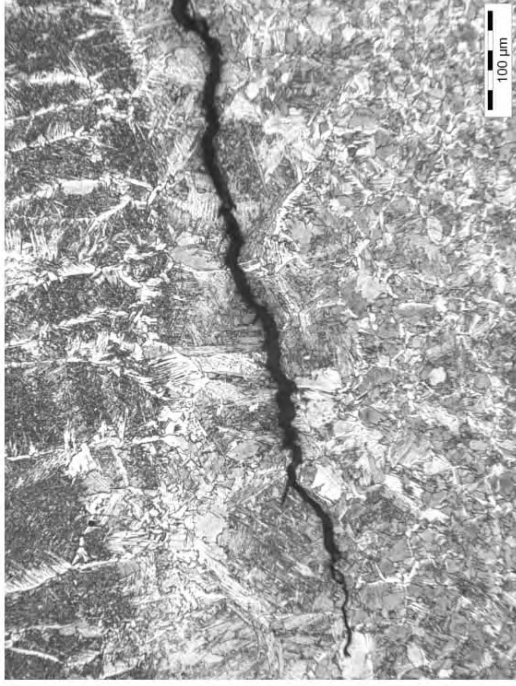
Figure 71: Micrograph (original image captured at X200), specimen etched in Nital. Detail of fillet weld root cracking shown earlier in figure 70 and including features more consistent with hot cracking originating during the original welding.

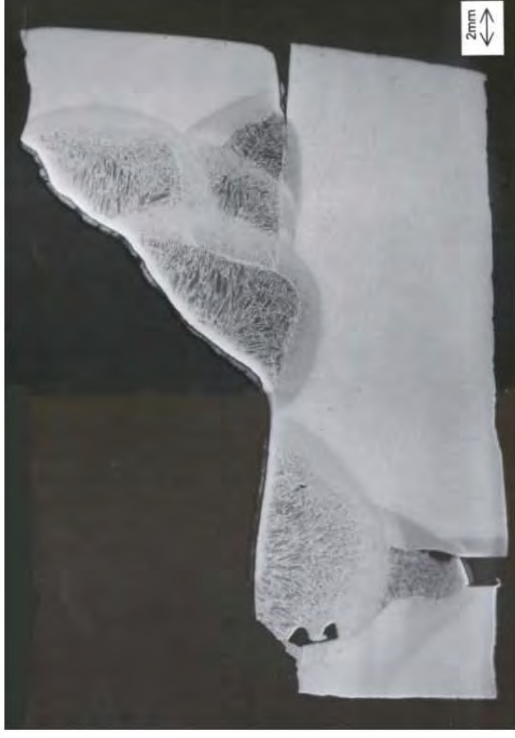
Figure 68: Macrograph (original image captured at X4), specimen etched in Nital. Cross section from fracture in starboard side of keel blade, showing fatigue fracture top of field and a hot crack in the weld root. The figure also shows lack of fusion, porosity and lack of root fusion and penetration in the taper box construction weld (lower left field).

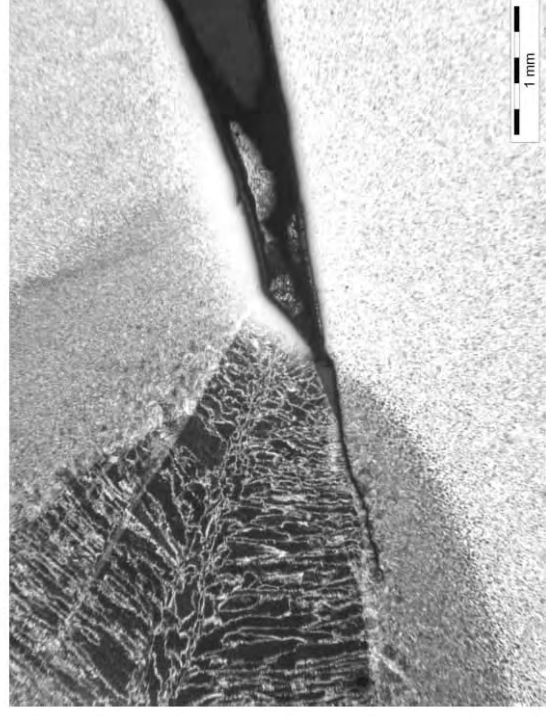
Figure 70: Micrograph (original image captured at X25), specimen etched in Nital. Starboard side fillet weld root crack originating from slag or silica entrapment.

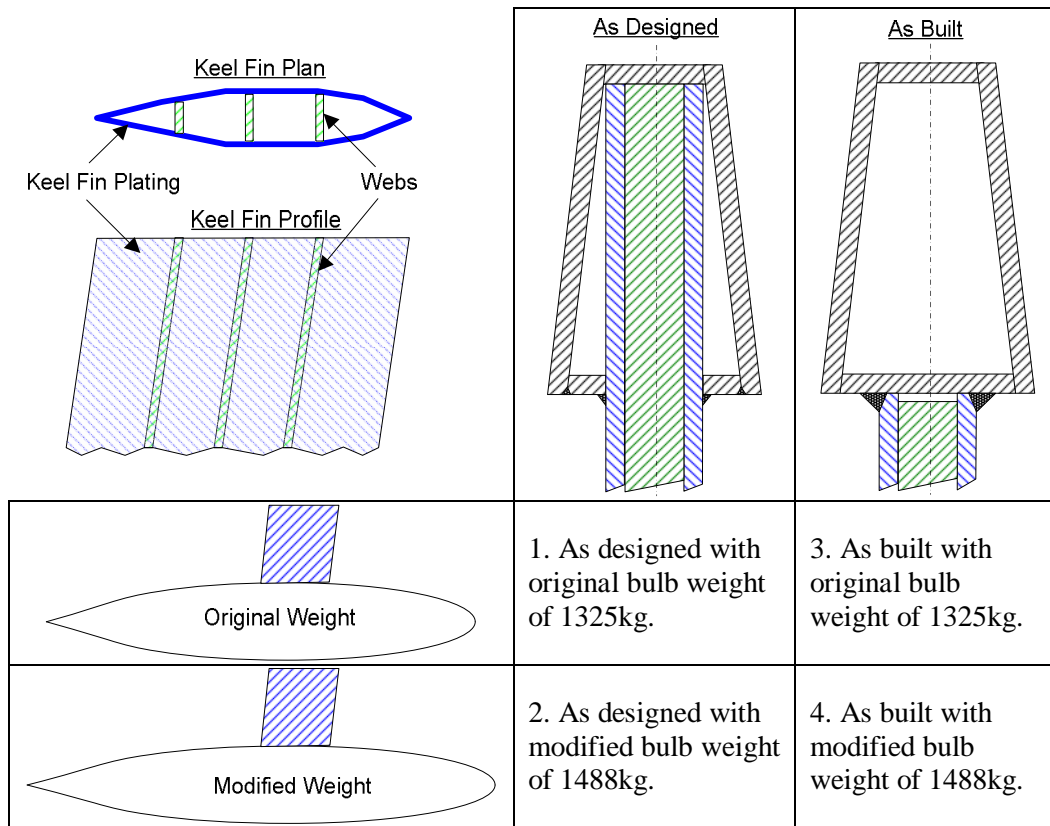
See also Figure 1 for a schematic of the as designed vs. as build configurations.
