# Part 3 – Leisure Craft

# The Sailing “Taster” that Left a Bitter Taste

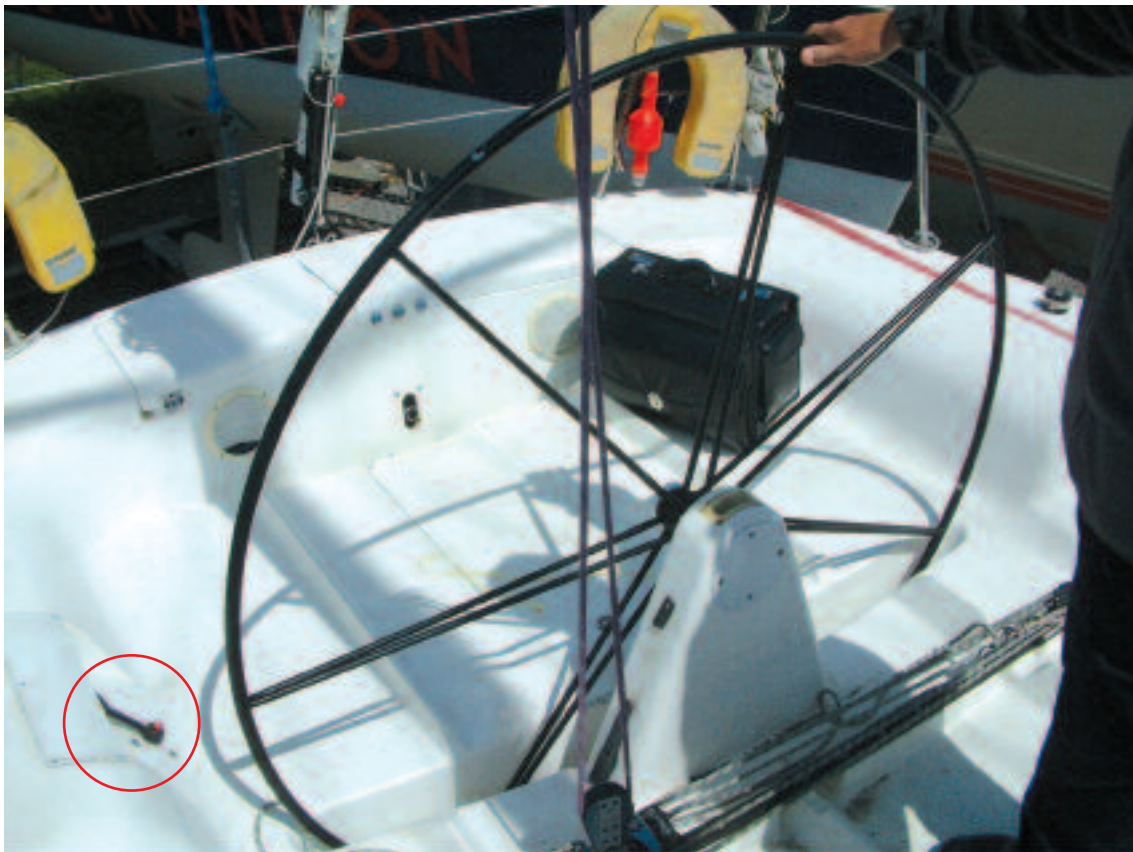
Figure 1 – Position of engine control lever

At 1426 the yacht was tacked back up the channel. The skipper then asked the Day Skipper to start the engine. The Day Skipper unclipped his safety line as he prepared to check that the engine control was in neutral, but he found the lever to be seized (Figure 1). He spent the next 2 minutes releasing it; he then moved in front of the wheel to go down below to start the engine, but he was brought to an abrupt halt. His foot became entangled in the traveller because his safety line became taut (Figure 2). His line had not been released as first thought. The skipper, now distracted, turned round to release the safety line and, at the same time, the yacht conducted an

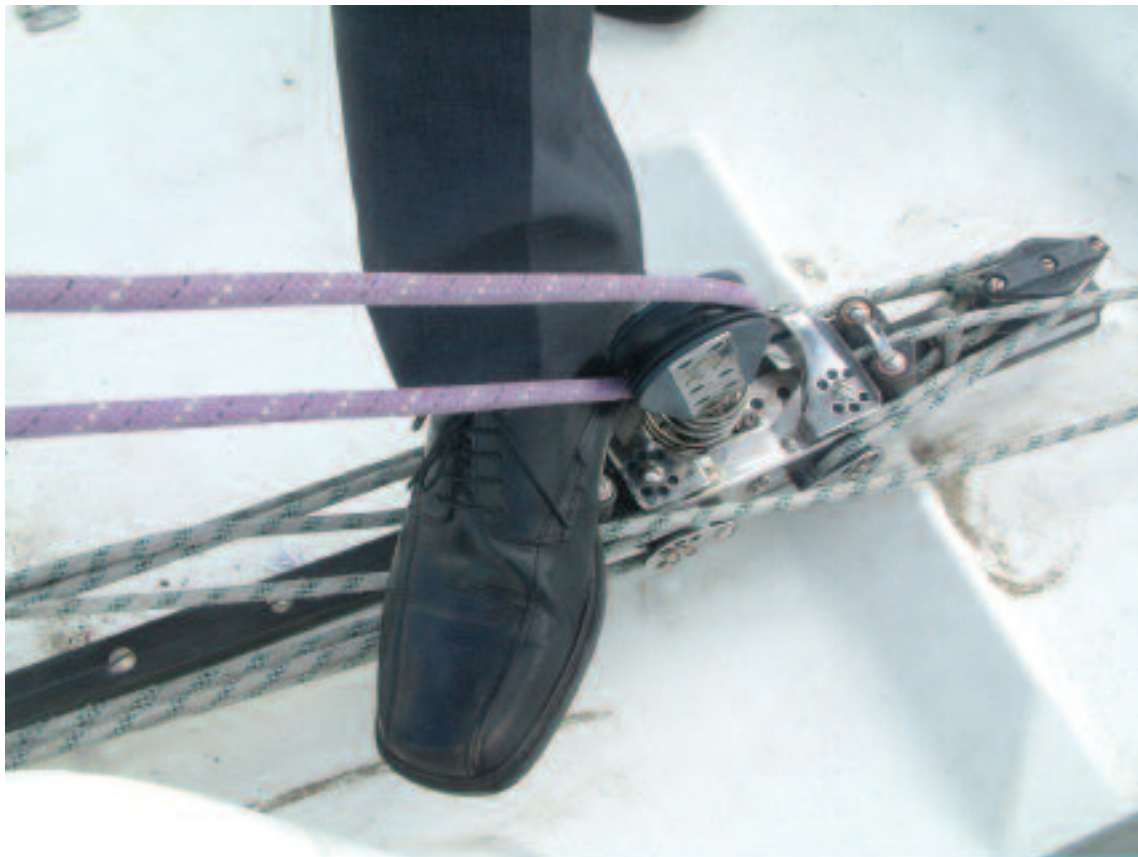
Figure 2 – Day skipper's leg position on the traveller rig

inadvertent gybe. The boom moved rapidly from starboard to port, trapping the Day Skipper's leg with the mainsheet, causing multiple fractures to his right leg. The boom immediately returned to the starboard side.

The accidents were caused by a combination of the skipper being distracted and the possible snagging of the Day Skipper’s lifeline around the wheel, as well as inattention to the weather conditions.

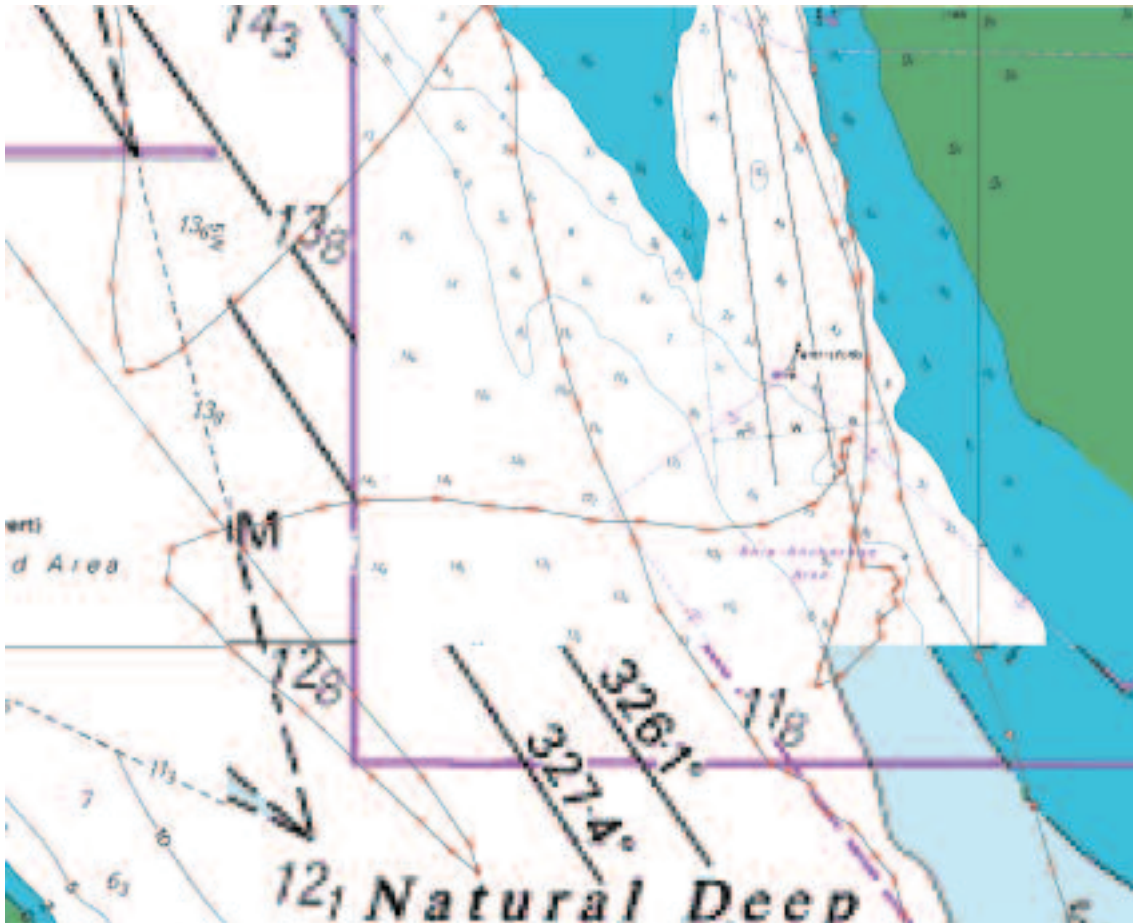
Figure 3 – Detailed GPS track showing key accident points

back inboard. Bleeding profusely from her ears, nose and mouth, her situation was potentially life threatening. The skipper now busied himself in trying to get the sail down. A GPS track identifying the accident points is at Figure 3.
