# Part 3 – Leisure Craft

# Uncontrolled Gybe Leads to Avoidable Death in the Baltic

## Blank Off Ventilation at Your Peril

## Short Sailing Trip Ends in Tragedy

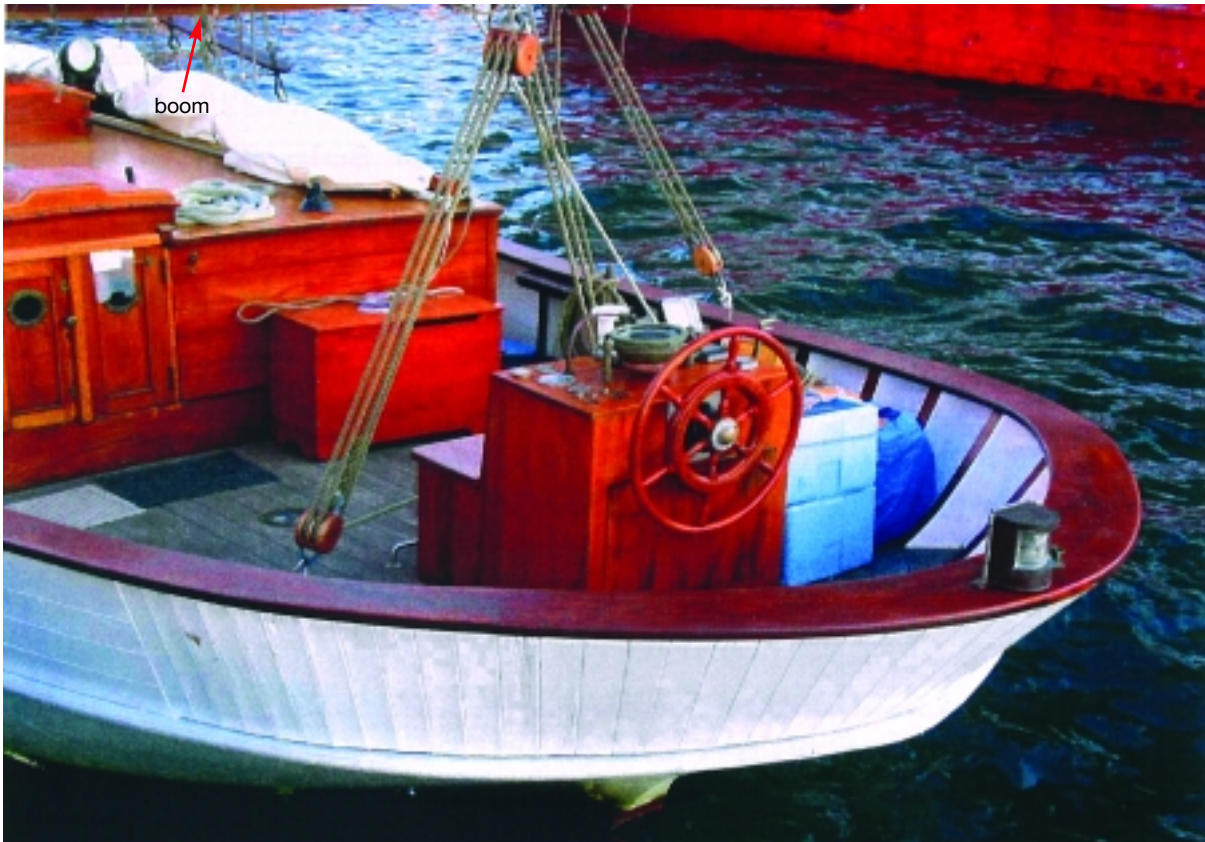
Rear of the vessel

Needing to make a course alteration the crew prepared for a gybe. Two crew members were required to pull in the mainsheet so that the boom was close to the centreline. The sheet was then made off on a cleat. At that point, the gaff gybed across to the starboard side and the force of this caused the sheet to break free, and the boom swung violently to starboard. As a result of this, one crew member was swept over the side.

- 1. This accident highlighted the importance of being able to carry out a manoverboard recovery manoeuvre under a variety of conditions. The attempts to recover the man who was lost were hampered by the fact that the approaches were made too fast for a line or a boathook to be used properly. When the casualty was still conscious he caught hold of the line that was thrown, but he let go of it under load.**

- 3. Safety equipment will only be of any use if it can be deployed immediately. Tragically, this yacht carried a manoverboard retrieval system comprising a rescue harness on a heaving line, but it was stowed below decks under a berth. Had it been fitted as was designed to be, on deck, the crew would have had a better chance of saving the crew member's life.**

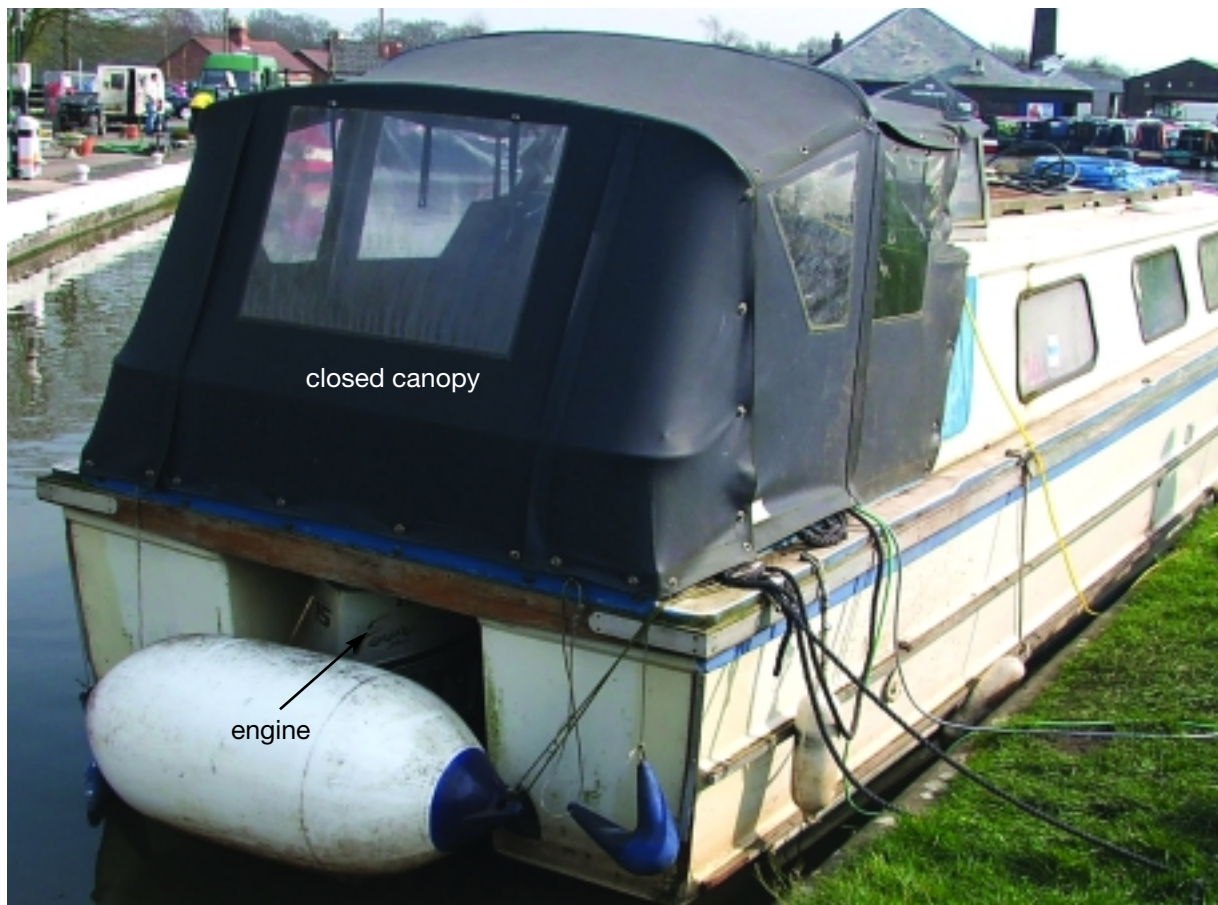
A couple were living on board a 1980s built, 4 berth, 8.2 metre inland waterway cruiser which was moored on a canal. It was winter. The 11kW (15hp) outboard engine was mounted on the transom stern, which was partially enclosed by the structure of the vessel. The engine space was separated from the cockpit above by removable wooden panels, which were not gas tight. The canopy over the cockpit was closed. A large fender had been secured across the vessel's stern and immediately aft of the outboard engine space.

- The three cabin roof plastic mushroom type ventilators had been sealed off with masking tape; only the stainless steel ventilator was found to be open.
- The ventilators at the bottom of the two doors that led from the cockpit to the cabin had been covered with masking tape on the inside.
- The heater and the cooker had been switched off. However, the gas supply to the cooker was leaking.
- The 12 Volt battery, which provided power to the cabin lights through the vessel's electrical system, gave a reading of just over 1 Volt.
- The outboard engine drove a small alternator which provided a trickle charge to the battery.

On running the outboard engine, gas detection probes indicated that it was producing carbon monoxide, which permeated into the cockpit and cabin. It is probable that the combination of wind direction, the ventilation of the engine space being substantially limited by the fender and blanked off cabin ventilators, allowed dangerous levels of carbon monoxide to build up in the cabin from the continuously running engine.

2. Taping over high and low level ventilators prevents air from circulating freely in cabin spaces, and could allow inadvertent leakage of carbon monoxide and/or domestic bottled gas to accumulate to dangerous levels. Minimum ventilation requirements are set out in the Boat Safety Scheme Standards.
3. Careful thought should be given to the prevailing conditions when running an engine continuously. Exhaust fumes should be allowed to ventilate freely to atmosphere and be prevented, so far as is reasonably practicable, from permeating into living and/or working spaces.

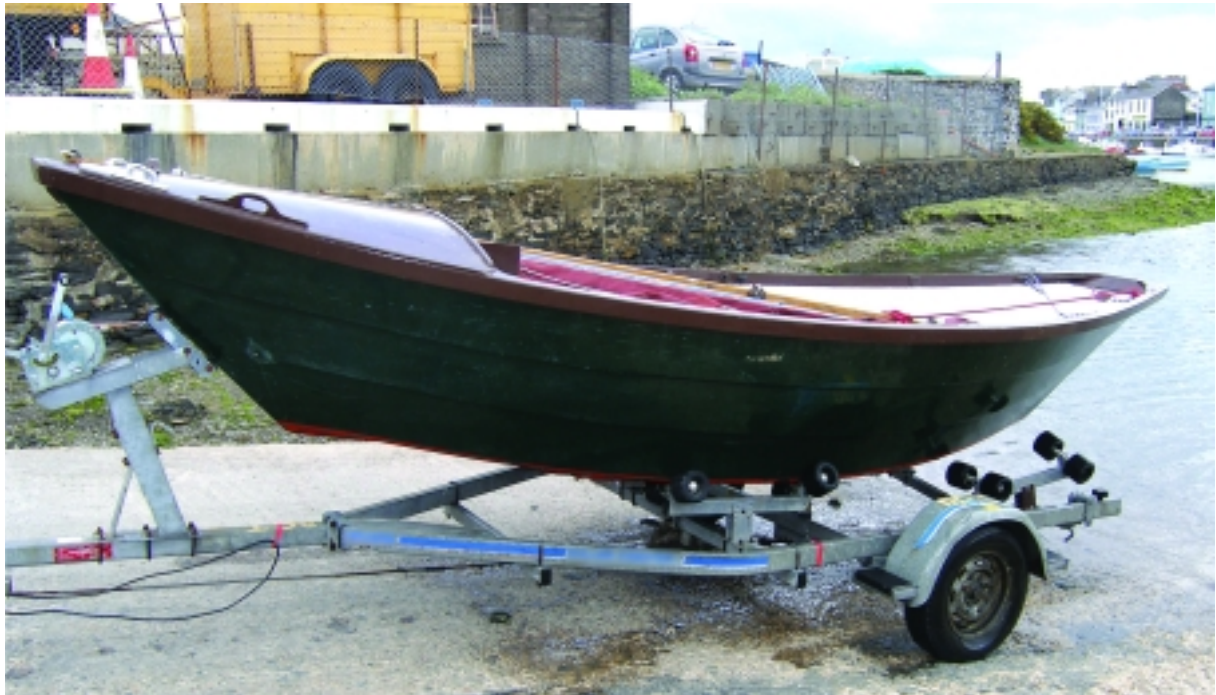
Figure 1: 5.5m open sailing boat

The owner had altered the vessel during his ownership, fitting a small forward locker and some instrumentation. With the aim of making the vessel more stable, he had also added sand bags as ballast and modified the dagger-board to make it heavier.

The boat headed south. The wind backed and probably increased a little from that experienced at the launching point. Within 1-2 nm of the departure point the boat capsized and both crew were thrown into the water. Both men were wearing personal buoyancy but, unfortunately, their mobile telephone had been stowed in the forward locker and they were unable to transmit a distress message.

1. Take great care and seek professional advice when making alterations to your craft. Although adding ballast to improve stability may appear very sensible, the knock on effects on freeboard and structural strength must be considered.

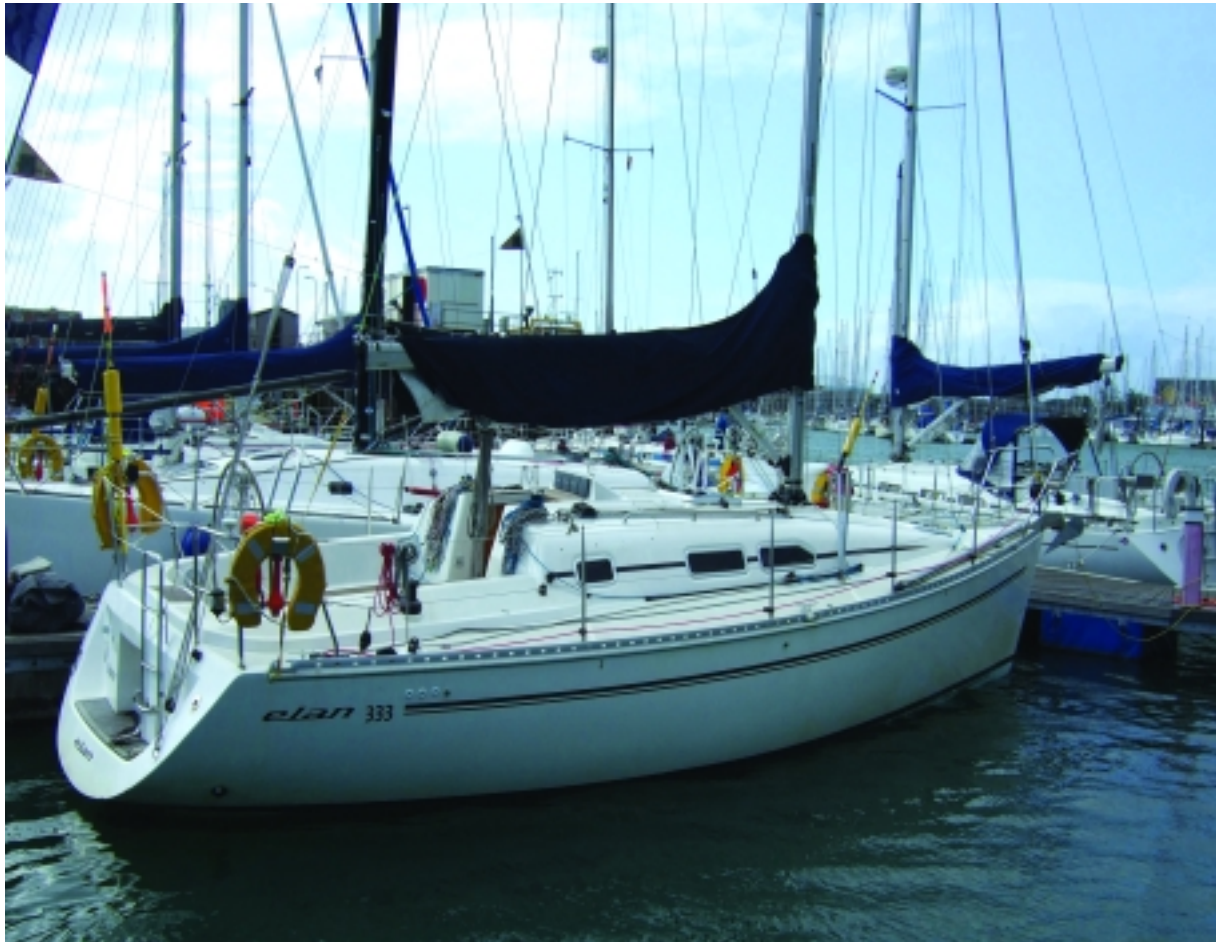
Figure 1

An Elan 333, 10-metre cruiser racer (Figure 1) had been chartered through a yacht club for a week of sailing along the south coast of England. Strong northerly winds had been blowing in the preceding days, and were again forecast for the coming day when the yacht set sail to the east.

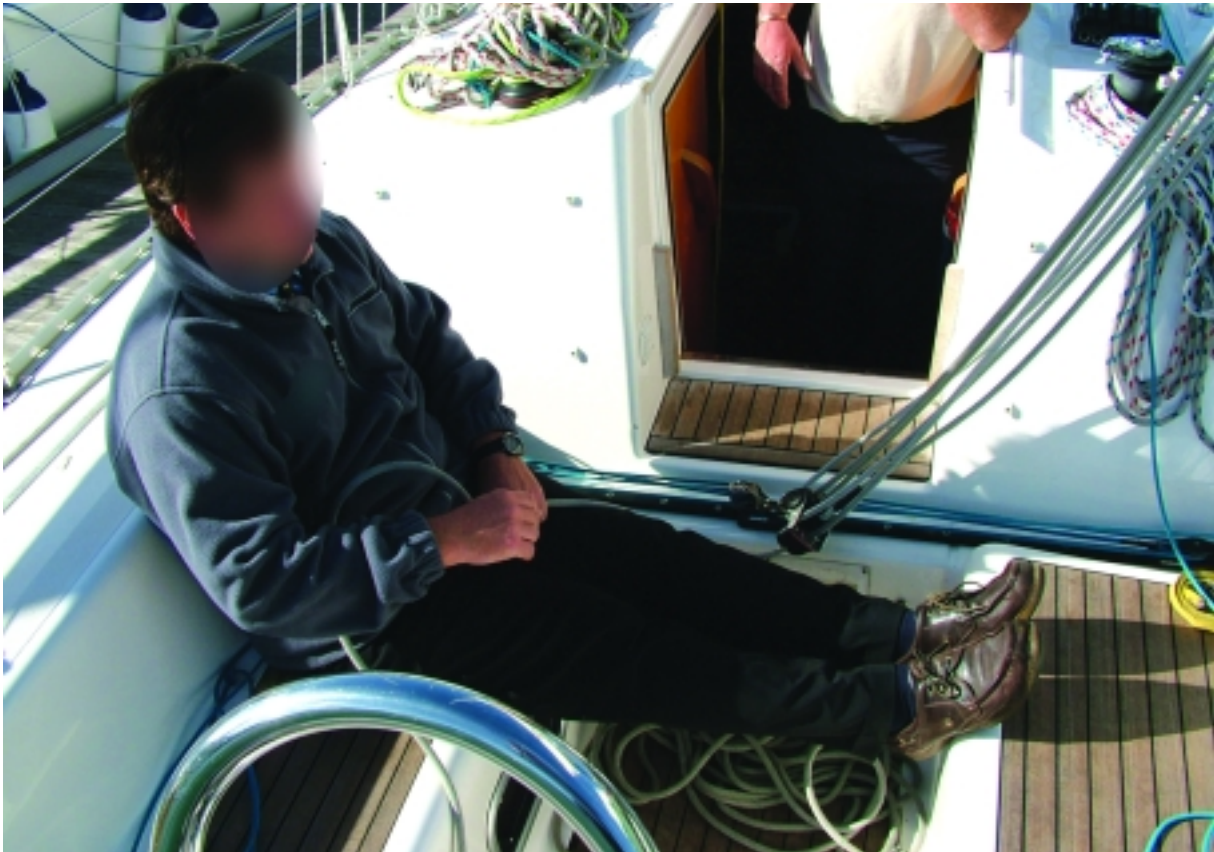
Figure 3: Location of casualty when caught by the sheet

As the boom crashed across, the sheets caught the mate, who was sitting in the cockpit just aft of the traveller (Figure 3) and threw him forward, against the top edge of the coachroof. He sustained fatal head injuries.

2. When the gust hit, the helmsman was not fully aware of what was happening to the yacht, or the consequences of leaving full starboard helm on after the gust had passed. An uncontrolled gybe in these conditions unleashes huge forces, and, unfortunately in this case, the forces proved to be fatal. The only person who could have controlled the situation was the mate, but he was pre-occupied with managing the sails in the gusty conditions.
3. As well as avoiding being hit by the more obvious hazard of the boom itself during a gybe, crews need to maintain an awareness of the risk of injury from being hit by the mainsheet, and the mainsheet fine tuning blocks where these are fitted.
