Report on the investigation of
the grounding of the cargo ship

Carrier

at Raynes Jetty in Llanddulas, North Wales

on 3 April 2012

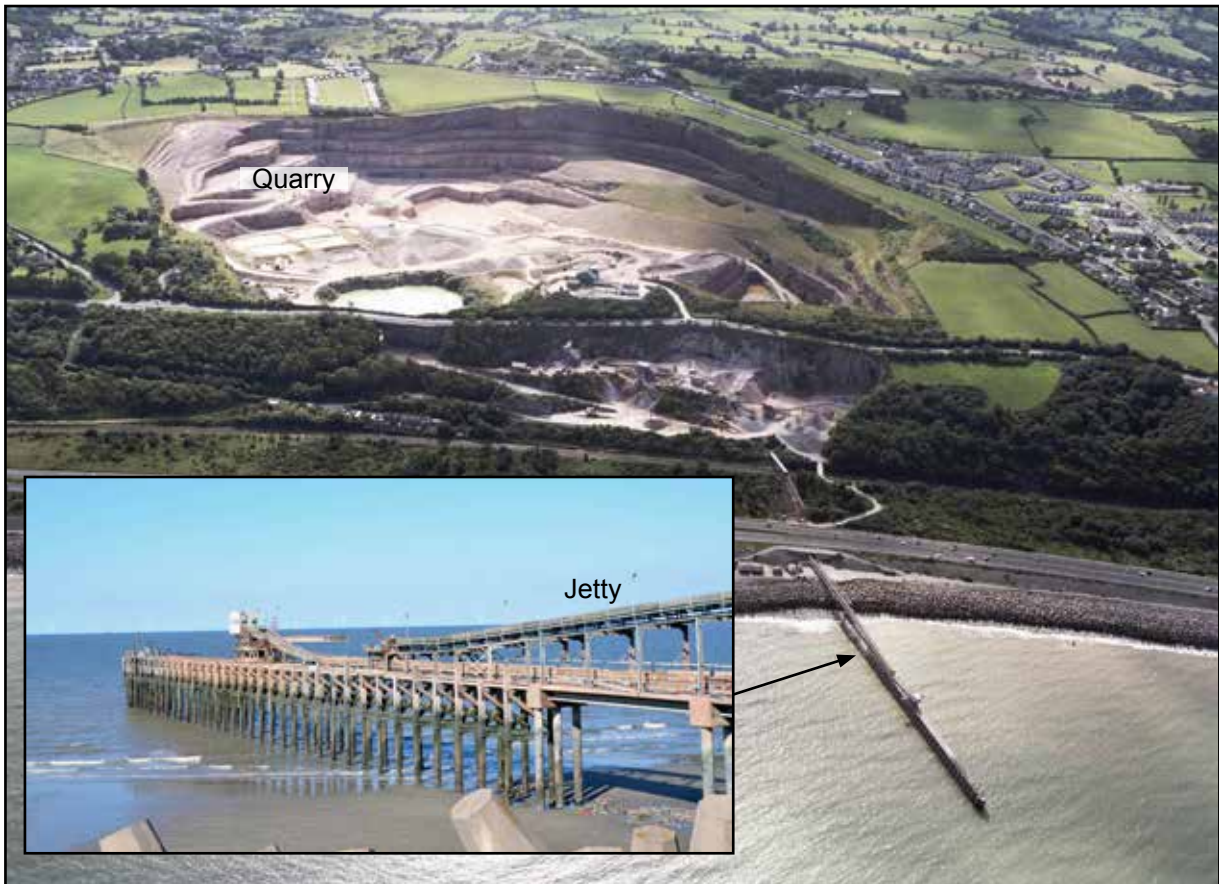
Figure 1: Raynes quarry and Jetty

Carrier was mostly engaged in carrying bulk cargoes around the coast of the UK and Ireland, with occasional trips to continental Europe. Limestone from Raynes Quarry (**Figure 1**) at Llanddulas, to the east of Anglesey in North Wales, was transferred to a dedicated jetty where the cargo was loaded on to ships. The use of Raynes Jetty was constrained by the tidal height. The window for vessels to be alongside the jetty was normally from 4 hours before to 1 hour after high water. Occasionally, vessels were deliberately sat aground on the berth to await the next high water window but this was not considered to be safe practice due to the presence of scattered rocks in the proximity of the jetty¹ (**Figure 2**). *Carrier* had loaded at Raynes Jetty on two occasions in the 5 year period preceding the accident: once in 2010 and again in December 2011. Due to poor trading conditions, the vessel had been laid up without cargo from June 2011 to October 2011.

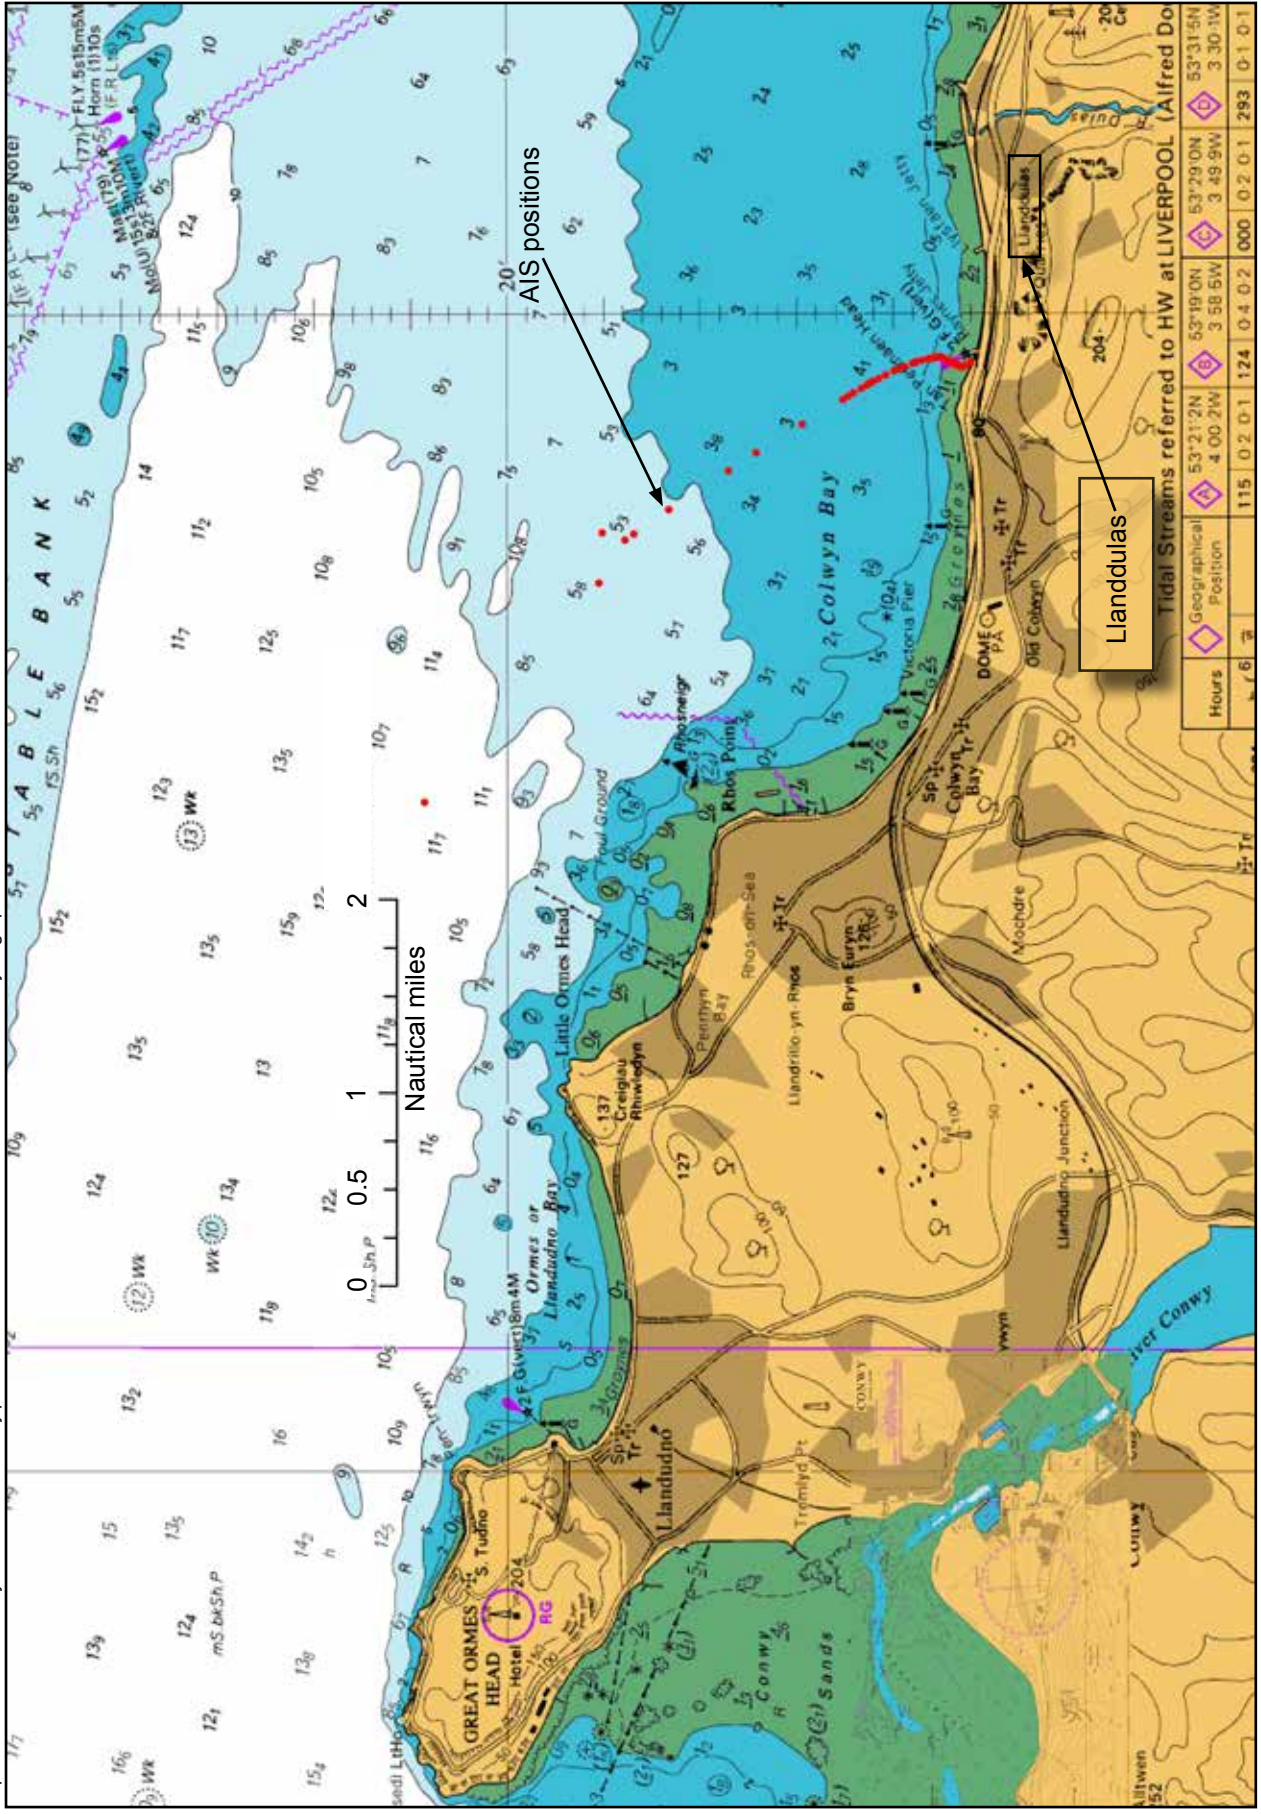
Figure 3: Chart extract showing the location of Llandudlas and Carrier's AIS track towards the berth

On the morning of 3 April 2012, *Carrier* arrived at Llanddulas, approximately 10 miles east of Great Ormes Head (**Figure 3**), from Belfast in Northern Ireland. *Carrier* had been delayed leaving Belfast and another vessel had berthed on the morning high tide at Raynes Jetty. *Carrier's* master was asked by the jetty staff to anchor his vessel 2nm north of the jetty and wait for the next tidal window to load its cargo. The weather was forecast to deteriorate during the day, with gale force winds predicted for the Irish Sea area.

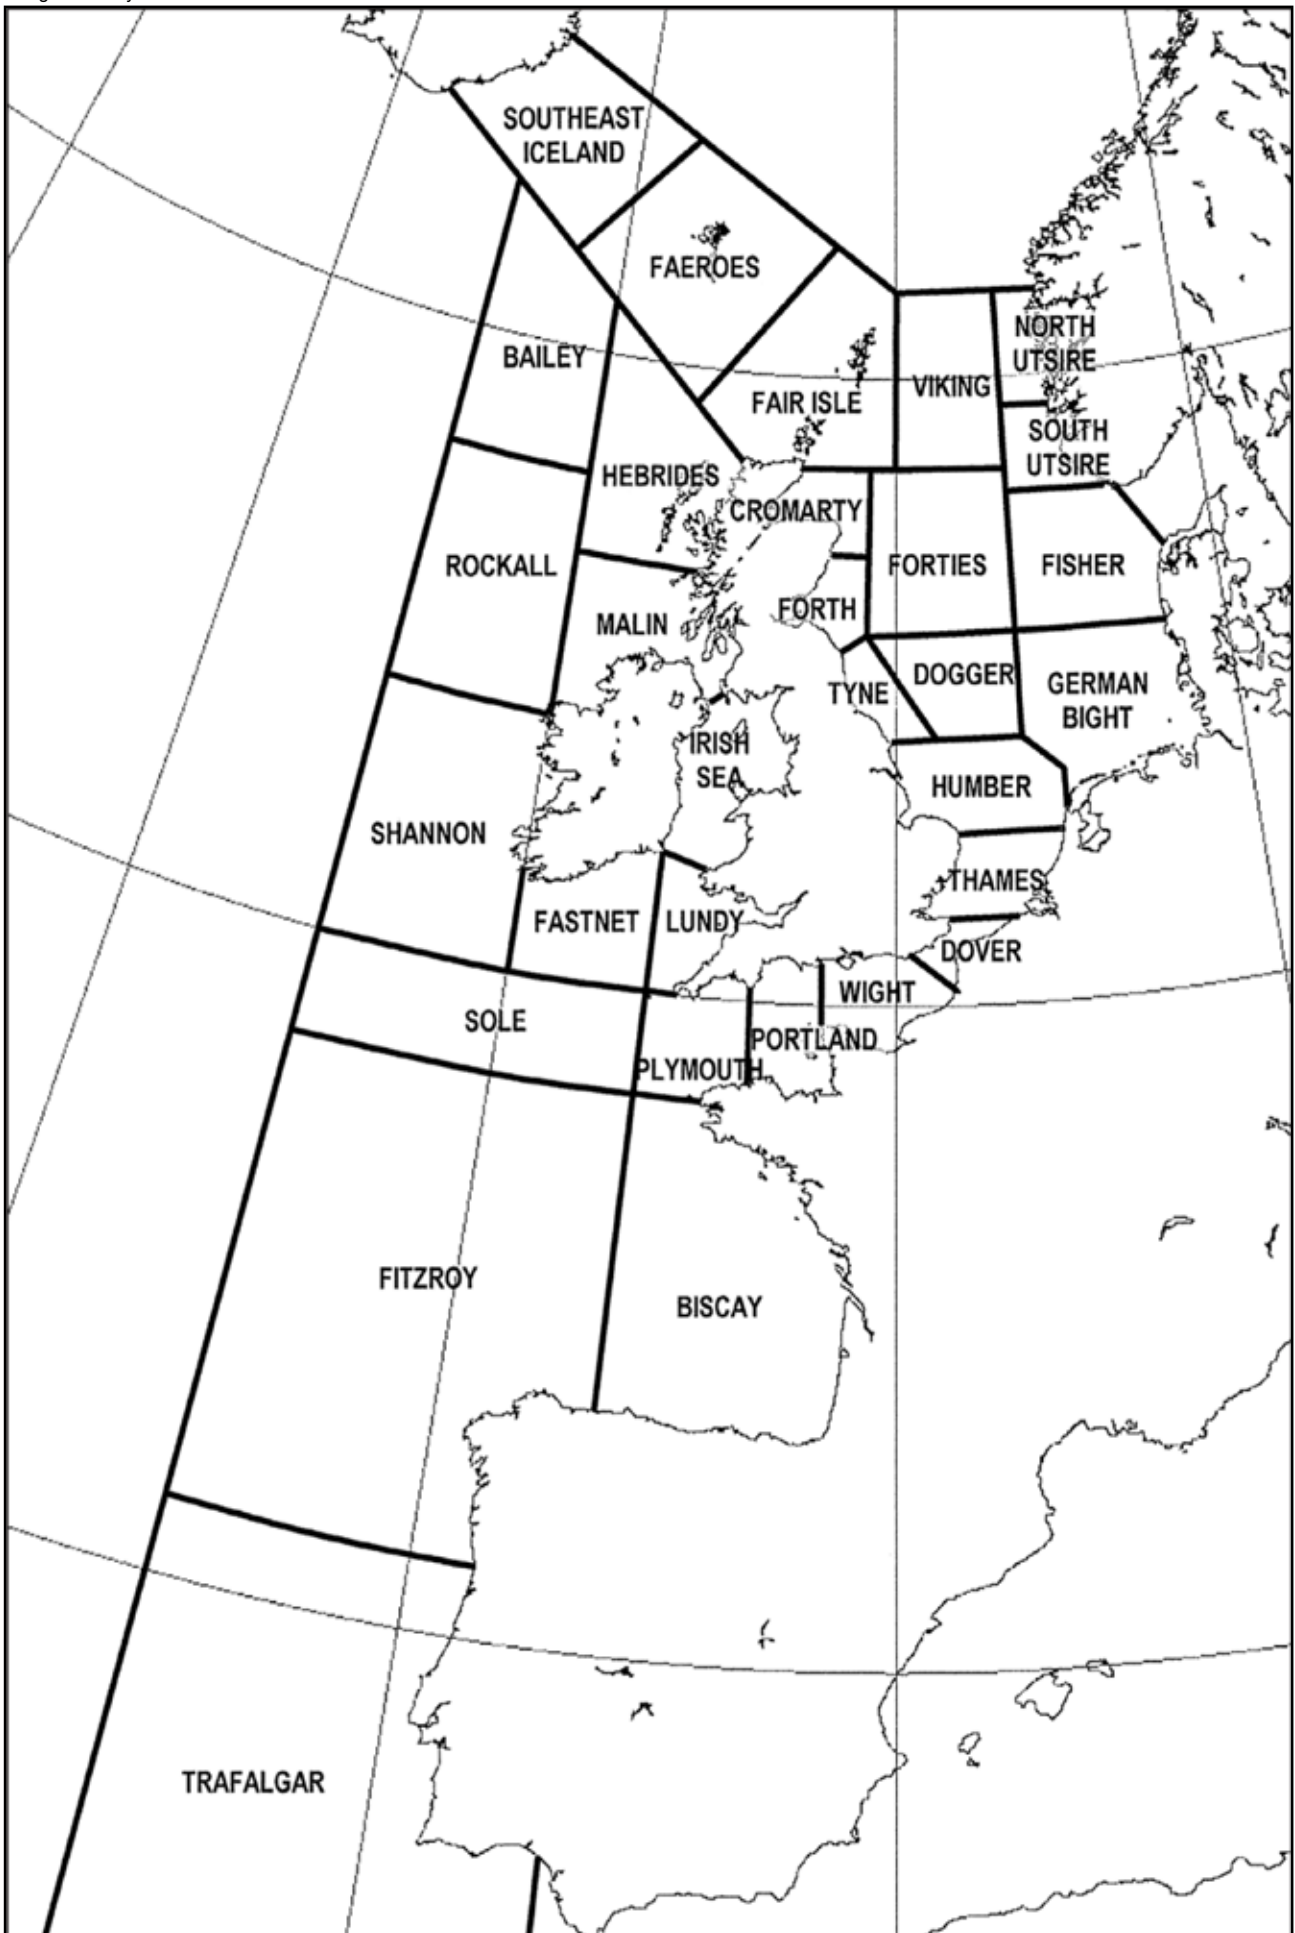
Figure 9: UK Meteorological Office sea areas

The sea areas as defined by the Met Office are shown in **Figure 9**; Raynes Jetty was in the Irish Sea area. The next gale warning transmitted by the Met Office was at 1032 on 3 April. A NAVTEX printout, partly defaced from being soaked in seawater, was found on the deck of *Carrier’s* bridge; the gale warning was underlined (**Figure 10**) and stated:

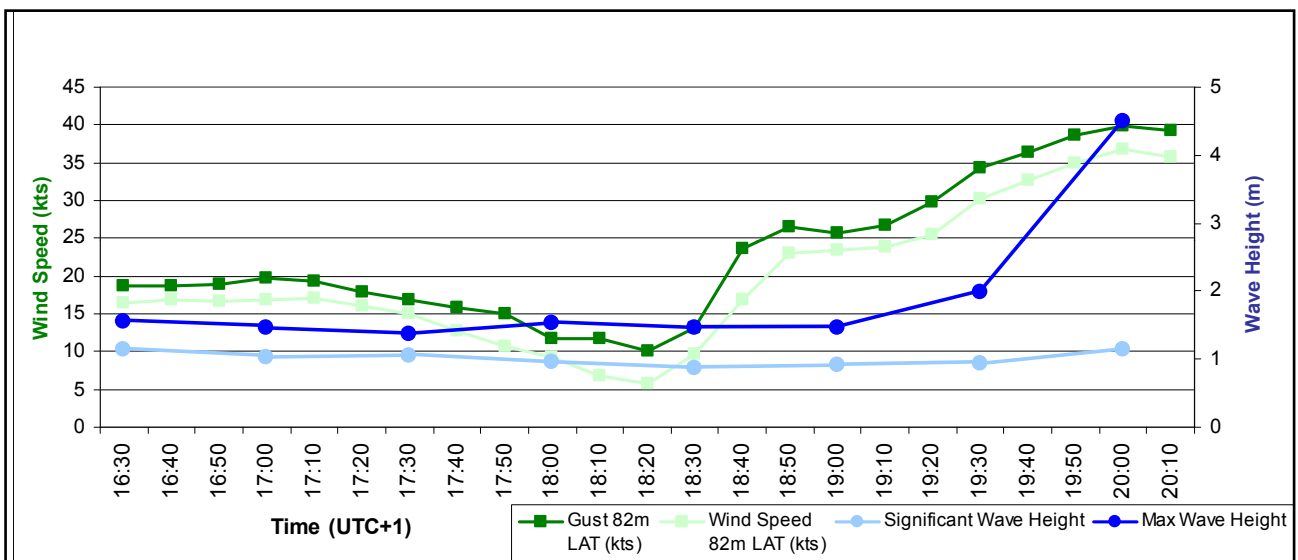
Figure 11: Wind speed and wave height data from 1630 to 2010 on 3 April

The actual weather data recorded on the day of the accident was obtained from the Rhyl Flats offshore wind farm, which was approximately 5m north of Raynes Jetty. The wind speed and wave heights from 1630 to 2010 are indicated in **Figure 11** and the wind direction during this period is in **Figure 12**.
