Report on the investigation of the
escape of Vinyl Chloride Monomer onboard

Coral Acropora

Runcorn, Manchester Ship Canal

Report No 4/2005
March 2005

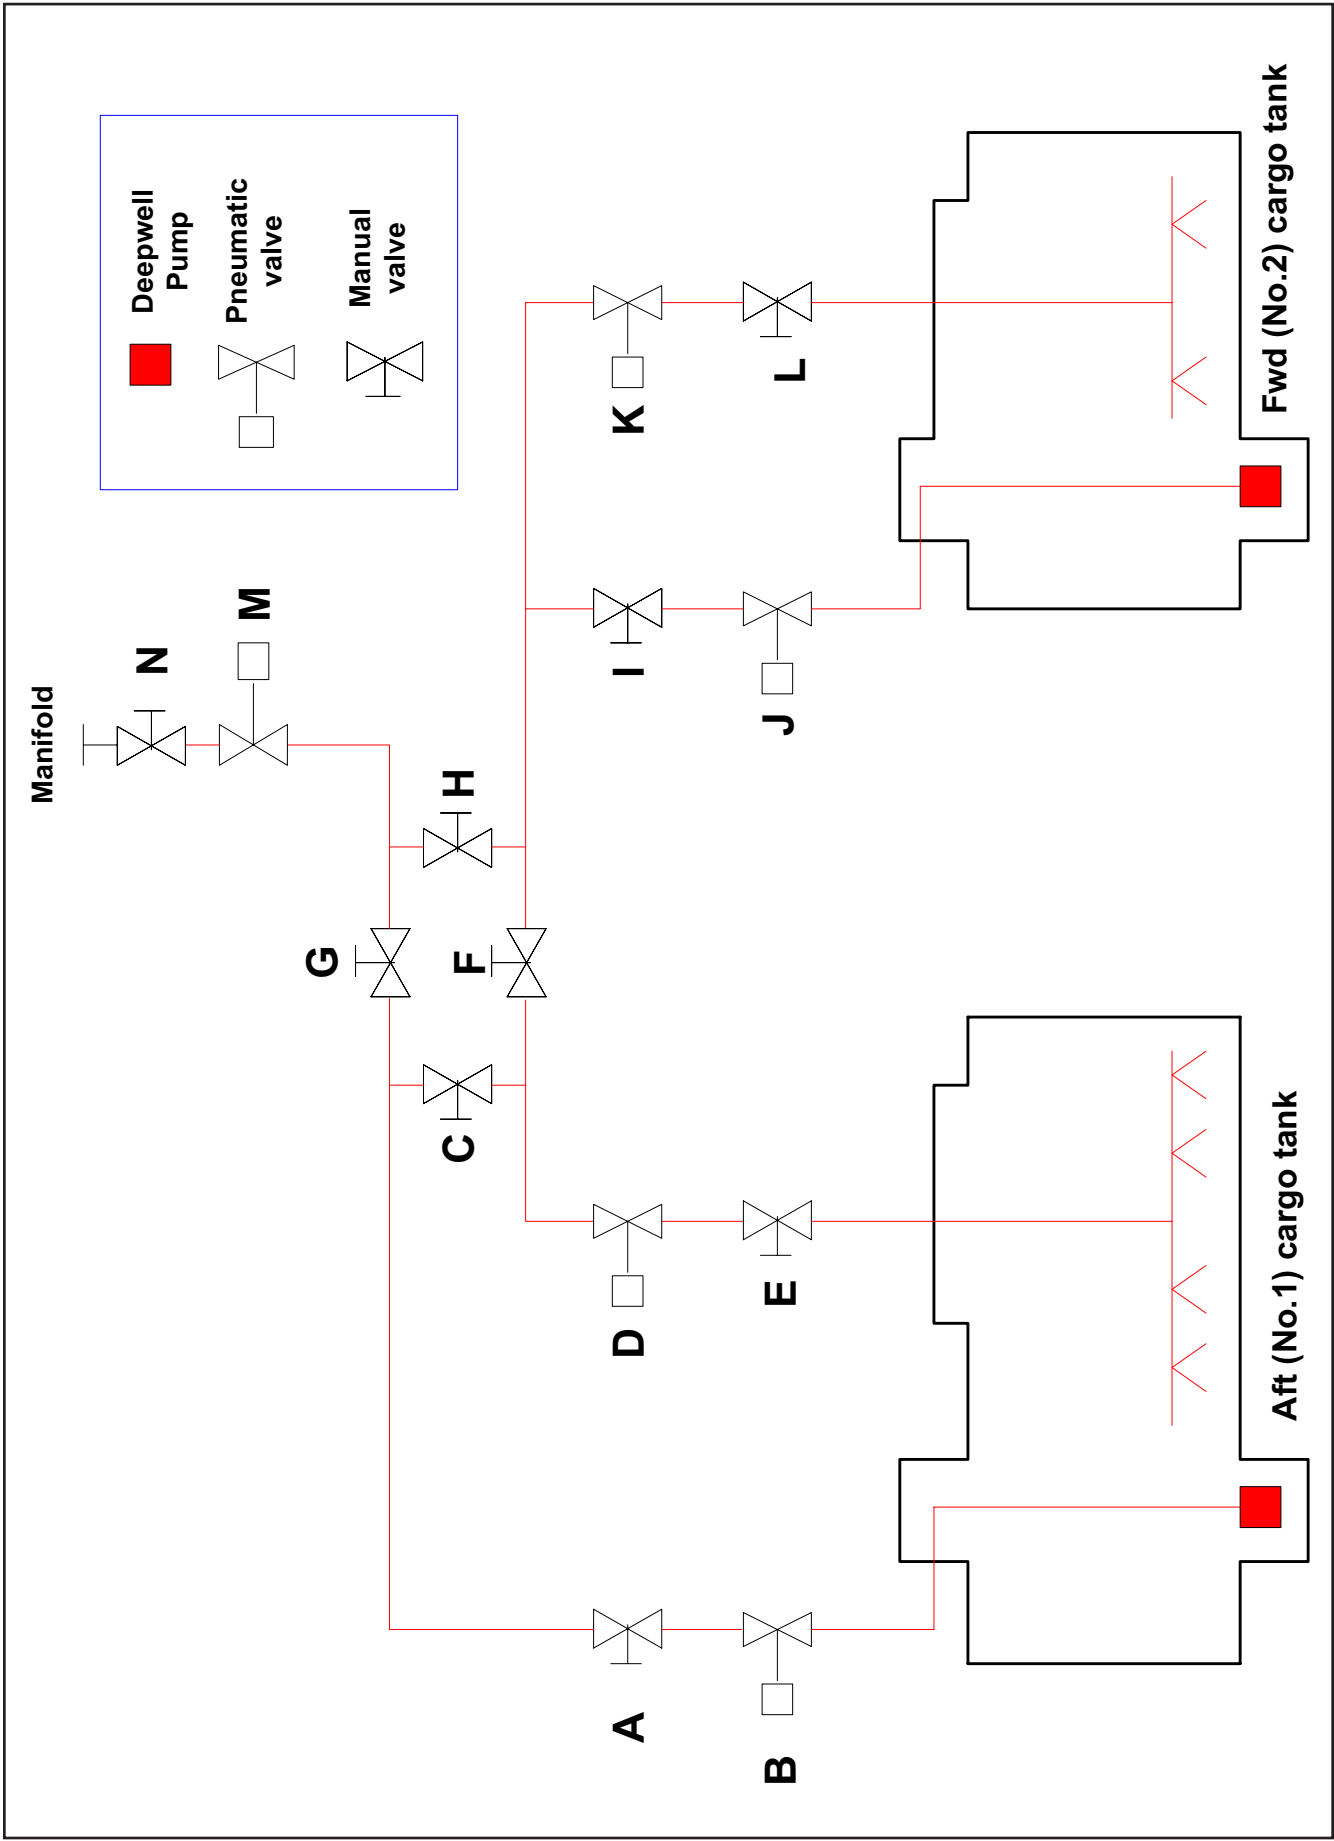
Figure 3

The chief officer went on deck just prior to berthing to complete the usual pre-arrival cargo checks. He checked the 98% high-high level alarms (HHLA) on the aft tank by locally switching the pneumatic loading valve **D (Figure 3)** to the open position, and confirming the valve remained shut. The 98% alarm had been activated by the vessel's movement during the voyage and, at that time, had not been accepted and cancelled. The chief officer believed that this tank was loaded to below the 98% alarm setting, so he switched the local valve control back to the shut position, to stop the valve from opening once the 98% alarm was accepted and cancelled.

Relevant valve and piping arrangement - Basic

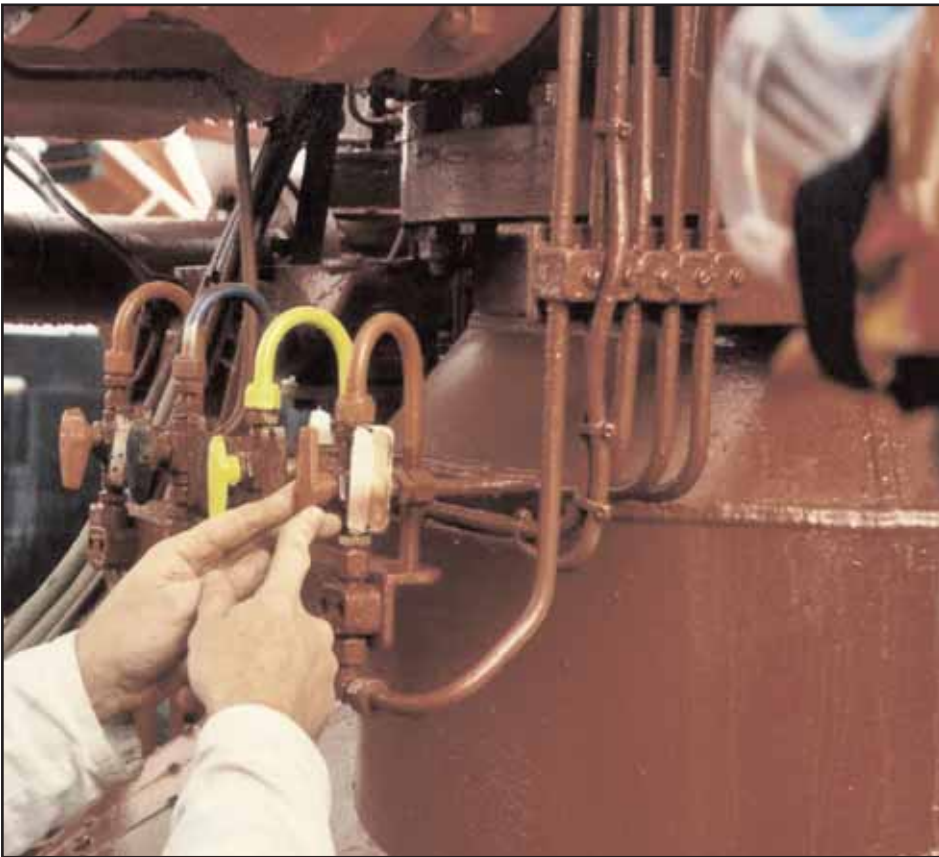
Figure 4

At the forward tank, the chief officer confirmed the pneumatic loading valve **K** remained shut when switching it locally to the open position. However, he left this valve control in the open position, because he wrongly believed the tank was loaded above the 98% alarm setting and therefore it would remain shut when the 98% alarm was later accepted and cancelled (**Figures 4 & 5**).

Forward tank pneumatic valve controls

Pneumatic valve [K]

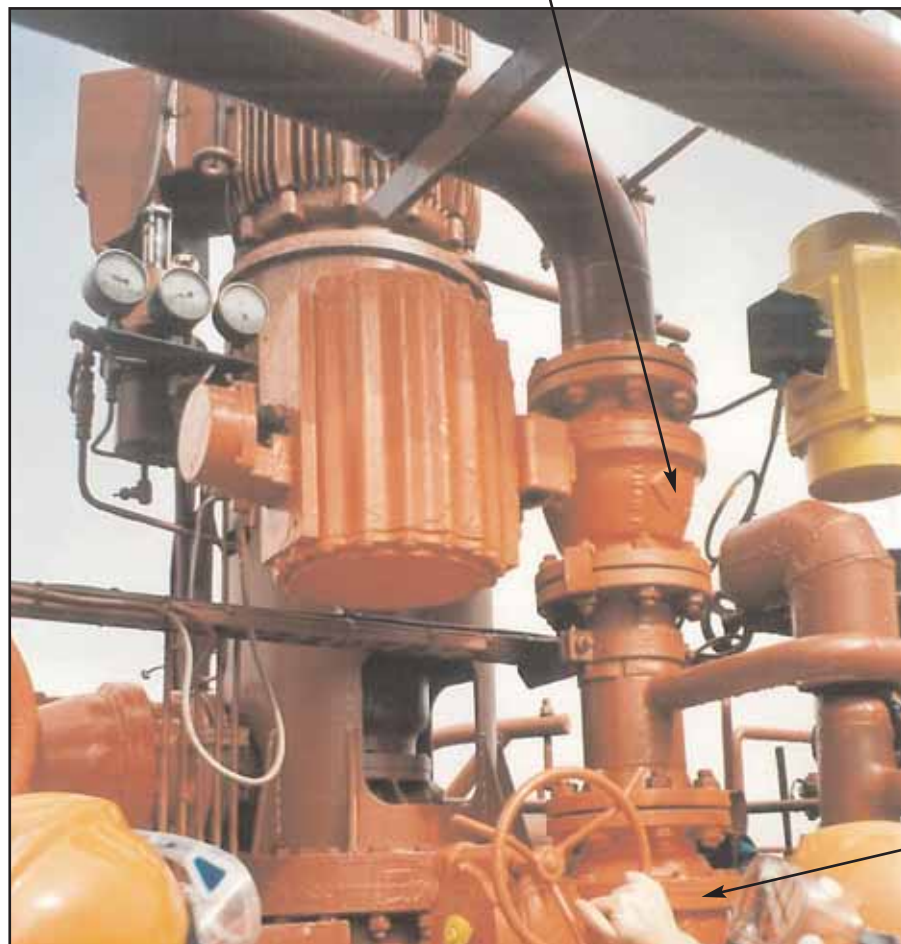
Figure 5

Manual valve [L]

Forward tank loading valves

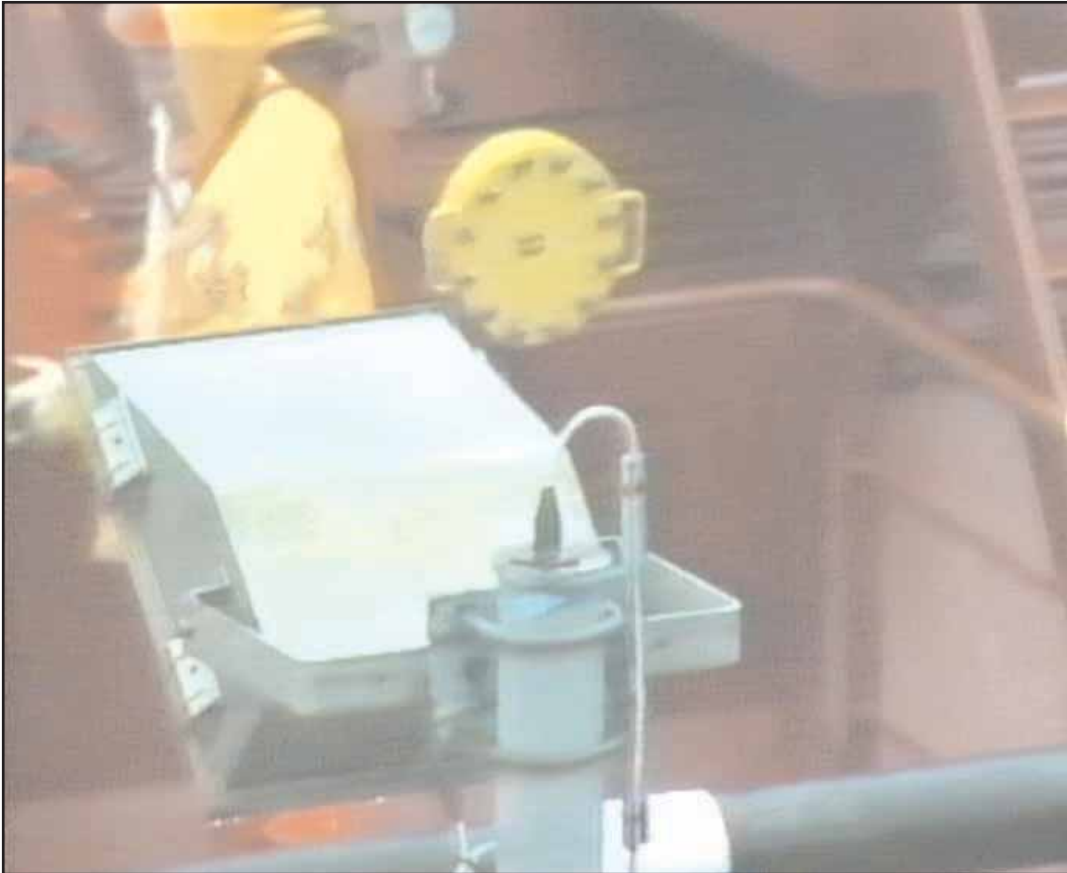
Figure 6

At 1046, the AB on deck watch went to the manifold and removed the manifold blank in preparation for the shore loading arm being connected (**Figure 6**).

Crewman removing ships manifold blank

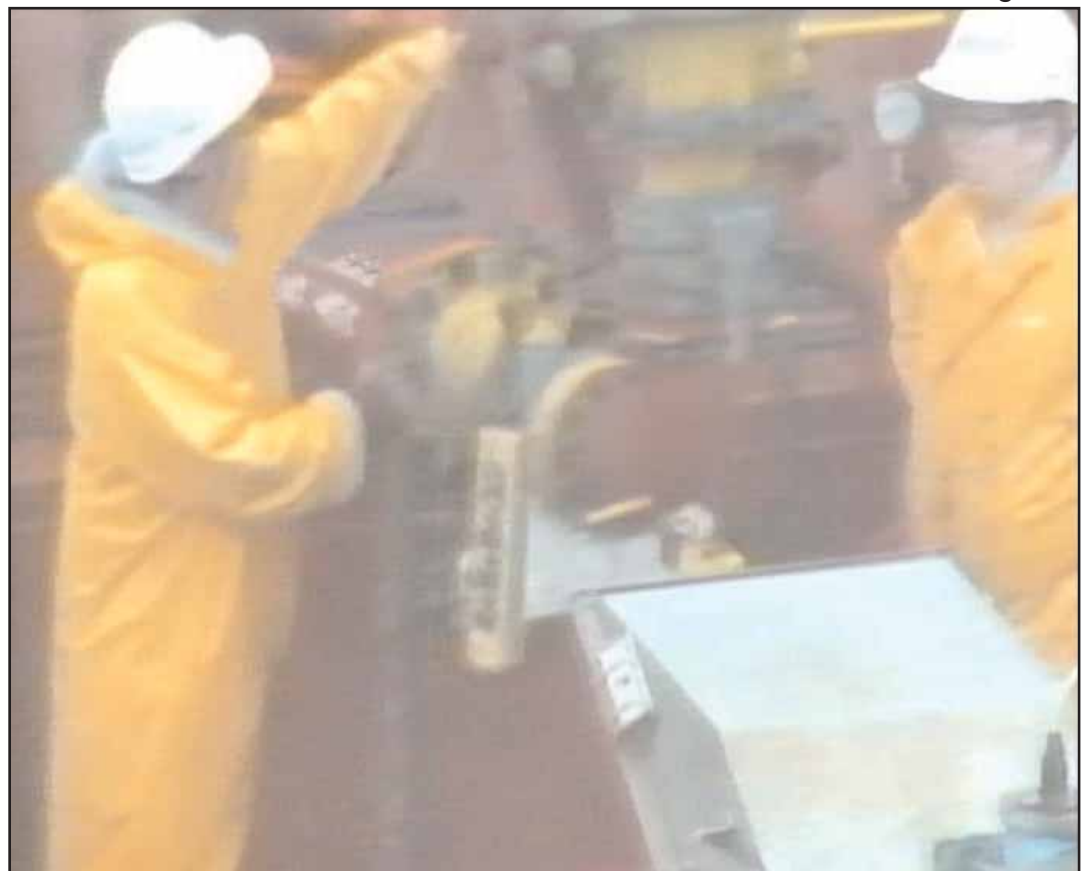
Figure 7

Shortly afterwards, two shore operators boarded the vessel and went directly to the manifold area and rigged the manifold gas alarm unit. At 1052, they swung the shore loading arm over the vessel and began connecting it to the vessel's cargo manifold (**Figure 7**). The chief officer noticed that they were onboard and connecting the loading arm.

Two shore operators connecting the loading arm to ship's manifold

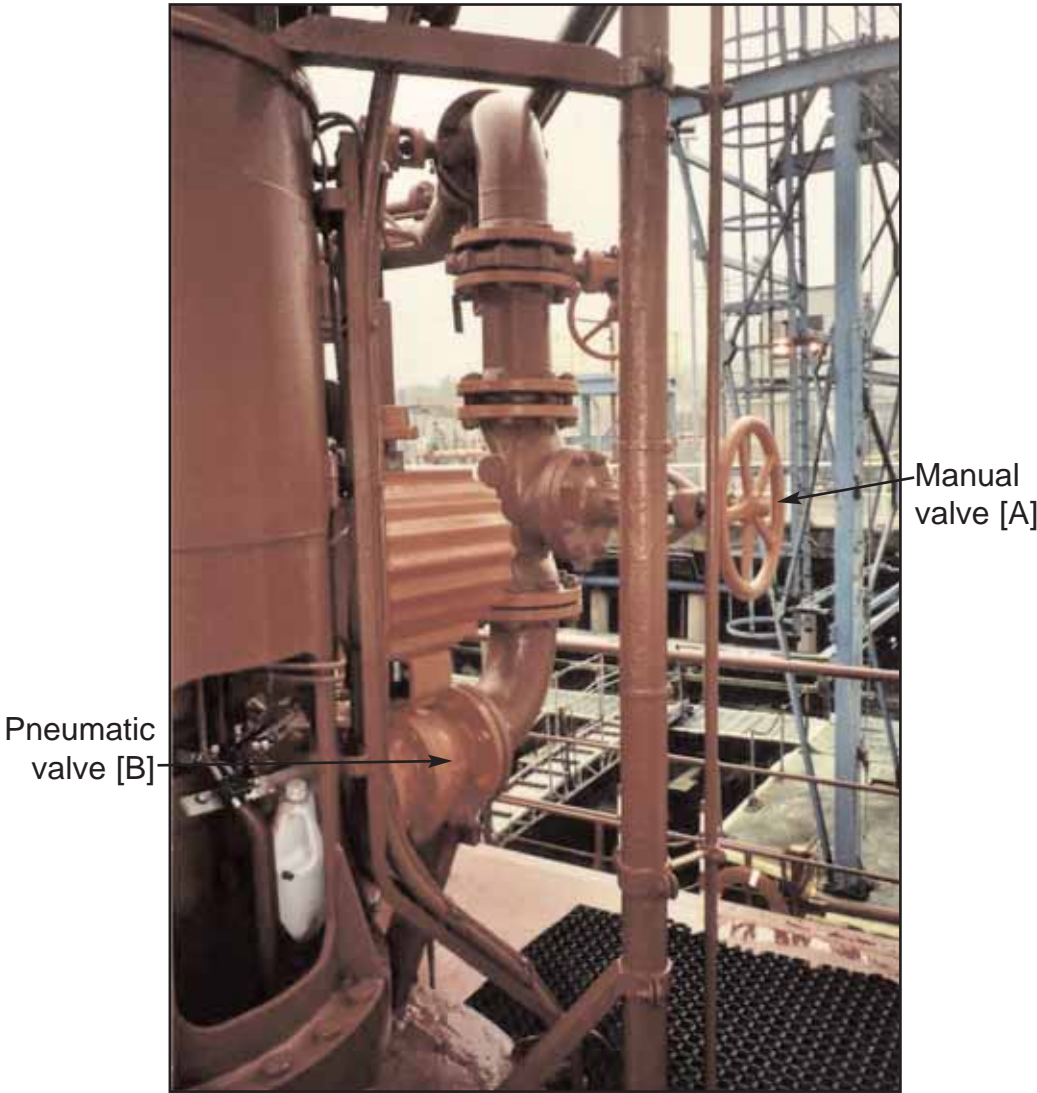
Figure 9

Aft tank discharge valves

Cargo pumps could only be started locally on deck in the vicinity of the tank top. The cargo pumps were electrically driven, and worked at a fixed speed. The pumping rate could be controlled by adjusting the position of the pump discharge valve (**Figure 9**).

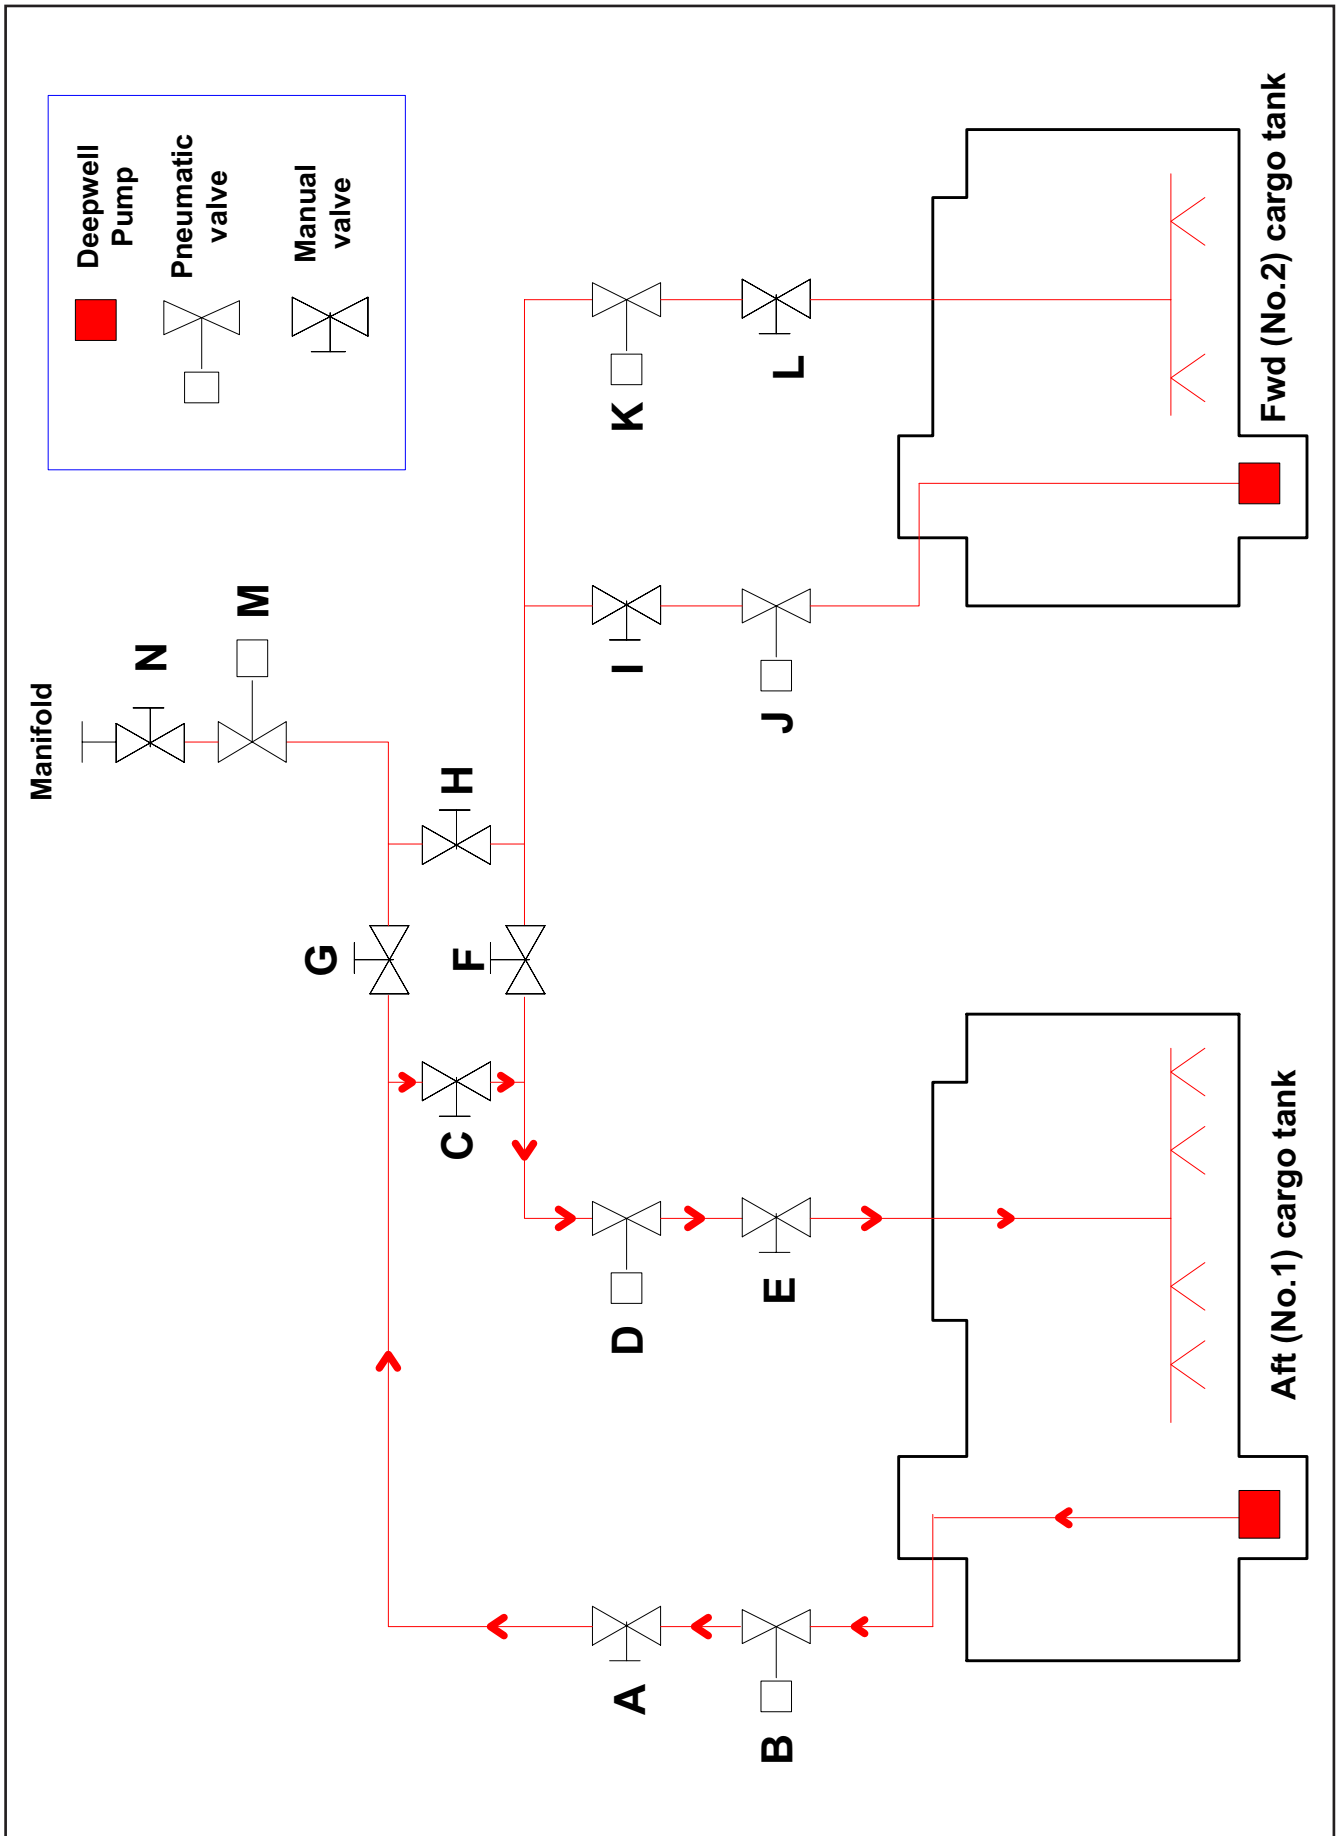
At about 1100, the chief officer and cargo surveyor proceeded to the deck to take the samples, starting at the aft cargo tank. The chief officer was not wearing breathing apparatus (BA), as required by the owner's instructions. The chief officer opened the aft cargo tank pneumatic loading valve **D** and pneumatic cargo pump discharge valve **B** (**Figure 9**) and started the aft tank cargo pump, with the intention of circulating the cargo around the aft tank (**Figure 10**). The cargo surveyor began filling his sample cylinders.

Relevant valve and piping arrangement - Intended flow

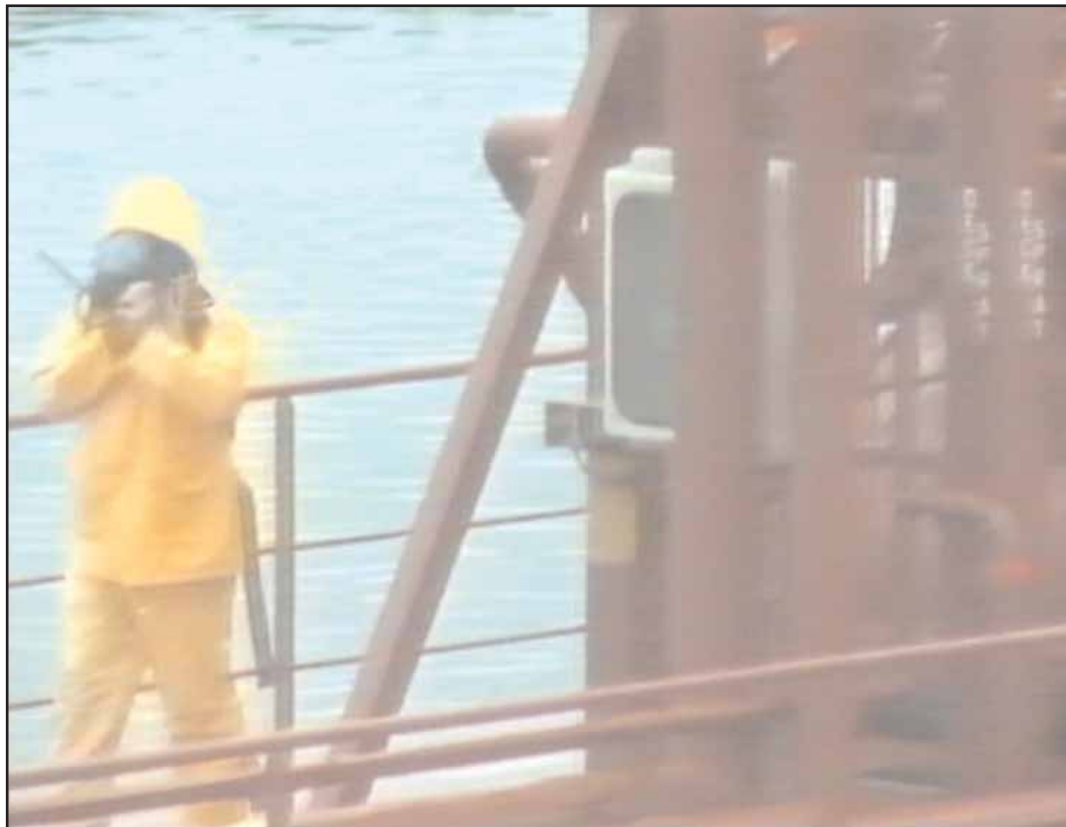
Figure 17

At about 1120, the chief officer and the watch AB went on deck to assess the situation, wearing breathing apparatus (**Figure 17**).

Vessels' chief officer checks deck

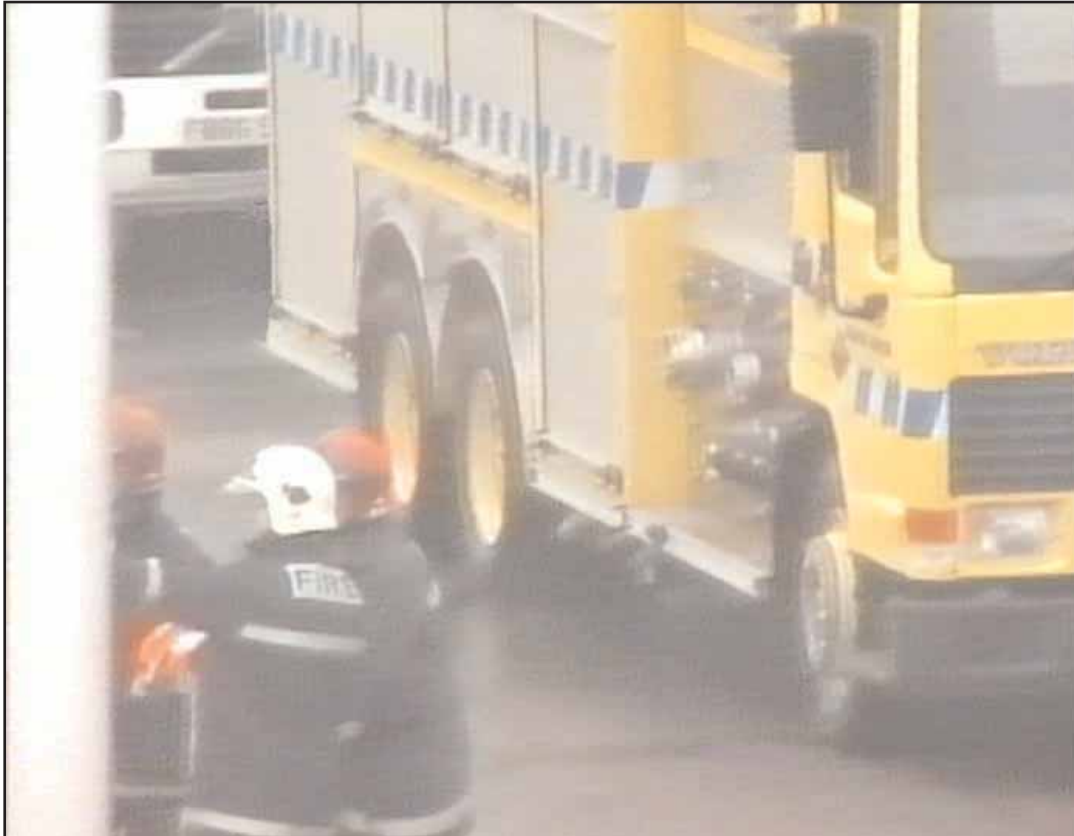
Figure 19

At about 1126, the first of the chemical plant and local emergency services began arriving at the berth (**Figure 19**).

Emergency services arrive on berth

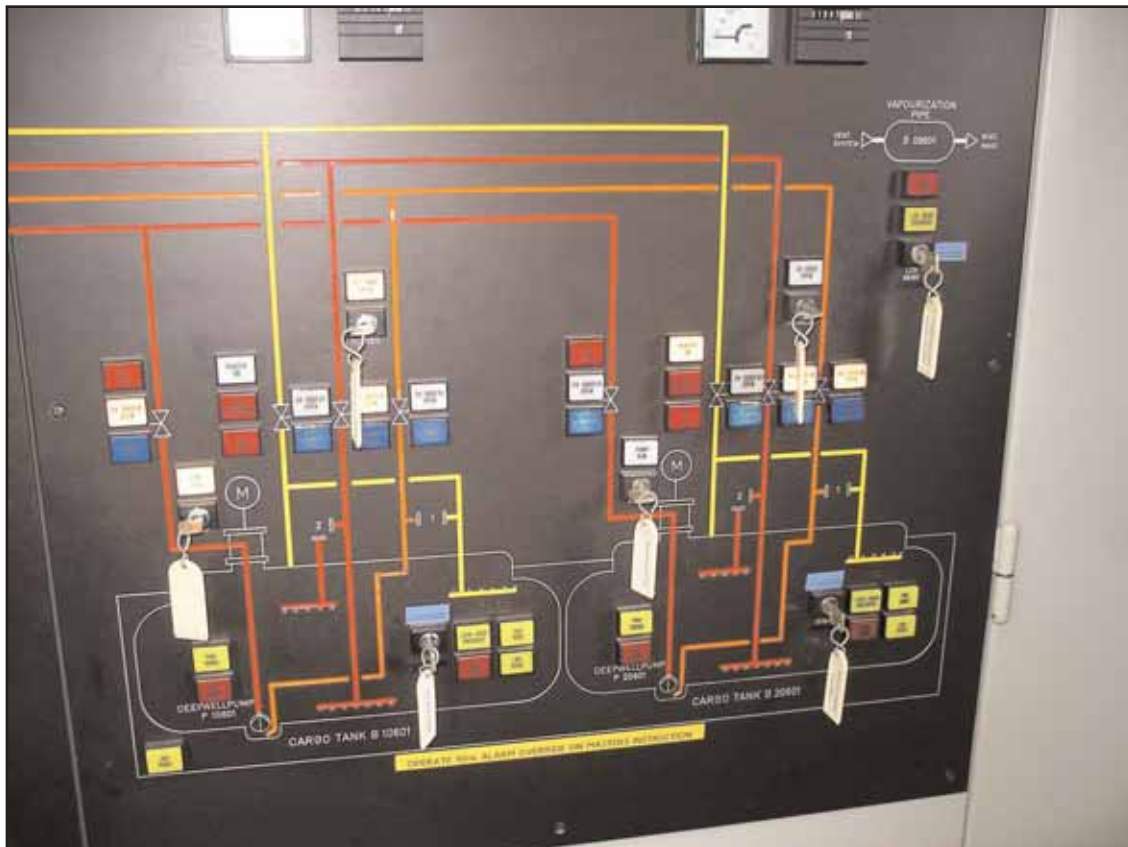
Figure 21

The chief officer then switched the forward cargo tank 98% HHLA to the override position (the alarm has a cargo pump interlock stopping the pumps while the alarm is active), so he could start the cargo pumps (**Figure 8**). At about this time, he accepted and cancelled all the alarms on the cargo office mimic board that had been displayed during the sea passage. However, in doing so, he did not notice the forward cargo tank HHLA was accepted and cleared.

pressure gauges and ullage indication could also be read in the cargo office, as well as details of all activated alarms. The 98% HHLA cargo tank override switches were situated on the mimic panel (**Figures 21 & 22**).

Cargo office mimic board

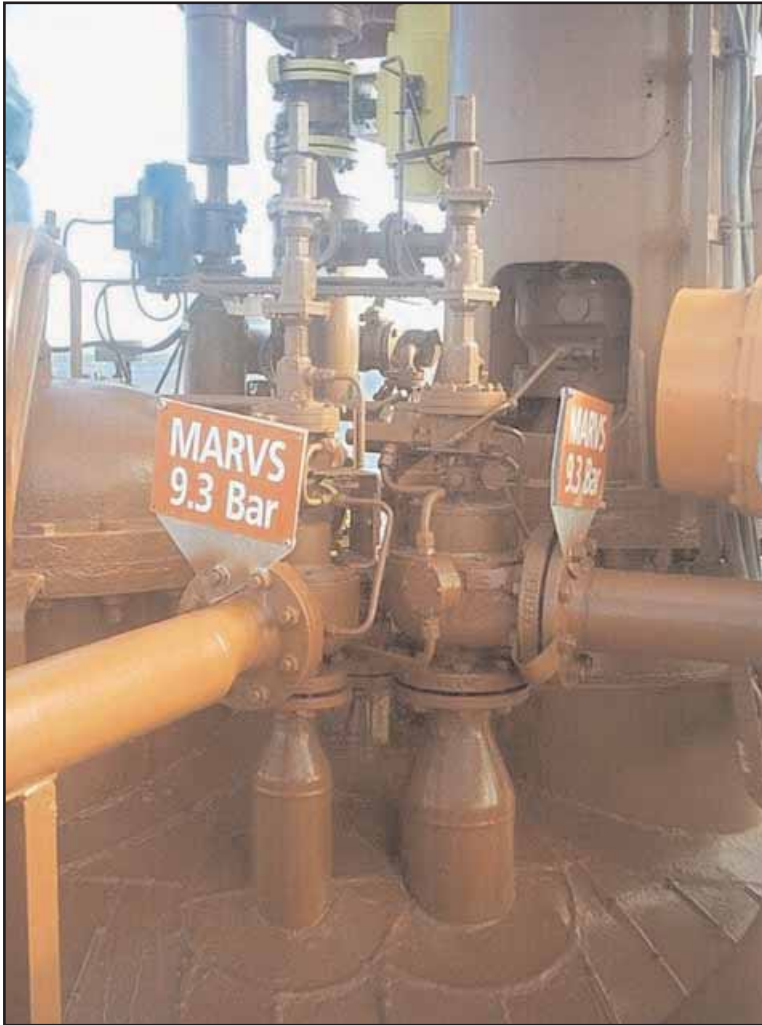
Figure 23

To protect against over pressurisation, each cargo tank was fitted with two pressure relief valves set to lift at 9.3 bar (**Figure 23**).

As a result of the accident, the forward cargo tank was subjected to a pressure equivalent to the maximum allowable, which resulted in the operation of the pressure relief valve. The vessel's crew checked the containment space for signs of possible tank structural failure 4 hours after the accident. None were found.

Forward cargo tank pressure vacuum valves

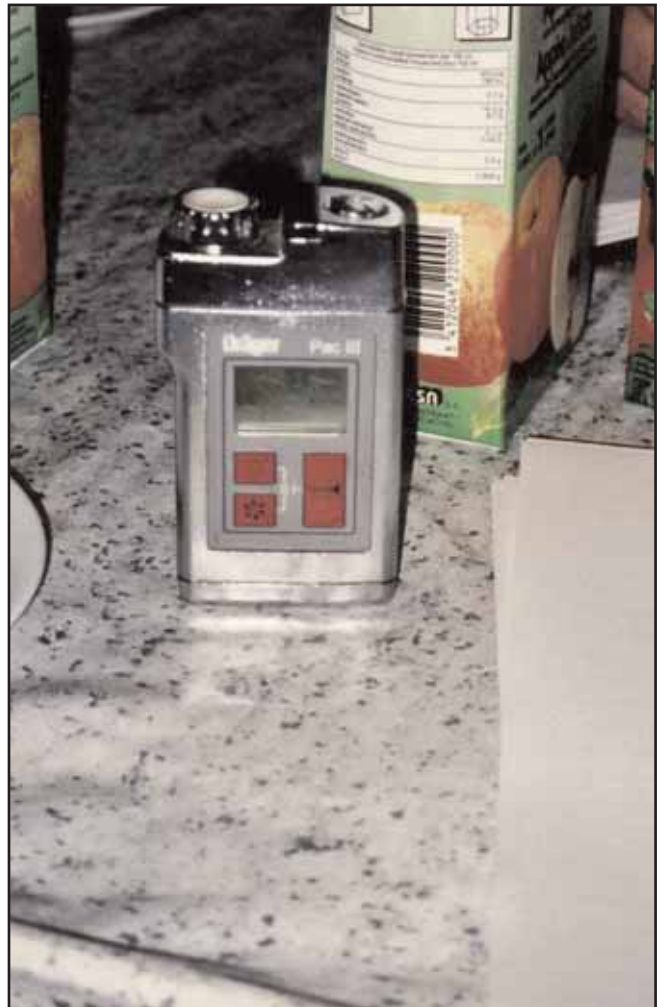
Figure 24

At the time of the accident, the vessel had two Dräger Pac III type portable gas detectors on board, in accordance with the owner's minimum standards (**Figure 24**).

Portable gas detector
