Report on the investigation into the grounding,
and subsequent loss, of the ro-ro cargo vessel

Riverdance

Shell Flats – Cleveleys Beach, Lancashire

**Report No 18/2009
September 2009**

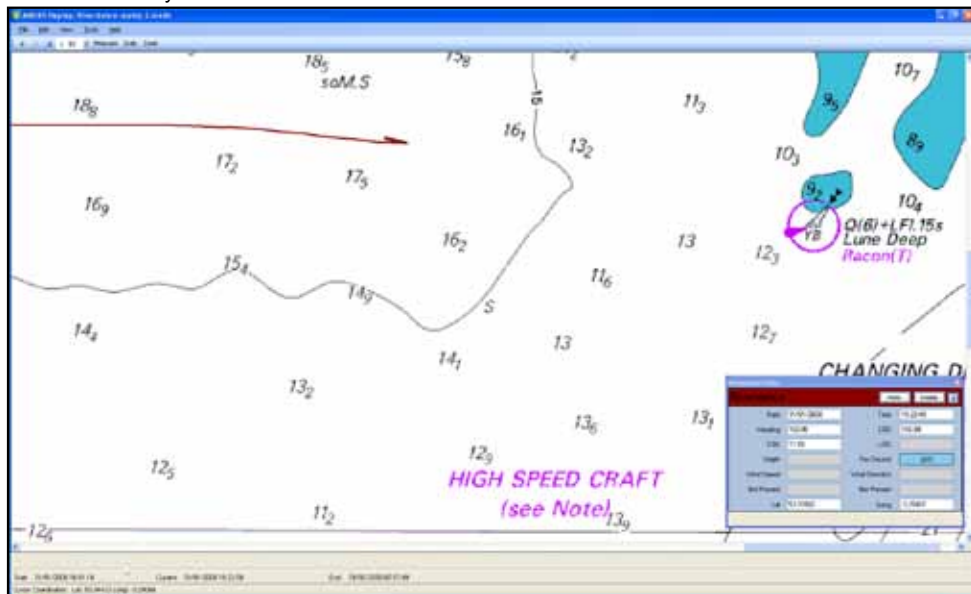
Figure 4a

Meanwhile, on the bridge, the master had disengaged the automatic pilot and, in manual steering, placed the wheel hard over to starboard. It was his intention to bring *Riverdance's* head round into the wind to reduce the rolling. *Riverdance* then experienced a change of ship's head from 103° to 170° within 39 seconds, a rate of turn of over 100° per minute (**Figures 4a and b**). During the turn, the vessel's list to port increased substantially, reportedly up to 50°.

Riverdance AIS track prior to the turn (Time: 19:22:49)

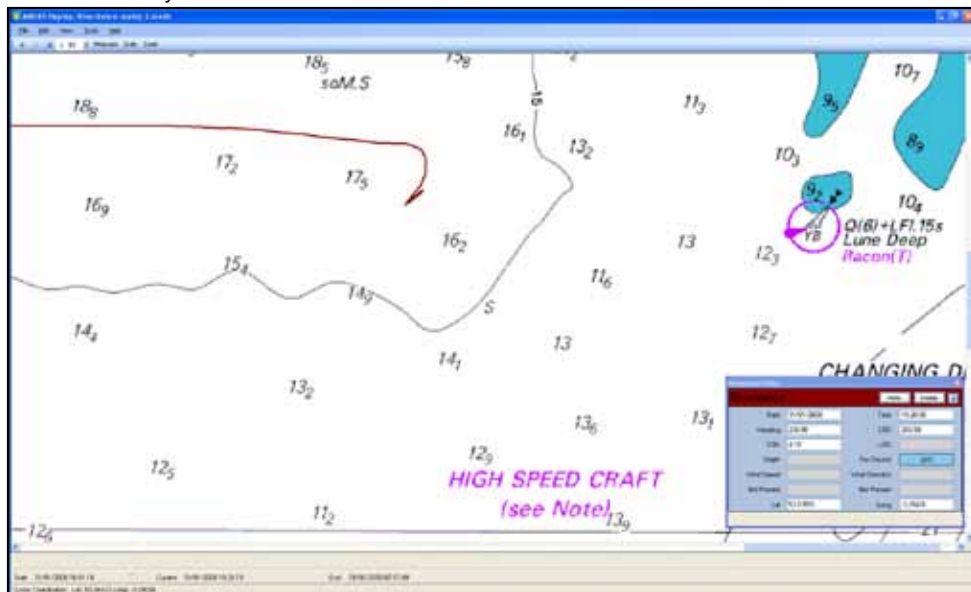
Figure 4b

Riverdance AIS track after the turn to starboard (Time: 19:26:09)

Thereafter, the turn to starboard continued at a reduced rate until the ship's head reached 250°, almost into the wind, when the list reduced to between 30° and 40°. The port main engine stopped around this time.

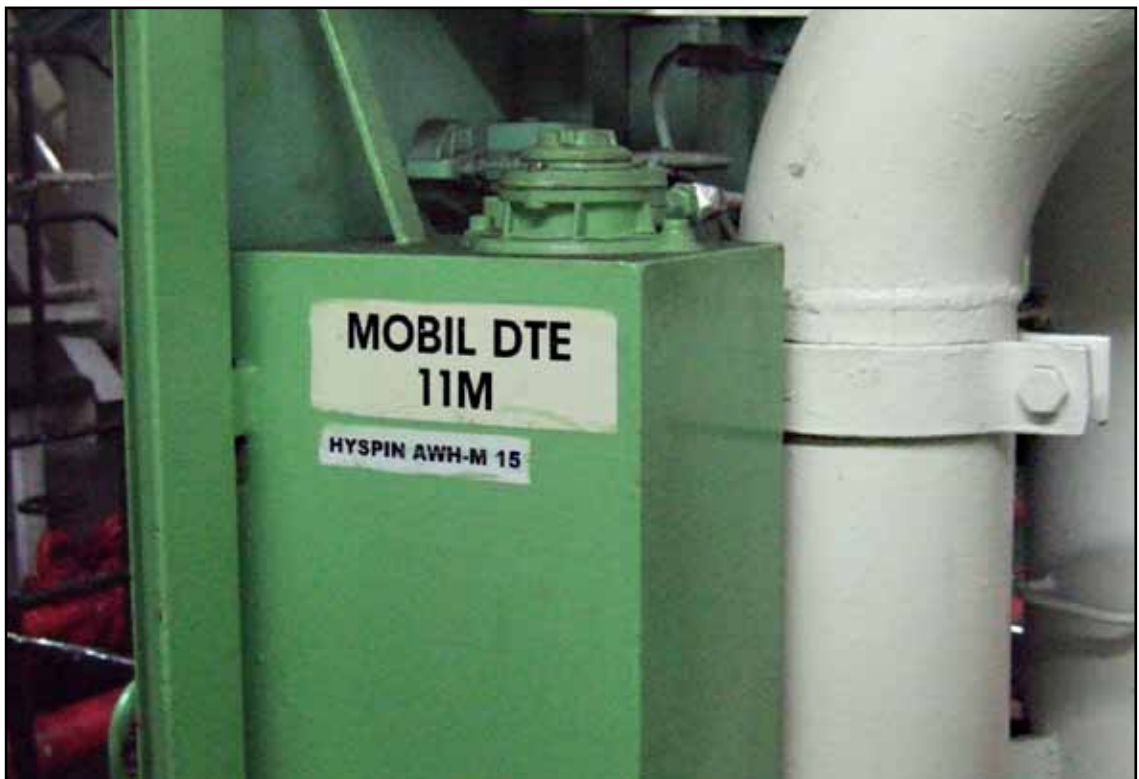
Figure 12a

Riverdance was still fitted with the original ballast valve operating system as installed at new build in 1977. This included a hydraulic storage tank which held about 30 litres of oil (**Figure 12a**). Oil was routed to the required tank ballast valve through a combination of control valves (**Figure 12b**); each individual tank valve consisted of the valve body and an actuator which incorporated a spring-loaded plate. The system provided no mimics at the control station to indicate the states of the valves. The only indication that the valve was fully open was when the in-line pressure gauge indicated a rising pressure and it became difficult to continue pumping as the valve actuator became hard up against its open "stop".

Hydraulic storage tank

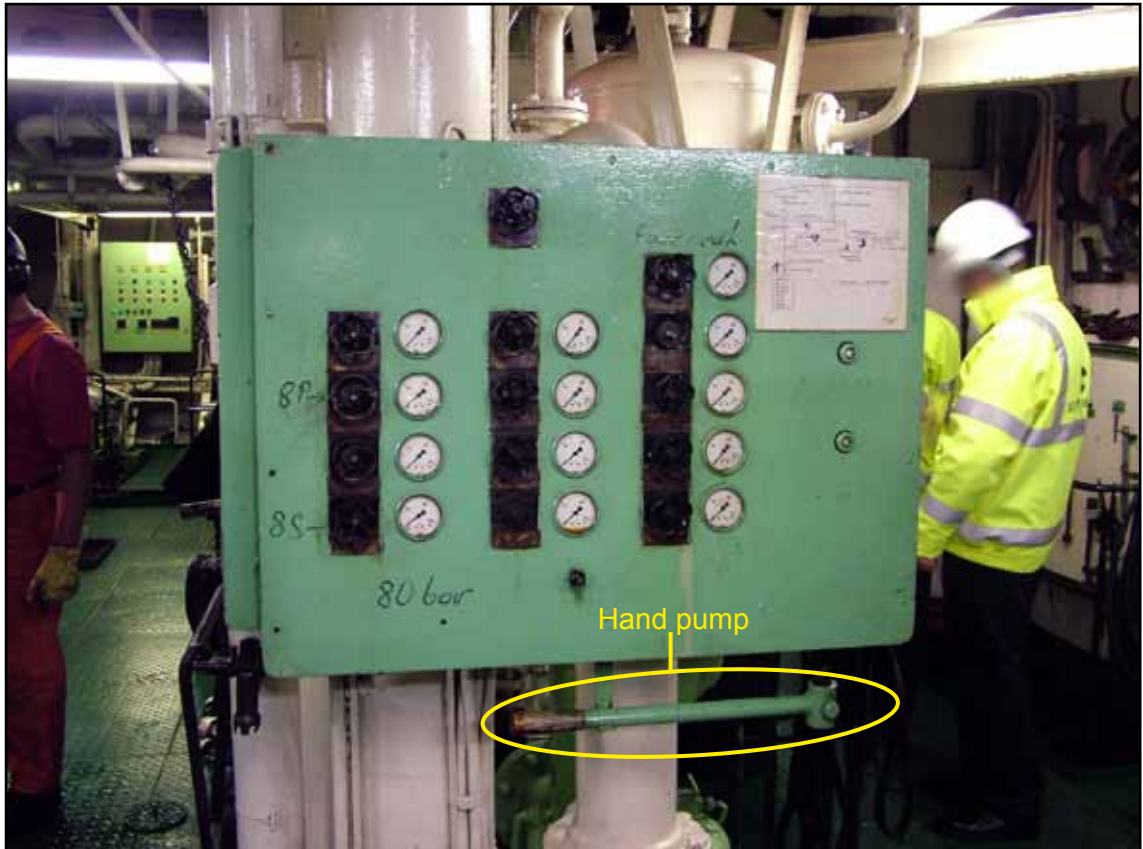
Figure 12b

Ballast distribution control panel

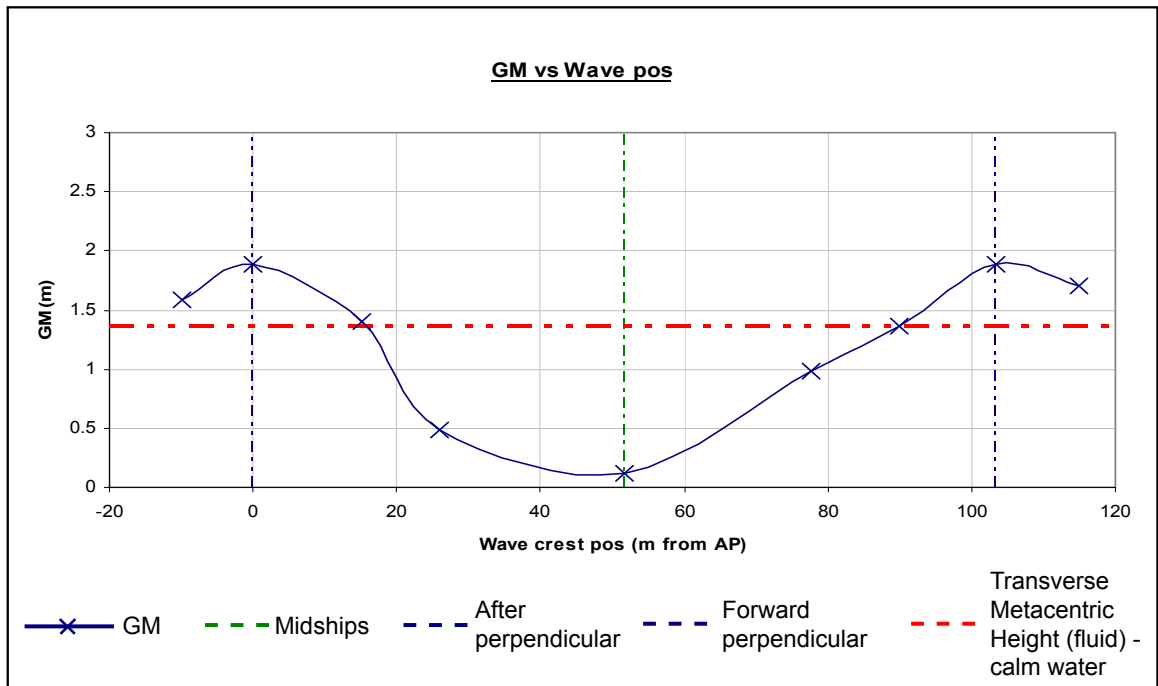
Figure 26

As can be seen in **Figure 26**, in the case of *Riverdance* there would have been a very large reduction in the GM as the wave passed amidships.

Loss of GM on a wave crest (extract from Annex 1 - QinetiQ report, Section 3.2.11)

Based on the departure stability condition of *Riverdance*, it was calculated that the GM could be reduced to 0.10 m or even less, during the passage of the waves.
