## **SIRENA SEAWAYS**

### **Heavy contact with berth, Harwich International Port**

**22 June 2013**

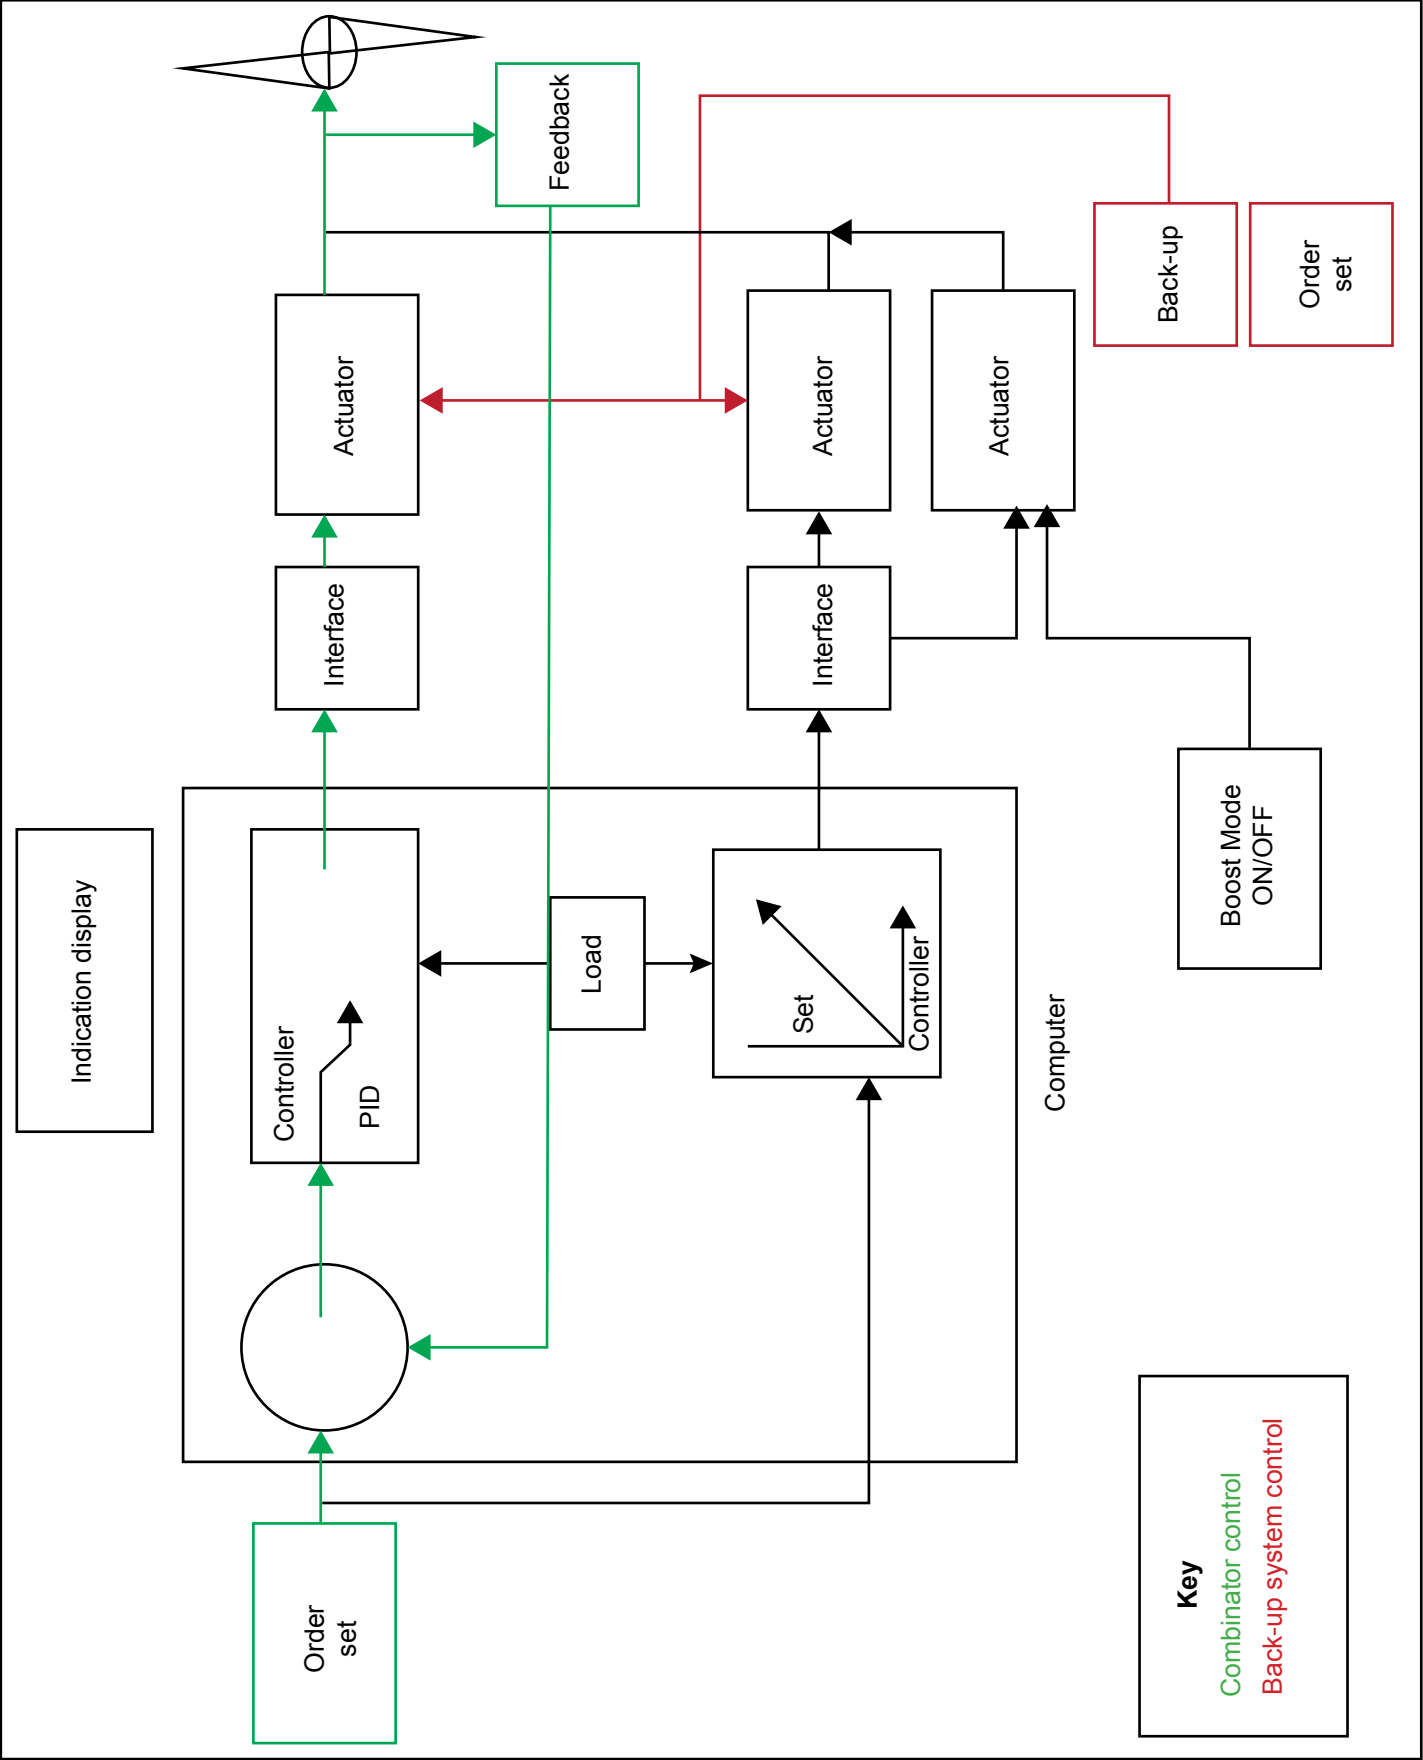
Figure 10: Pitch control system

The CPP system comprised a LIPS mechanical and hydraulic system and a Wartsila Wichmatic II electronic propulsion control system. The propulsion control system (**Figure 10**) could be operated from the bridge centre and two wing consoles, and from the ECR console. CPP pitch orders were sent, via the combinator levers and computer, to the CPP hydraulic actuators in the engine room. A feedback signal, measuring the response to the order, was sent back to the computer to ensure matching of the demand and response signals. Indicators at each of the control consoles displayed this information to the operator.

If a computer failure or other electronic system fault occurred, back-up systems for port and starboard pitch controls could be operated from the bridge centre console. The back-ups were stand-alone systems; separate from the emergency pitch controls that were located near the CPP actuators in the engine room. Each back-up control system was activated with a push-button switch and operated with its own joystick lever. The joysticks bypassed the computer system and operated the CPP hydraulic actuators directly (**Figure 10**). Commands from the back-up control systems overrode those from the combinator levers on all the consoles. When control was changed over to a back-up control system, the CPP pitch remained set at the last input until it was altered by the back-up control joysticks. Separate indicator lamps, to show that back-up control had been selected on the port and starboard CPPs, were fitted on the bridge centre and wing consoles. There were no back-up control joysticks on the bridge wing consoles.
