Report on the investigation into  
the structural failure and foundering  
of the general cargo ship

***Swanland***

Irish Sea

27 November 2011

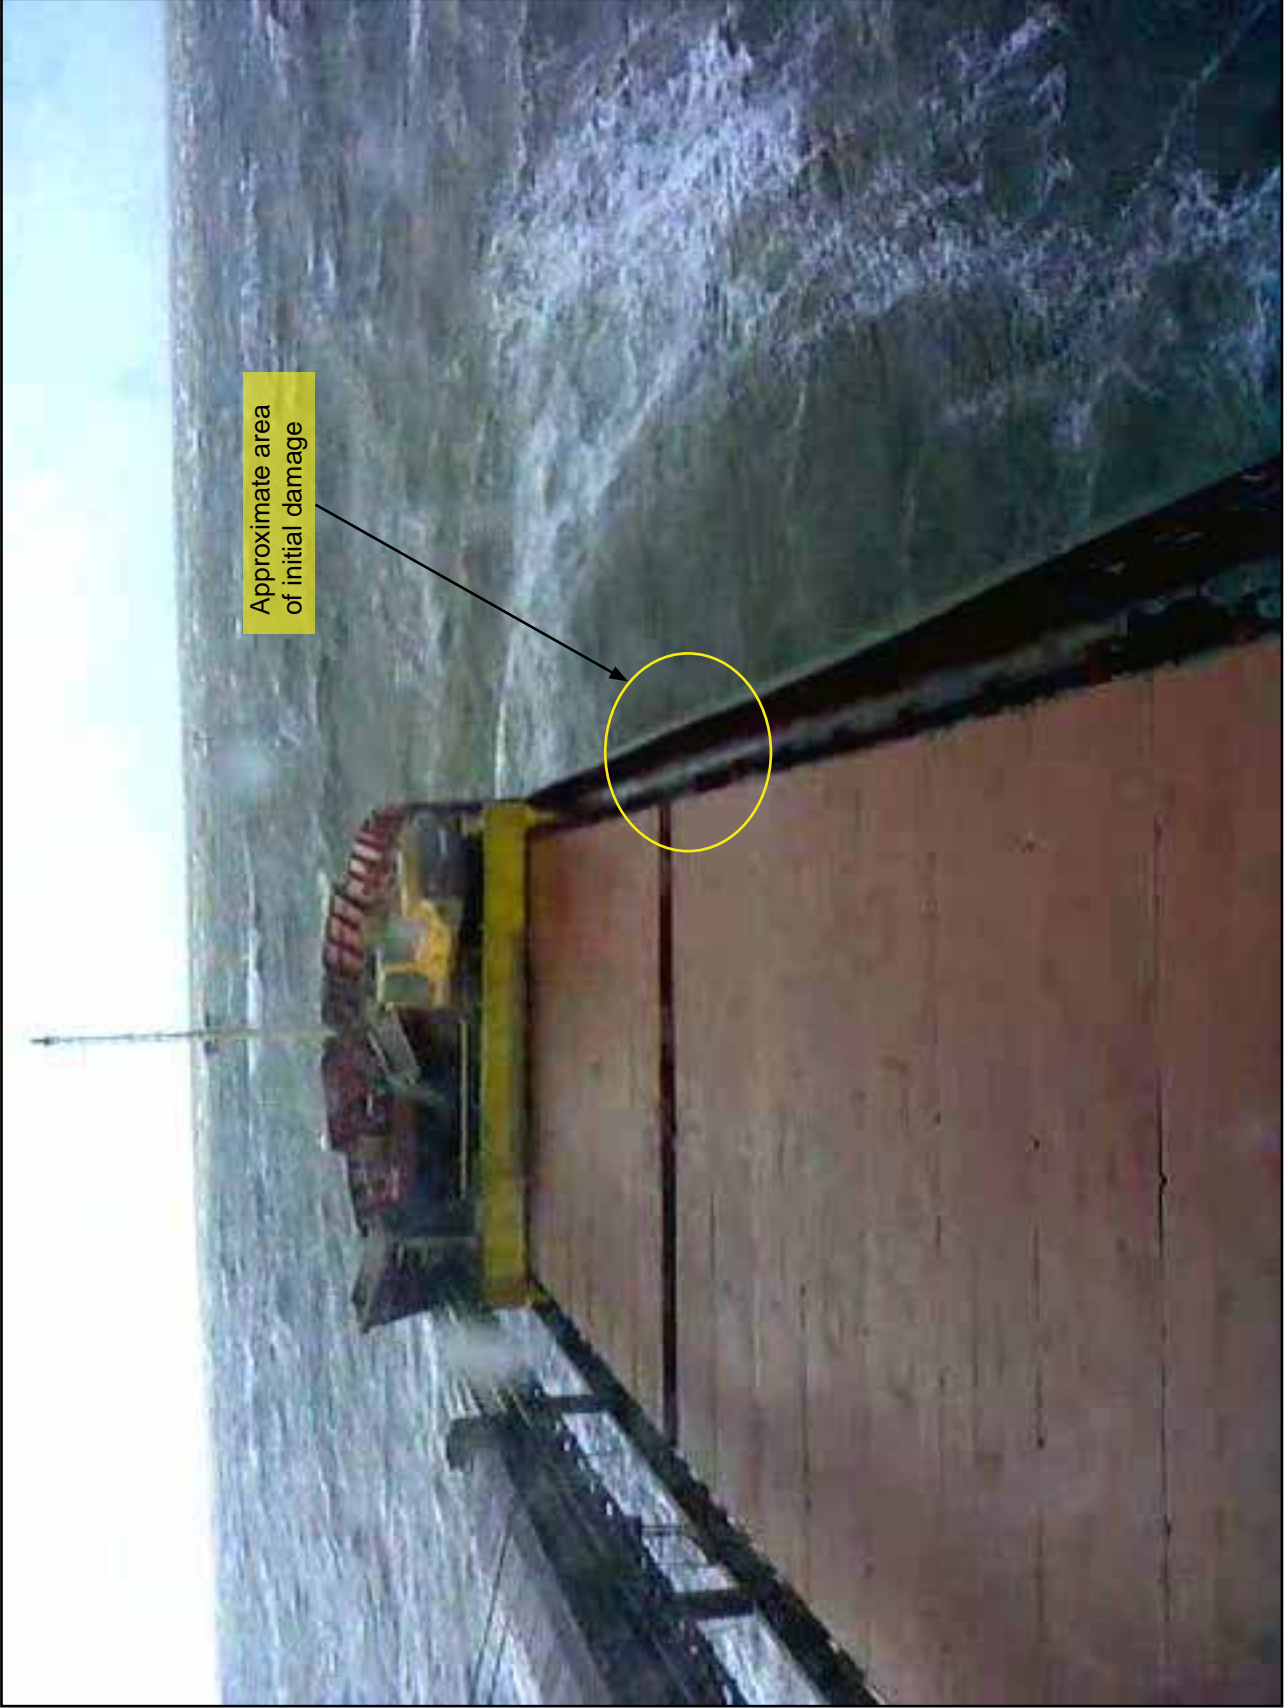
**Figure 8:** View looking forward from wheelhouse, annotated to show approximate area of initial damage

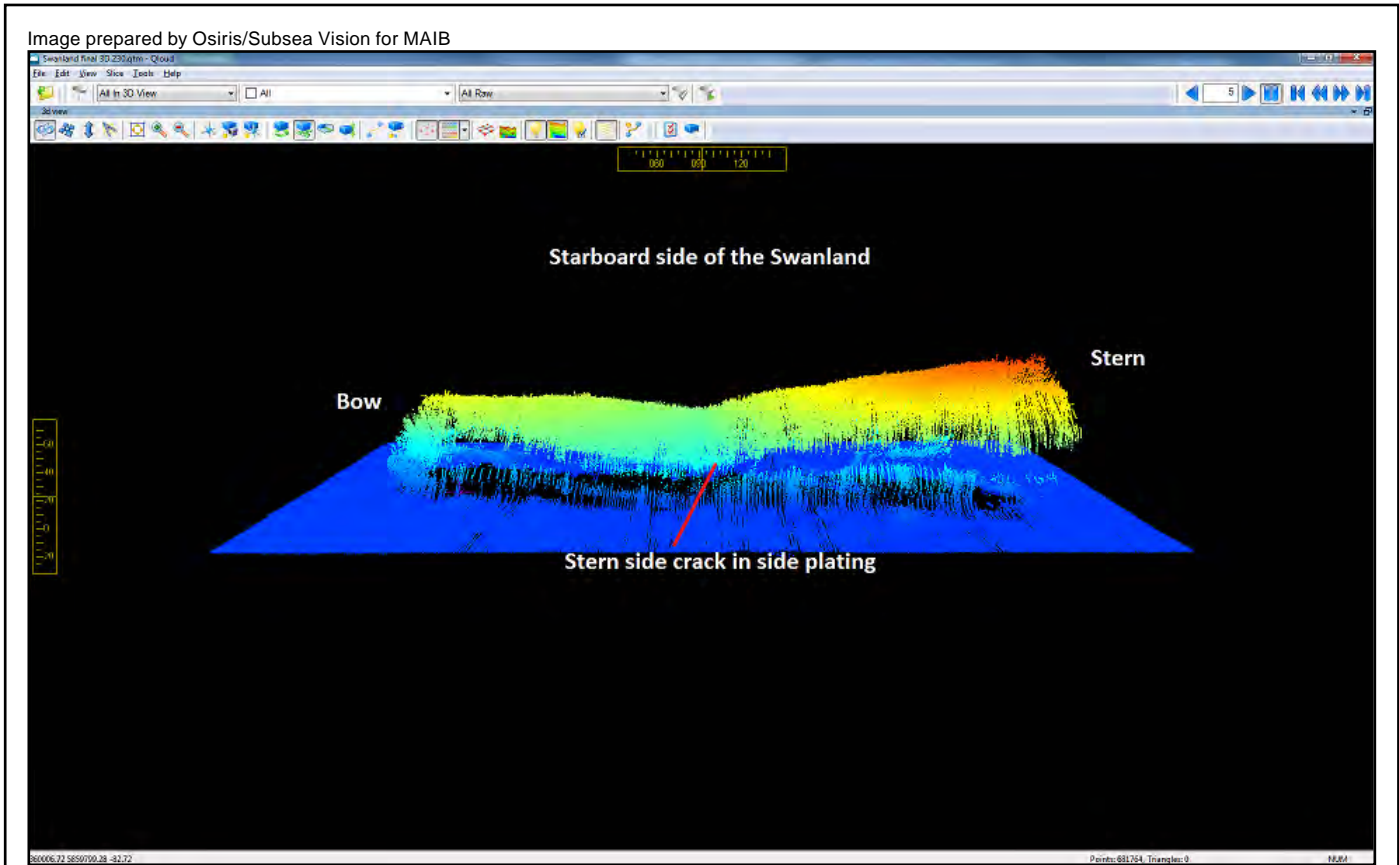
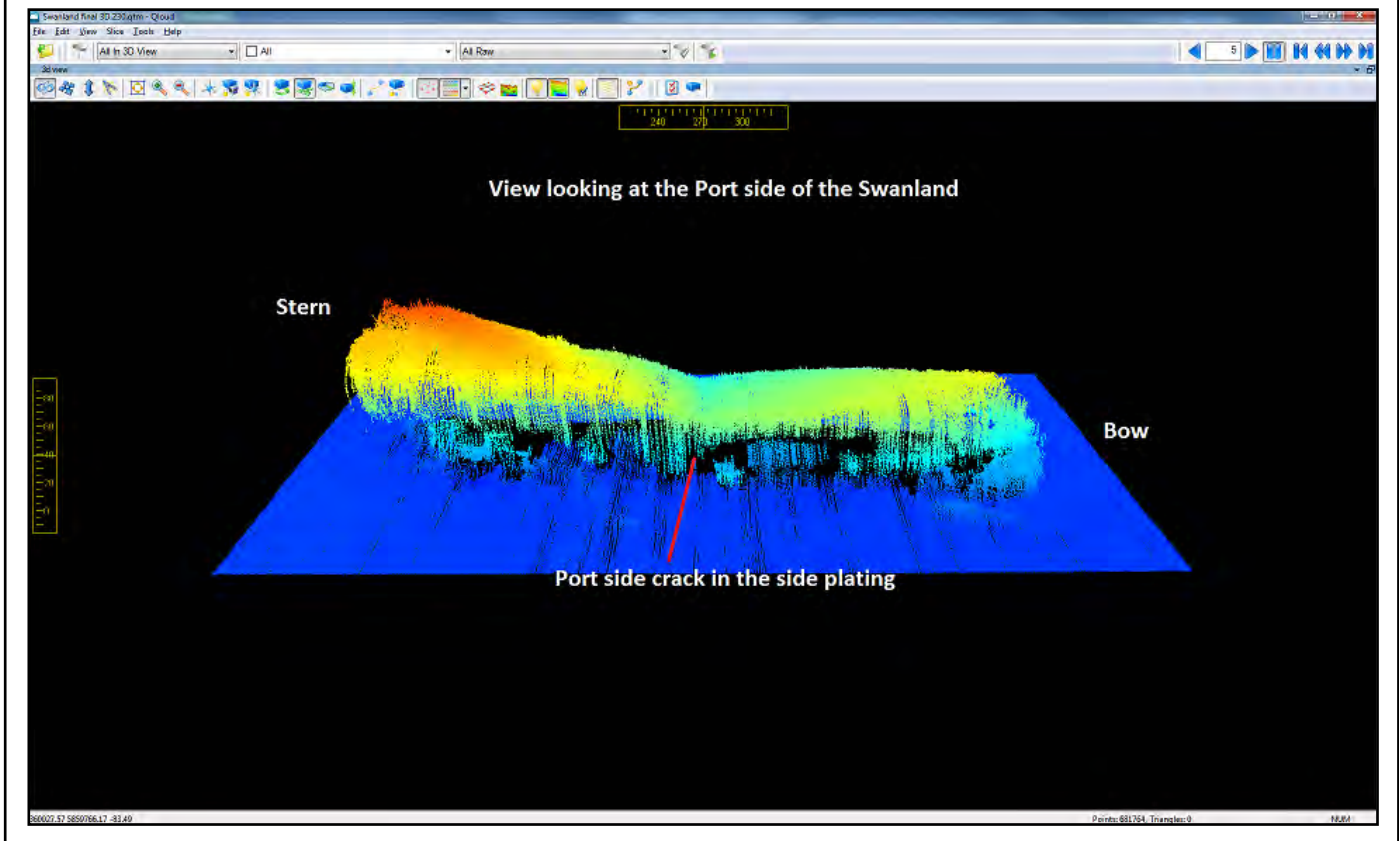
Figure 17a and 17b: Subsea Vision multi-beam sonar scans showing *Swanland* is inverted but in one piece

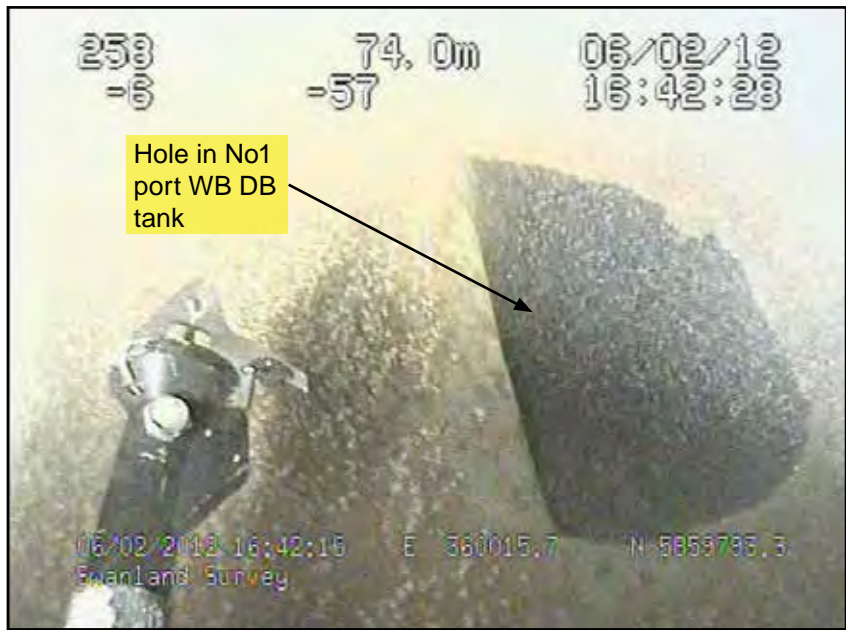
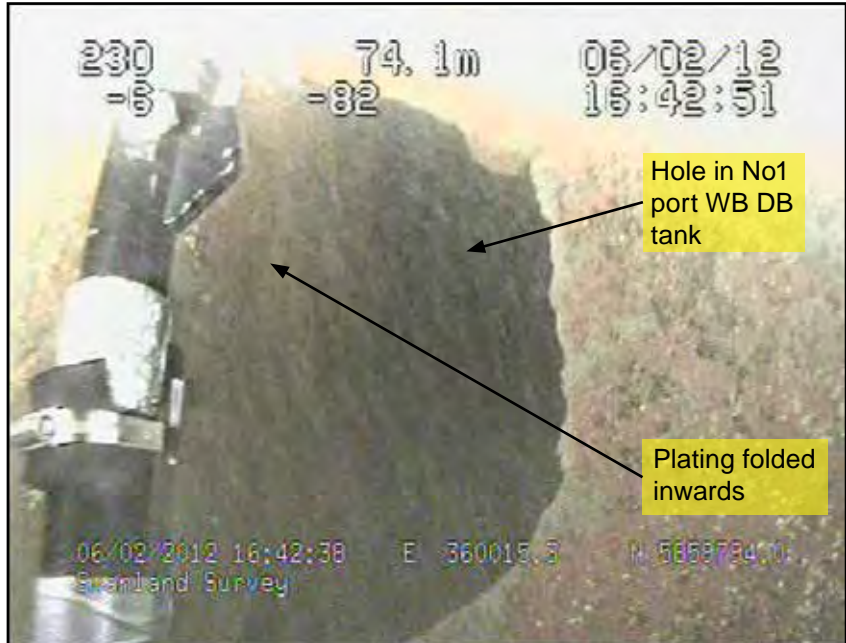
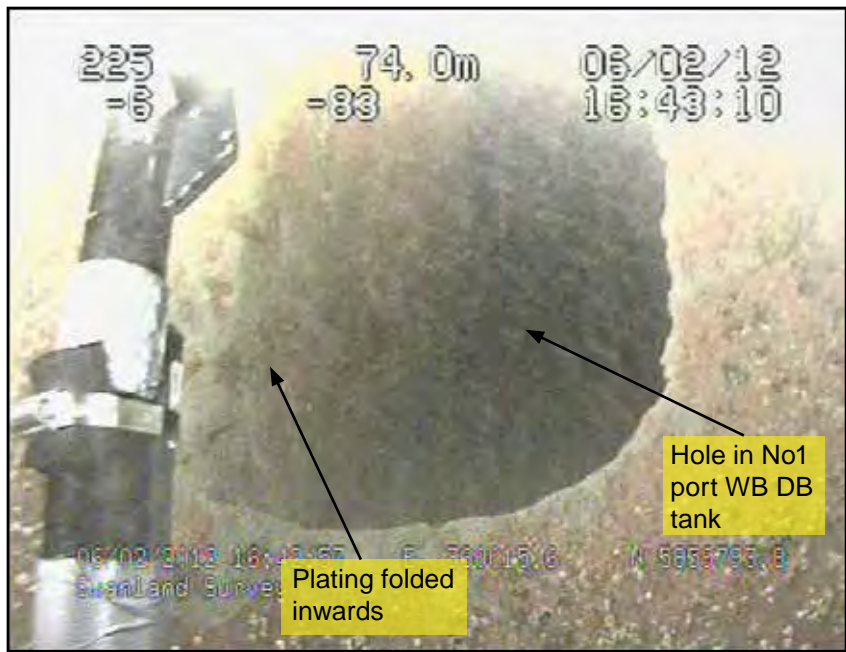
Figures 28a, 28b and 28c: Stills from ROV footage showing hole in way of No.1 Port WB DB tank

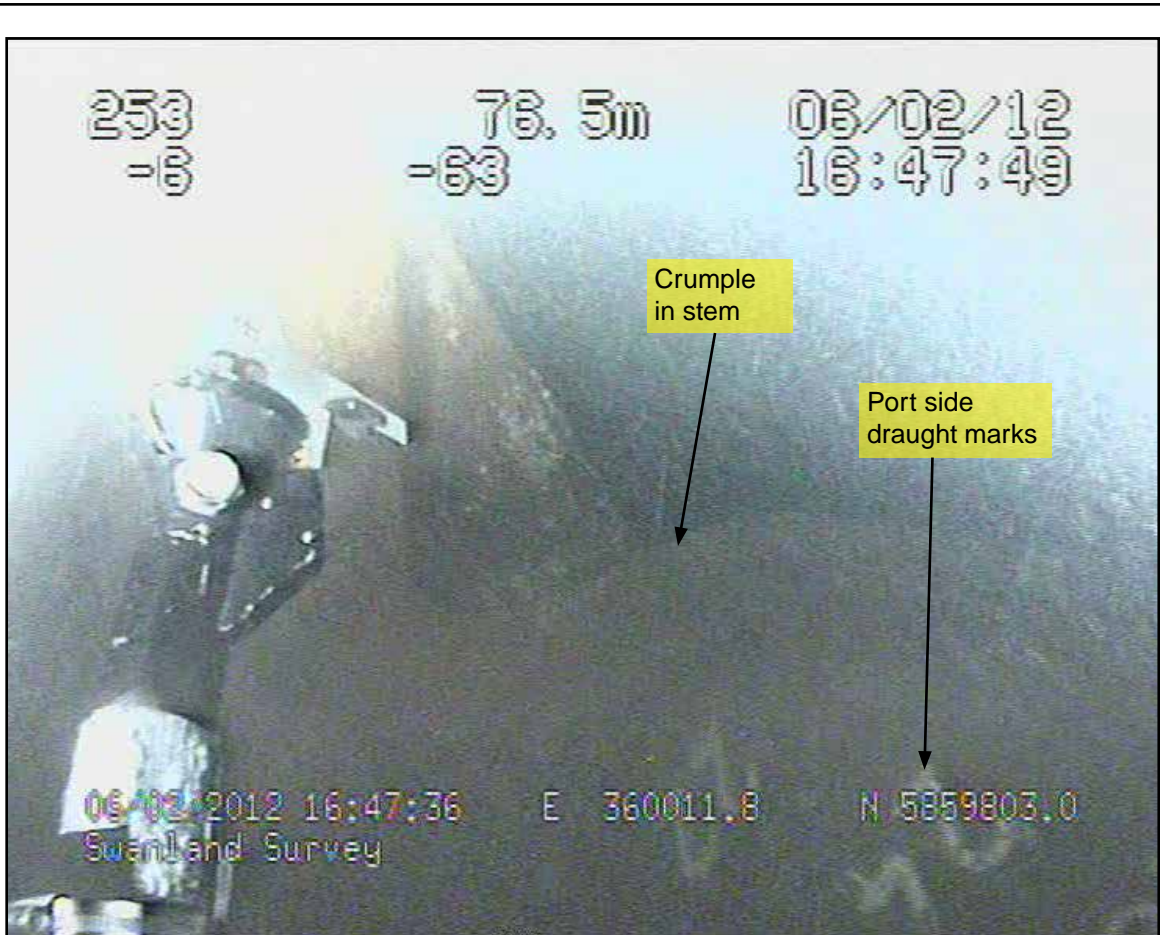
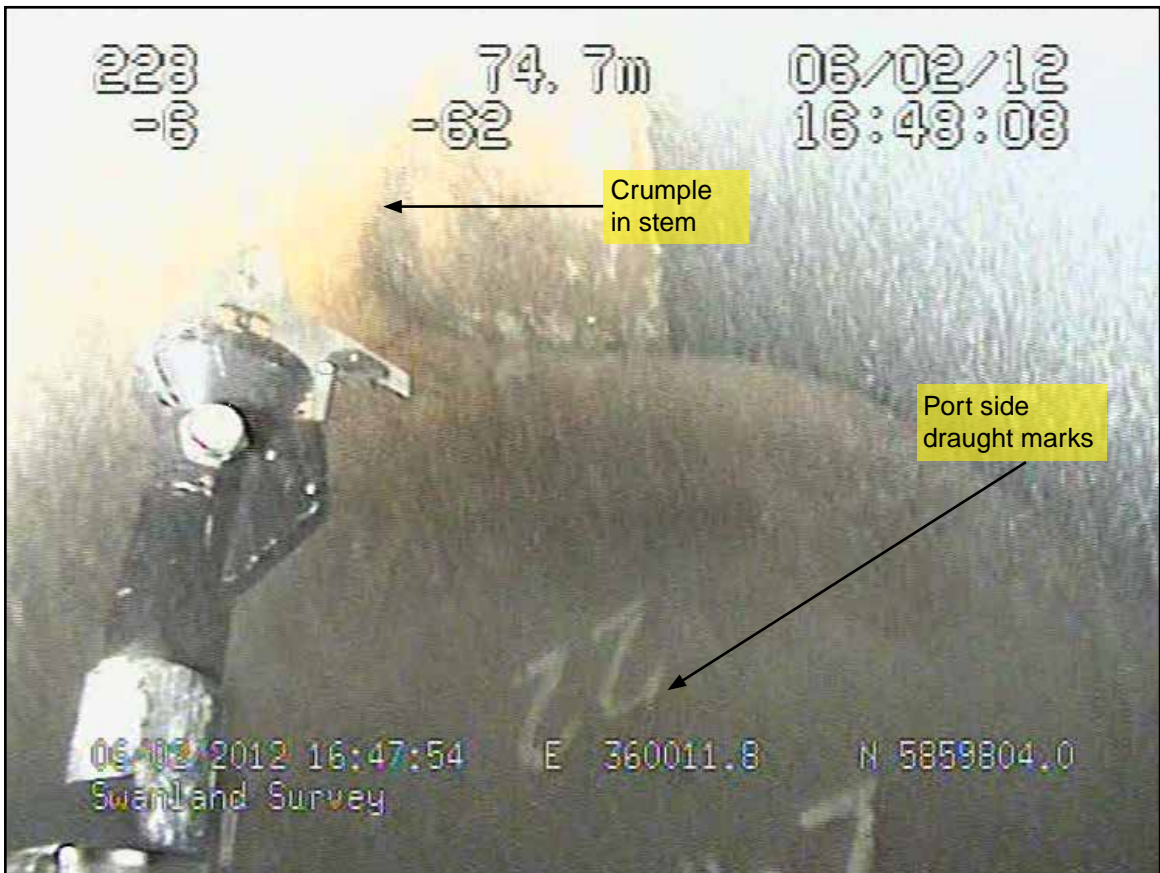
**Figures 29a and 29b:** Stills from ROV footage showing crumpling of the lower stem

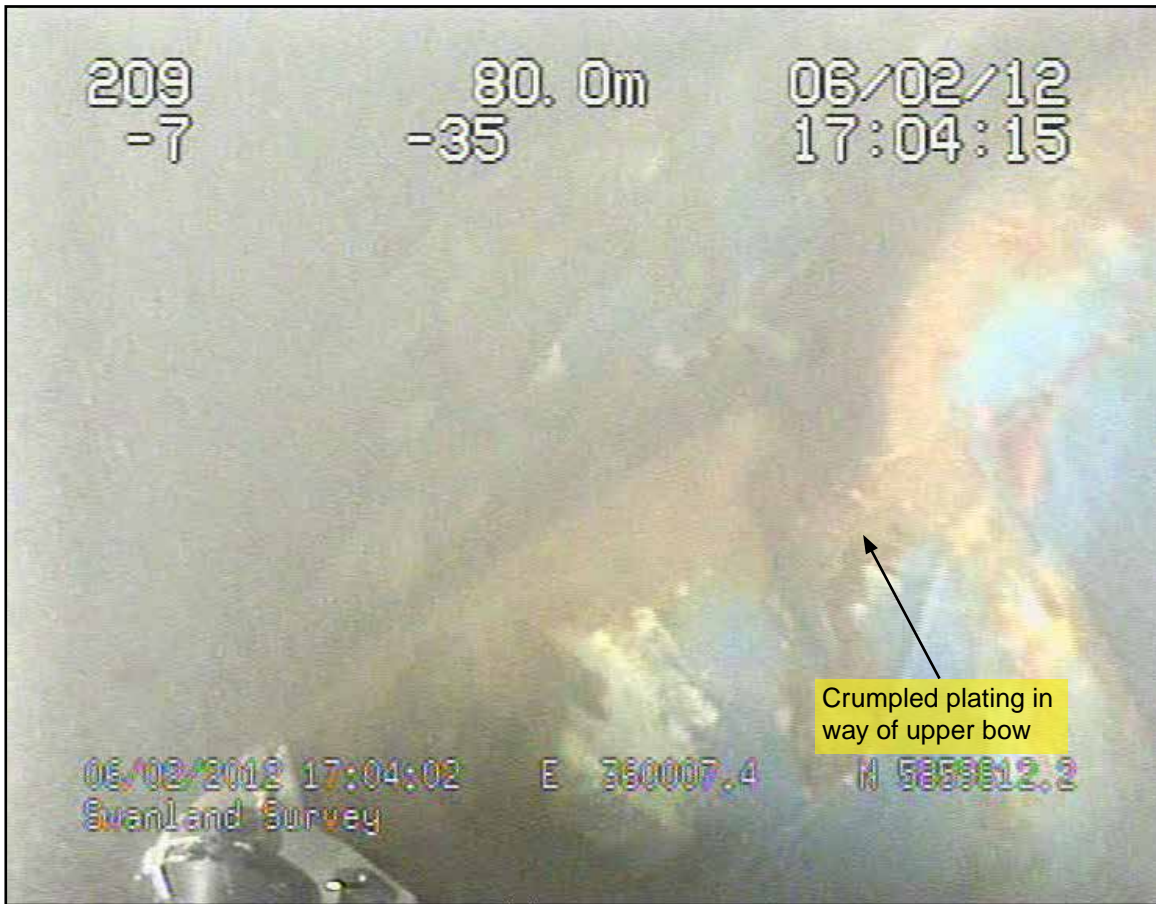
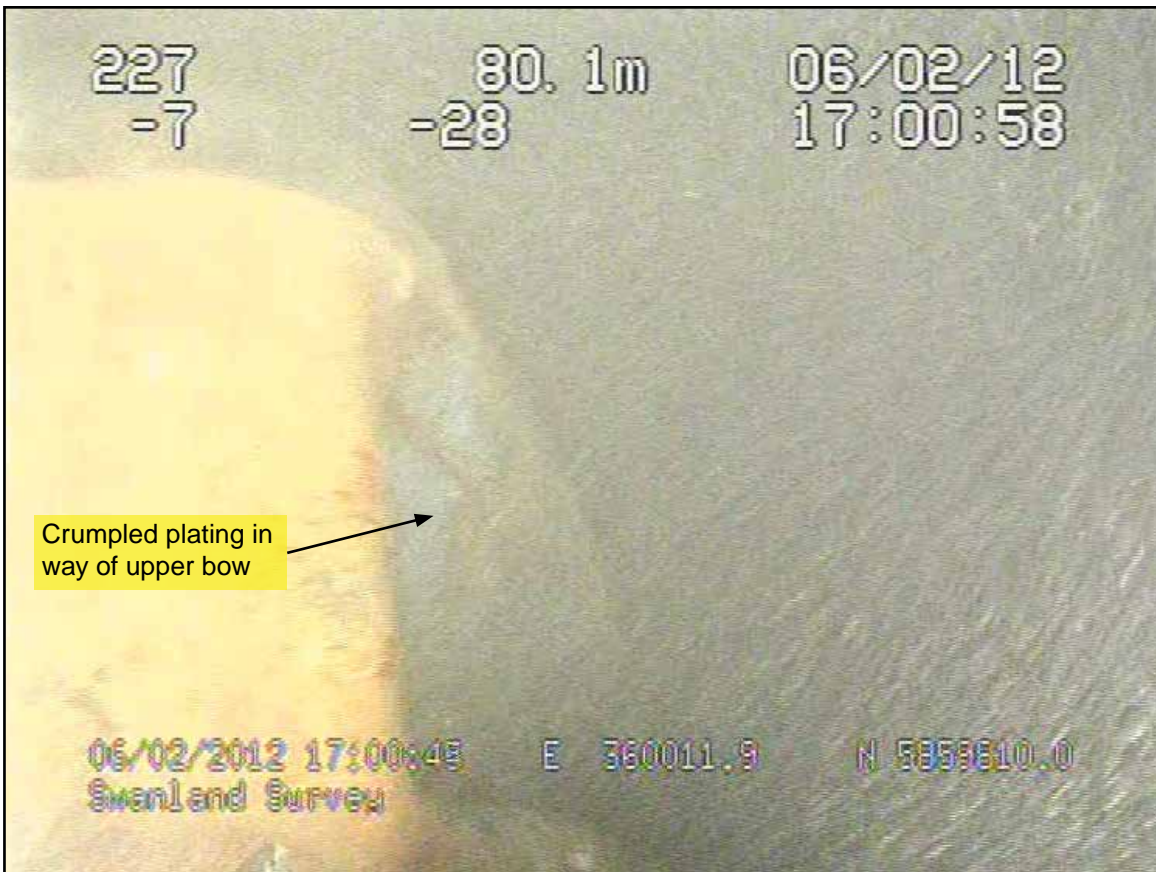
**Figures 30a and 30b:** Stills from ROV footage showing crumpling of the top of the stem and bulwarks

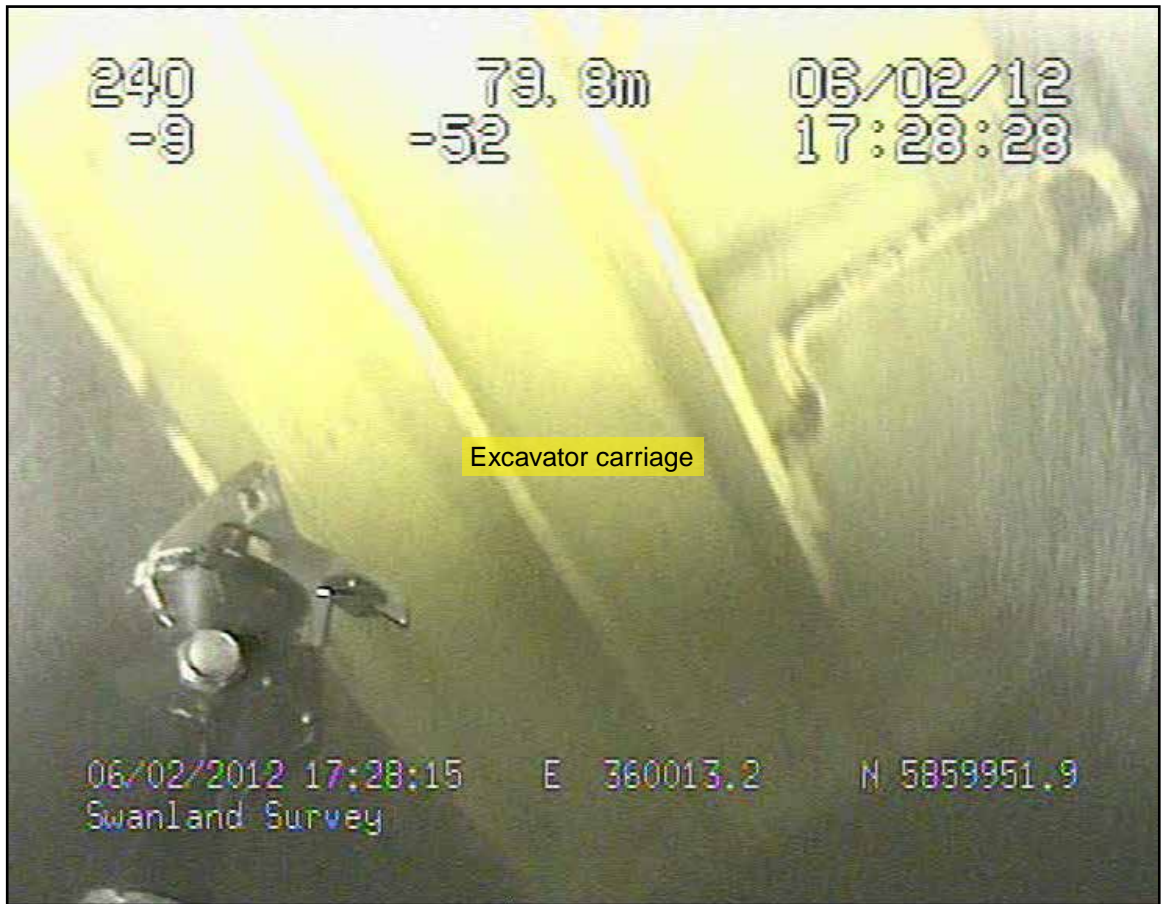
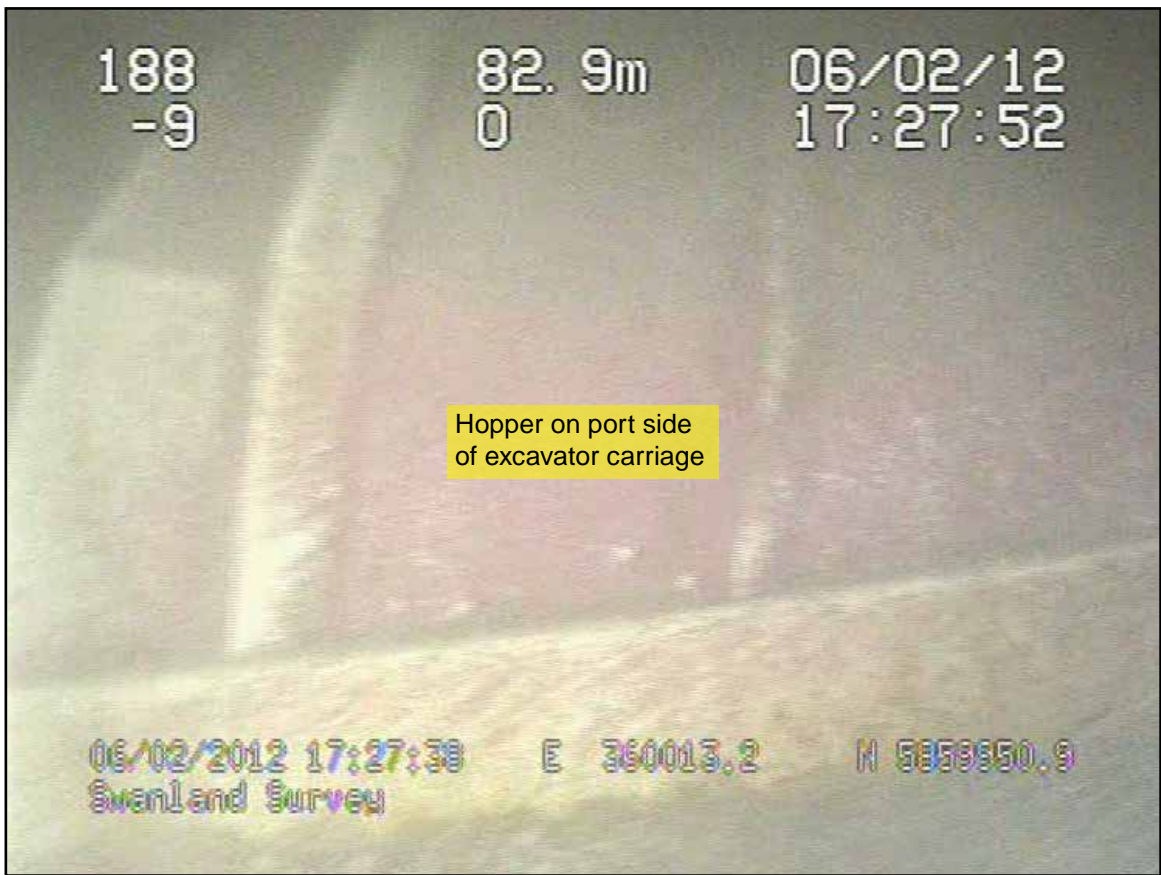
The ROV was also used to survey the debris to the north of the main wreck on the seabed. This appeared to be the remains of the excavator carriage, resting on the seabed beneath a pile of the limestone cargo (**Figures 31a and 31b**).

**Figures 31a and 31b:** Stills from ROV footage showing remains of excavator carriage beneath a pile of limestone

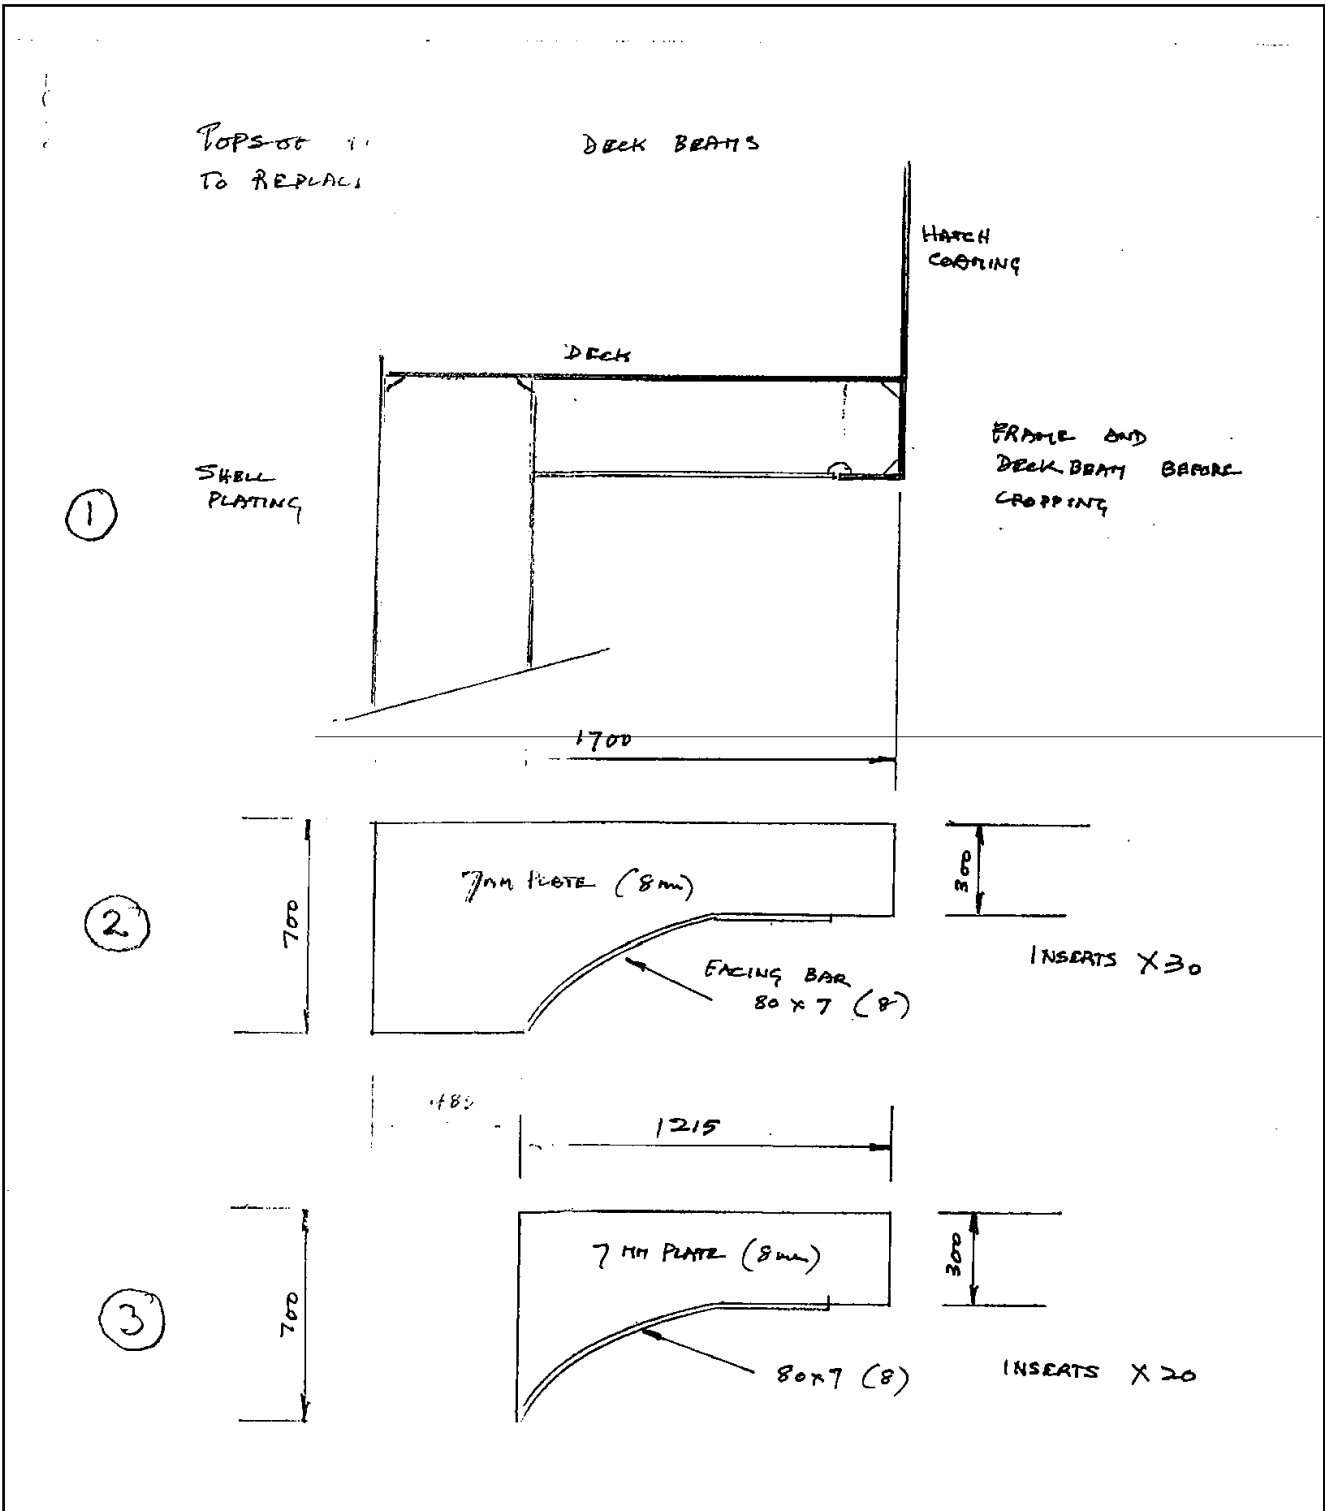
Figure 38: Contemporaneous sketch of modifications to cargo hold deck beams carried out in 2003

As part of its analysis (**Annex D**), Braemar commented that the addition of the self-discharging equipment would have had an overall beneficial effect on the structural capacity of *Swanland*, given the alterations to the transverse frames. However, Braemar also noted that the installation of the rails either side of the hatch coamings would have created a water 'trap' area where corrosion would have been more likely to develop, as shown at **Figures 39a** and **39b**.

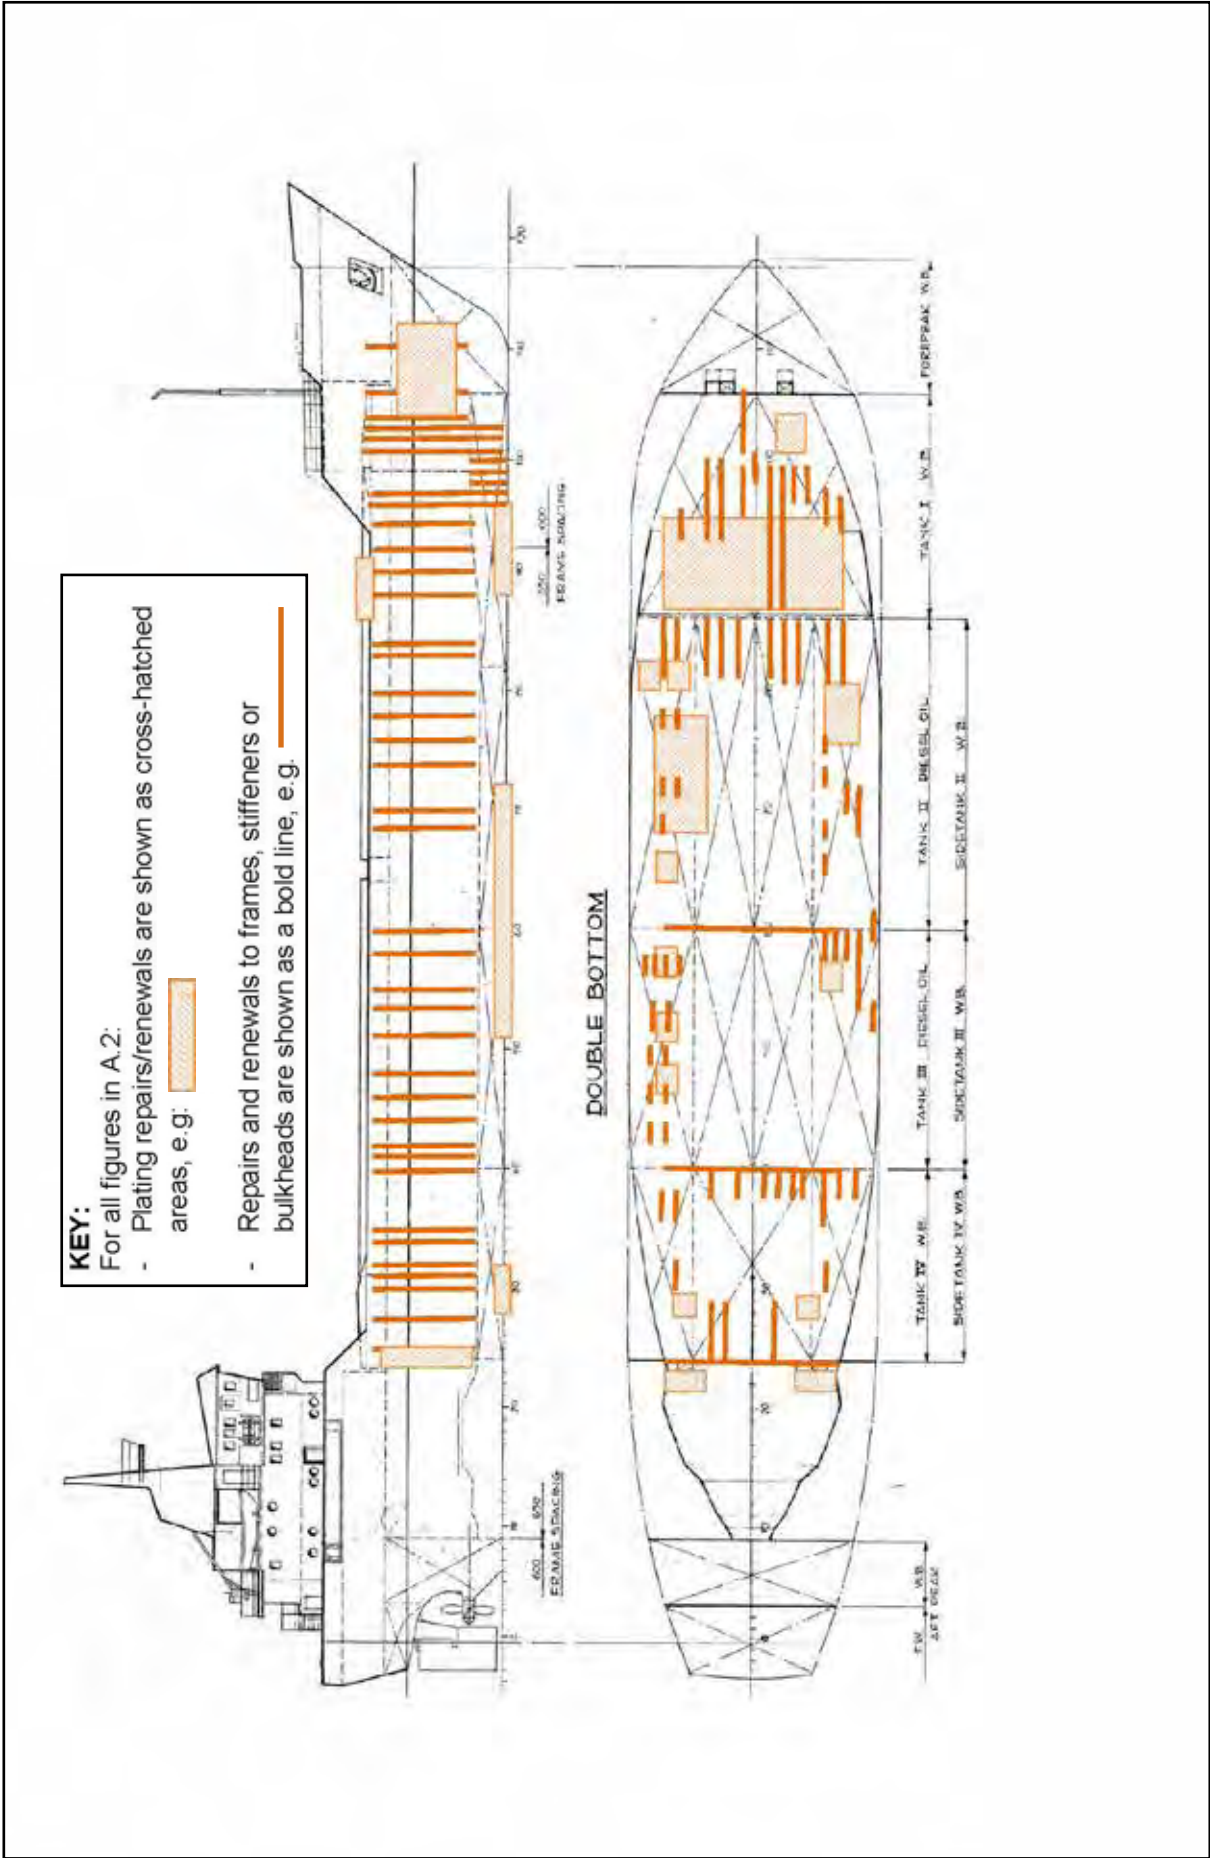
**Figure 41:** Summary diagram showing extent of repairs in Liepaja in 2006

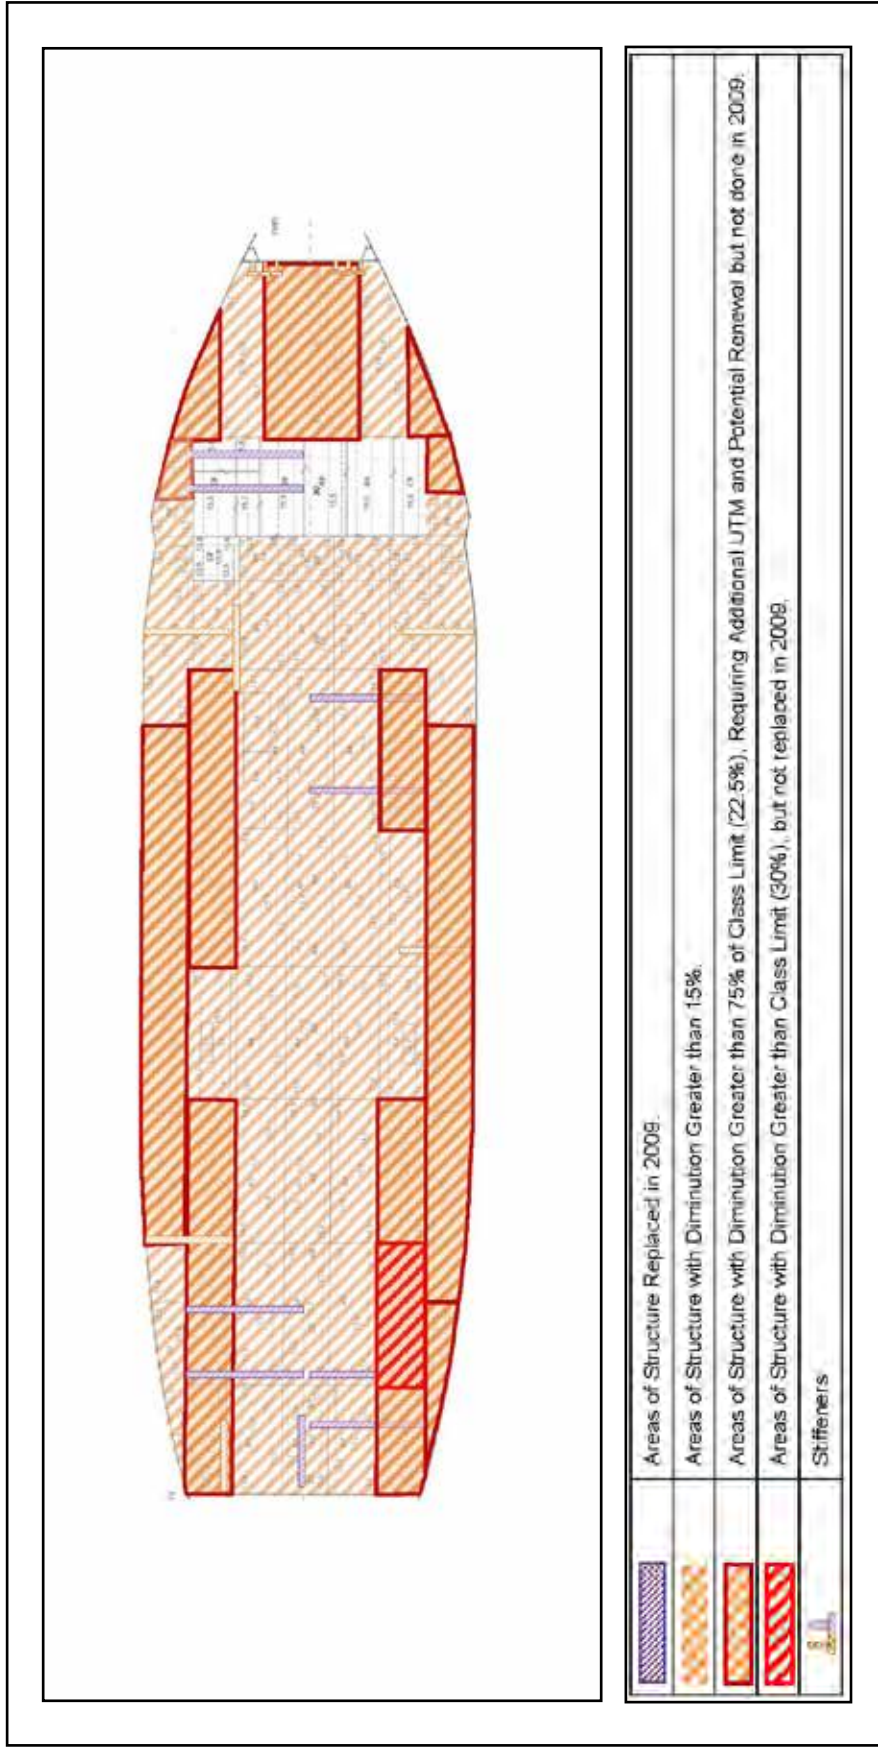
**Figure 42:** Summary diagram showing tank top plating renewed during 2009 intermediate survey and areas of diminution greater than 15%

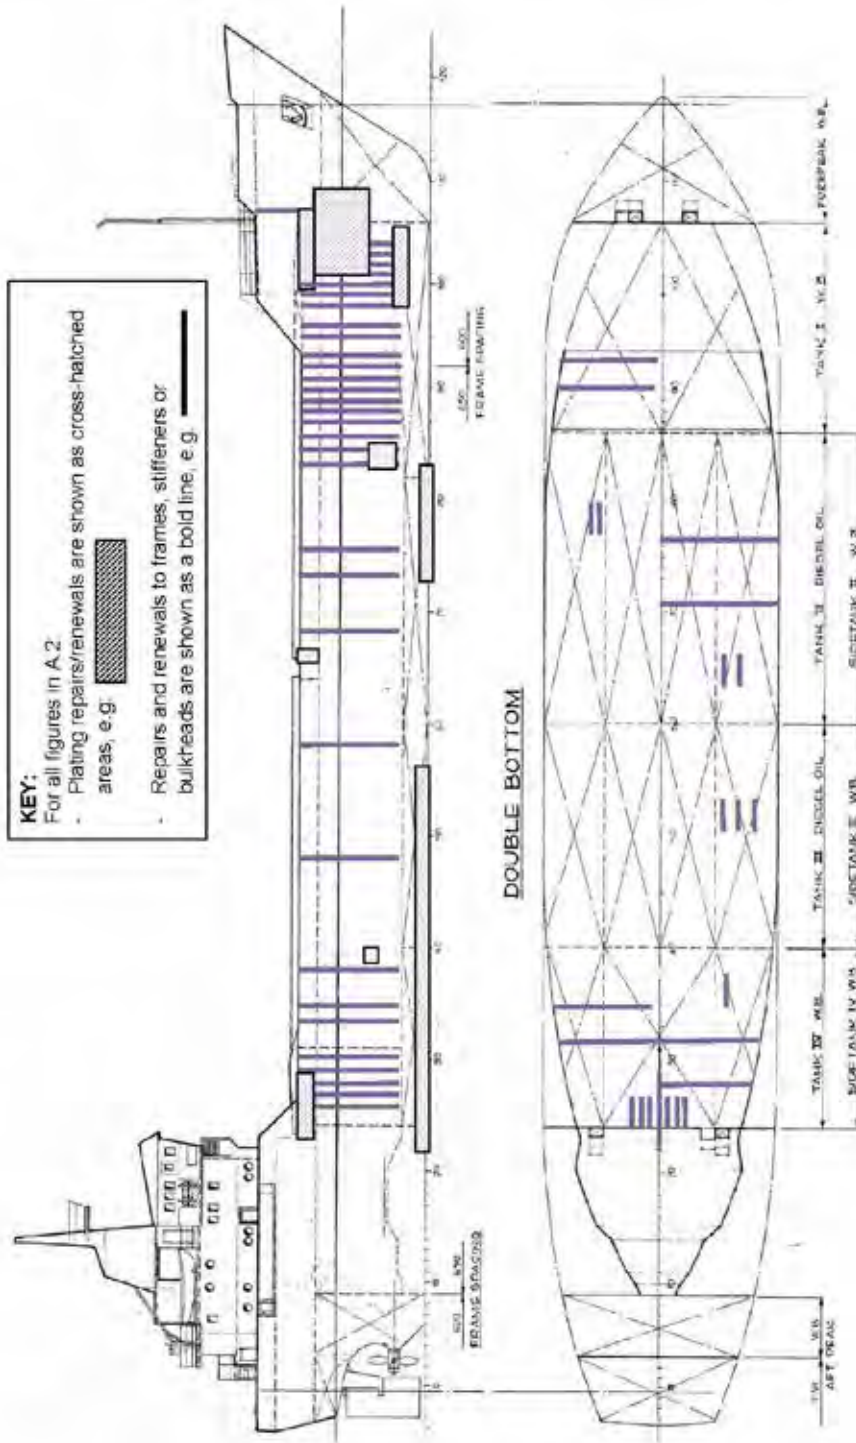
**Figure 43** shows the repair work underway, while **Figure 44** (taken from **Annex D**) illustrates the extensive nature of the repairs undertaken, which included bottom plating, main deck plating, double bottom structure and a large number of frames in the hold. **Table 4** confirms that the repairs cost about £149,000.

Figure 43: Repair work underway in Kaliningrad in 2009

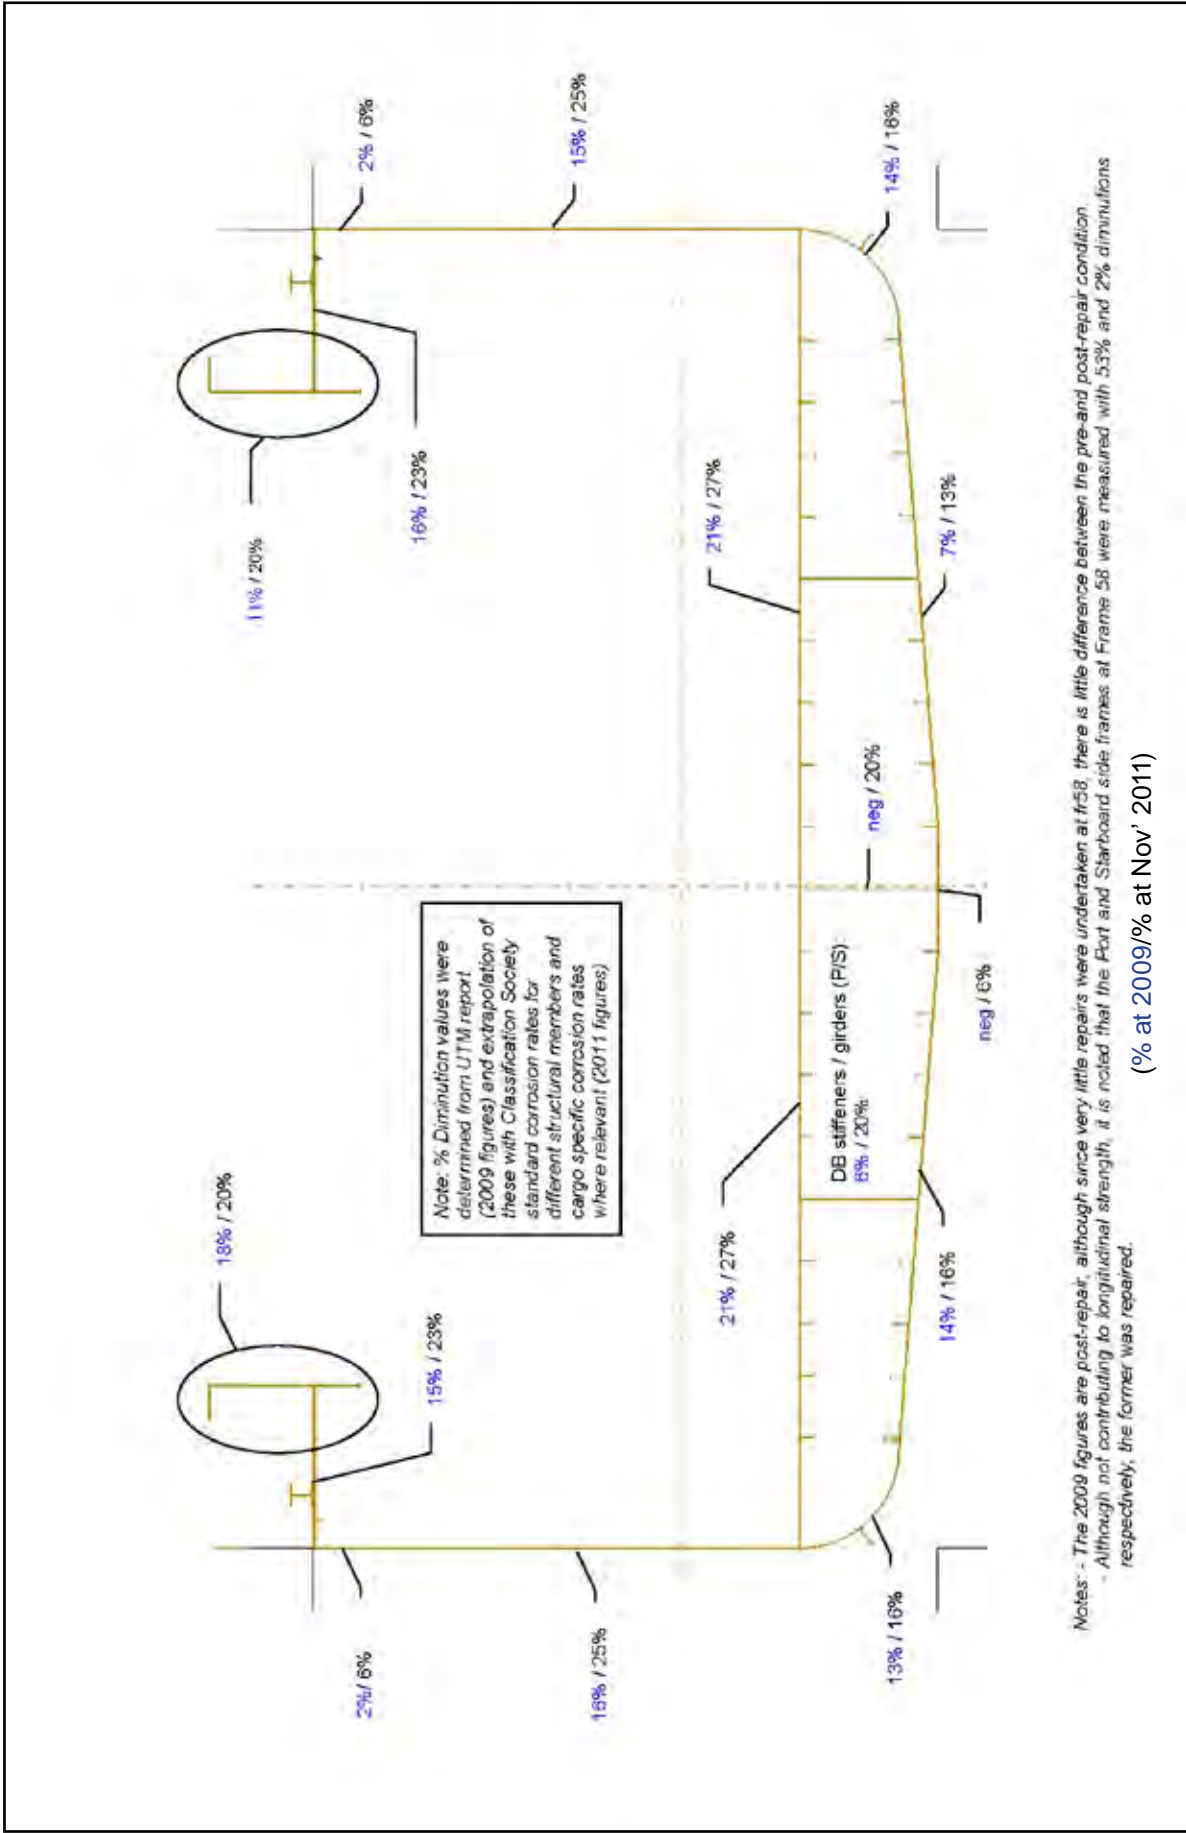
**Figure 45** (taken from **Annex D**) shows the percentage diminution values in May 2009 and as estimated in November 2011 for the various structural elements contributing to the longitudinal strength at *Swanland*'s midships section at Frame 58. This confirms that by the time of the accident, the amount of diminution in significant elements of the structure might have been approaching the 30% limit in the INSB rules that should have triggered their renewal.

**Figure 45:** Comparison of Swanland's midship section diminution values in May 2009 and in November 2011 (as estimated by Braemar based on assumed corrosion rates)
