Report on the investigation into  
the structural failure and foundering  
of the general cargo ship

***Swanland***

Irish Sea

27 November 2011

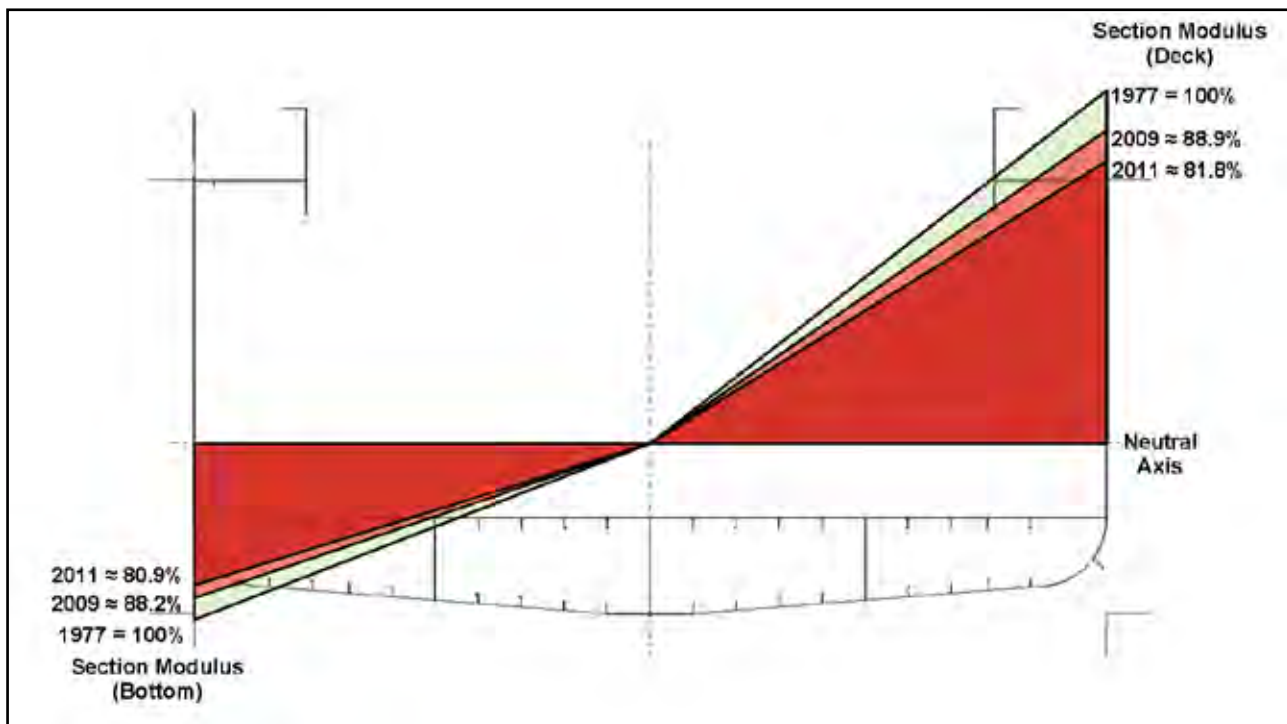
**Figure 46** shows that even following the repairs conducted as part of the 2009 intermediate survey, the deck section modulus had reduced by approximately 11% from its original 'as-built' value. Applying the assumed corrosion rates, Braemar estimated that the section modulus would have been further reduced by about 18% of its original 'as-built' value by November 2011.

Braemar concluded that by the time of the accident, significant areas of *Swanland's* structure contributing to her longitudinal strength would have been significantly weakened due to corrosion and damage. At the time of the accident, the reduction in the thickness of some of these elements would also likely have been close to the INSB diminution limits.

**Figure 46:** Comparison of calculated *Swanland's* midships section modulus using scantlings: as-built; in May 2009; and in November 2011 (as estimated by Braemar based on assumed corrosion rates)

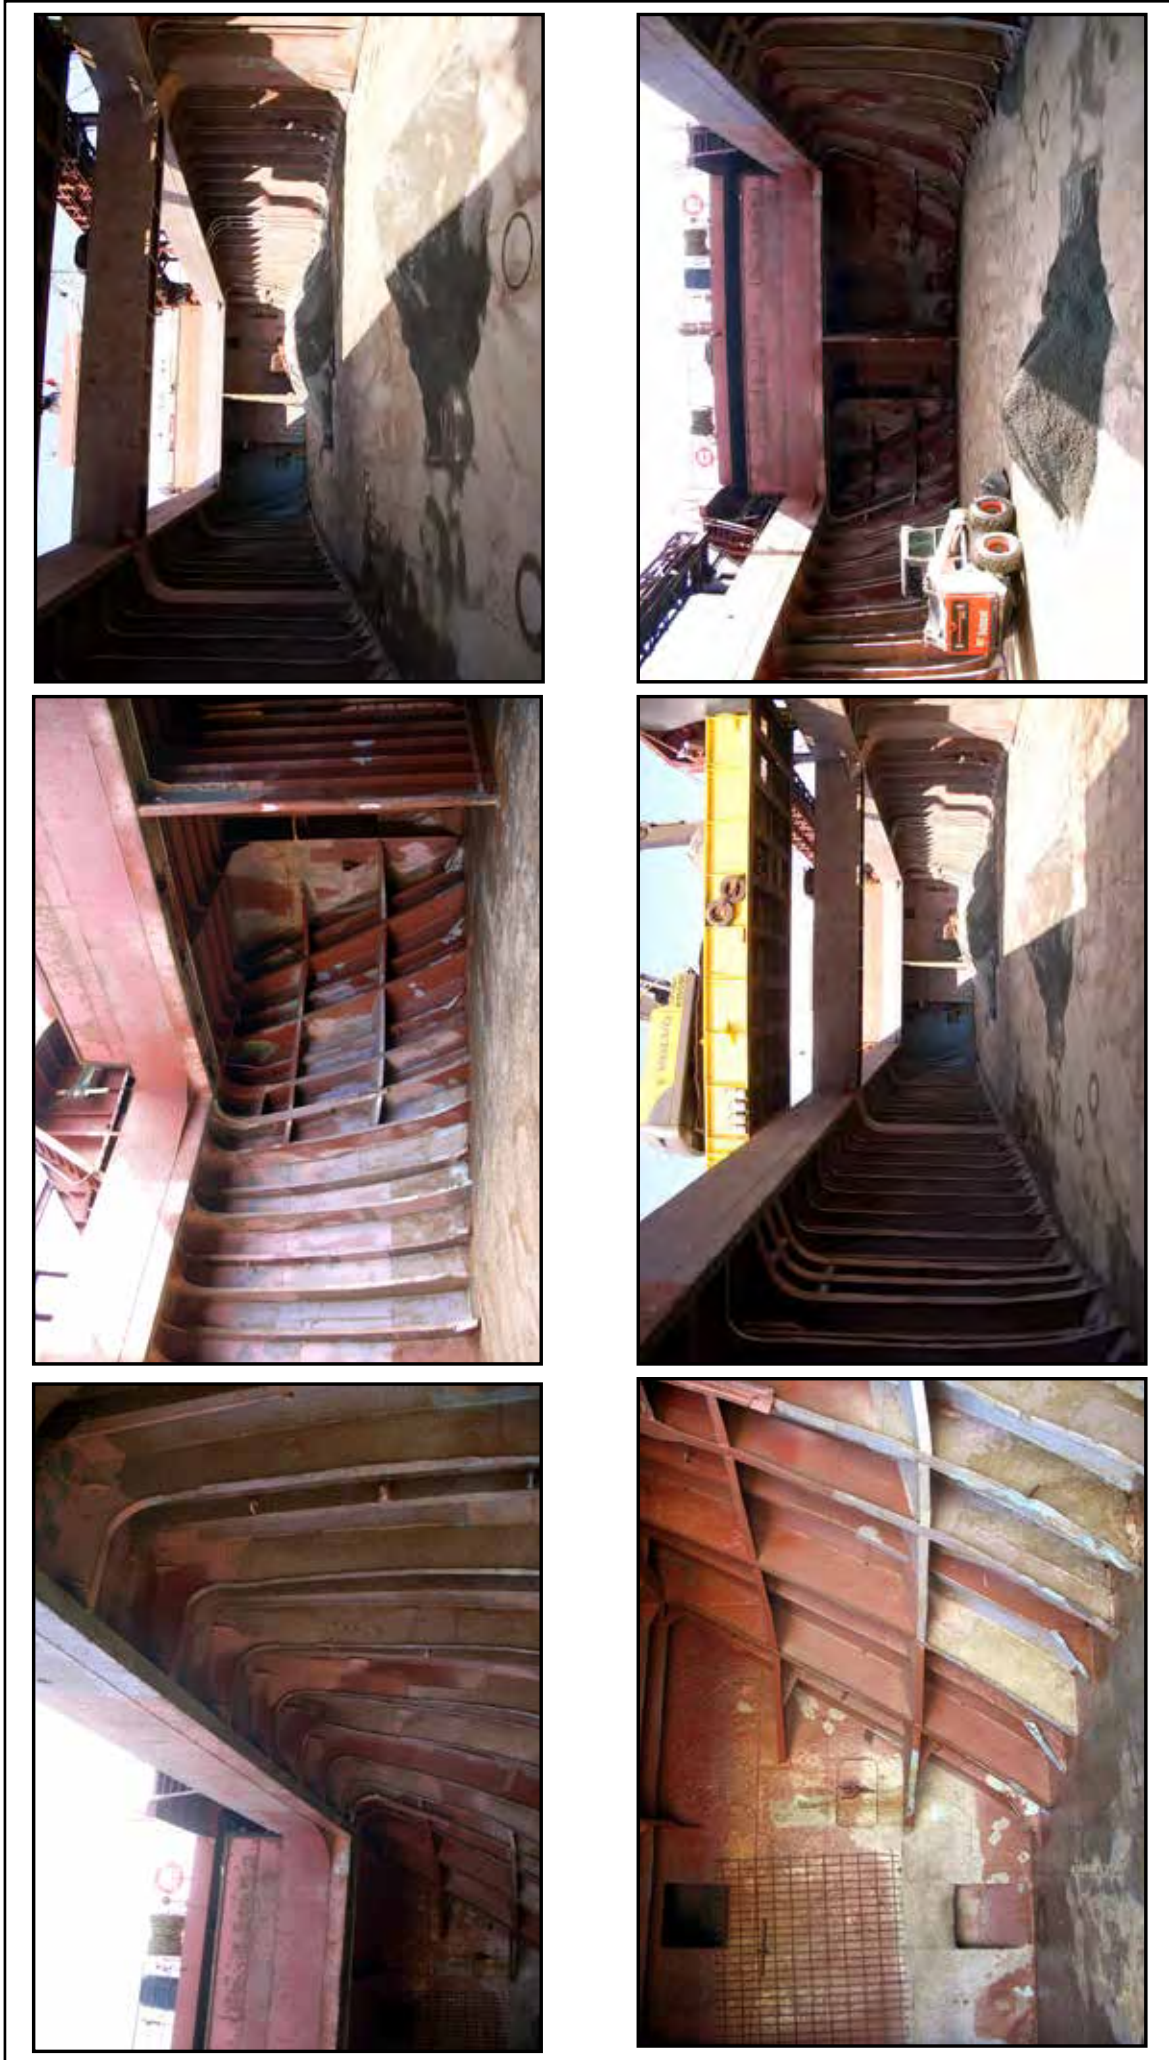
In July 2011 *Swanland's* cargo hold was cleaned using an industrial ultra high pressure water jet machine. The hold was then painted. The work was undertaken by the crew while alongside in Ipswich, UK. Photographs of the hold taken in September 2011 are shown in **Figures 47a, b, c, d, e and f**.

Figure 47: Photographs of Swanland's hold in September 2011

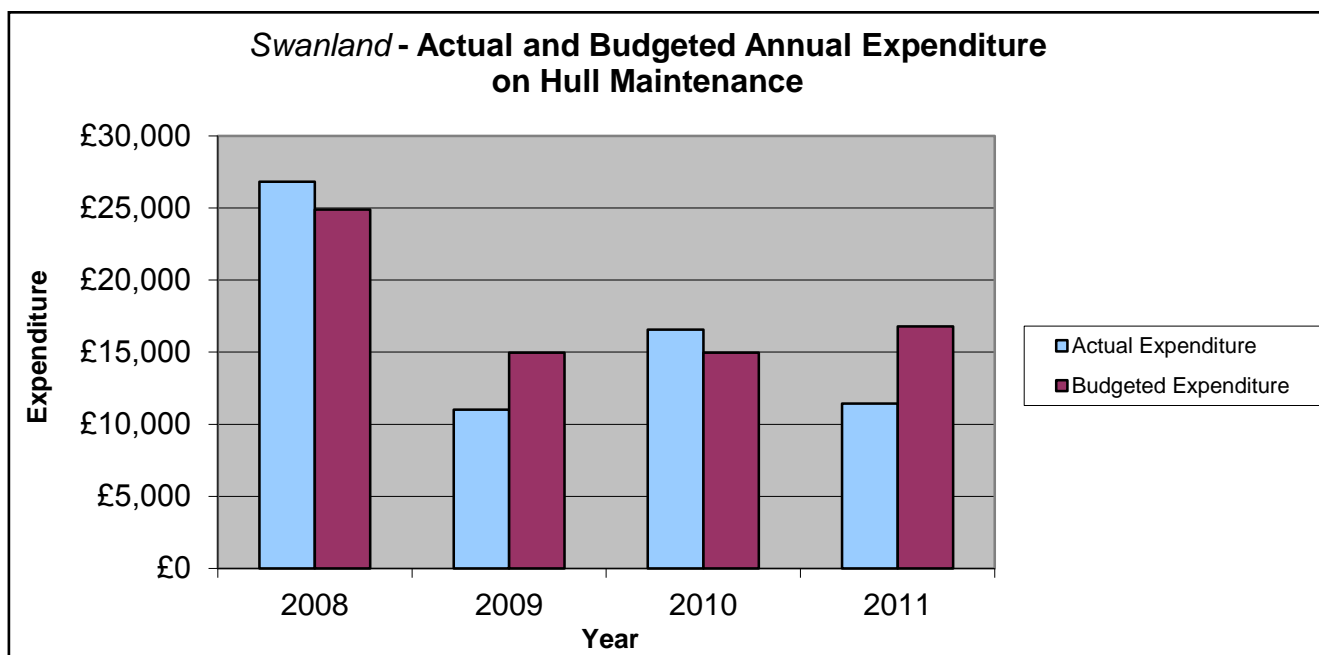
**Figure 48** shows that both the actual and budgeted annual expenditure on "hull maintenance" reduced after 2008.

**Figure 48:** Actual and budgeted Annual Expenditure on *Swanland's* Hull maintenance, 2008 - 2011

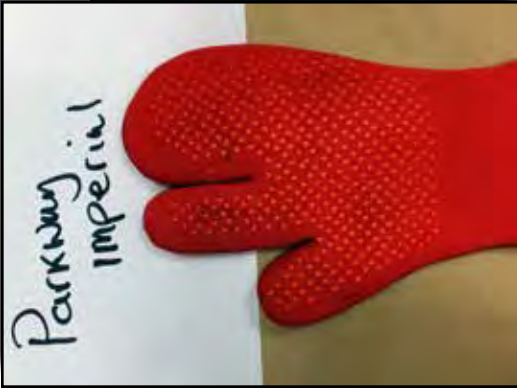
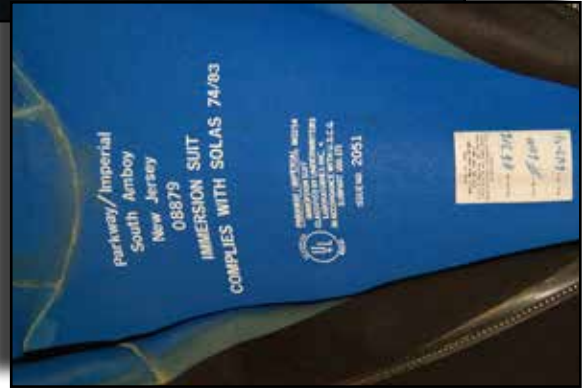
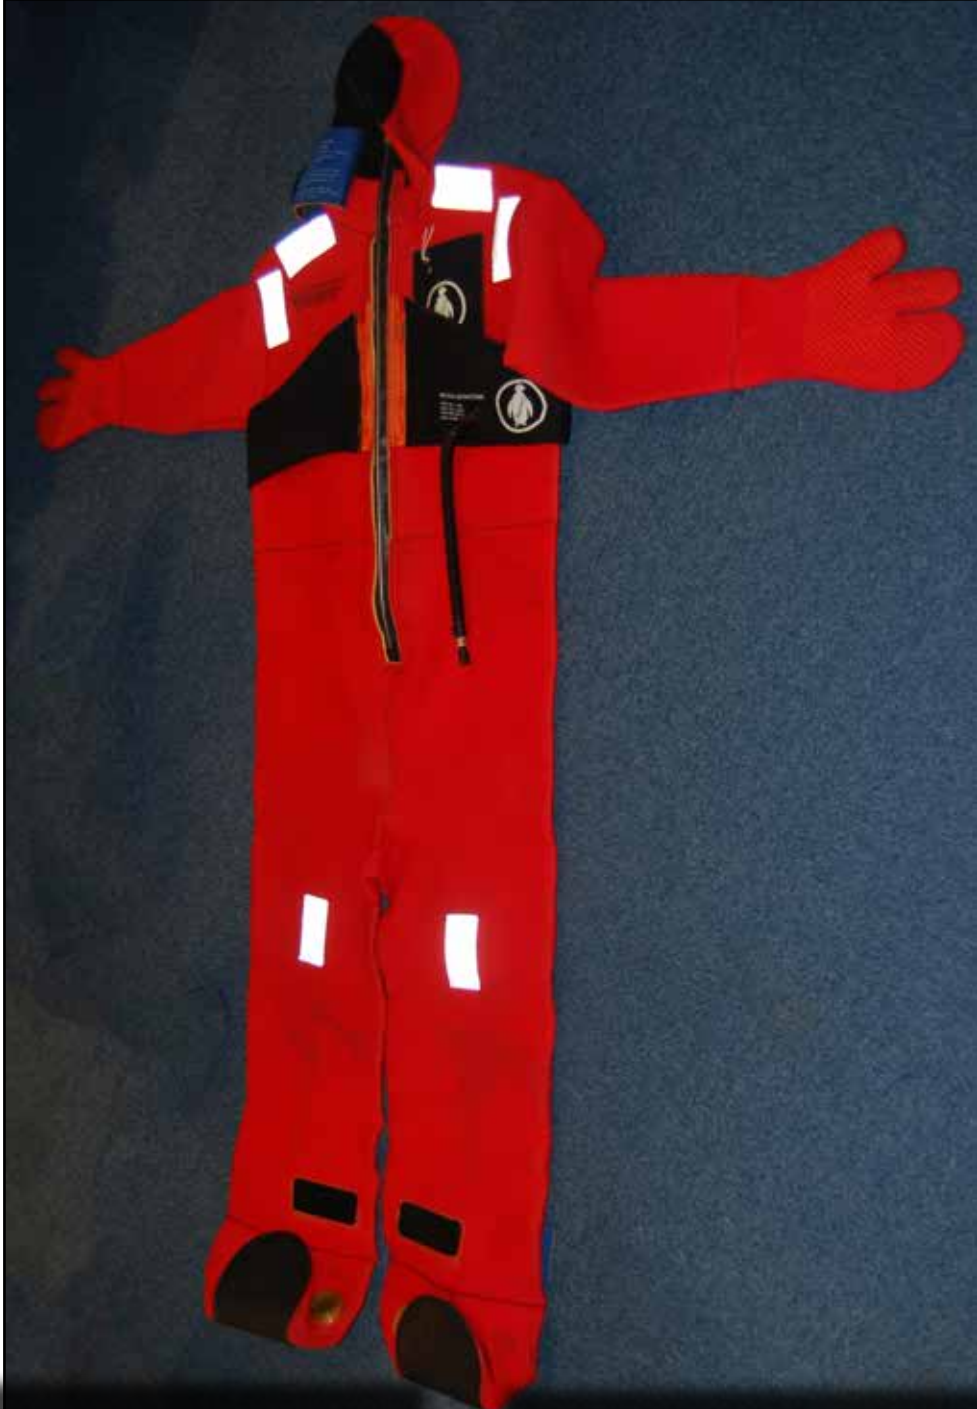
The immersion suits worn by the second officer and the AB were Parkway Imperial MQ254 (**Figure 56**) (serial numbers 118716 and 118781 with a manufactured date of 27.6.91). Details embossed on the fabric indicate that the suit was approved by the United States Coastguard (USCG) and met the requirements of SOLAS 74/83. The immersion suits were fitted with rings that were inflated by the wearer in order to provide sufficient buoyancy to keep the wearer afloat without the assistance of a lifejacket. The glove design fitted to the Parkway Imperial MQ254 is shown at **Figure 56**.

Figure 56: Parkway Imperial immersion suit used by survivors, showing label and glove design

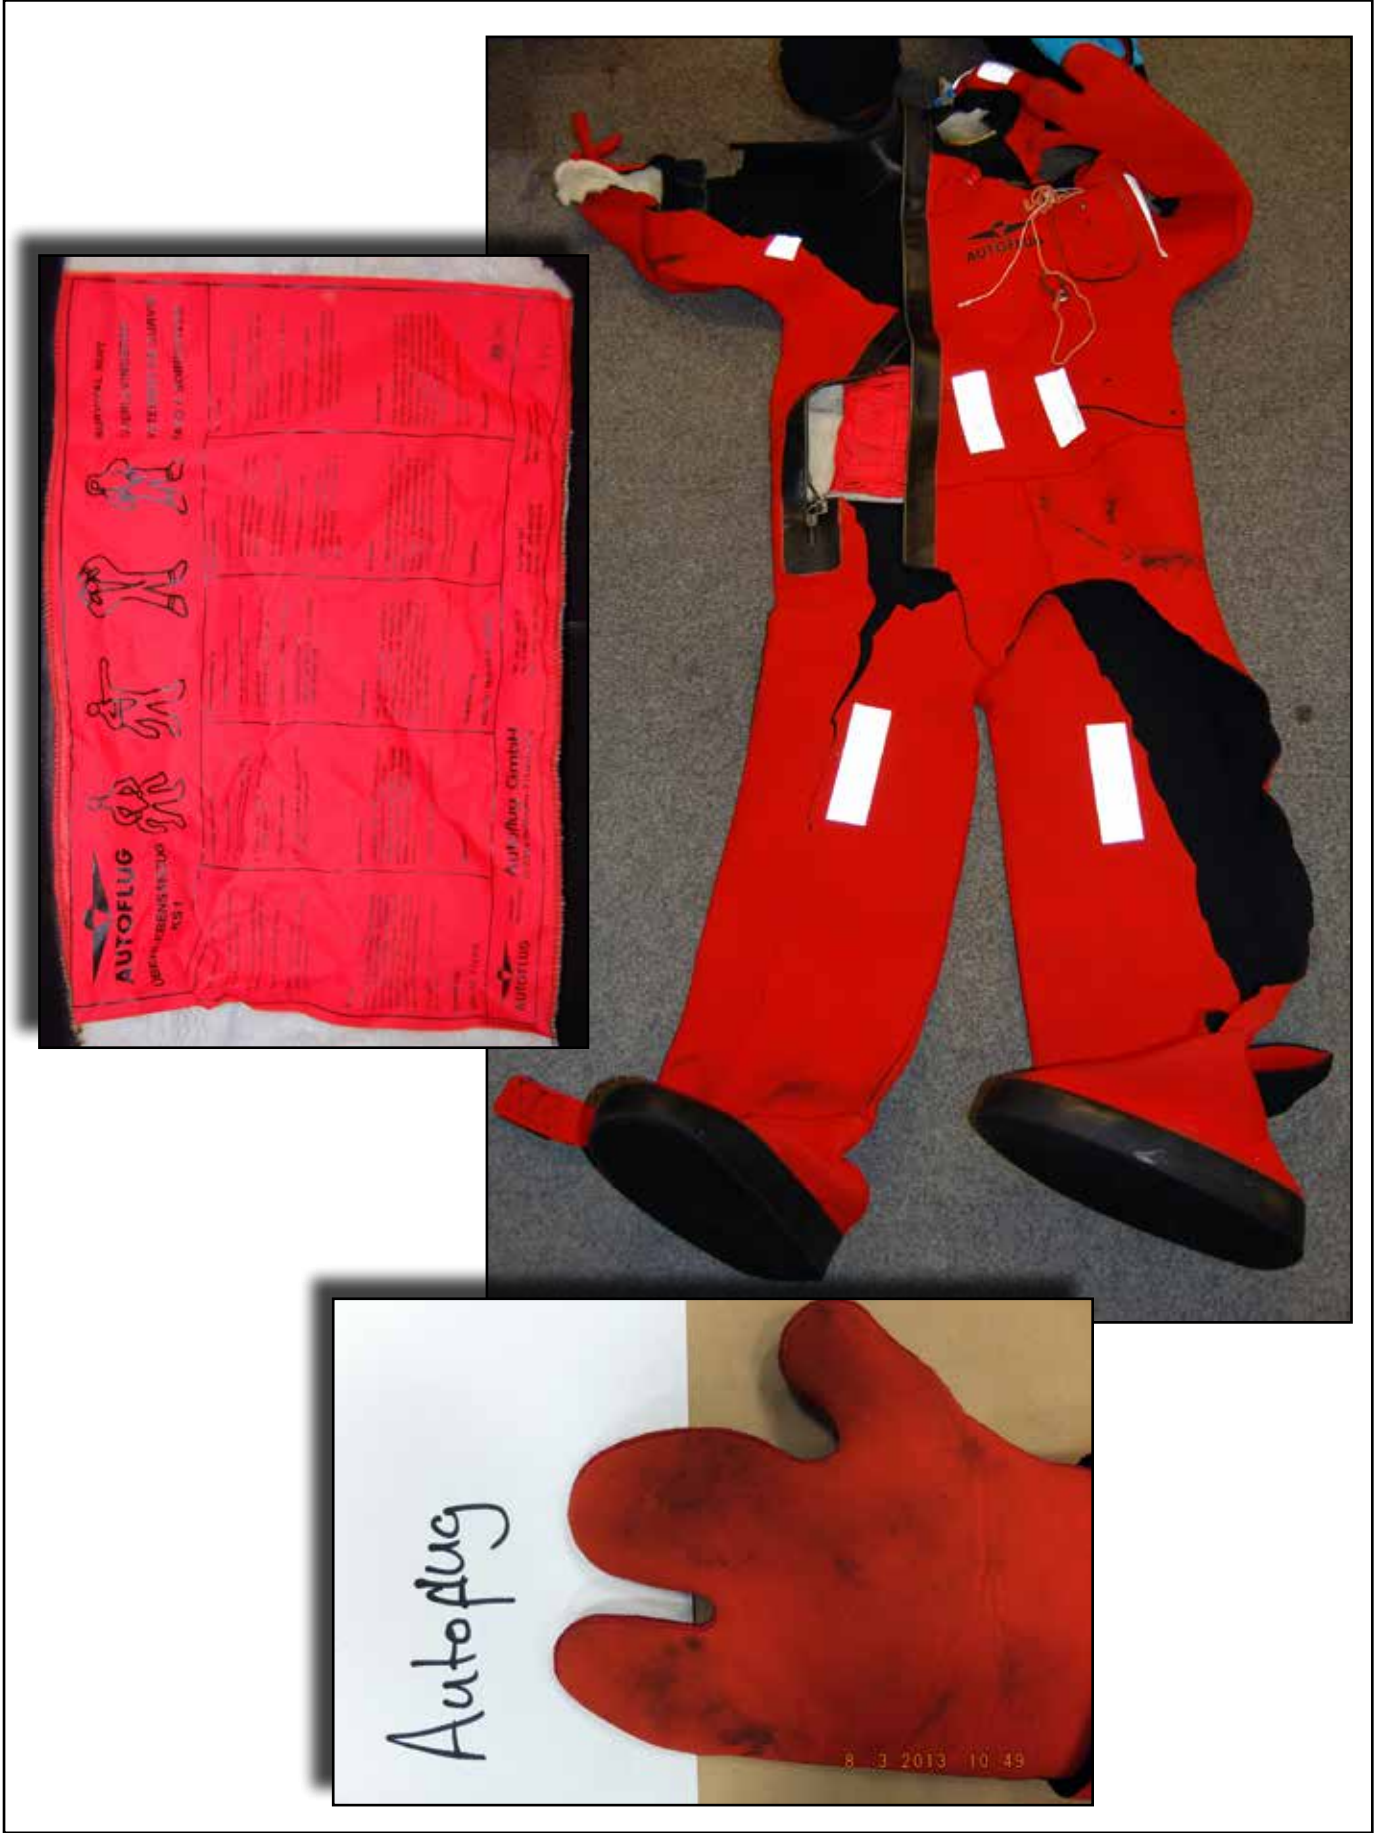
The immersion suit worn by the chief officer was an Autoflug KS1 (**Figure 57**), which was originally manufactured for use within the aviation industry. The label inside the suit indicated that the suit was approved in 1988. The suit was not designed to provide sufficient buoyancy to keep the wearer afloat and therefore needed to be used with a lifejacket. The glove design fitted to the Autoflug KS1 is shown at **Figure 57**.

Figure 57: Autoflug K1 immersion suit worn by chief officer, showing label and glove design

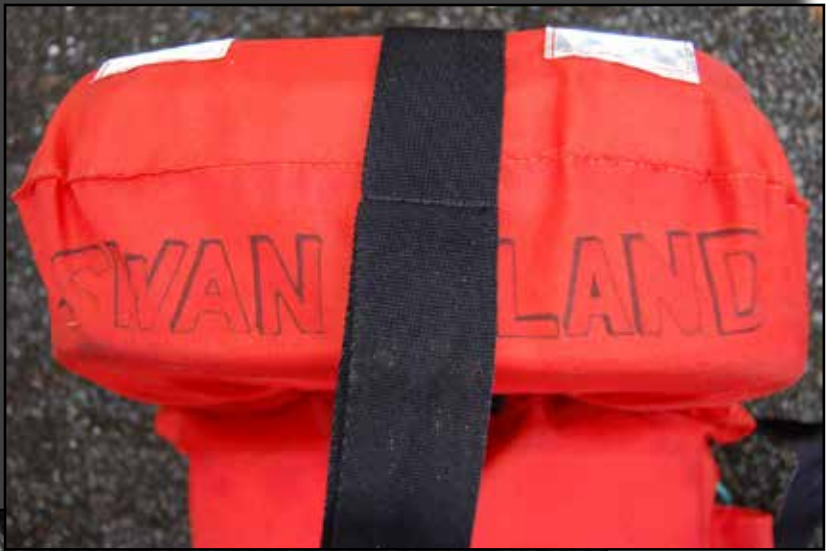
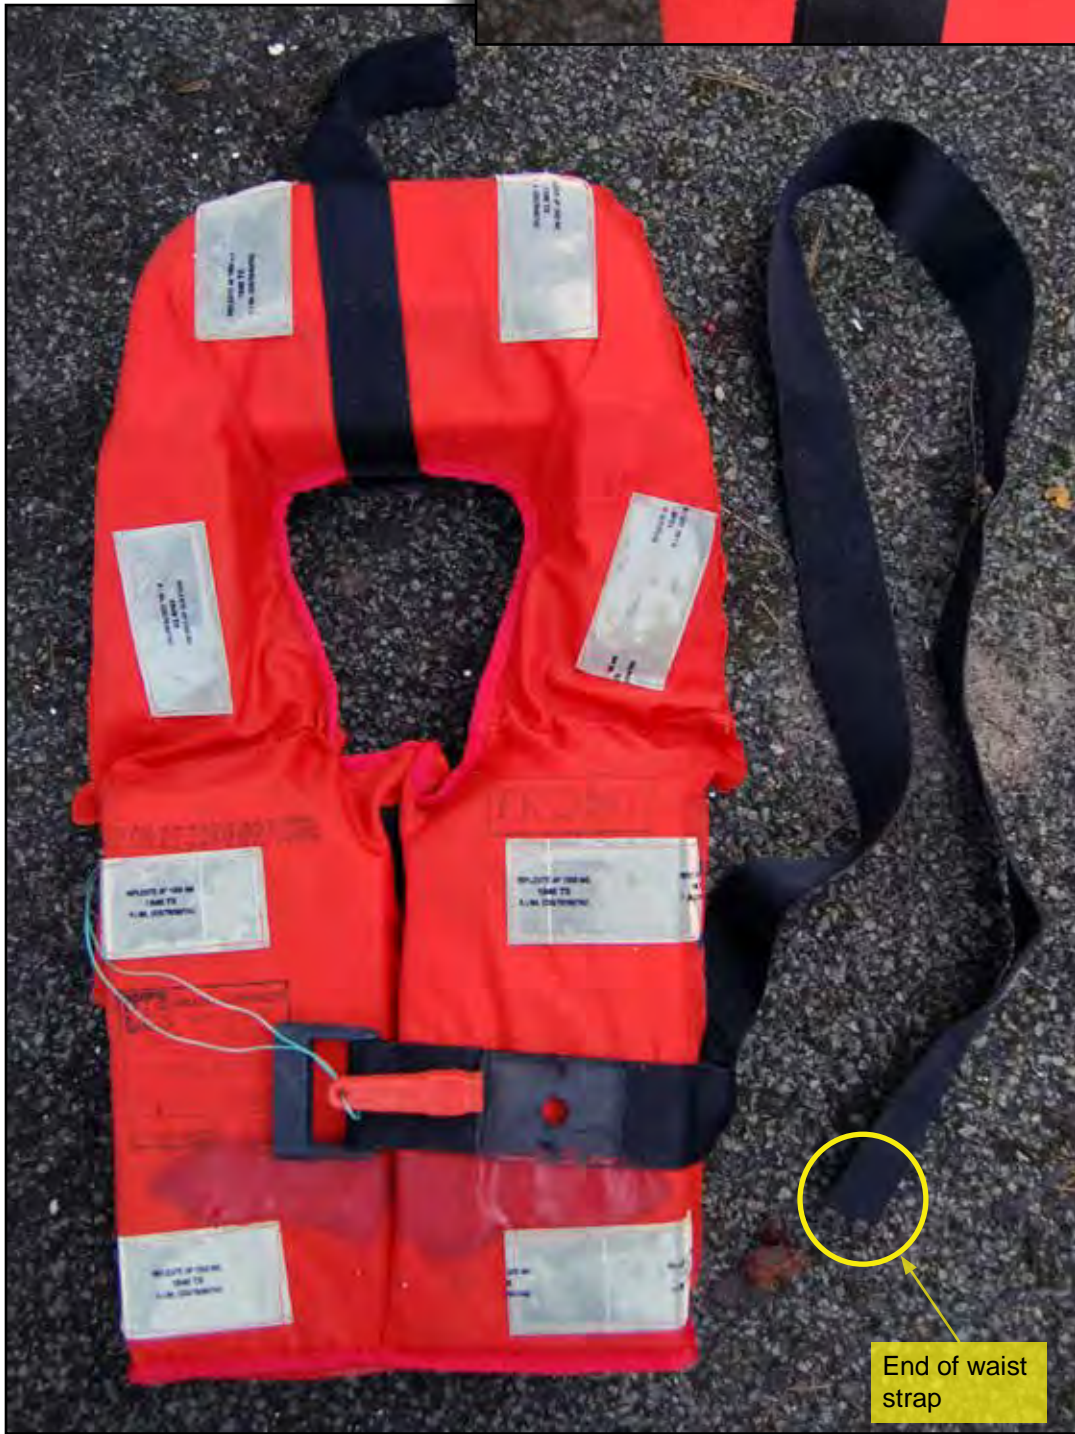
During the search for *Swanland's* missing crewmen between 27 and 28 November 2011, one of the vessel's lifejackets was washed up onto a beach in Hell's Mouth (Item 13 on **Figure 10**) and was recovered. Two other lifejackets were also sighted at sea, but these were some distance from other flotsam and were not confirmed to be from *Swanland*. The recovered lifejacket (**Figure 58**) was an Aquavel Mk2/UK which was stamped to indicate that it was approved by the Department of Transport and was manufactured in 1996. The lifejacket was intended to be secured onto a person with a webbing belt fitted with a male/female buckle arrangement. The male bayonet attachment was missing from the webbing belt and there was no evidence that the end of the webbing belt had been stitched to prevent the male bayonet from detaching (**Figure 58**).

**Figure 58:** Aquavel Mk2/UK lifejacket recovered during search and rescue (item 13 on **Figure 10**)

In view of the fact that the male bayonet attachment was missing from the only lifejacket from *Swanland* to be recovered, a serviceable Aquavel Mk2/UK was obtained from Torbulk. Unlike the recovered lifejacket (**Figure 58**), the serviceable lifejacket had a male bayonet fitted to the webbing strap.

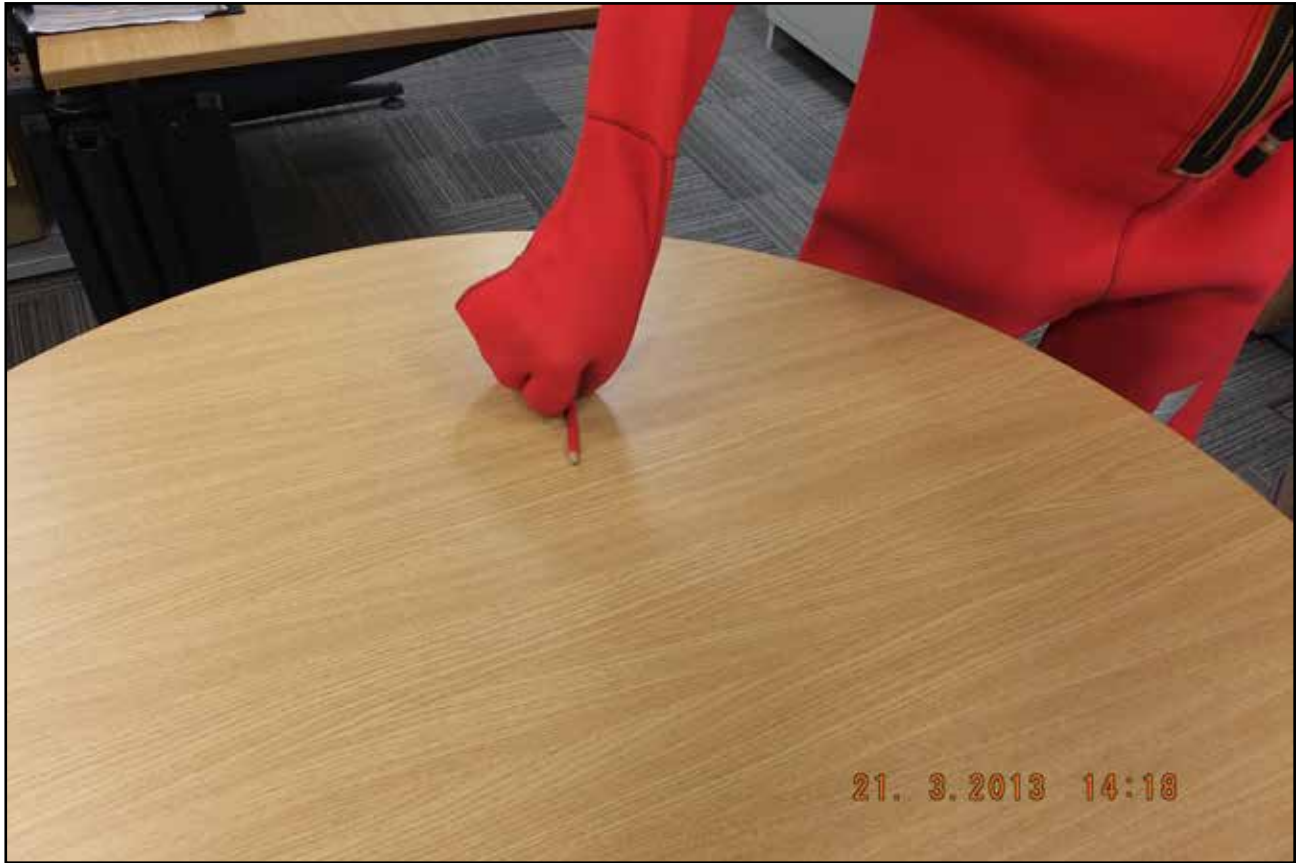
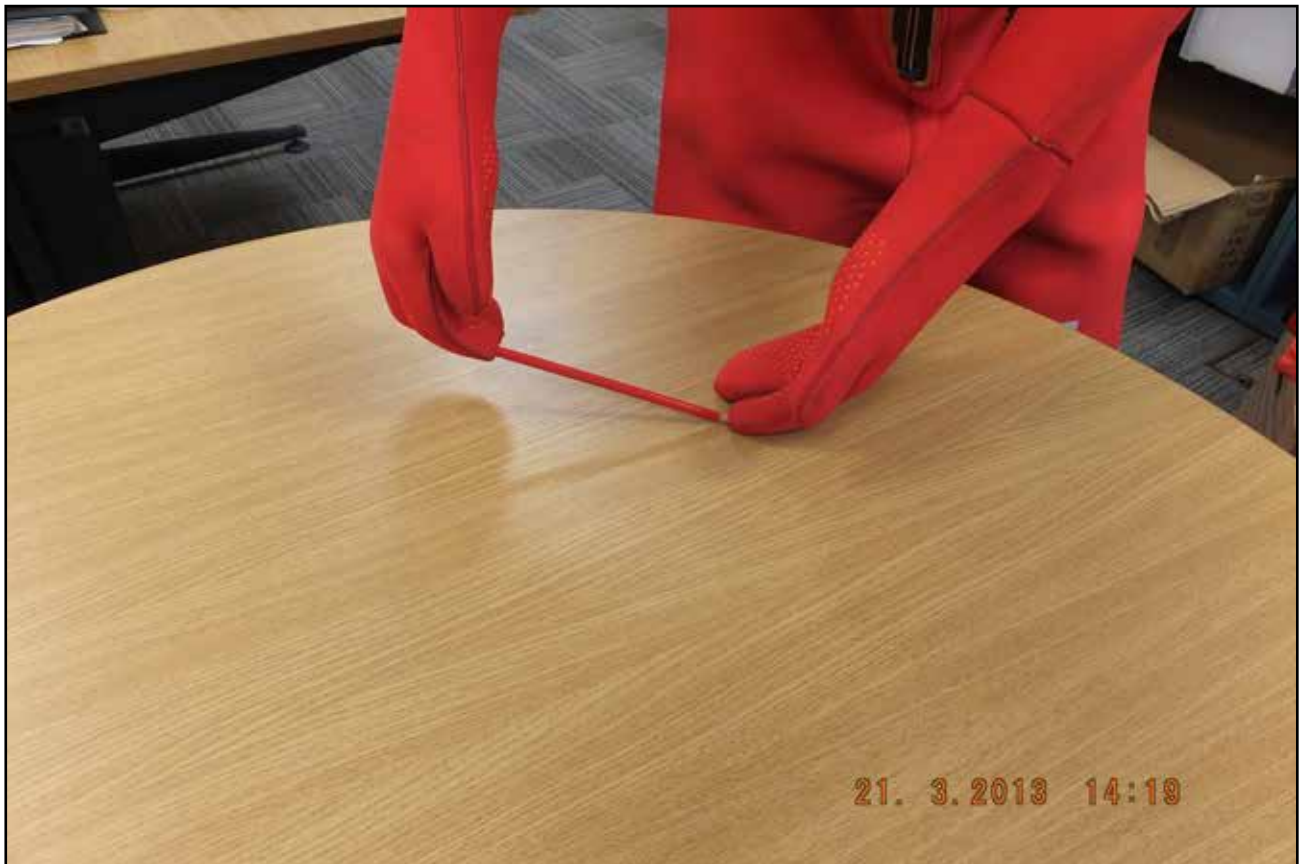
In order to assess the dexterity afforded by the Parkway Imperial MQ254 and the Autoflug KS1 immersion suits, the MAIB conducted practical trials (**Figure 59a** and **59b**) in accordance with the requirements of both MSC 81(70) and ISO 15027-2:2012. During the trials, the wearer experienced no difficulty with either of the suits when picking up and securing an 8mm rope around his waist with a double overhand knot. However, he could only pick up an 8mm pencil from a flat surface by using two hands. Although this task became less difficult when a larger diameter pencil was used, two hands were still generally required. Once the pencil had been lifted from the flat surface, the wearer had no difficulty in writing his name.

**Figures 59a and 59b:** Dexterity trial conducted by MAIB using Parkway Imperial immersion suit

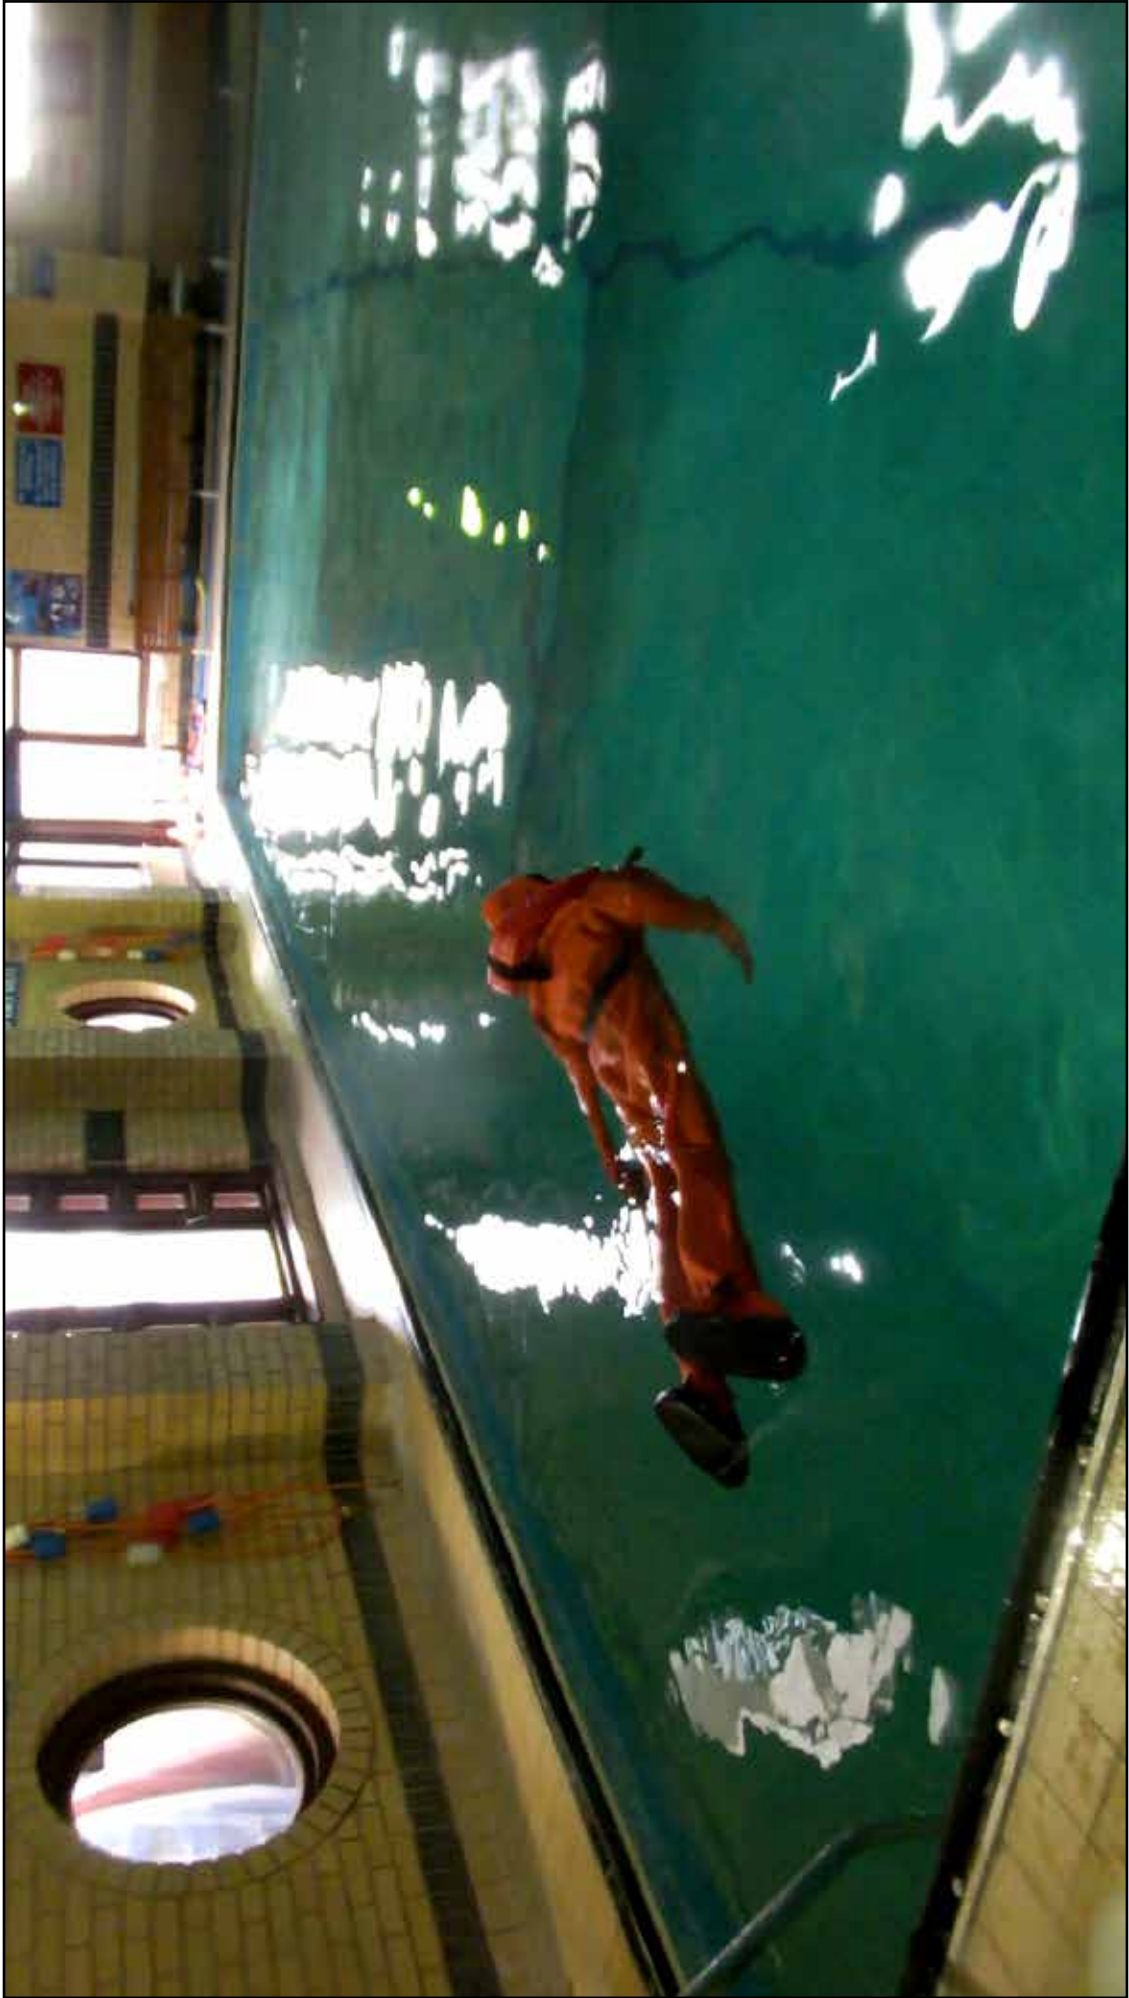
During the trials, the subject wearing the Autoflug KS1 immersion suit was able to don and secure the Aquavel Mk2/UK without difficulty. After swimming 3 strokes forward (breast stroke), the subject remained 'face-down' in the water (**Figure 60**). The immersion suit and the lifejacket did not produce any self-righting moment in this respect. However, with effort, the subject was able to turn from a 'face-down' position in the water to a 'face-up position' within 5 seconds. Once in a 'face-up' position, the subject's mouth was kept clear of the water by 135mm. The lifejacket remained in position and did not harm the subject.

**Figure 60:** Immersion suit/lifejacket compatibility trial using Autoflug KS1 immersion suit and Aquavel Mk2//UK lifejacket

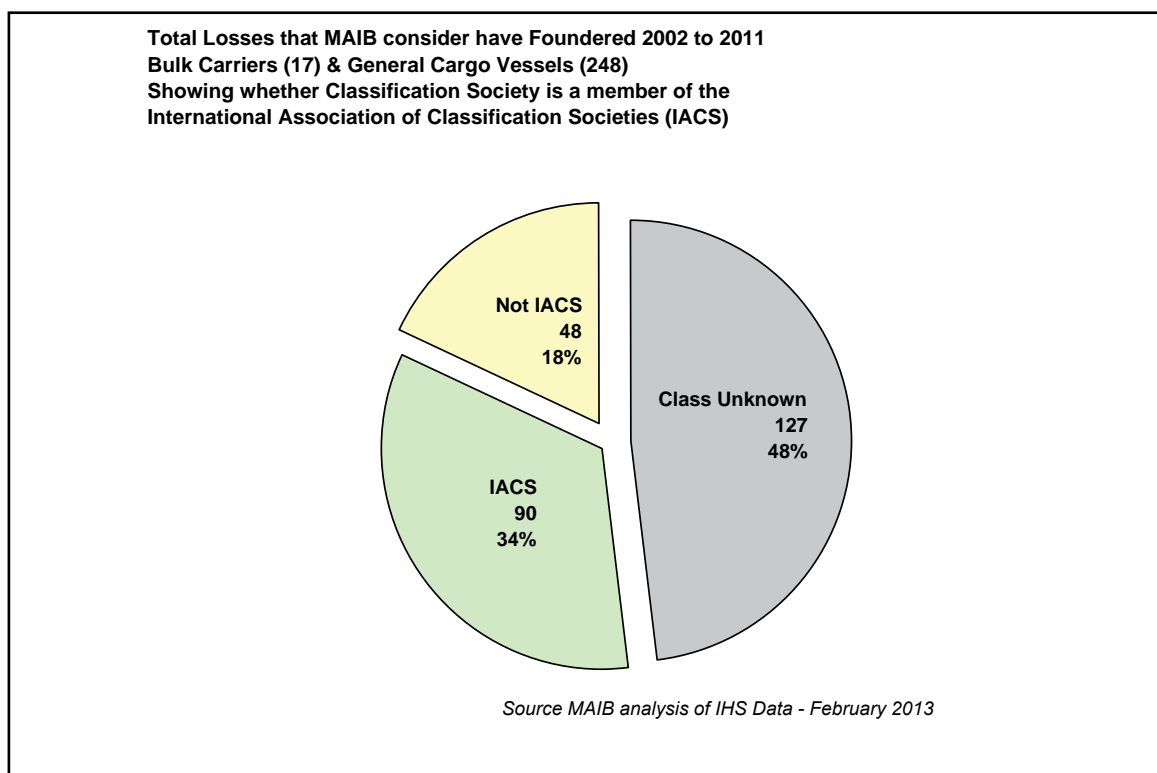
- Of the 248 general cargo ships and 17 bulk carriers considered to have foundered, the class of 127 vessels (48%) is unknown, 90 (34%) are entered in class with IACS societies and 48 (18%) were entered in class with non-IACS societies (**Figure 65**).

**Figure 65:** Selected total global losses of general cargo ships and bulk carriers between 2002 to 2011 showing classification status for vessels

**Figure 65** shows that a significant number of the 248 foundered vessels were not entered in class with IACS members. Many were also over 25 years old. Therefore, the vessel parameters used in the IACS FSA conducted between 2007 and 2008 (classed with IACS member and not more than 25 years old) did not accurately represent the full scope of the problem. As a result, the FSA's conclusion that the risk associated with the operation of general cargo ships was 'tolerable' was potentially over-optimistic.

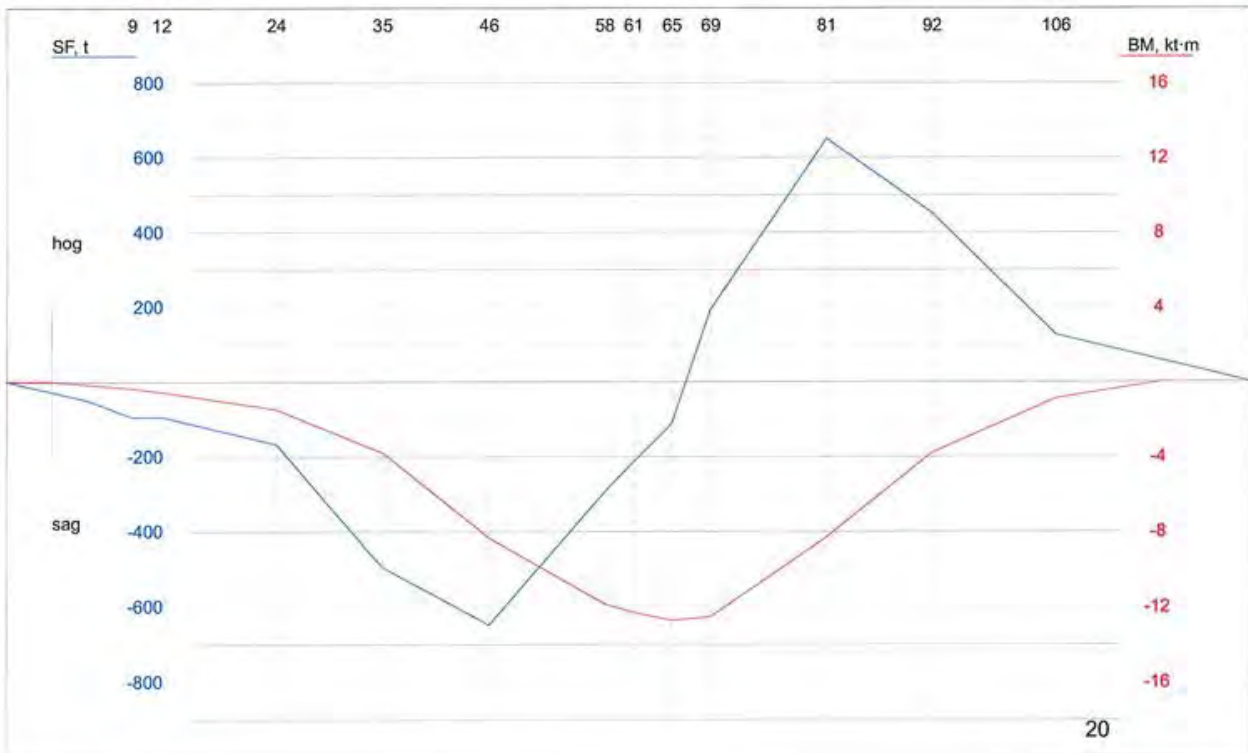
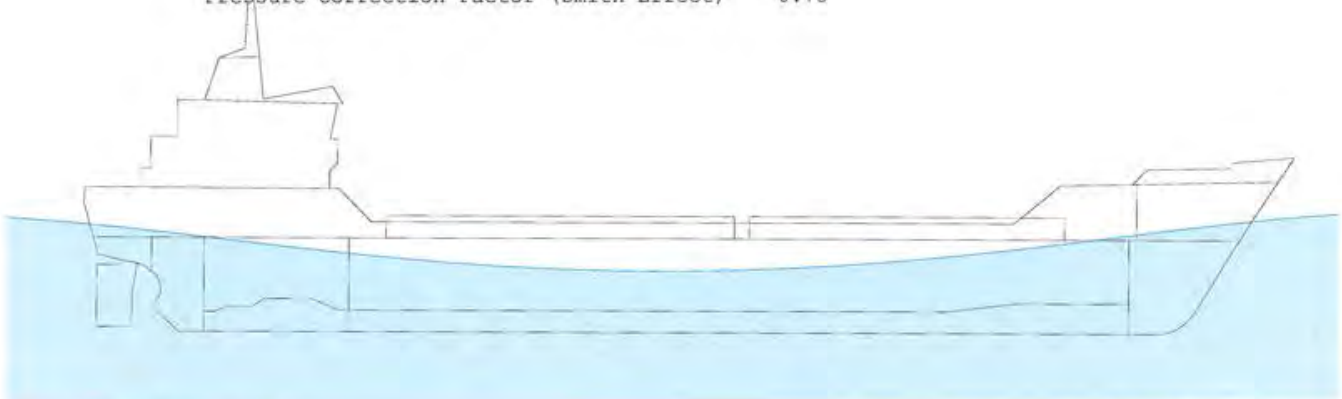
Output from TMC’s analysis (**Figure 66**) represents *Swanland* in the sea conditions encountered at the time of the failure, and confirms that the maximum bending moment (**red** line) would have occurred at Frame 65, the middle of the transverse central beam. The positioning of the maximum bending moment in this area was to be expected given that Frame 65 coincided with the approximate longitudinal centre of the limestone cargo in the hold (**Figures 3, 67a** and **67b**).

As the structure beneath the transverse beam had been strengthened to form a portal frame (**Figure 36**) during the vessel’s construction, a structural failure at this particular frame would have been unlikely. However, **Figure 66** also indicates that a large bending moment would have still been present in the general midships area, particularly between Frame 58 and Frame 69.

Figure 66: Output from TMC analysis showing *Swanland* in the estimated sea conditions encountered at the time of the failure and the calculated bending moments (condition 5b)

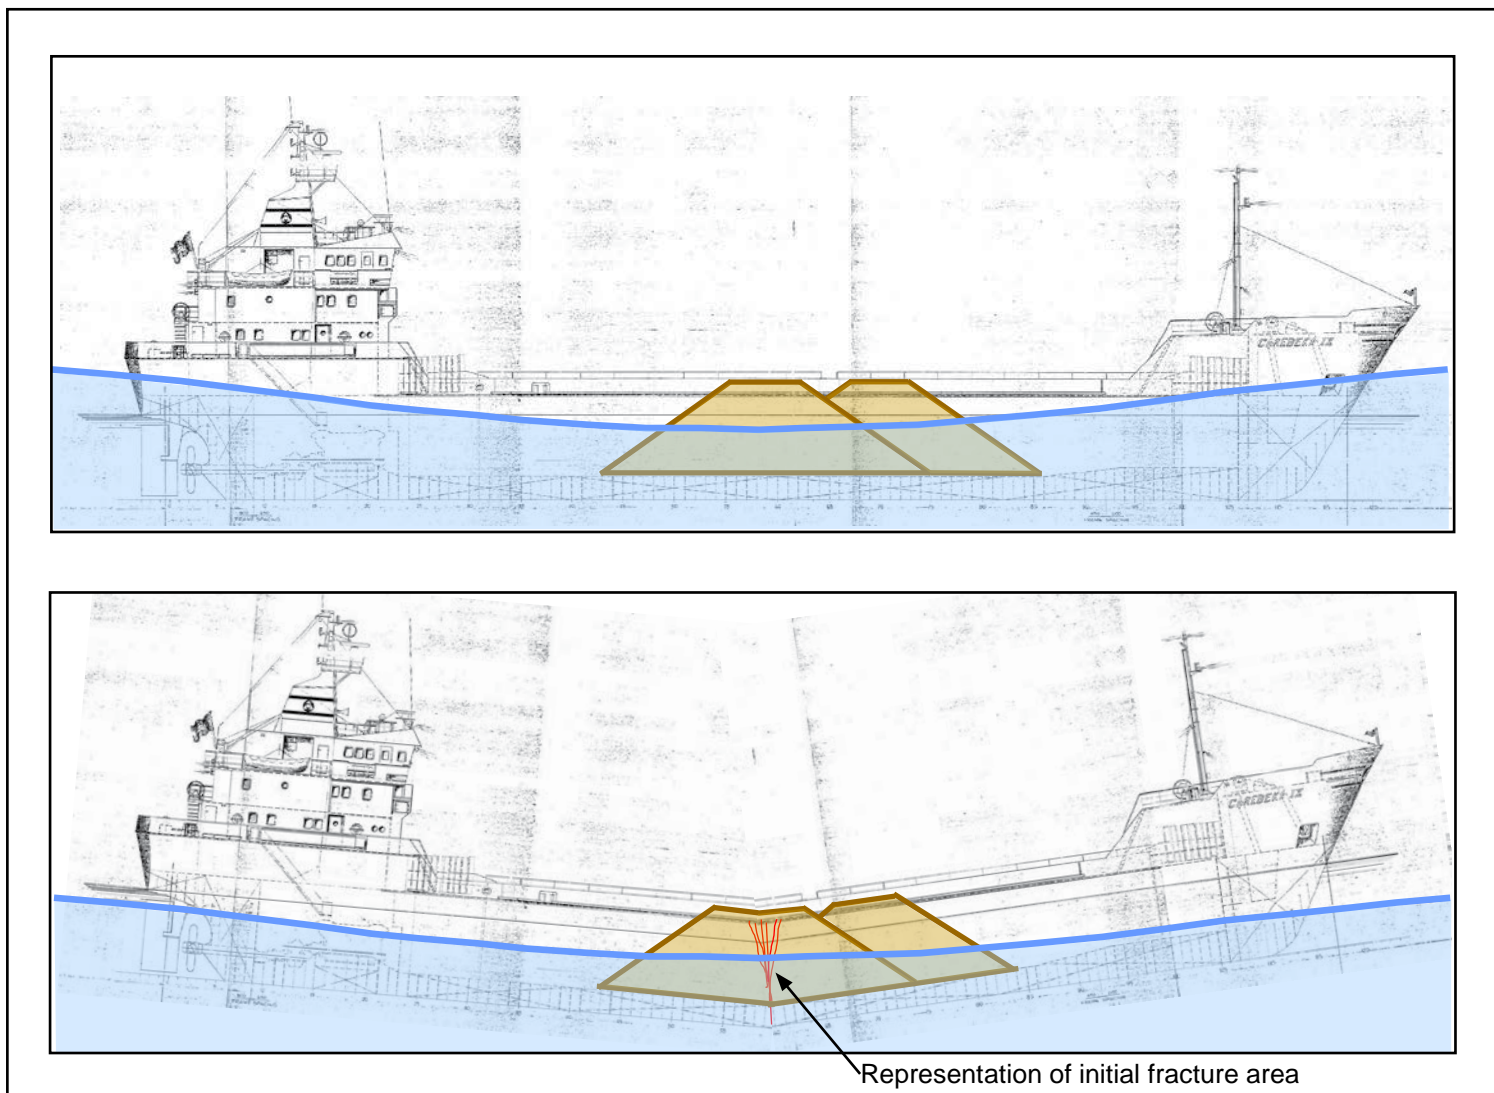
**Figures 67a** and **67b** represent *Swanland* in the sea conditions and the possible post-failure sagging condition respectively. Both of these figures include the distribution of cargo (TMC’s condition 5b); **Figure 67b** also shows the most likely location of the initial structural failure on the starboard side, based on the underwater evidence described below.

**Figures 67a and 67b:** Representation of *Swanland* in the estimated sea conditions at the time of the initial failure and the possible post-failure sagging condition

midships section would have been in the wave trough when her bow was lifted by the large wave at the time of the initial structural failure, as illustrated at **Figures 66** and **67b**. It is also significant that Table 5.1 of the Met Office report (**Annex B**) confirmed that the estimated wave heights were at their maximum around the same time as the structural failure; the tidal stream and the seas were also in direct opposition, which would have caused the steepness of the waves to increase.
