Report on the investigation into  
the structural failure and foundering  
of the general cargo ship

***Swanland***

Irish Sea

27 November 2011

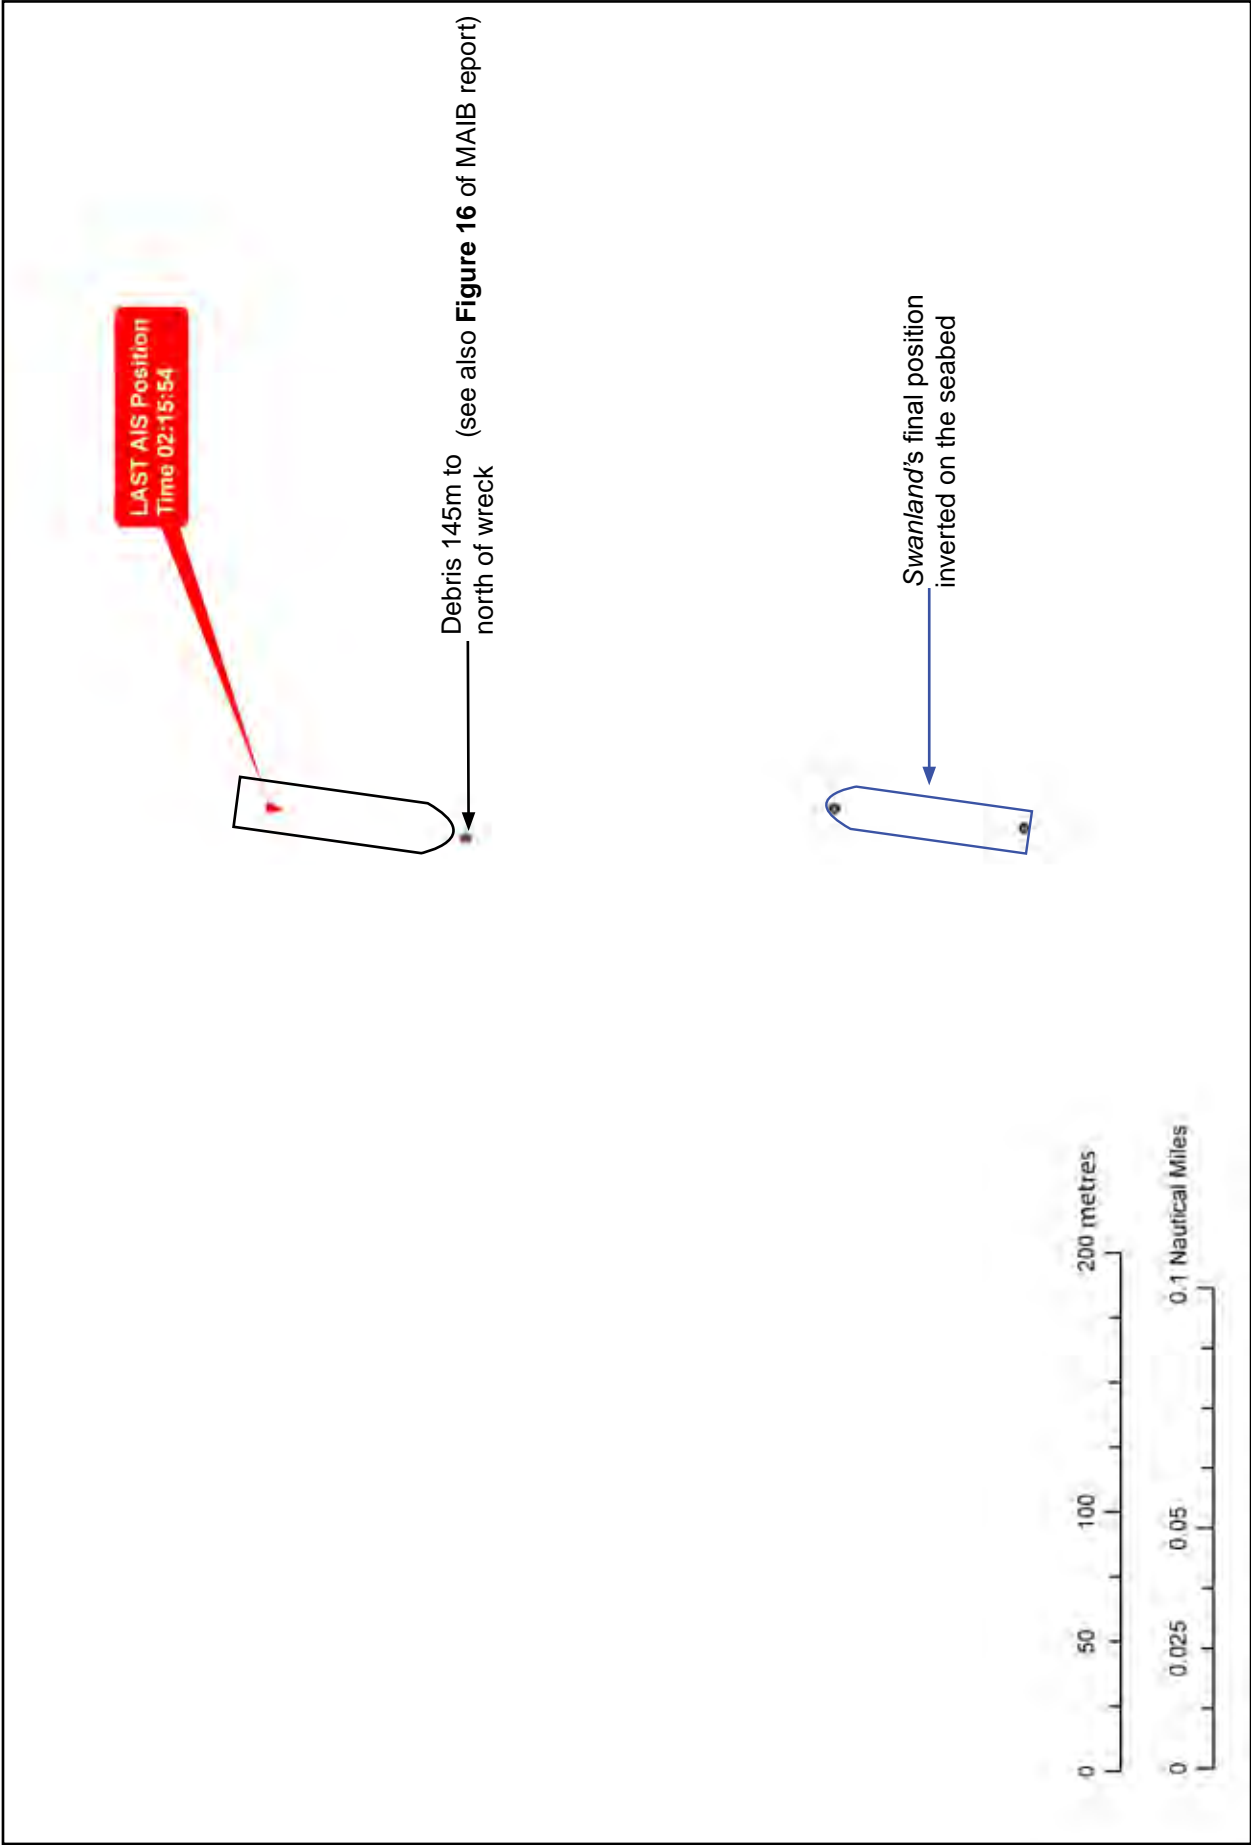
As shown at **Figure 72**, by the time of the final AIS transmission *Swanland* was on a heading of 193° but was being set in the same direction by the tidal stream. The final sequence of events leading to *Swanland* ending up inverted on the seabed on a heading of approximately of 008° (**Figure 16**) will never be known. However, it is evident that the vessel must have capsized at some stage after the two survivors were swept overboard. In view of the close proximity of the excavator carriage on the seabed to the vessel's last AIS position, it is evident that capsizing must have occurred at about 0216.

**Figure 72:** Chart showing *Swanland's* last AIS position and heading relative to her location and orientation on the seabed

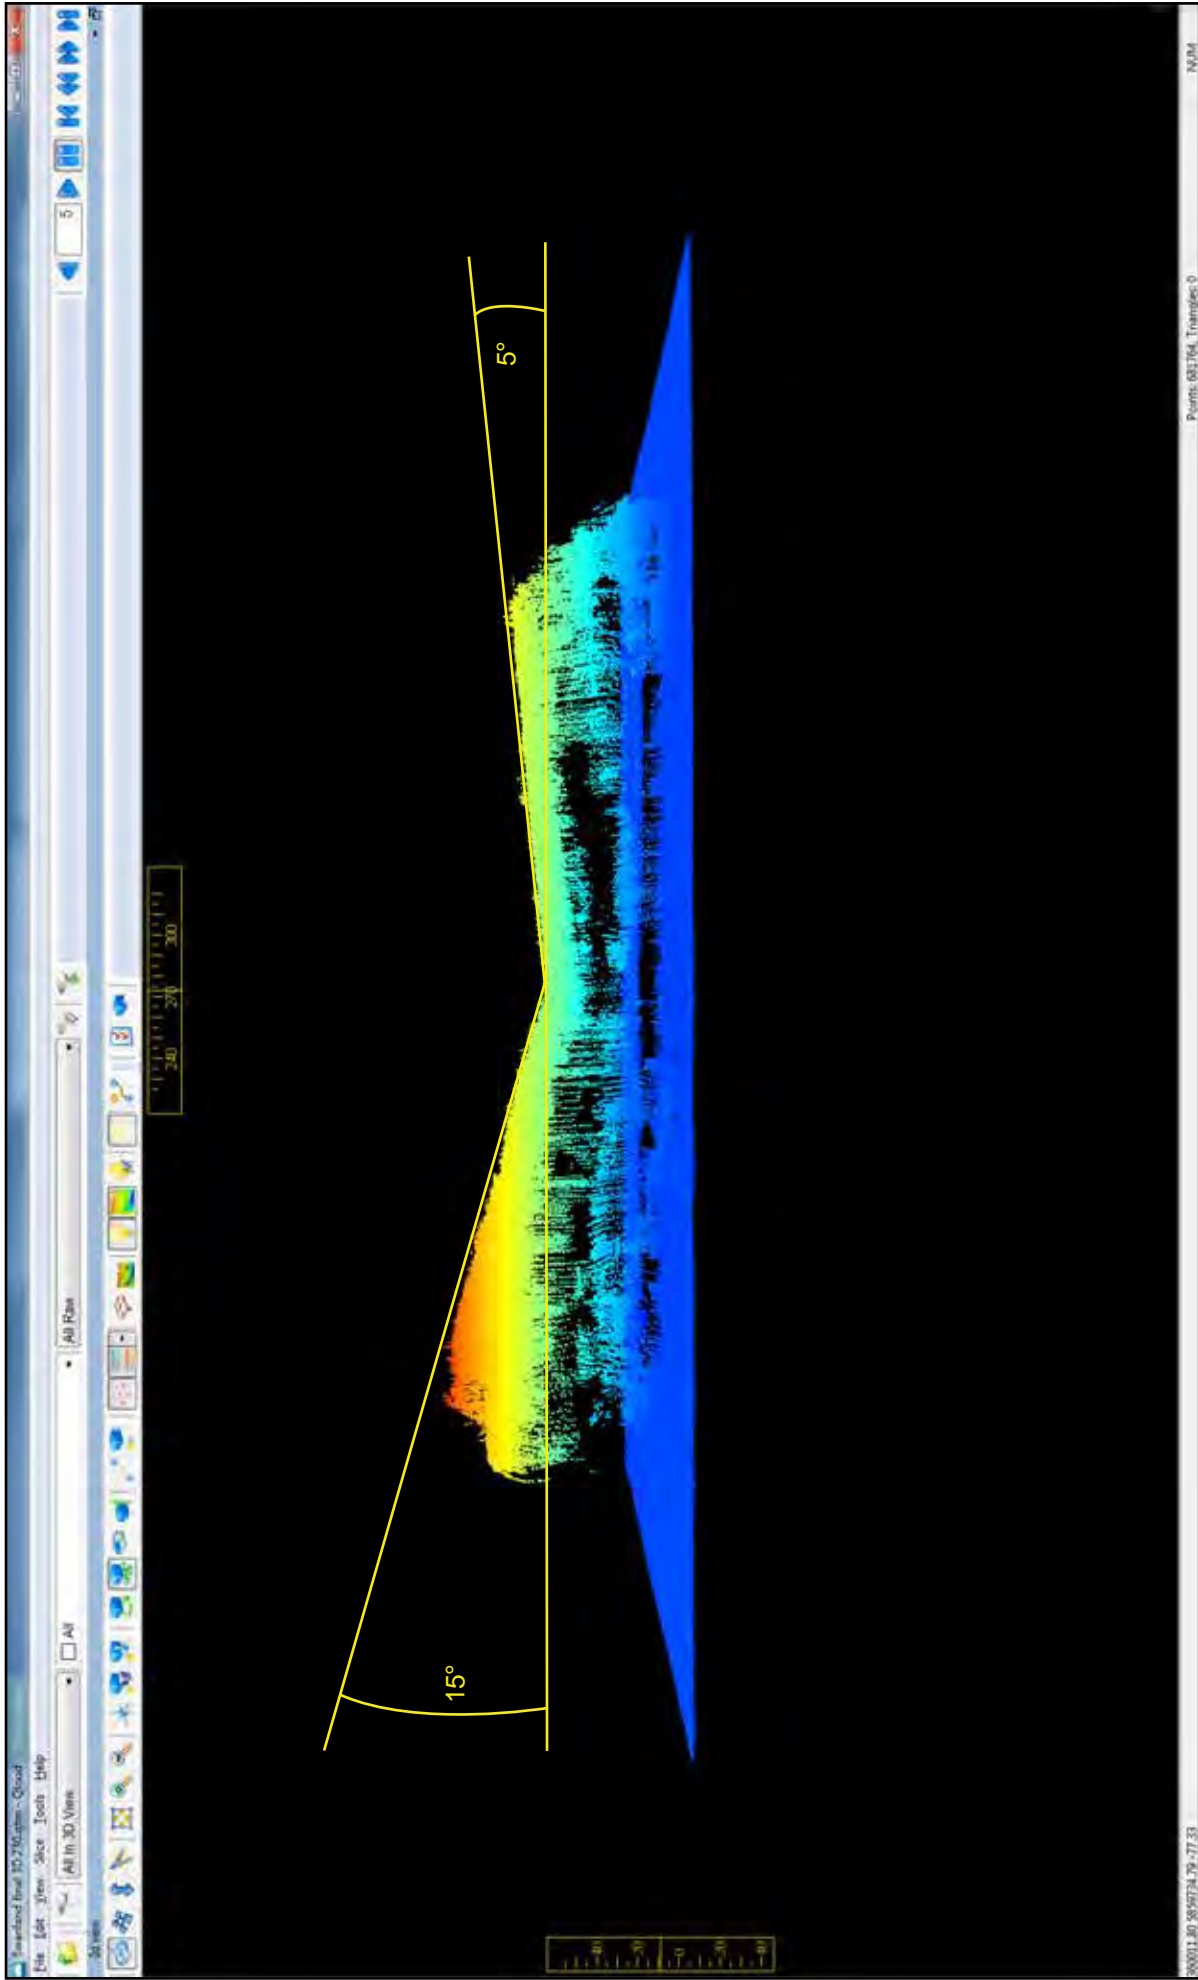
**Figure 73** shows a multi-beam sonar image of the elevation of the wreck on the relatively flat seabed. This is further interpreted in **Figures 74a** and **74b**, which suggests that *Swanland's* final orientation would have been influenced by her enclosed foc'sle and aft superstructure block. Although both of these blocks of structure would have crumpled to some extent and become embedded as the vessel landed on the seabed, the structures would have also pushed *Swanland's* keel upwards at the bow and the stern (**Figure 74a** and **74b**). This is considered to be the most likely reason for the 'hogged' condition of the wreck on the seabed and probably accounts for the tensile brittle failure evident in some areas of the fracture. The impact on the seabed would almost certainly have led to a rapid widening of the main midships fracture paths, as indicated by comparing **Figure 67b** with **Figures 74a** and **74b**. It is also likely to have either caused or exacerbated the transverse crease in the bottom plating. **Figures 16, 17a** and **17b** confirm that *Swanland* was intact on the seabed.

**Figure 73:** Subsea Vision multi-beam sonar scan showing elevation view of *Swanland* on the seabed, annotated to show angles of keel line

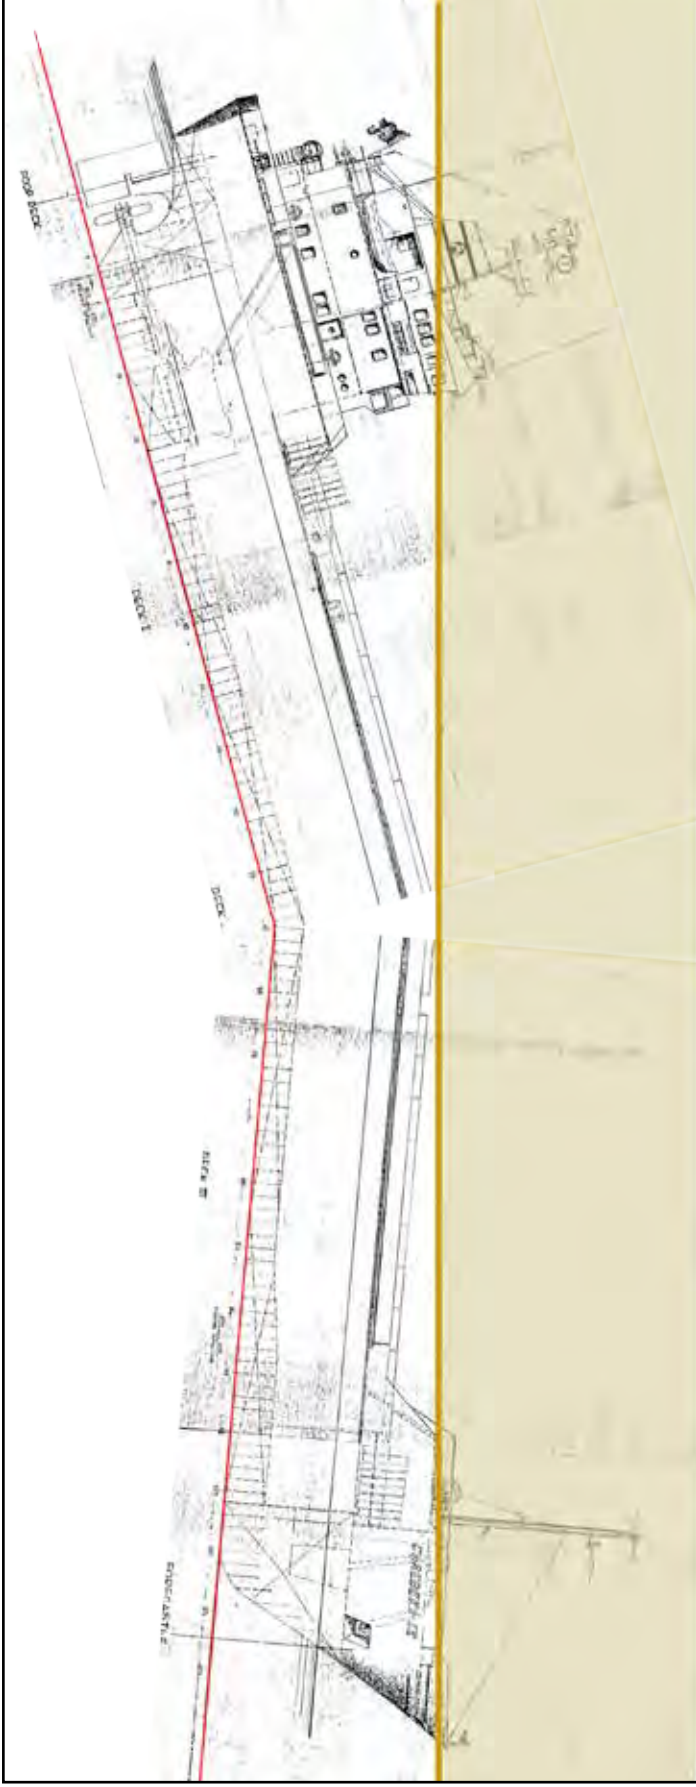
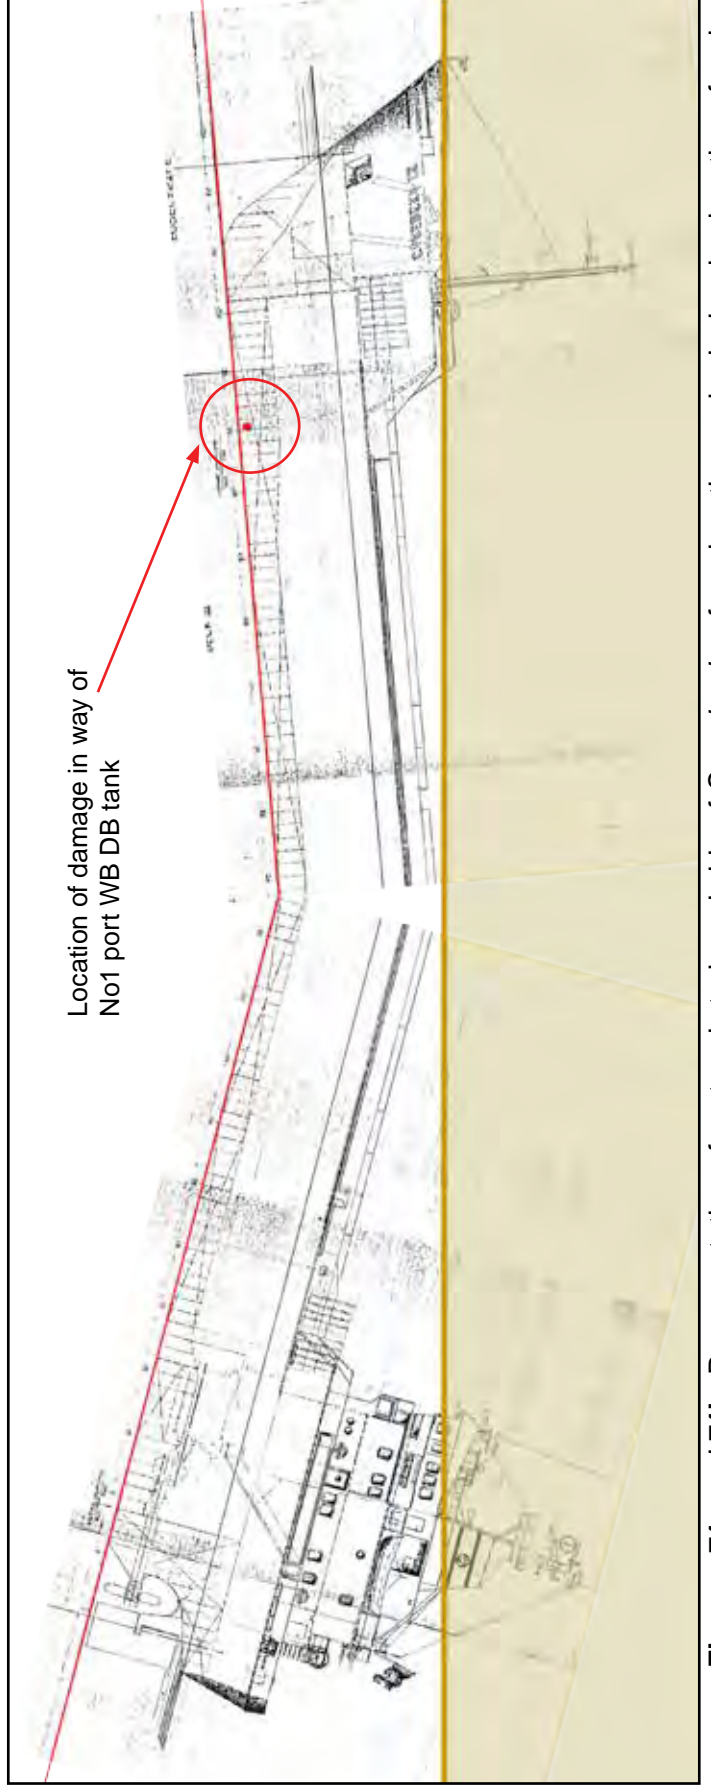
There is no evidence to suggest that the localised crumpling damage identified on *Swanland's* bow at the top of the stem and around 2m above the base of the stem (**Figures 29a, 29b, 30a** and **30b**) occurred before the initial structural failure at around 0200. As indicated in **Figures 74a** and **74b**, the damage at the top of the stem almost certainly occurred during the impact with the seabed.

**Figures 74a and 74b:** Representation of port and starboard side of *Swanland* as found on the seabed, showing location of main fracture path and hole in way of No1 port WB DB tank

Implosion is also considered to be the most likely cause of the small hole in the bottom plating in way of number 1 WB DB port tank (**Figures 28a, 28b, 28c and 74b**). This hole appeared to have been formed when a “D”-shaped section of plating hinged inwards around a frame. There was no evidence of any localised impact damage and there was also no evidence to suggest that the tank had been damaged and flooded prior to the structural failure. As this tank would therefore have been empty at the time of the accident, the increasing water pressure as the vessel sank probably caused a weak area in the plating to fail. With sea water then rapidly filling the tank, the internal and external pressure would have equalised, thus preventing any further pressure damage.
