Report on the investigation of
the capsizing of the fishing vessel

Aquila

with the loss of three lives
Bo Faskadale Reef, Ardnamurchan
on 20 July 2009

Report No 5/2010
April 2010

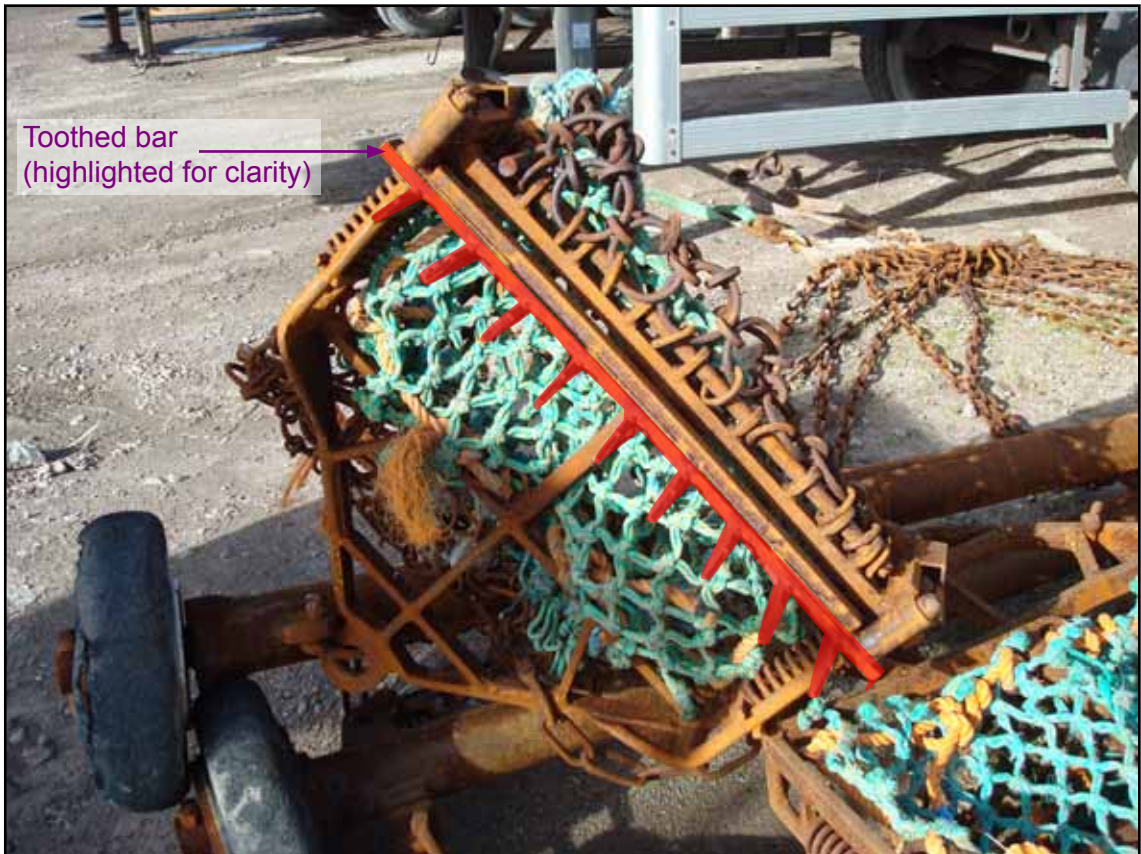
Dredge bag from *Aquila*, showing toothed bars

Aquila dredged for scallops by towing two wire warps, one from each side, attached to which were steel spreader bars which each held seven dredges (**Figure 9**). The dredges consisted of a frame with a toothed bar at the front, to dig the scallops out of the seabed, with a collecting bag behind it. The bag was made of chain links forming a chain mesh on the bottom with netting on the top (**Figure 3**).
