Report on the investigation of the
foundering of the fishing vessel

Blue Sinata

in Weymouth Bay
on 8 September 2005
with the loss of one life

**Report No 7/2006
March 2006**

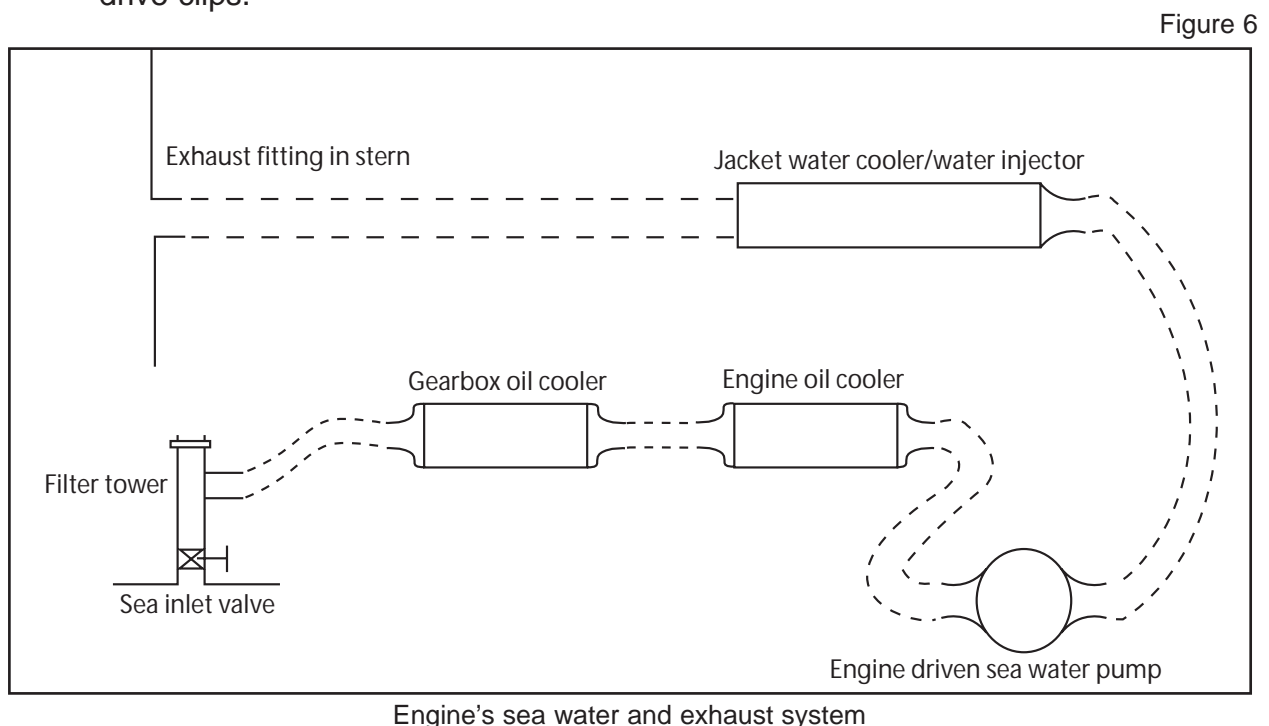
From the seawater inlet valve, below the circular deck hatch, water passed to a gearbox oil cooler mounted over the gearbox. From this cooler, the water then passed to an engine oil cooler on the port side of the engine, before entering the engine-driven seawater pump. The outlet from the pump went to the jacket water cooler, high on the starboard side of the engine, before being injected into the engine's exhaust for cooling and silencing purposes. All seawater pipes between these units were plastic hoses secured with worm drive clips (**Figure 6**).

The exhaust hose from the engine passed through the aft bulkhead, and then overboard through a skin fitting in the transom. This exhaust hose was of reinforced, corrugated, rubberised material, and was also secured with worm drive clips.
