Report on the investigation of the
Brenscombe Outdoor Centre
canoe swamping accident
in Poole Harbour, Dorset
on
6 April 2005

Marine Accident Investigation Branch
Carlton House
Carlton Place
Southampton
United Kingdom
SO15 2DZ

**Report No 22/2005
December 2005**

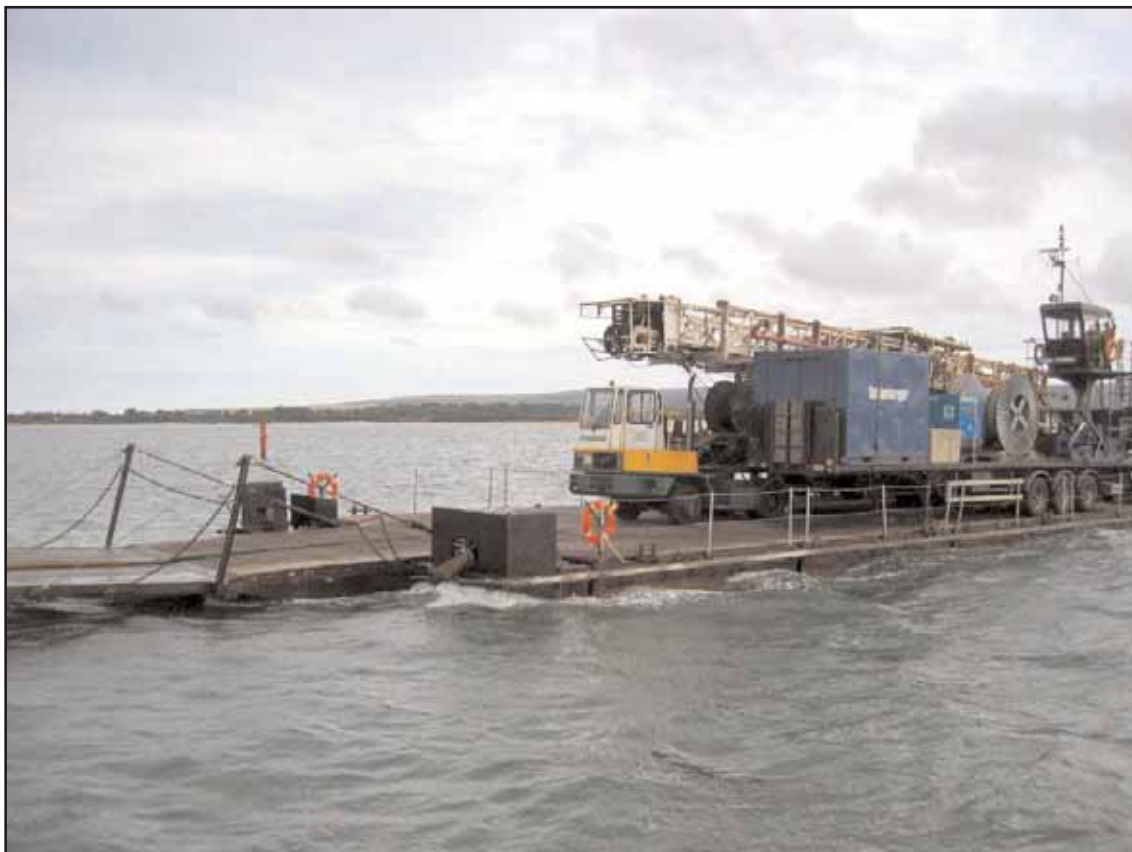
Supply vessel *Furzey Squirrel*

whole team to get into the safety boat to warm them up and to aid transfer to *Furzey Squirrel*. In doing so, he far exceeded the boat's 4-man capacity. Overloaded and shipping water, the safety boat capsized, plunging the team members, their personal kit, instructors and mobile telephone into the water.

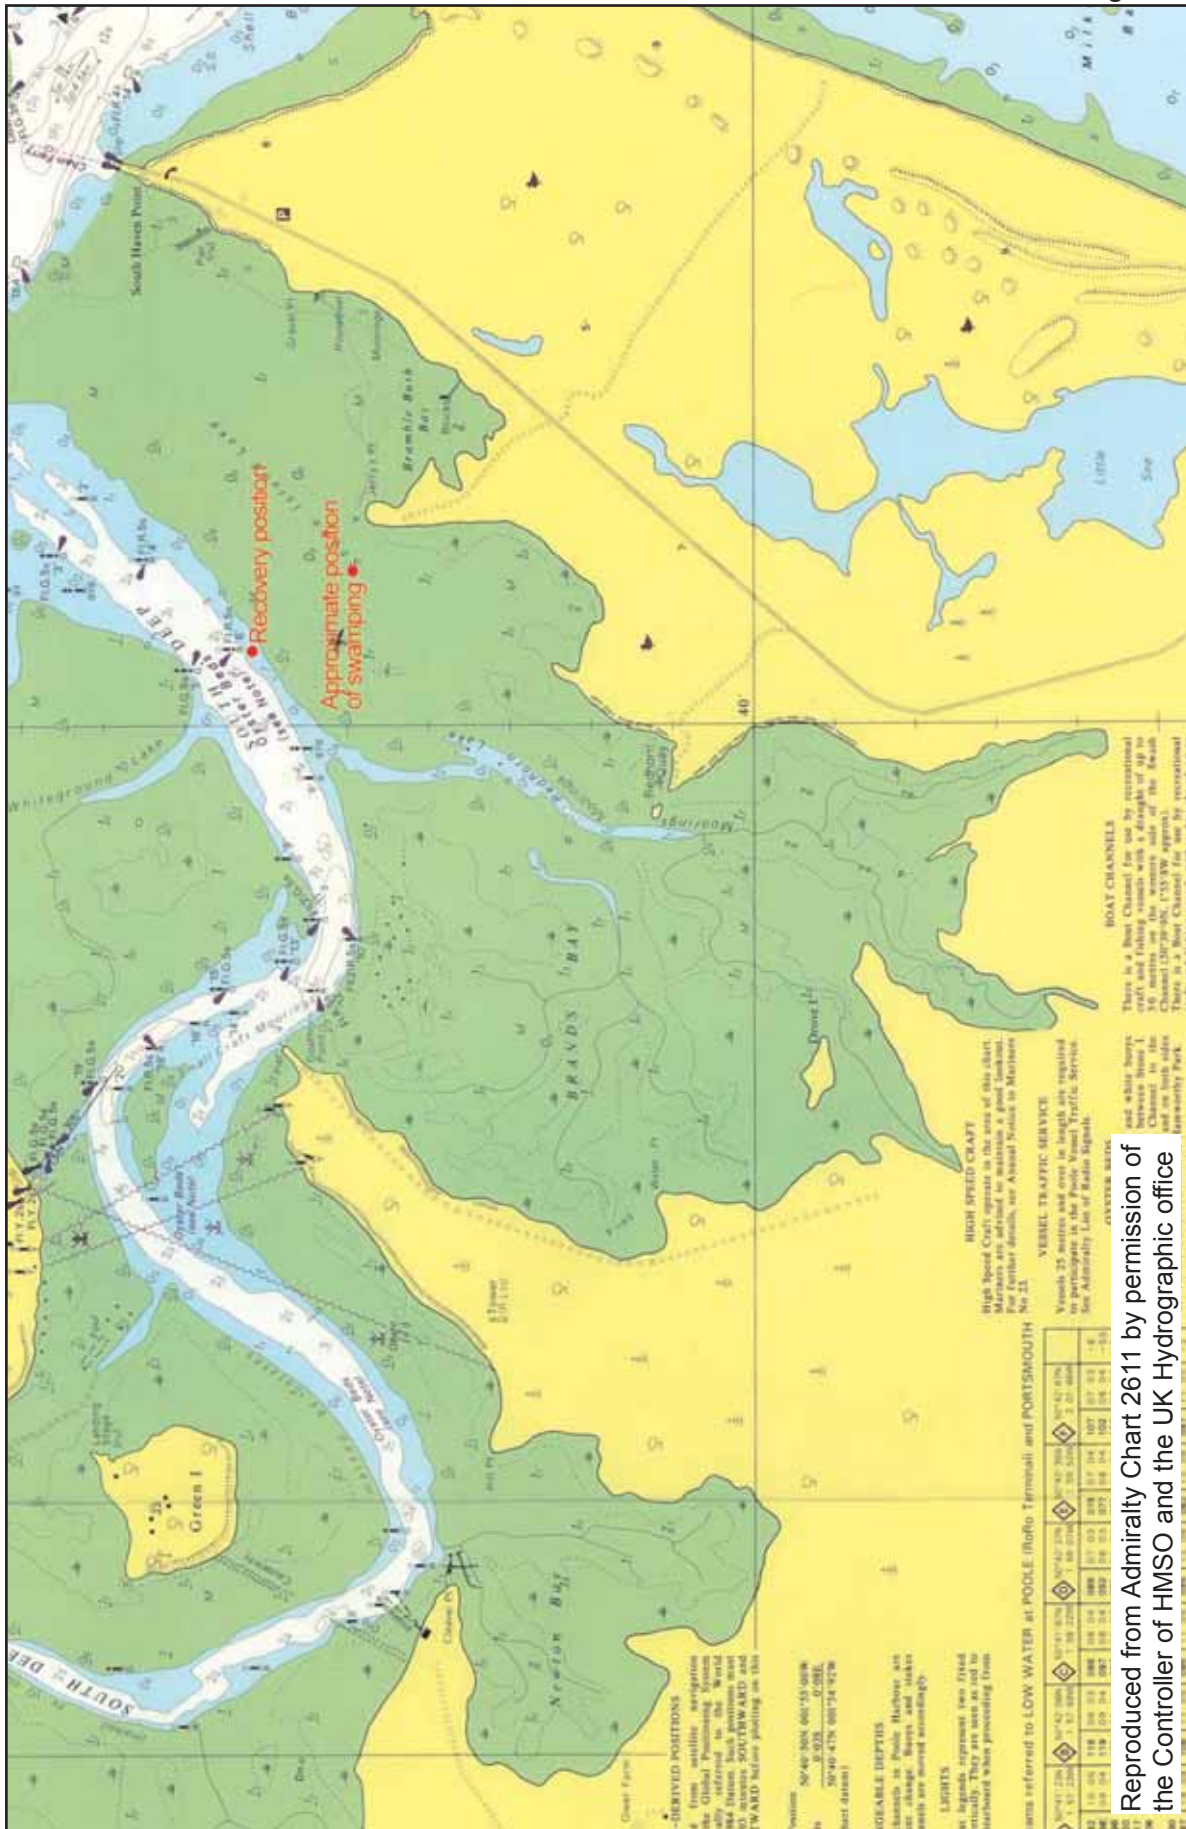
Figure 9

The accident location and recovery points are indicated at **Figure 9**.
