Report on the investigation of  
the fatality of a shore worker in No 2 cargo tank  
on board the oil/chemical tanker

***Bro Arthur***

at the Cargill Terminal, Hamburg, Germany

**Report No 9/2010**  
**August 2010**

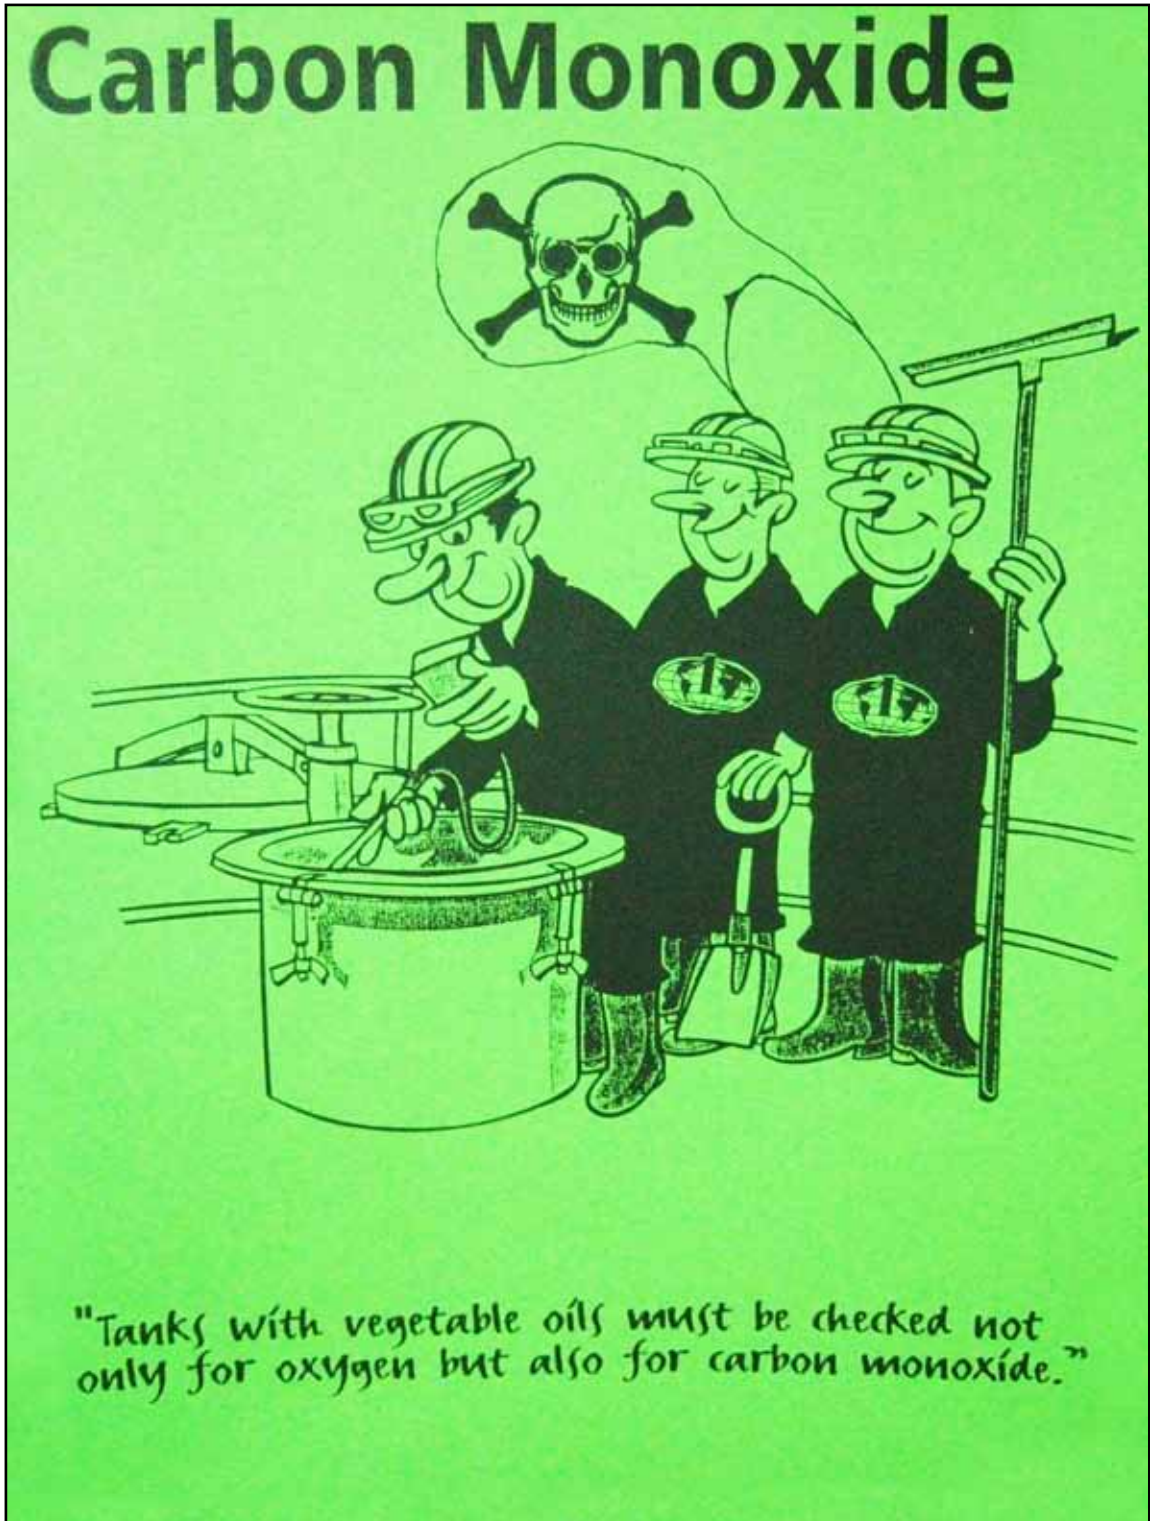
Figure 2

cargoes, there was nothing in the MSDSs which raised his concern or which required any special precautions to be taken. However, the supplier also passed a warning poster (**Figure 2**) to the chief officer. It advised that tanks containing vegetable oils should not only be checked for oxygen levels before entry but also for the presence of carbon monoxide (CO).

Vegetable oil warning poster supplied by P.T. Sari Dumai Sejati

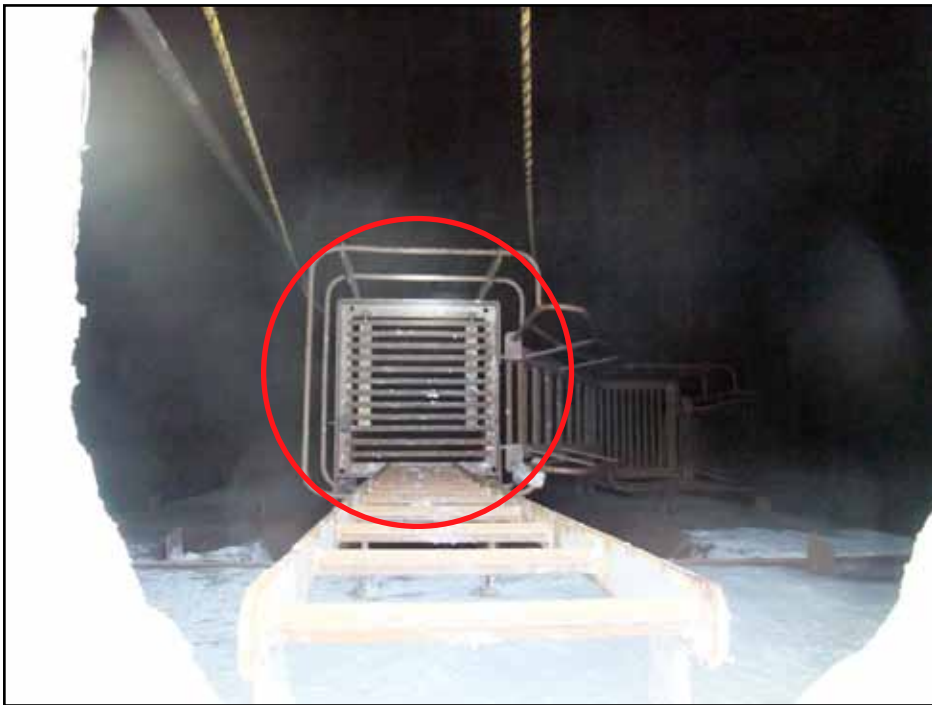
Figure 6

As the three “sweepers” descended the first vertical ladder, the supercargo followed and remained on the top resting platform (**Figure 6**) to act as communications link with the chief officer who was at the hatch coaming on the main deck. As the “sweepers” descended the three angled ladders to the bottom of the tank (**Figure 7**) the supercargo once again noted that “Sweeper” 1 was assisting “Sweeper” 2, but this did not cause him sufficient concern to abort the operation.

No 2 cargo tank - top resting platform

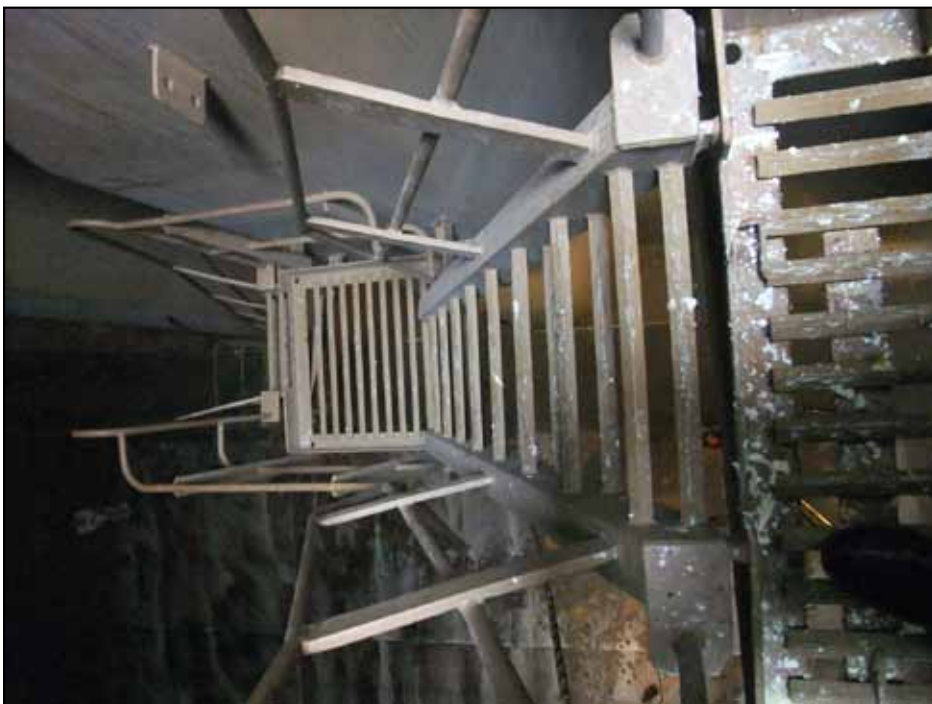
Figure 7

No 2 cargo tank - angled ladders

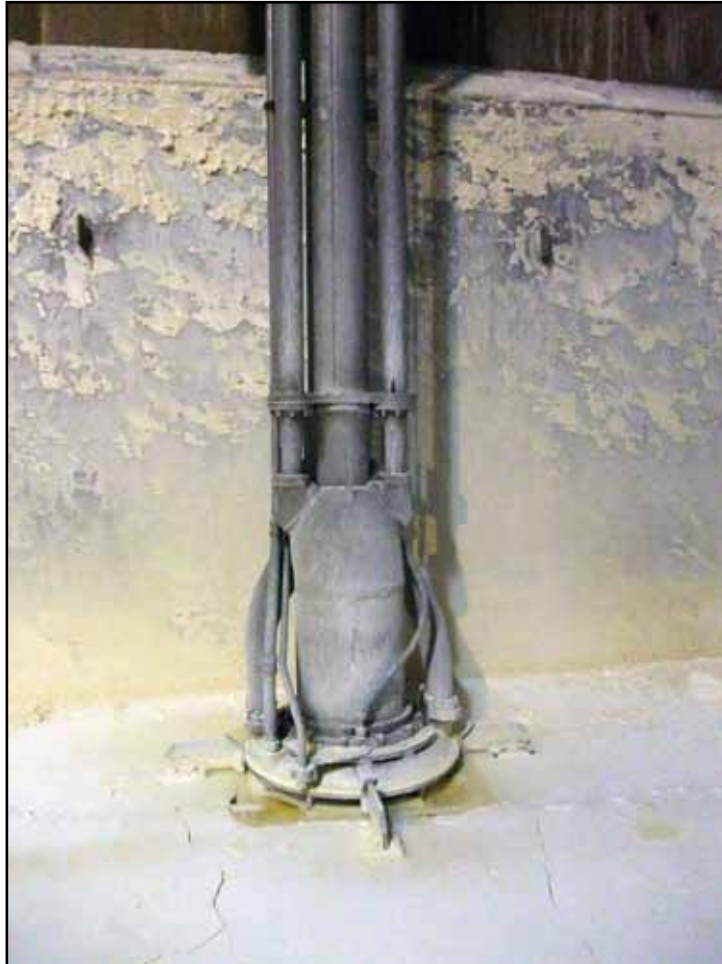
Figure 8

From his prominent position, and because of the lighting levels, the supercargo was able to easily monitor the cargo being “swept” into the pump suction well (**Figure 8**). At 2255 the supercargo called to the “sweepers” that he was satisfied, and indicated they should leave the tank. The supercargo saw the “sweepers” heading towards the first angled ladder as he exited the tank.

No 2 cargo tank - cargo pump section well

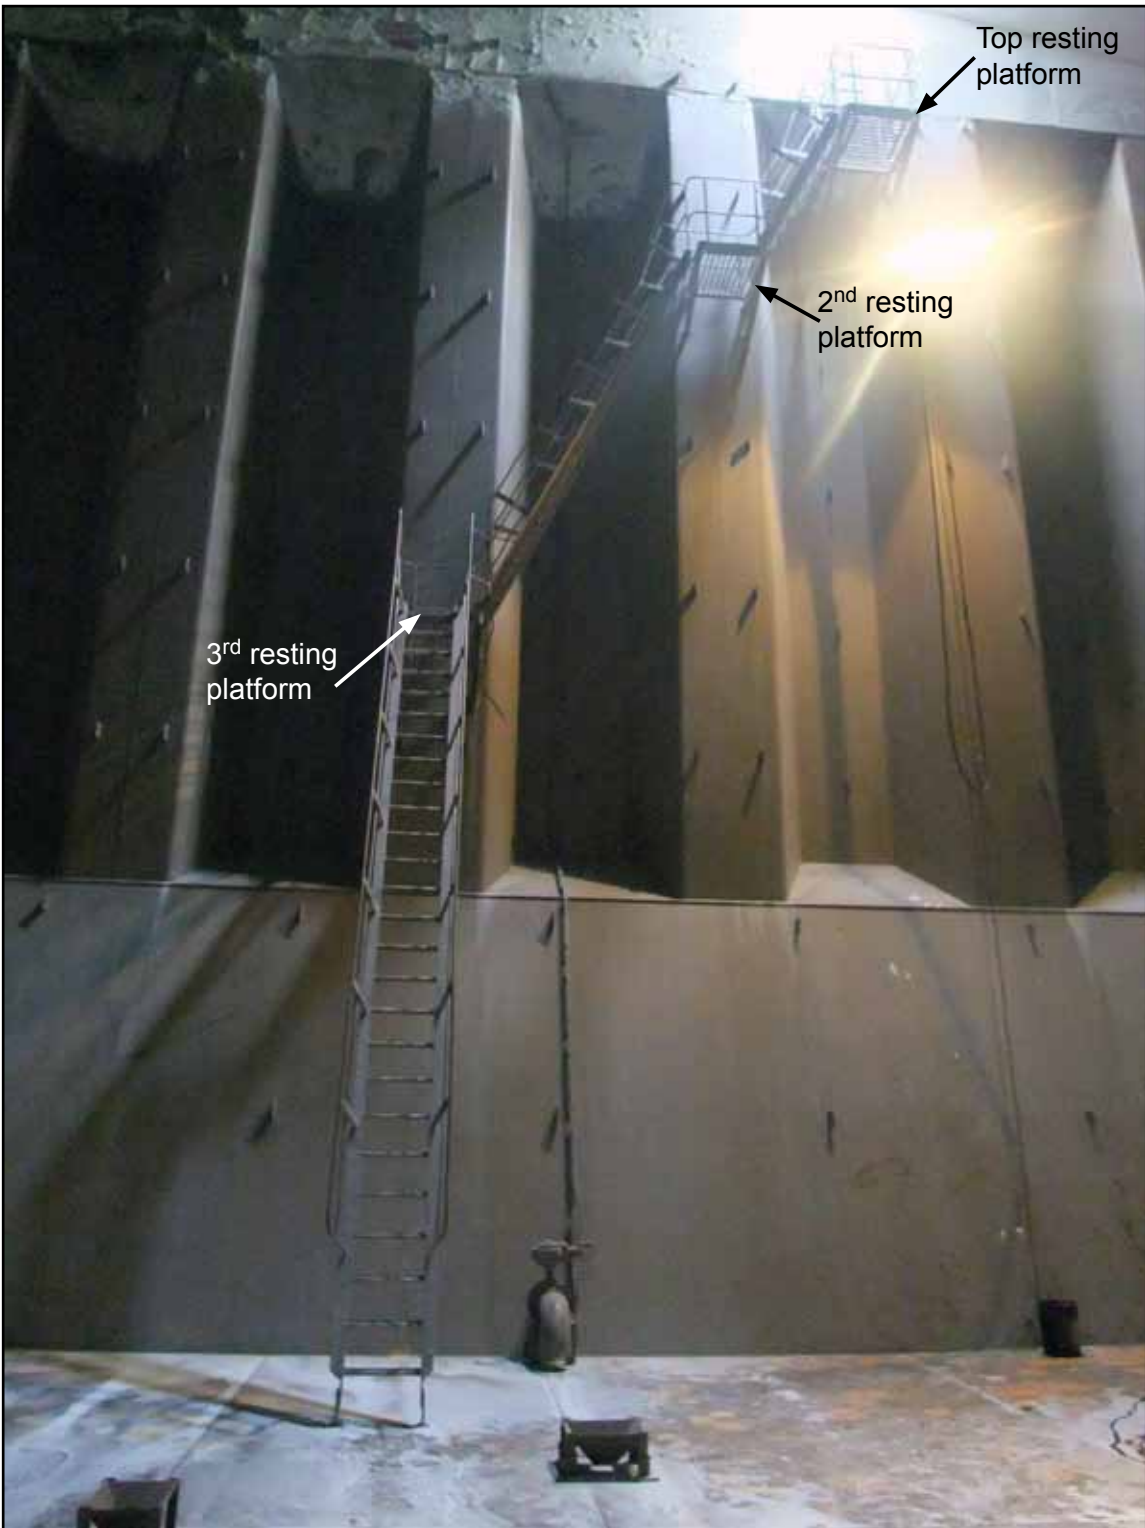
Figure 13

No 2 cargo tank was accessed directly from the main deck through a 1.1m diameter round hatch and 1m deep hatch coaming fitted with two internal and two external rungs. The 3.45m vertical ladder (**Figure 9**), which was not fitted with any back restraining hoops, led to the 0.8m<sup>2</sup> top resting platform (**Figure 6**). The platform was fitted with a central hinged access for casualty evacuation purposes. The access was secured with two drop nosed pins.

General arrangement of No 2 cargo tank access system

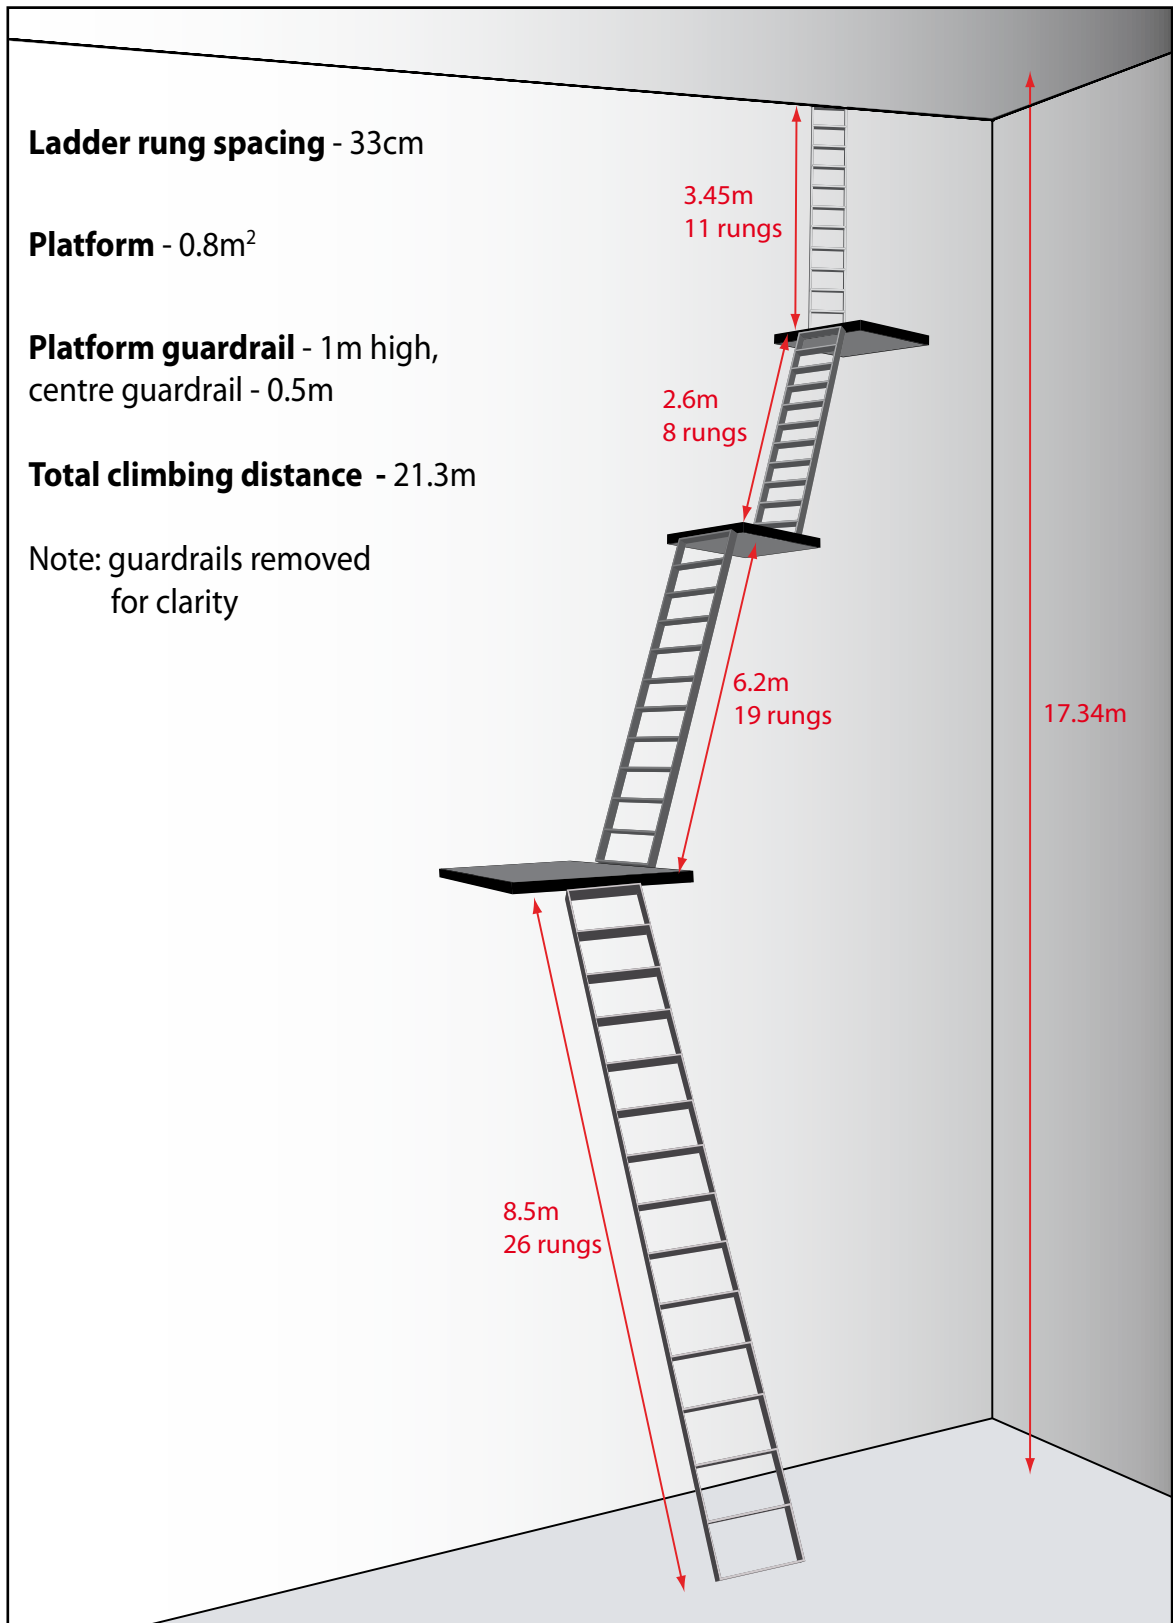
Figure 14

No 2 cargo tank vertical and angled ladder dimensions

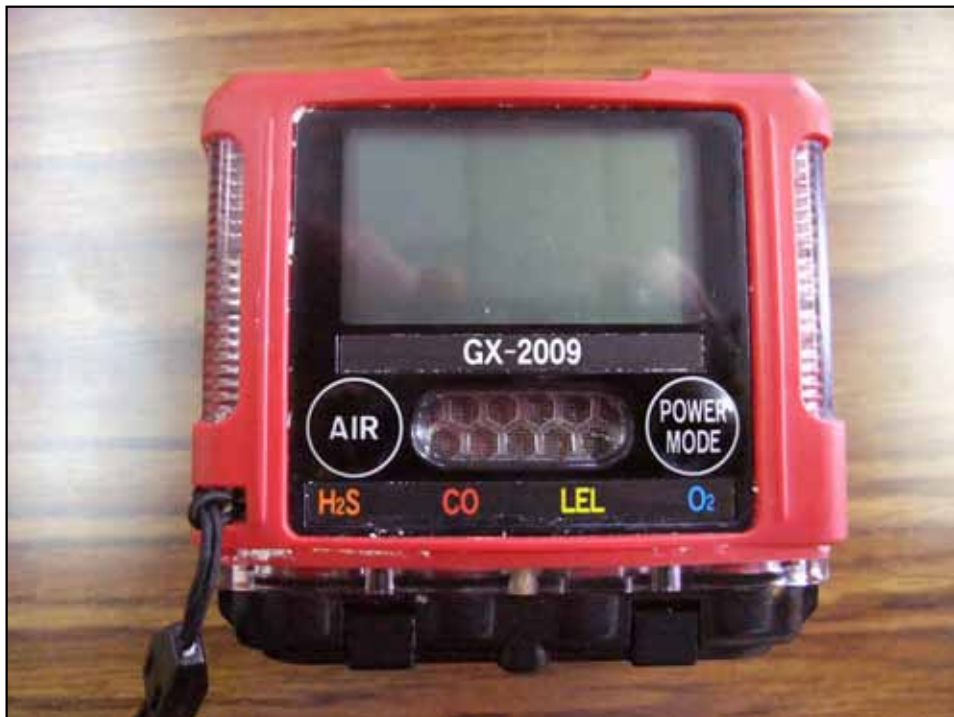
Figure 16

- Two Riken Keiki, GX-2009 (Ex Type A) PGMs with a 10m sampling extension hose (**Figure 16**), for measuring combustible gas, O<sub>2</sub>, H<sub>2</sub>S and CO levels.
- Two Gastec GV-100S (**Figure 17**) gas sampling hand pumps with a selection of detector tubes for measuring toxic gases including CO, H<sub>2</sub>S, benzene and total mercaptan. No sampling extension hoses were delivered with the units. However, since the accident, two 20m hoses have been supplied to the ship.

Riken Keiki GX-2009 (Ex Type A) Personal Gas Monitor
