Report on the investigation of
the grounding of
fv *Brothers*
with the loss of two lives
off Eilean Trodday
on
1 June 2006

Marine Accident Investigation Branch
Carlton House
Carlton Place
Southampton
United Kingdom
SO15 2DZ

**Report No 1/2007
January 2007**

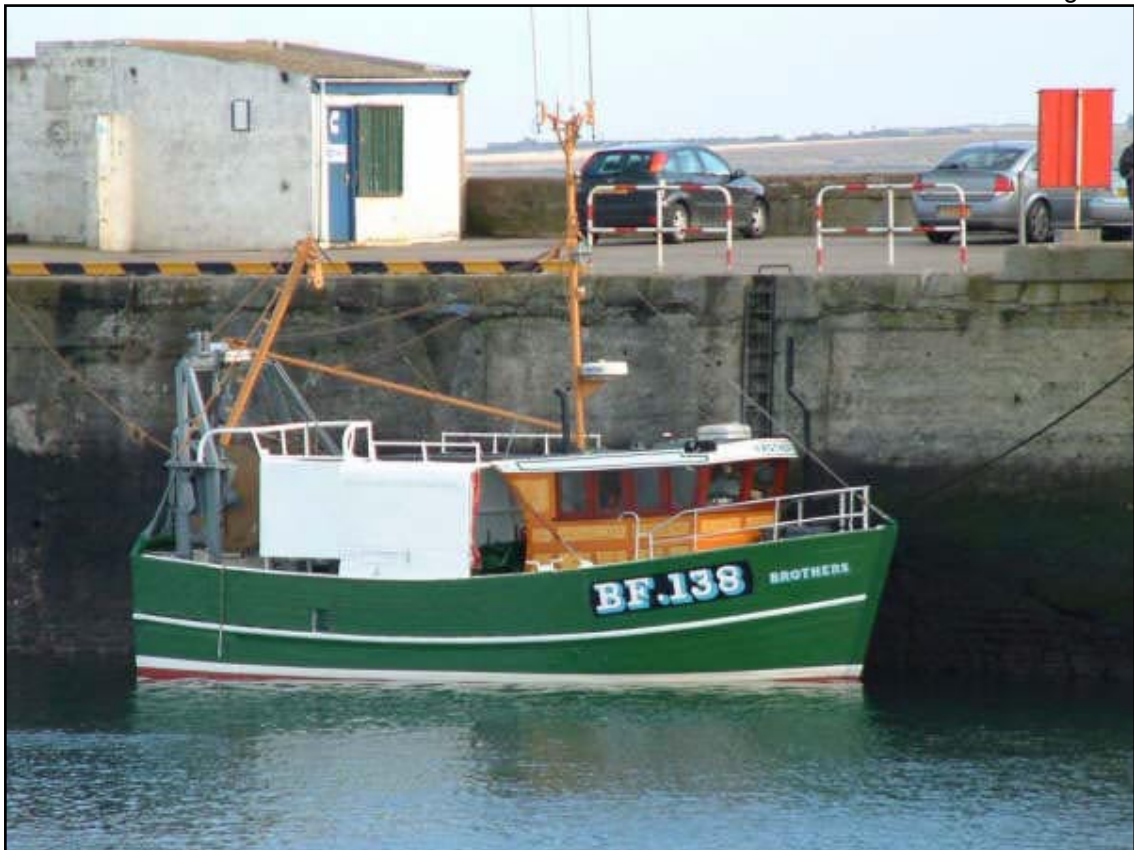
Figure 1

Brothers BF138

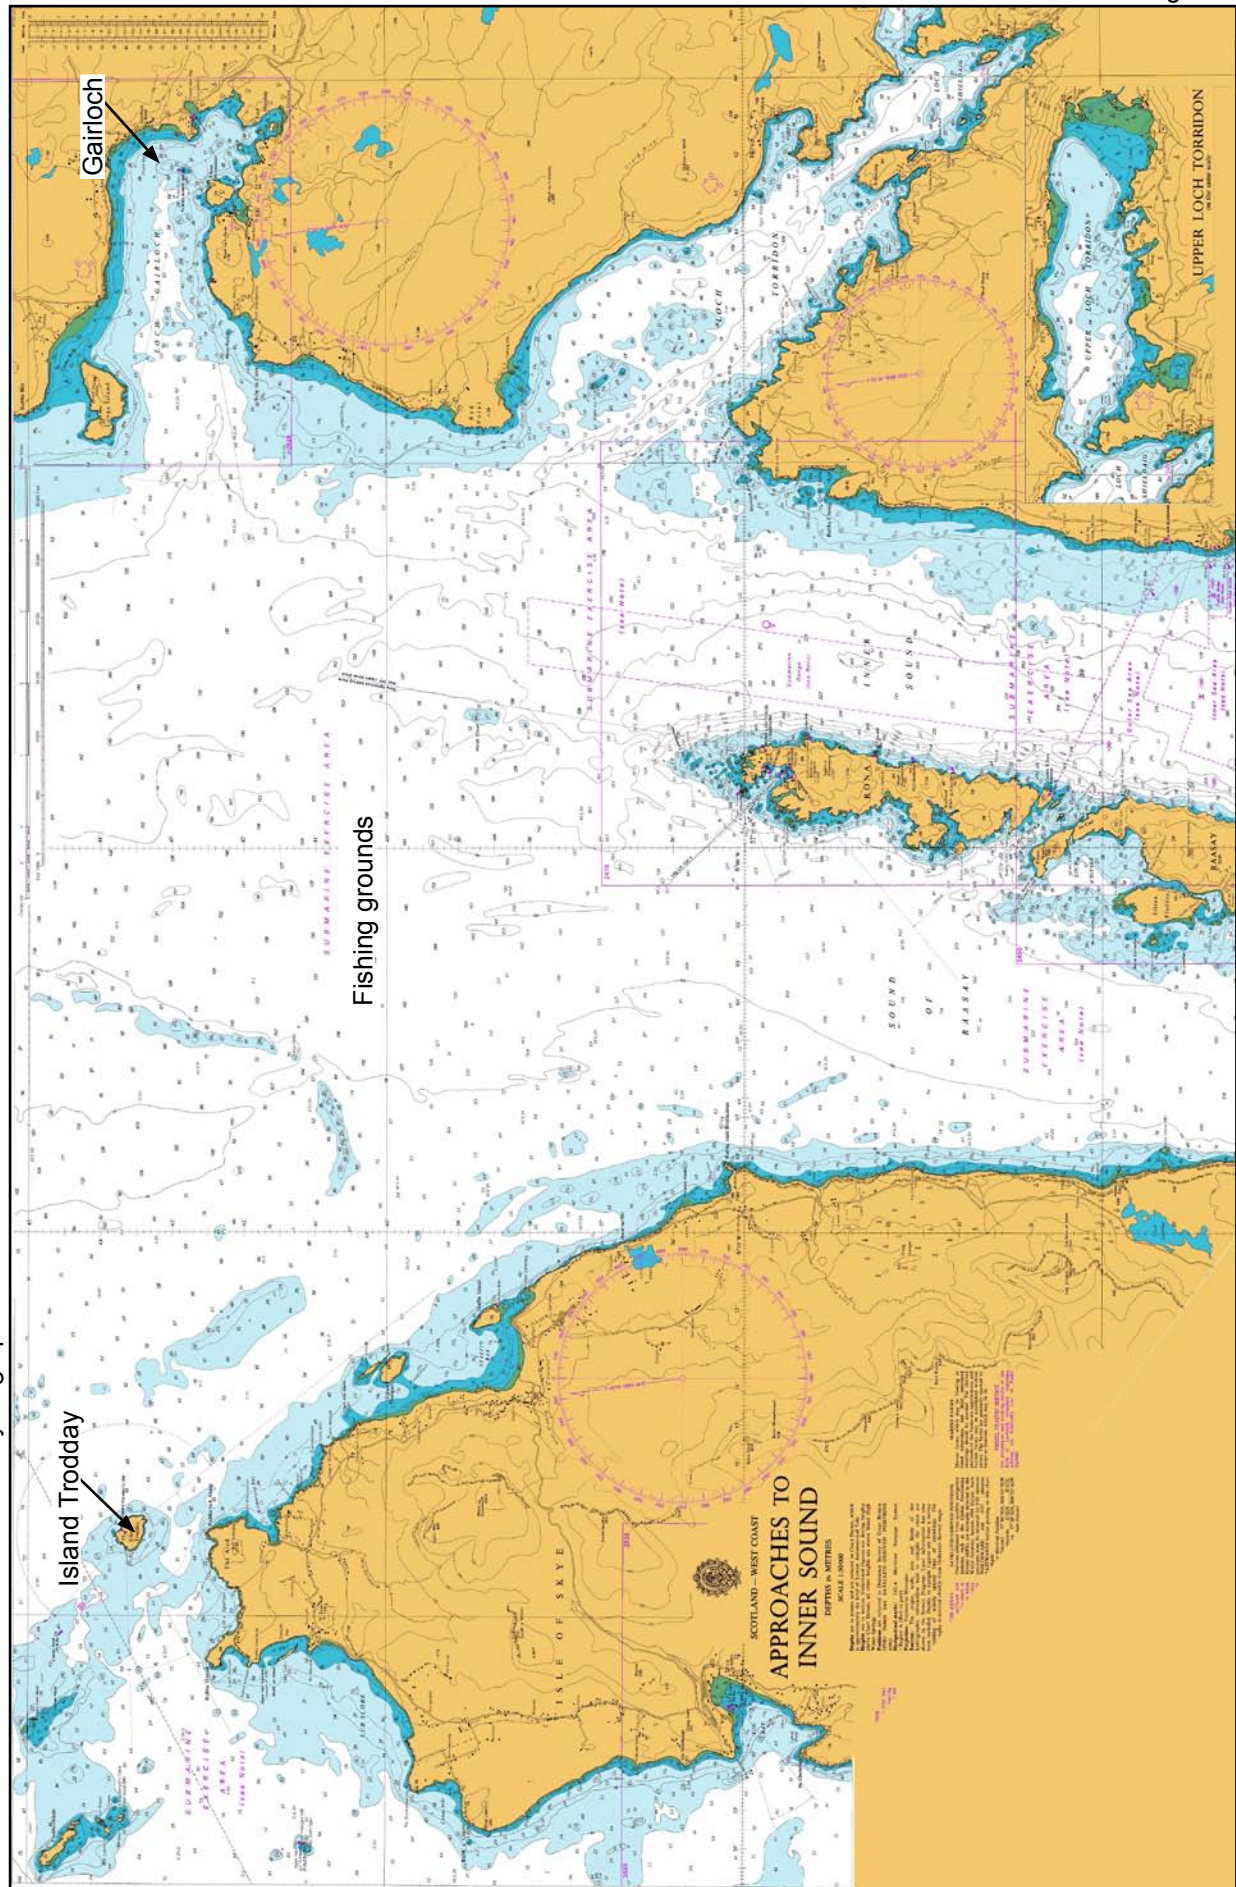
Figure 2

From discussions with the harbourmaster of Gairloch and local fishermen, the MRCC staff established that *Brothers* had last been seen at about 0230 as she headed out of the port towards the fishing grounds. The coastguard officers also learned that the vessel was probably intending to be out for just one tow. The intended fishing ground was identified from other information given by local fishermen as being about 6 miles east-north-east of Staffin Island (**Figure 2**).

Trodday fishing grounds

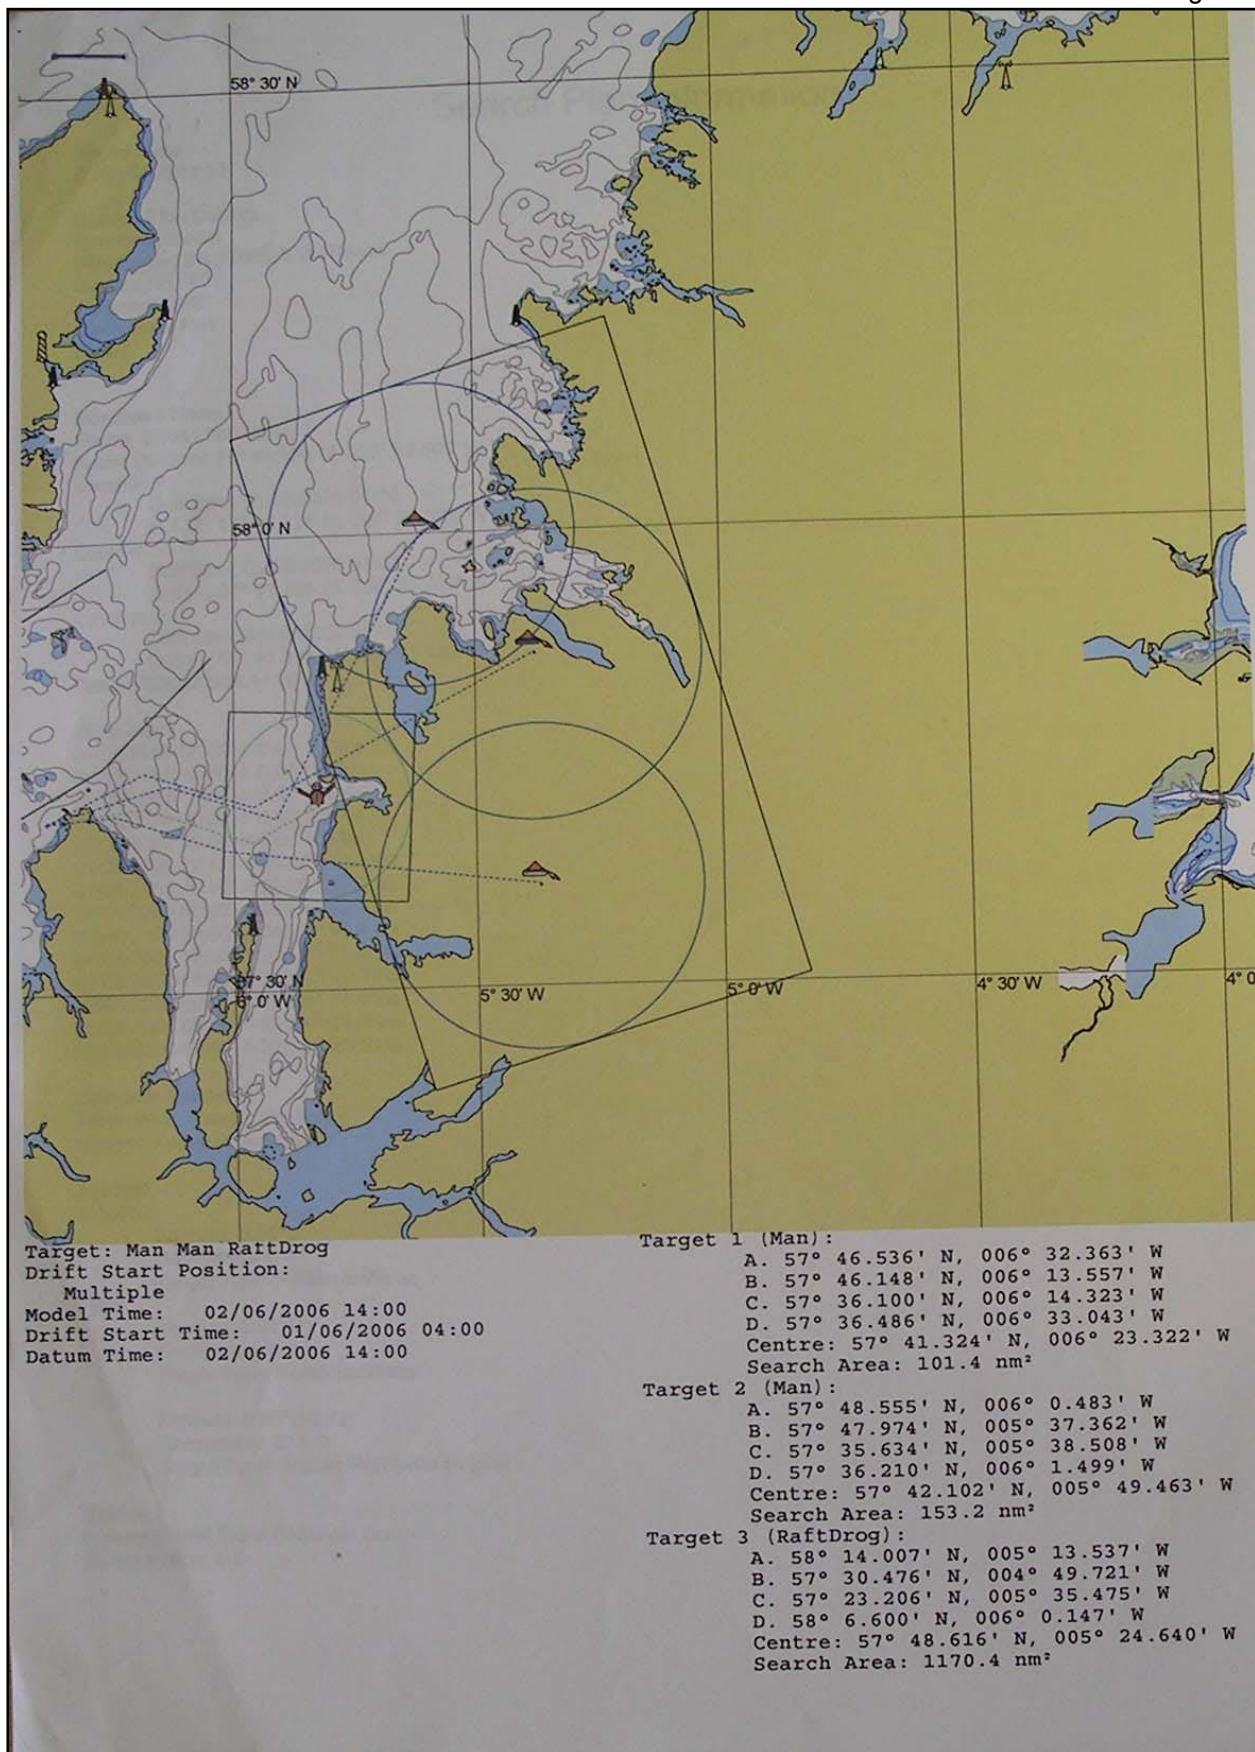
Figure 3

In order to determine where the flotsam might have drifted, the MRCC used its Search and Rescue Information System (SARIS) computer programme to form a hind cast model. Based on the positions and times that the items were discovered, and assuming that *Brothers* sank at 0500 (0400 UTC) on 1 June, it was concluded the flotsam might have come to the surface from the area around the north coast of Skye and drifted past the coast of Eilean Trodday east to where it was discovered (**Figure 3**). An alternative possibility that the items were floating to the surface from a sunken vessel in the immediate vicinity of the fishing grounds was also considered.

SARIS back track result

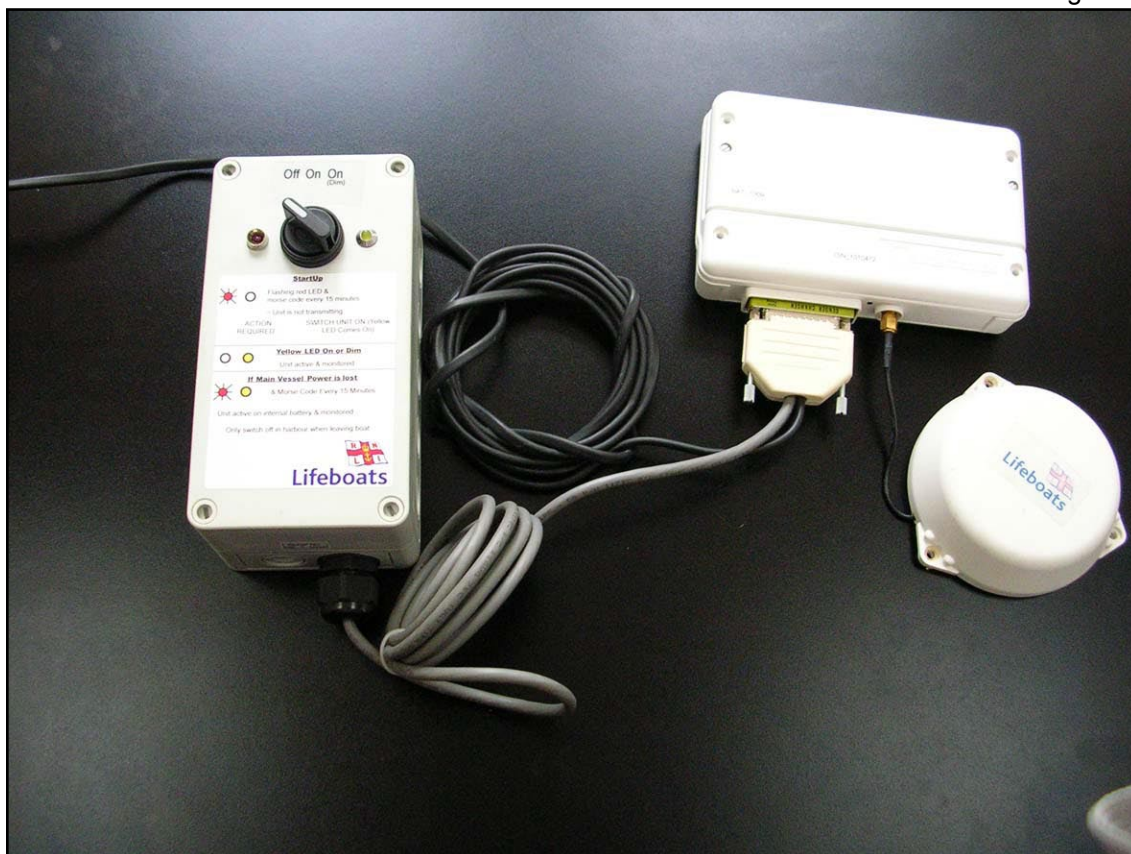
CPRS vessel equipment
