Report on the investigation of  
the major injuries sustained by a deckhand on board

**fv *Danielle* BM478**

on 6 June 2006

**Report No 5/2007  
March 2007**

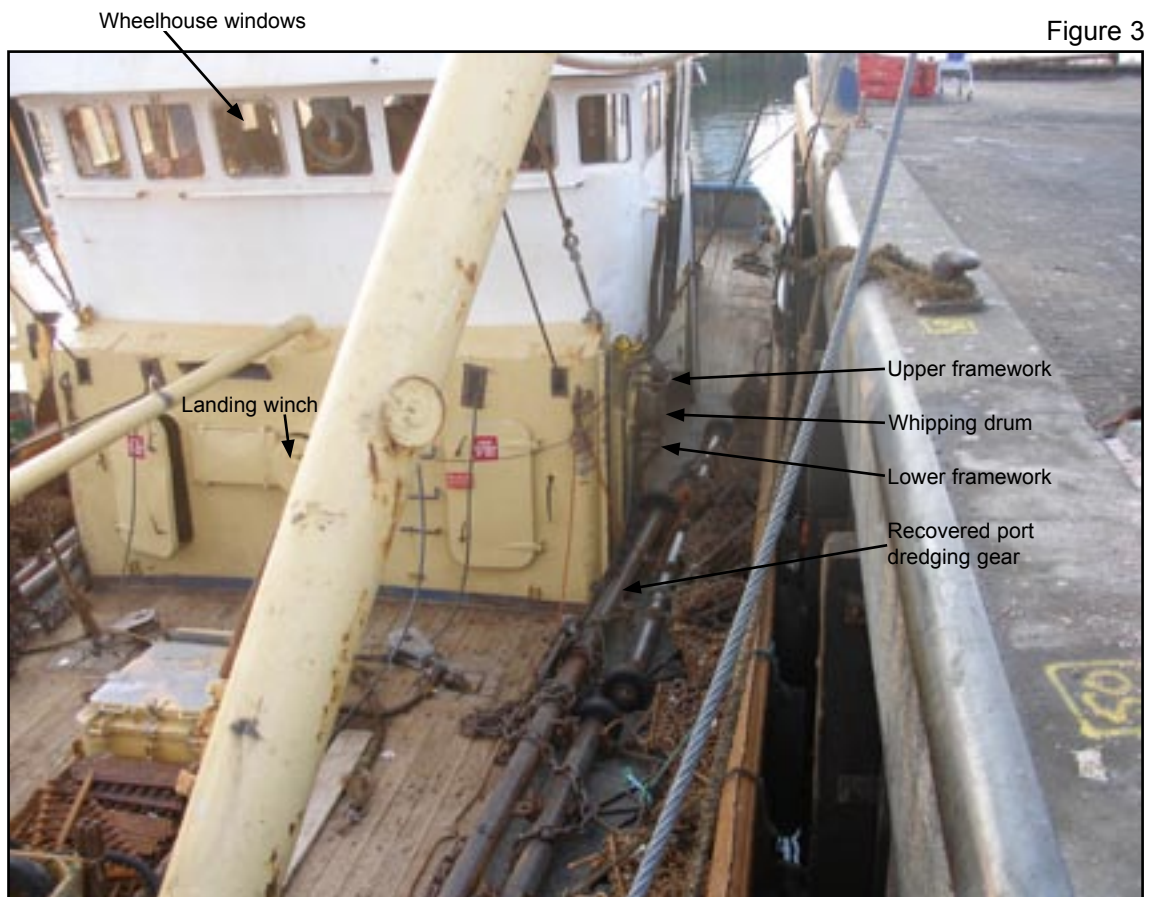
A description of the hauling procedure is provided at 1.6, which involves the gear being brought alongside the vessel, by the skipper or mate operating the winch in the wheelhouse. Once alongside, the deckhands then check the dredges on each side for any damage, before giving the all clear to the skipper or mate to commence the “tipping” of the contents of each dredge onto the deck. This is facilitated by using a whipping drum, or warping drum, located on each side of the winch house on the main deck. Depicted in **Figure 3**, this is used to individually raise each dredge in turn.

General port side main deck view, looking aft

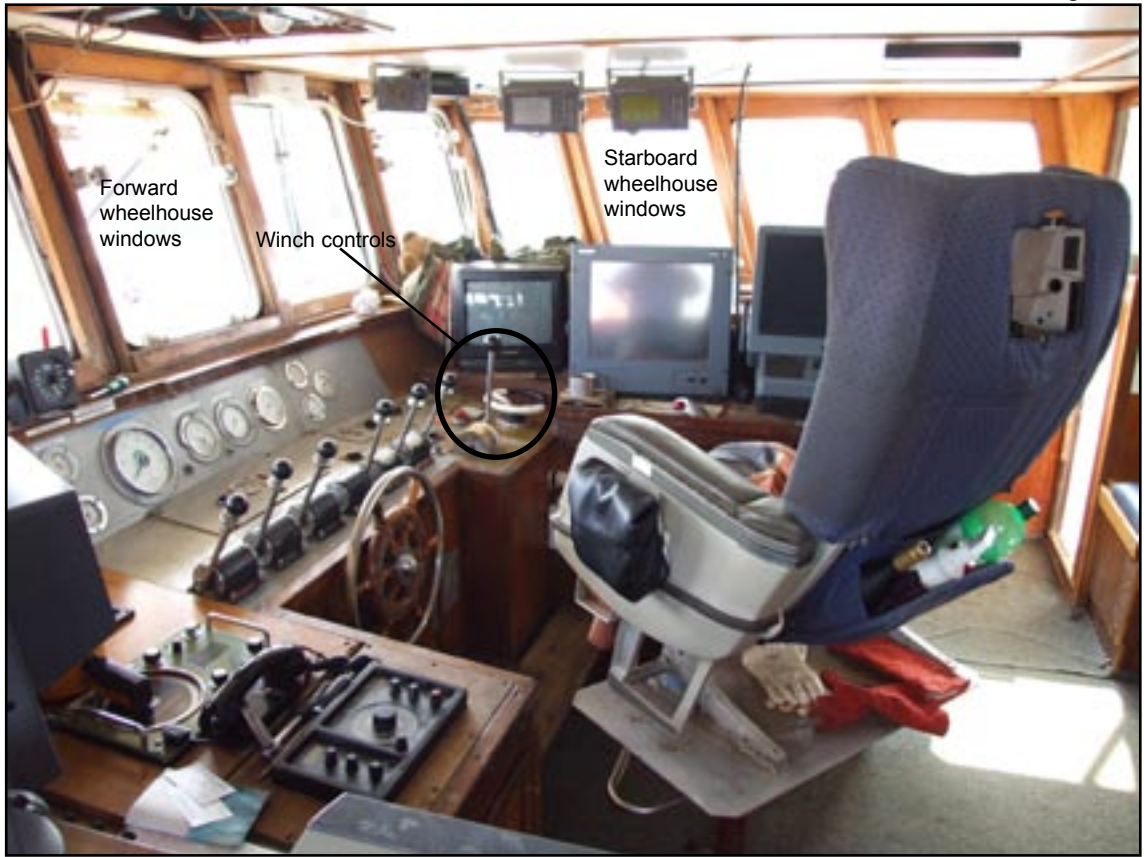
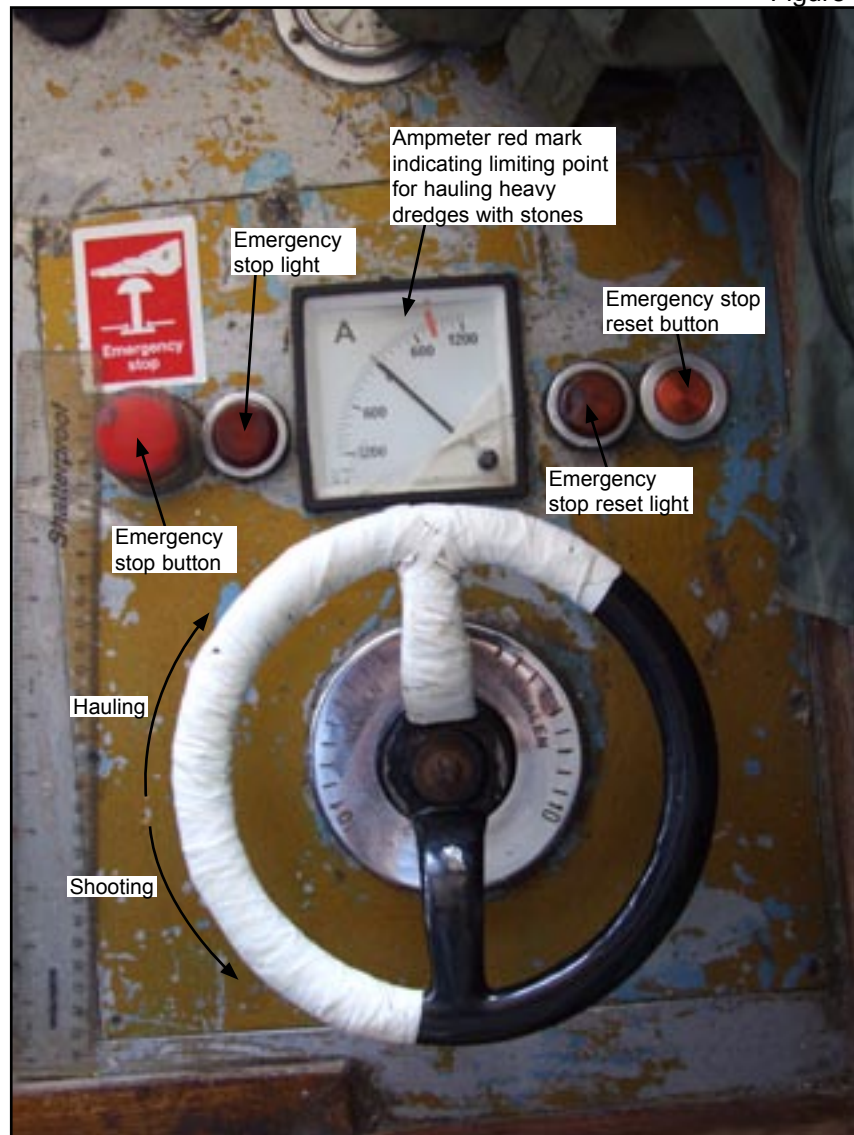
Figure 4

Wheelhouse, looking forward and to starboard

Close-up view of winch controls

The controls for the winch are located in the wheelhouse, as depicted in **Figures 4 and 5**. These incorporate a dial, for altering the speed of the winch, and an emergency stop and reset button. The normal setting for “tipping” resulted in the whipping drums rotating at around 27 rpm, with the port drum rotating anti-clockwise, the starboard drum clockwise.

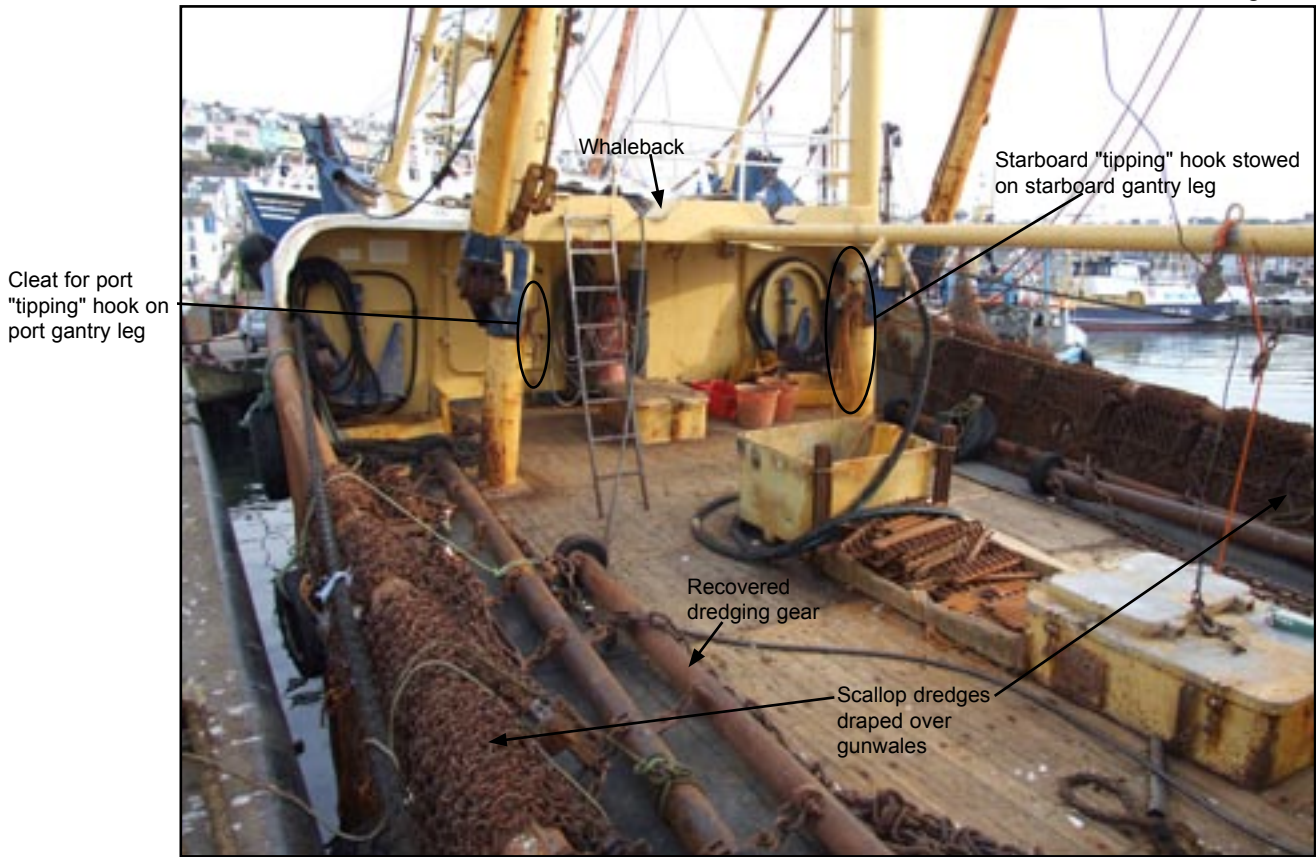
Figure 6

Main deck looking forward towards whaleback

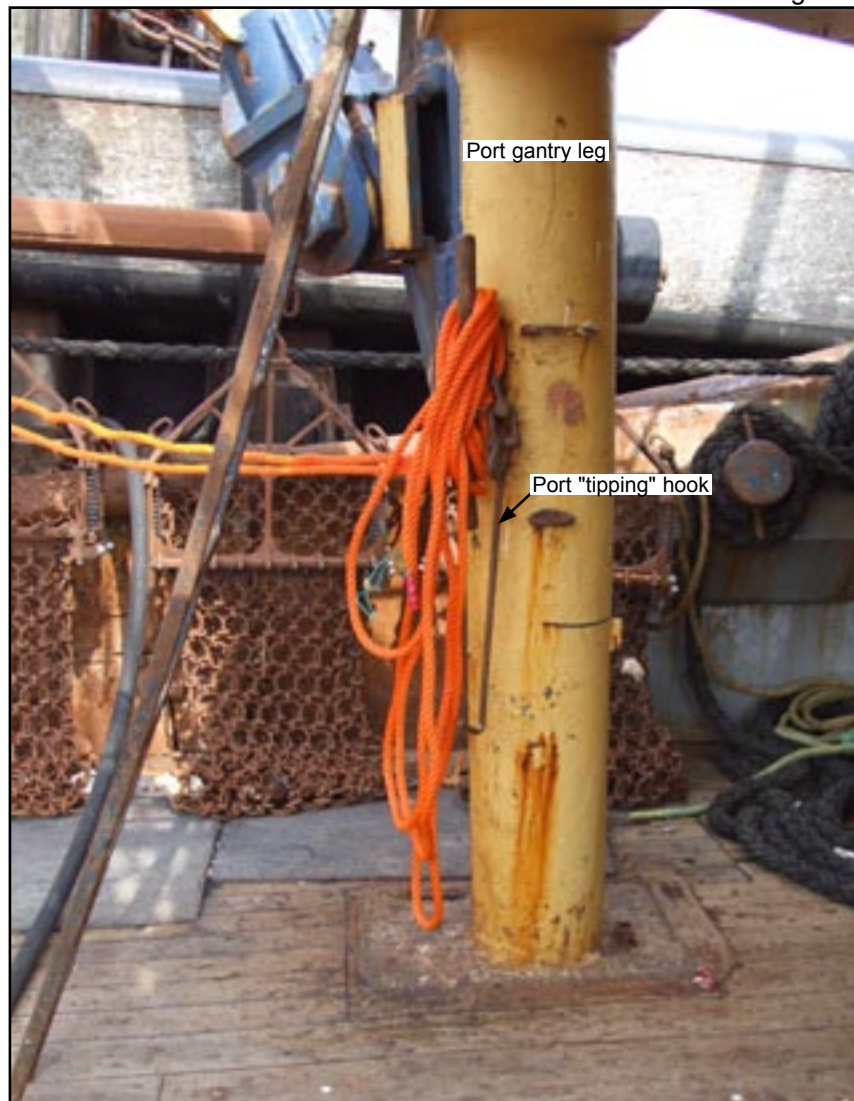
Figure 7

Once the dredges were on the rail, the skipper went to assist on the starboard side, while the port side deckhand began his normal “tipping” preparations. He firstly went forward to get the “tipping” hook, which was attached to an 18mm diameter “tipping” rope, from its stowed position on a cleat forward on the port gantry leg (**Figures 6 and 7**), and hooked it into the back of No.8 dredge<sup>1</sup>. He then fed the bitter end of the tipping rope through the “tipping” block arrangement at the forward end of the winch house (**Figure 8**), pulled the slack through, and laid the rope out along the dredges and aft to the whipping drum. The “tipping” rope was then fed into the forward bottom section of the whipping drum, and he put 2½ anti-clockwise turns round the winch head (**Figure 9**).

Port gantry leg and stowed port "tipping" hook

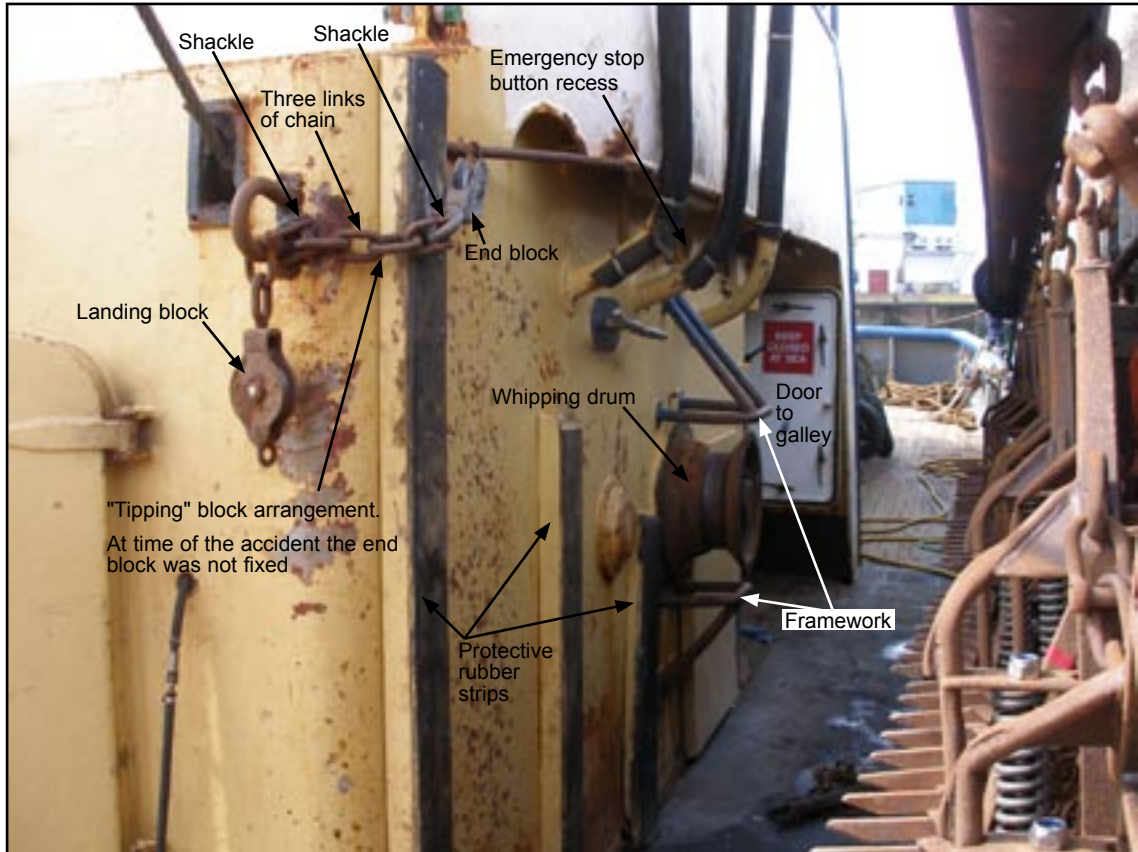
Figure 8

Passageway to port side of winch house

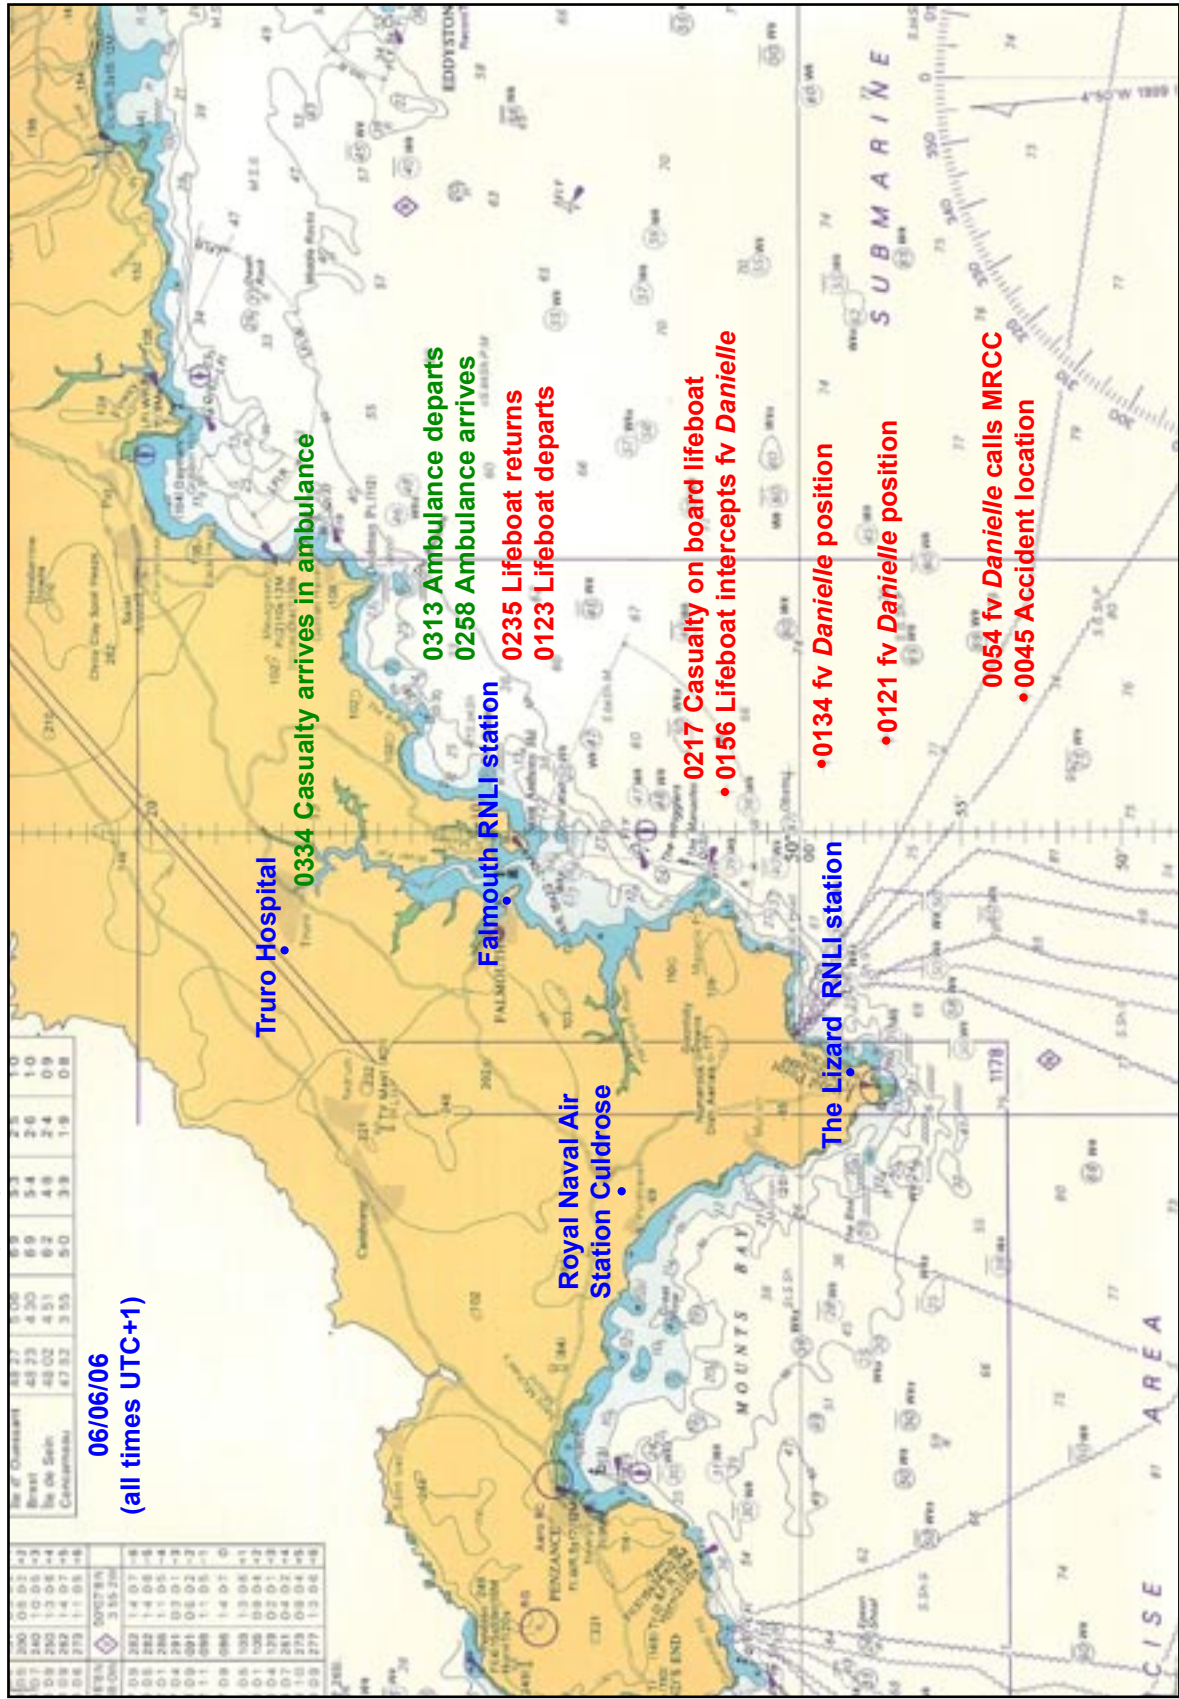
Figure 13

Chart showing accident timings and locations

At 0134, the MRCC contacted *Danielle* for a further update, and the skipper stated that the deckhand was complaining of breathing difficulties, was heavily perspiring, and that his condition had probably worsened. *Danielle's* position at this time is shown at **Figure 13**.

At 0258, the ambulance arrived at the Boathouse, and the on board paramedic immediately began treating the deckhand and preparing him for transfer to hospital. The ambulance departed at 0313 with the by now unconscious deckhand embarked, and arrived at Truro hospital at 0334 (see Figure 13).

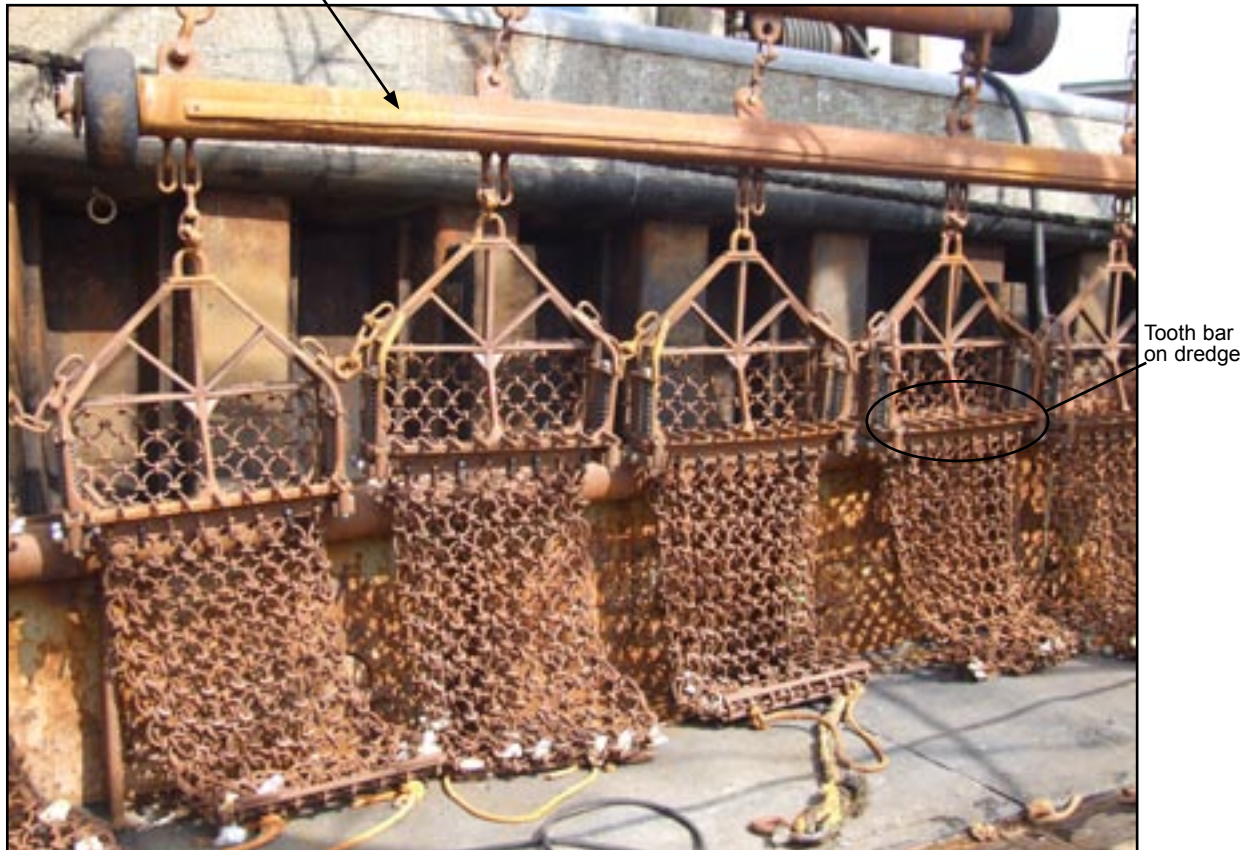
Figure 19

As the name of this type of fishing suggests, the gear is dragged along the seabed to dredge up scallops, a variety of shellfish. A sketch of a typical arrangement of dredging gear is shown at **Figure 17**, while **Figure 18** describes the design and operation of a standard scallop dredge. **Figure 19** shows the scallop dredge bags used on *Danielle*.

Port side scallop dredges on *Danielle*

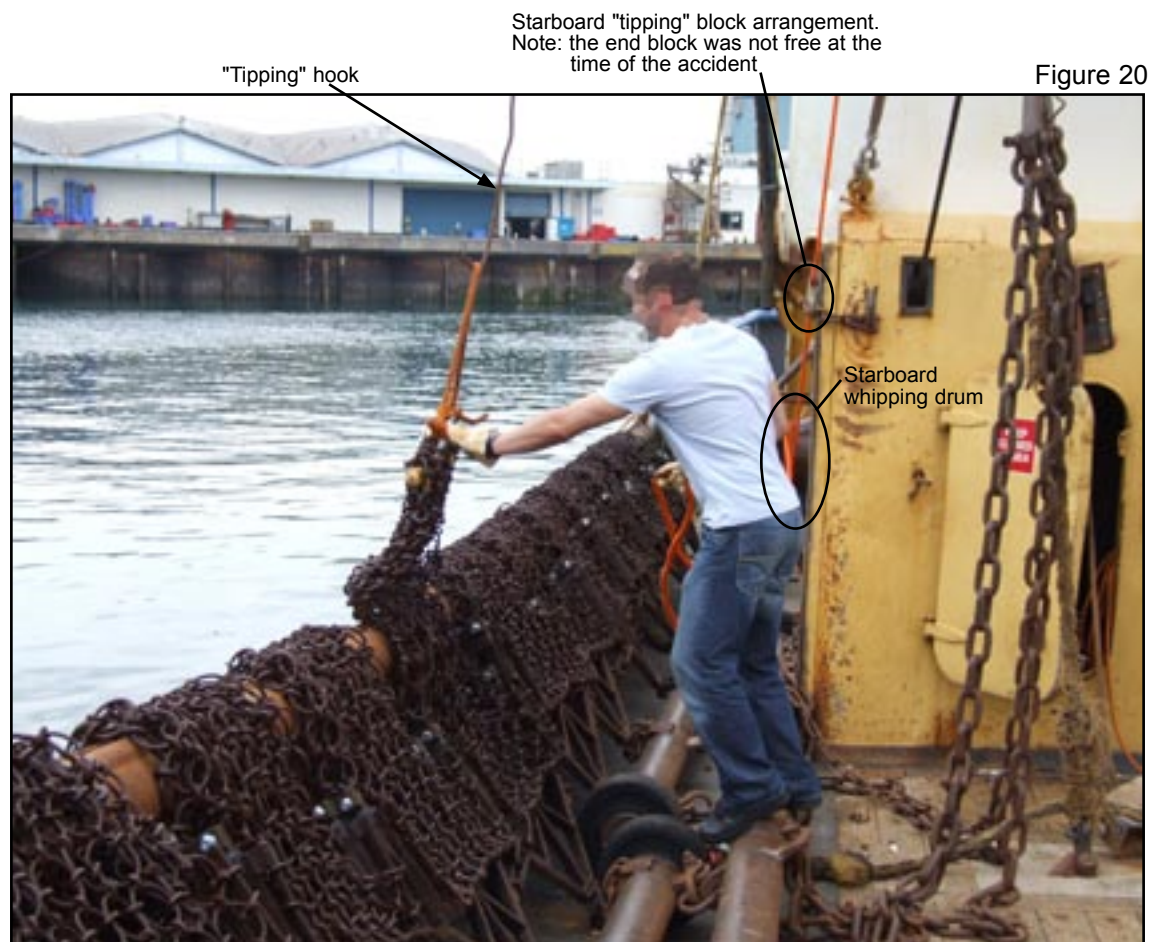
**Figure 20** shows a view of the “tipping” demonstration provided by the crew on 26 July 2006 on the vessel’s starboard side.

“Tipping” demonstration on board *Danielle* on 26 July 2006
