Report on the investigation  
of the loss of the tug  
***Flying Phantom***  
while towing  
***Red Jasmine***  
on the River Clyde  
on 19 December 2007  
resulting in 3 fatalities and 1 injury

Marine Accident Investigation Branch  
Carlton House  
Carlton Place  
Southampton  
United Kingdom  
SO15 2DZ

**Report No 17/2008**  
**September 2008**

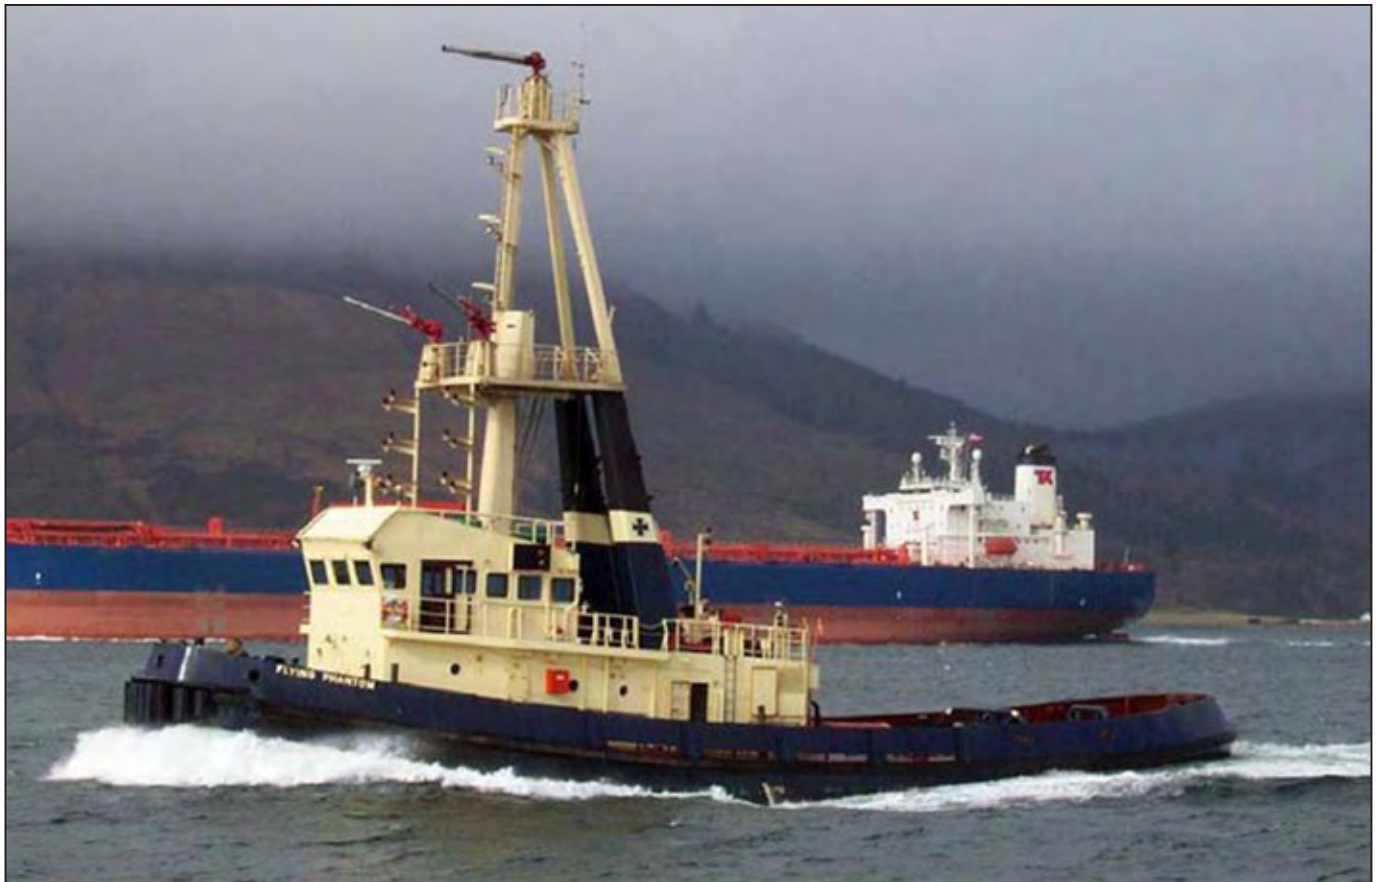
Figure 1

*Flying Phantom*

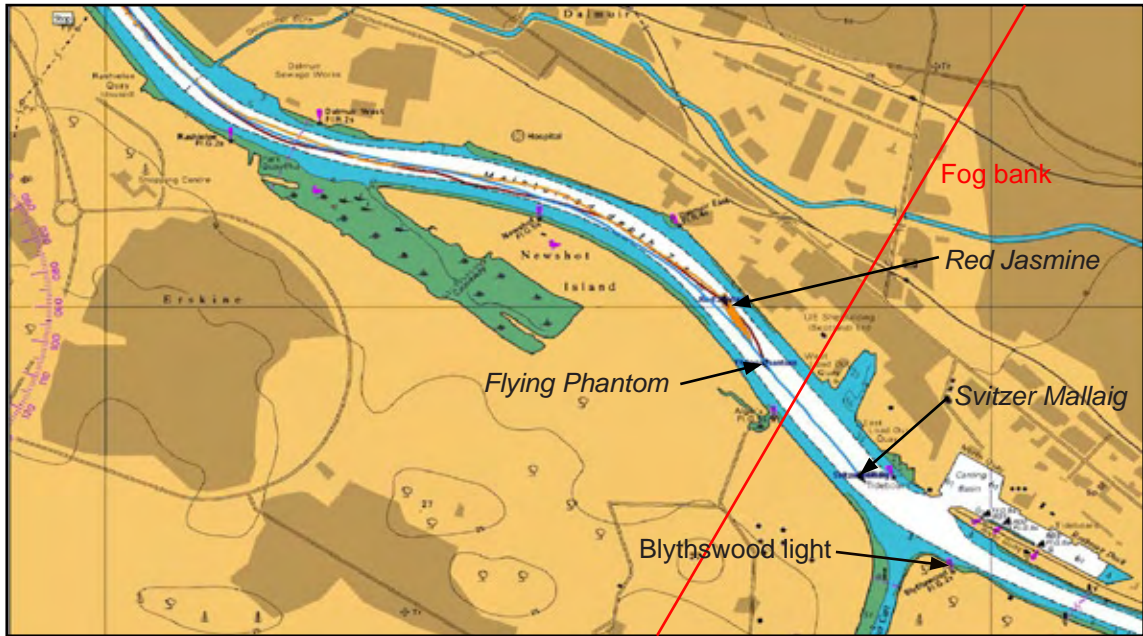
As *Flying Phantom* entered the fog it was apparent that the towing operation was becoming difficult. The skipper had been keeping the tow rope in line with *Red Jasmine's* foremast light, but lost sight of this in the fog. The skipper was worried that he was becoming disorientated in the fog, and around this time he discussed with the mate the option of staying in the centre of the channel and towing the ship.

Vessel tracks and estimation of fog bank

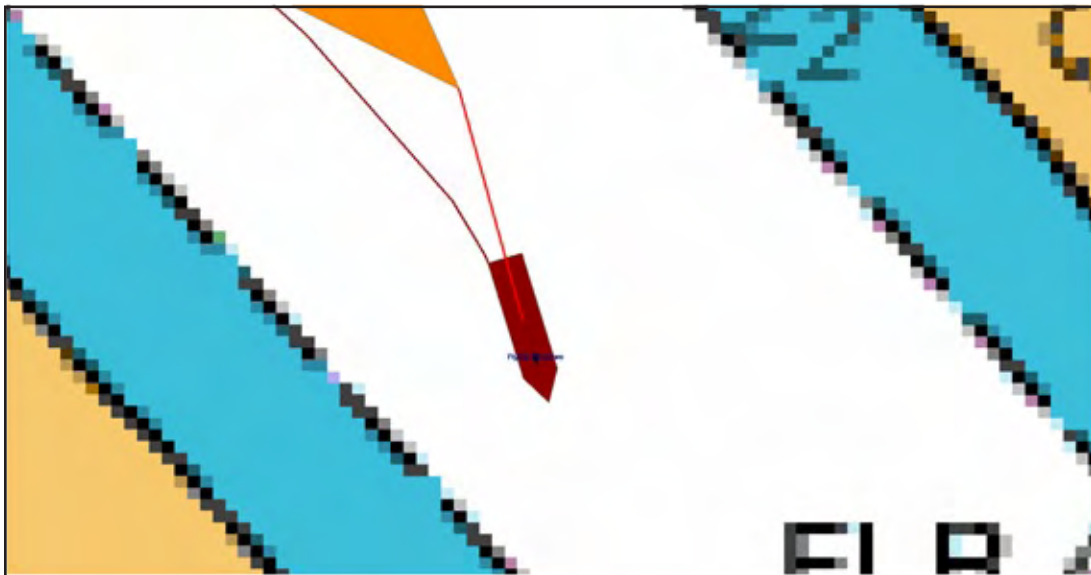
Figure 7

At 17:58.31 (**Figure 6**), concerned that *Red Jasmine* was not turning sufficiently quickly and was still headed for the groundways, the pilot called *Flying Phantom* to say that the bow needed to move further to starboard. As *Red Jasmine* started to respond, the pilot instructed *Flying Phantom* to ease off at 17:59.02, 1 minute after the initial order to take *Red Jasmine*'s bow to starboard (**Figure 7**). The instruction was followed a few seconds later, at 17:59.19, by the mate of *Flying Phantom* reporting that *Flying Phantom* was aground (**Figure 8**). The pilot responded, instructing the crew of *Flying Phantom* to

17:58.31 - Pilot instructs to pull further to starboard

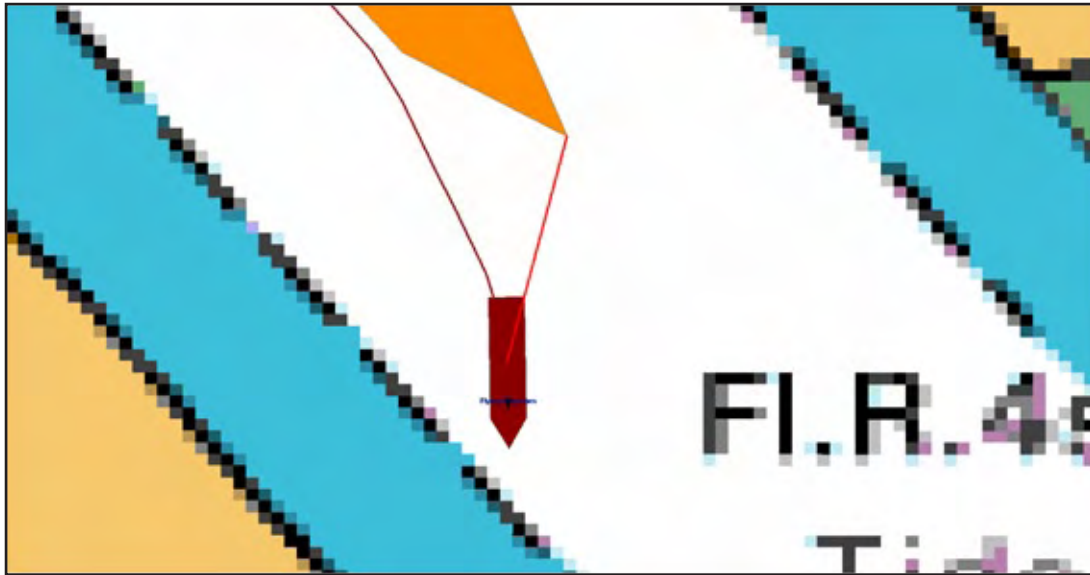
Figure 8

17:59.02 - Pilot instructs *Flying Phantom* to ease off

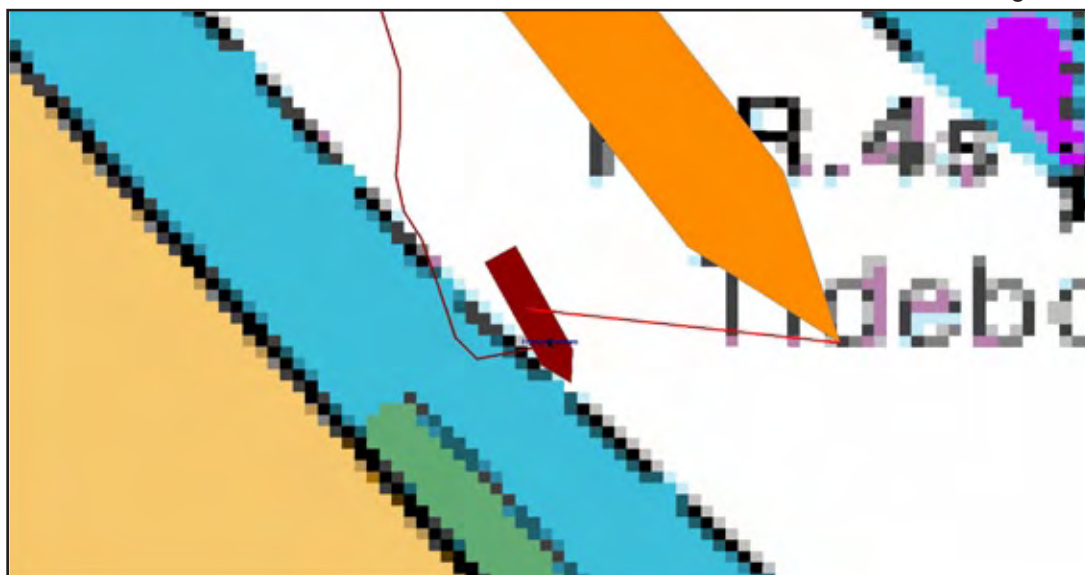
17:59.53 - Last recorded AIS position of *Flying Phantom*

As the tug heeled over the two crew members who had been below came up into the wheelhouse. As *Flying Phantom* continued to heel further over to port, the mate clambered out of the wheelhouse and on to the starboard side, expecting the rest of the crew to follow him. As he looked back into the wheelhouse, he saw water bubbling into the wheelhouse through the port door. He was aware the engines were still running at that time and he also heard the pilot's call on the VHF radio asking if *Flying Phantom* was alright, but he was unable to reach the radio to respond. *Flying Phantom* continued to heel over and the mate scrambled on to the side of the hull from where he could see the tug's partially submerged starboard bilge keel. He could also see, on the north side of the river, the red flashing navigation mark on the end of the groundways (**Figure 4**). He was not aware of *Red Jasmine* or *Warrior III* passing by, but thought he could hear the distinctive engines of *Warrior III*.

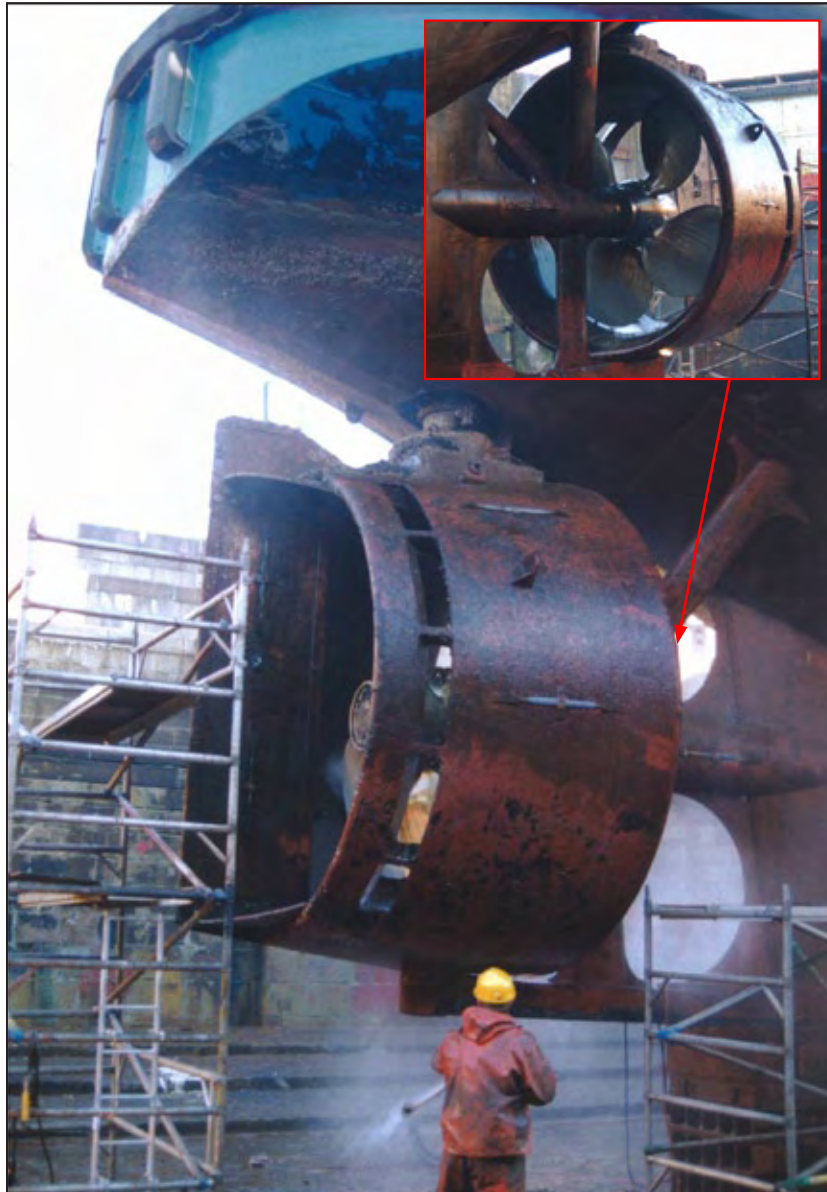
*Flying Phantom*'s propulsion system consisted of twin diesel engines driving a single shaft, through a gearbox, fitted with a controllable pitch propeller (CPP), housed within a steerable Kort nozzle (**Figure 13**). The engine revolutions would be set at standard rate, depending on the operation, and the thrust would be varied by adjusting the propeller pitch.

CPP in Kort nozzle

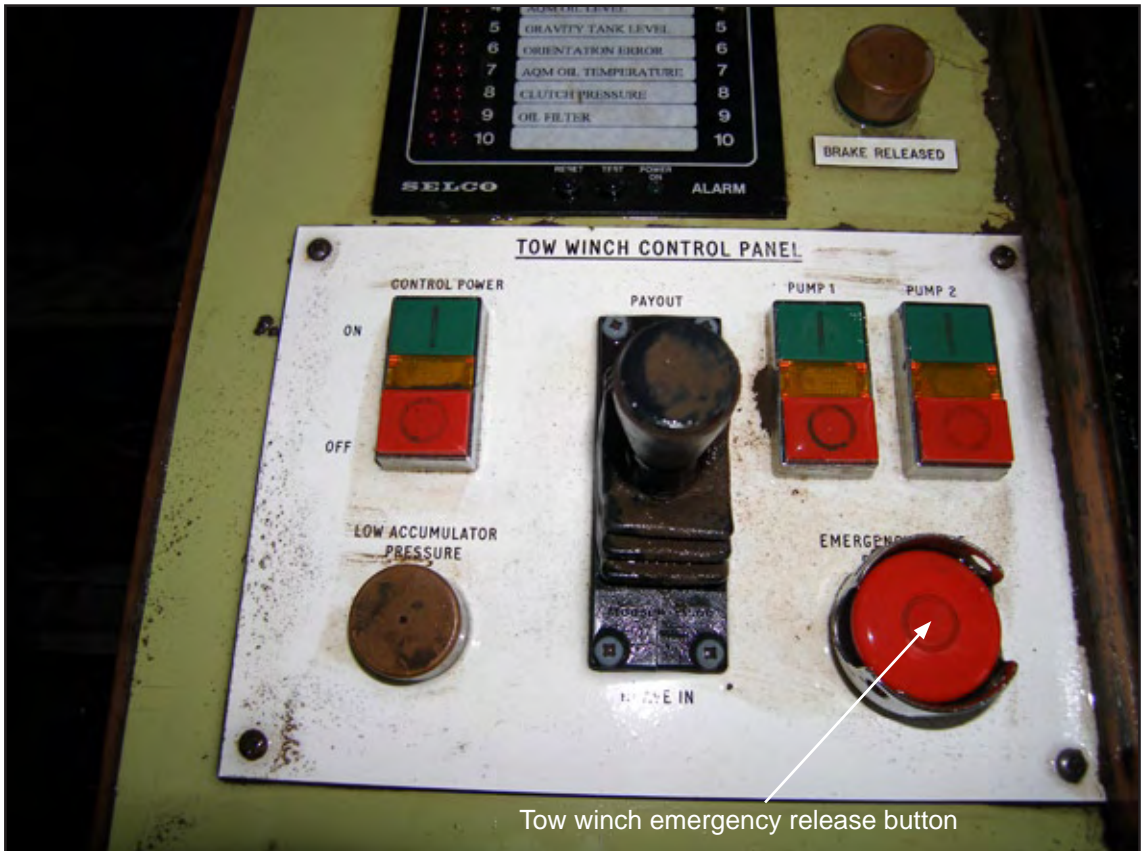
When the pilot requested *Flying Phantom* to pull the bow of *Red Jasmine* to starboard, the skipper used the helm to steer to starboard and he applied some more power to move *Flying Phantom* and her tow across the river. The mate was looking out of the starboard door and glancing at the radar when he noticed the riverbank radar return appeared very close, ahead of the tug's bow. *Flying Phantom* then lurched and heeled over to port. The skipper started to use the Aquamaster thrusters and, at the same time, the mate called the pilot and informed him the tug was aground. On receiving from the pilot the instruction to let go of the tow line, the mate immediately pressed the tow winch emergency release button on the starboard console.

Tow winch emergency release button

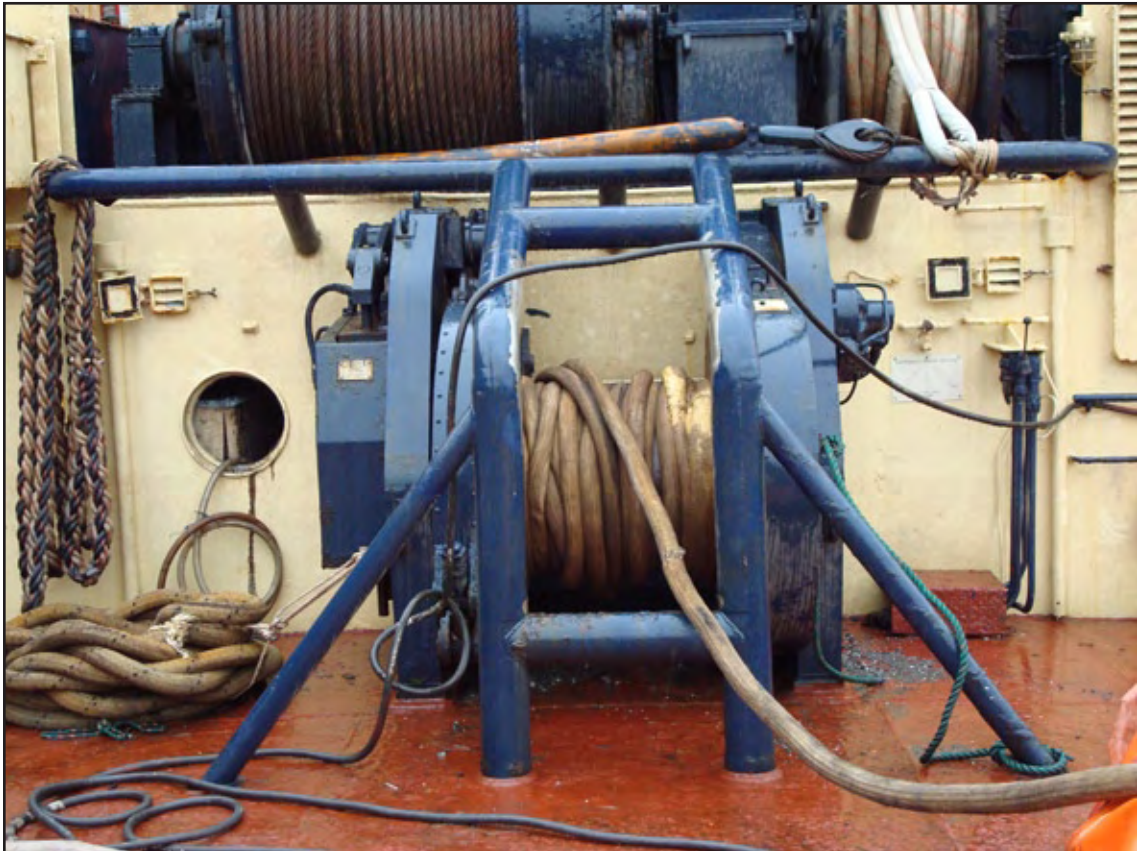
Figure 18

The towing winch (**Figure 18**) was fitted during the major refit in 1997. Prior to this, the primary towing attachment was a quick release towing hook, mounted on the aft bulkhead of the wheelhouse. The towing winch was mounted vertically on the bulkhead in place of the towing hook, rather than on the deck, which was more usual for this design of winch. This was because the deck structure had not been designed to take the towing load.

Towing winch

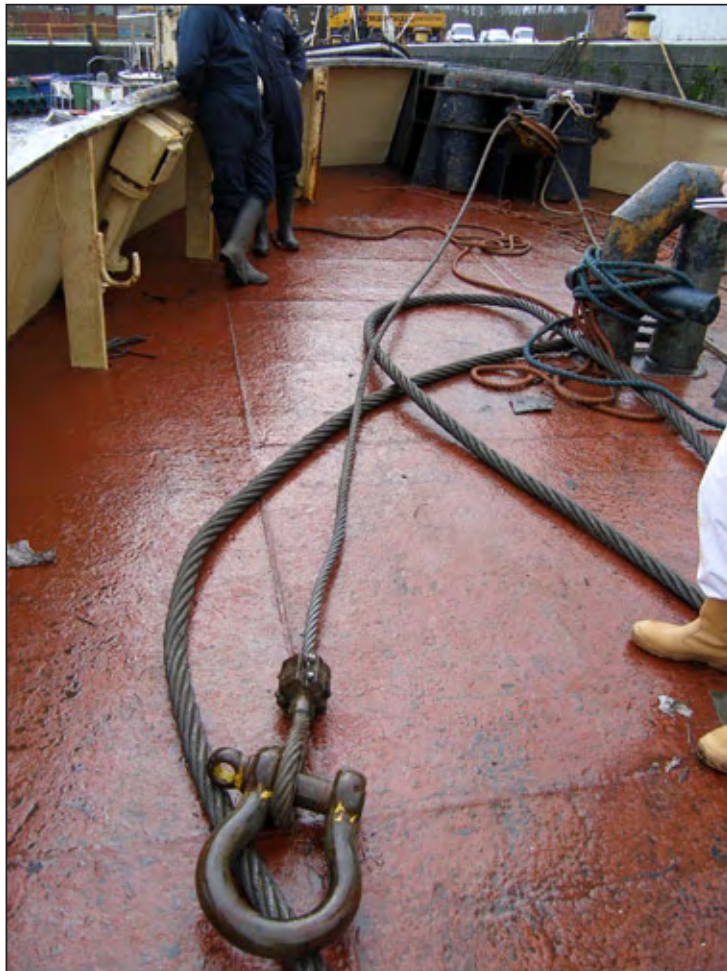
Figure 21

On *Flying Phantom*, the bridle winch was situated on the aft deck and the bridle wire from its drum ran through a swivel fairlead mounted inside the bulwark on the stern (**Figure 21**). The wire had a bow shackle at its end, through which the tow line would pass. The bridle winch was able to heave 9.8 tonnes on the bottom layer, when it was new, and had a specified 24.6 tonne brake holding capacity. Similar to the towing winch, the bridle winch could not be heaved-in under heavy loading.

Swivel fairlead on transom, bridle wire and bow shackle

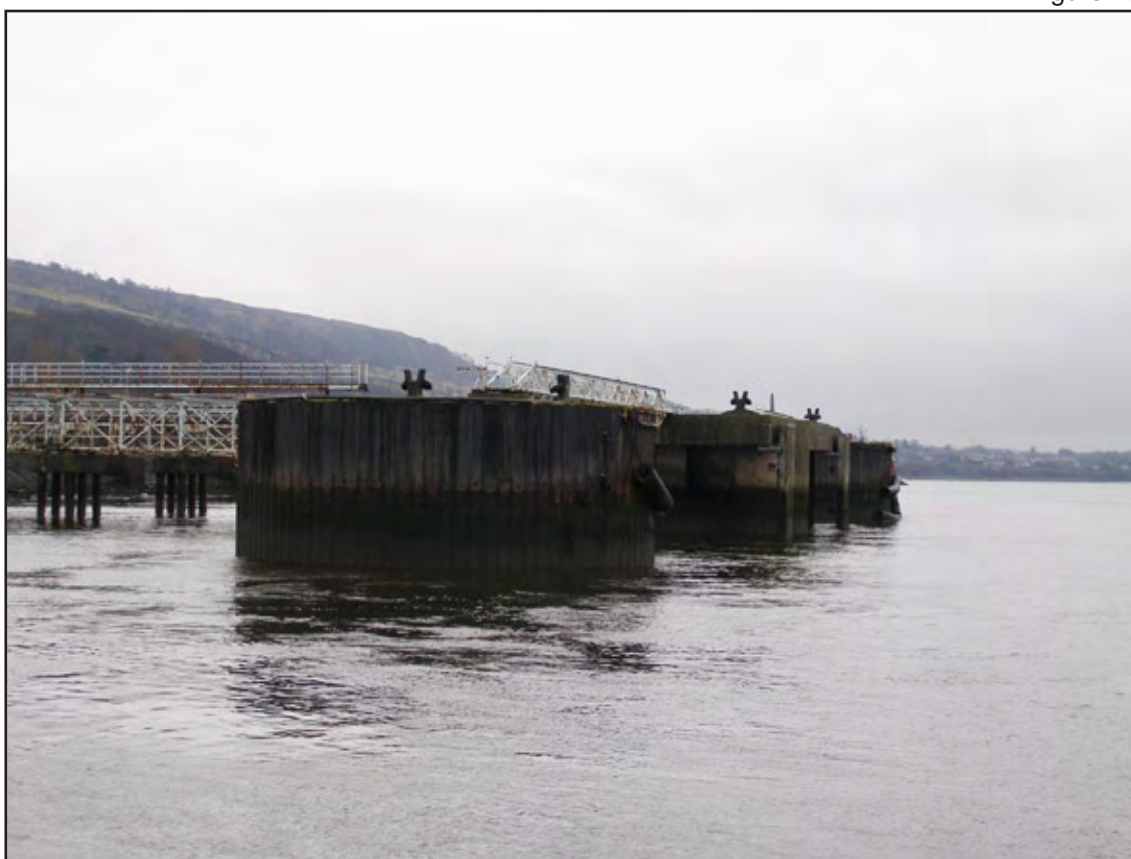
Figure 29

Once the pilot had received the report of fog, the only advice to him in WI/OP19/6 was to consider using the disused Esso Bowling Tanker Jetty (**Figures 29 & 30**) as a lay-by berth. *Red Jasmine* had only just passed this berth when the fog was reported, and to halt her and take her astern to the berth would have been possible. The pilot, however, did not consider this a viable option as the berth's condition was unknown, it having been left unused for approximately 12 years. A subsequent hydrographic survey of the berth revealed heavy silting, supporting the pilot's concerns; had *Red Jasmine* moored there, she would have grounded at low water and been at risk of significant hull damage.

ESSO Bowling Jetty

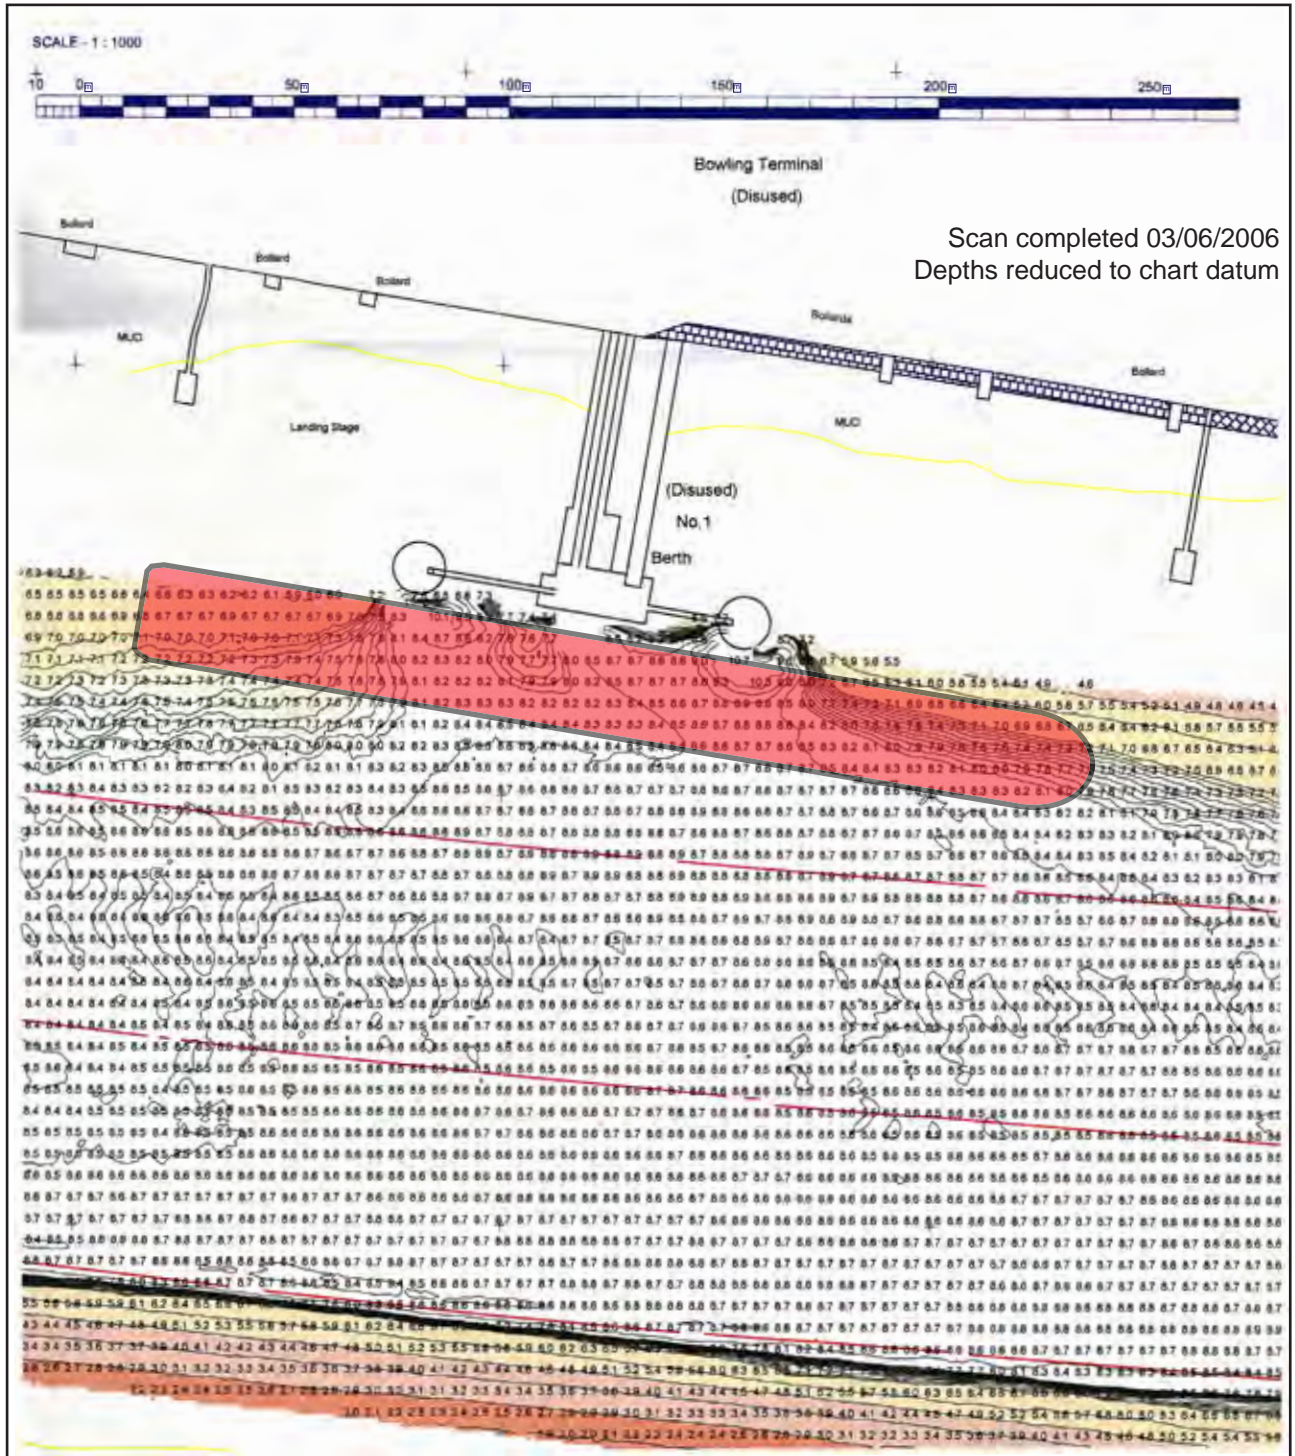
Chart of ESSO Bowling Jetty, showing an indication of *Red Jasmine's* position alongside
