Report on the investigation of the collision between  
two Offshore Circuit Racing powerboats

in Dover harbour

8 August 2009

**Report No 7/2010  
July 2010**

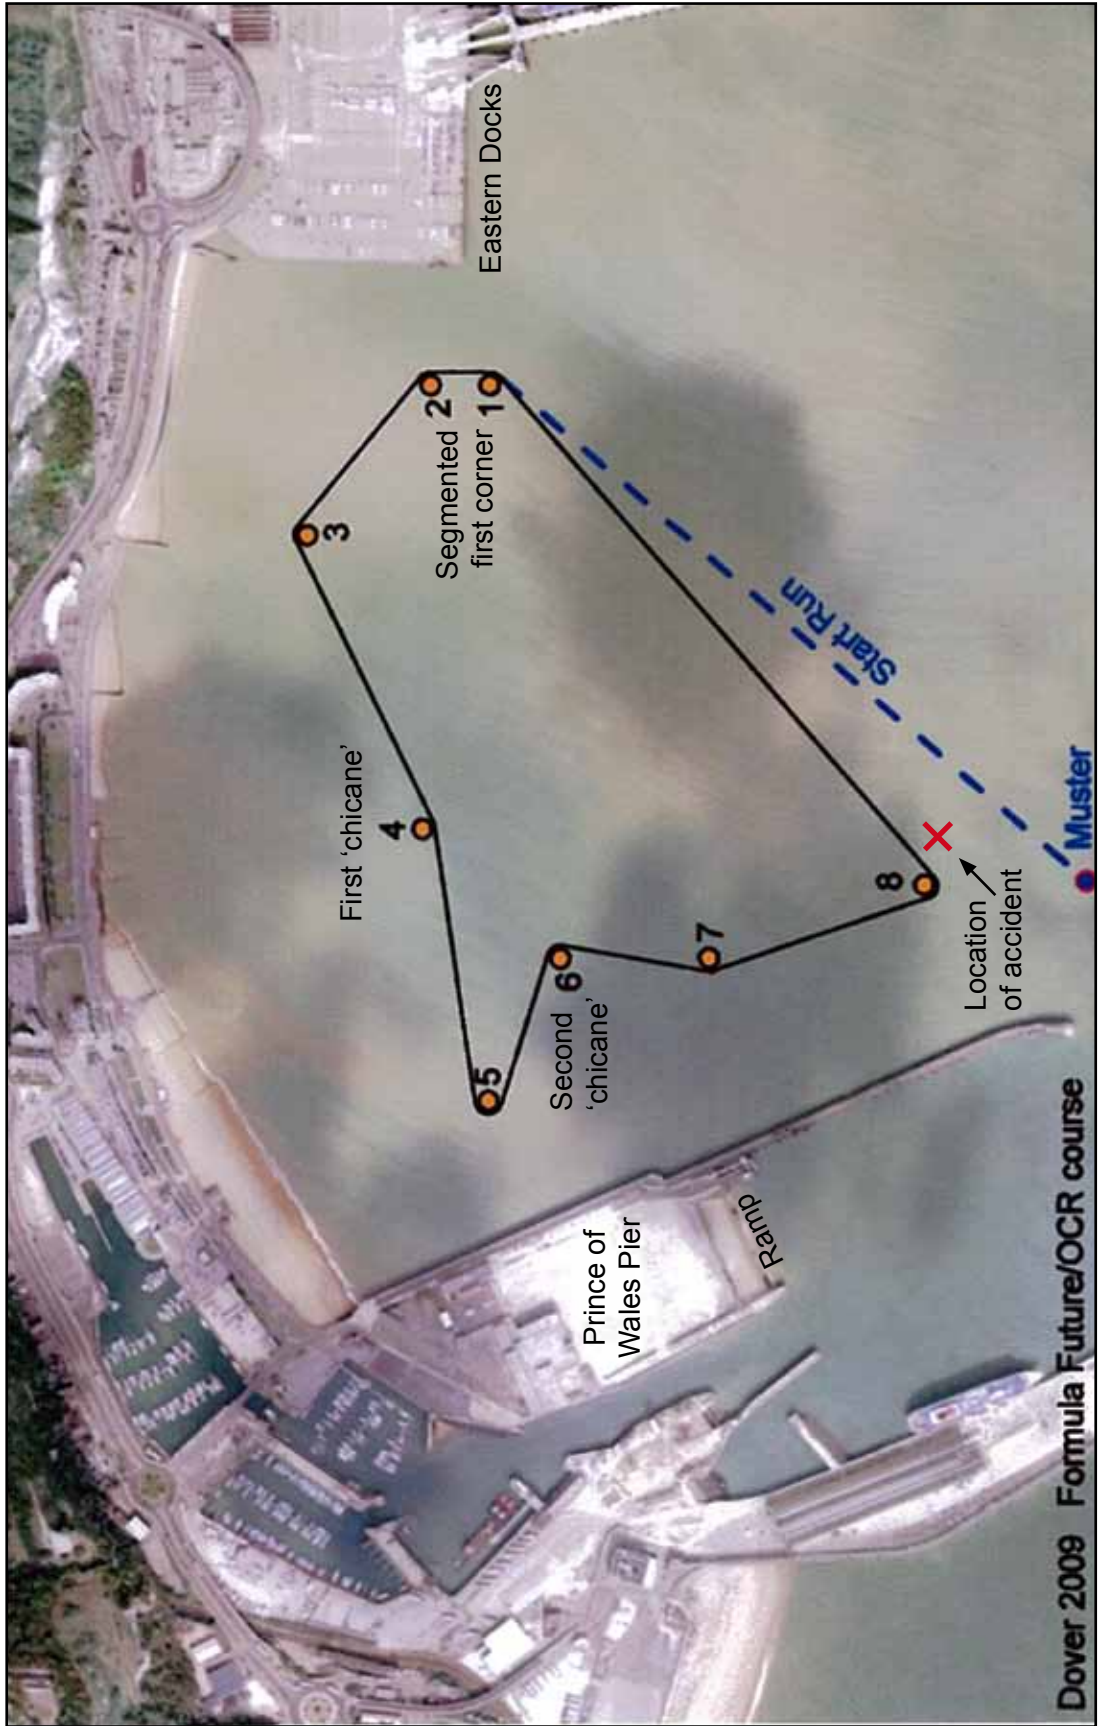
Figure 1

The course was designed by UKFFORC and used eight buoys to make an oval shape, modified on two sides with chicanes (**Figure 1**). The first turn consisted of two buoys (no.s 1 and 2), to create a longer arc and encourage separation between the boats at the end of the starting run. This feature was introduced to racing after a collision between two boats in a junior class which occurred at the first corner of a race in 2005<sup>2</sup>. The first chicane on the back straight was relatively gentle, but prevented the boats from straying too close to the beach. Buoy no. 5 was positioned towards the Prince of Wales Pier and was set out from the natural oval shape. It was followed by a chicane which made the turn around buoy no. 5 acute and caused the boats to slow as they approached the pier. The chicane then led the drivers through a more challenging right hand turn past buoys 6 and 7. The accident occurred near the last turn at buoy no. 8, a 90° left hand turn back onto the main starting straight.

Planned course (see Figure 14 for actual track of boats and position of fixed navigational marks)

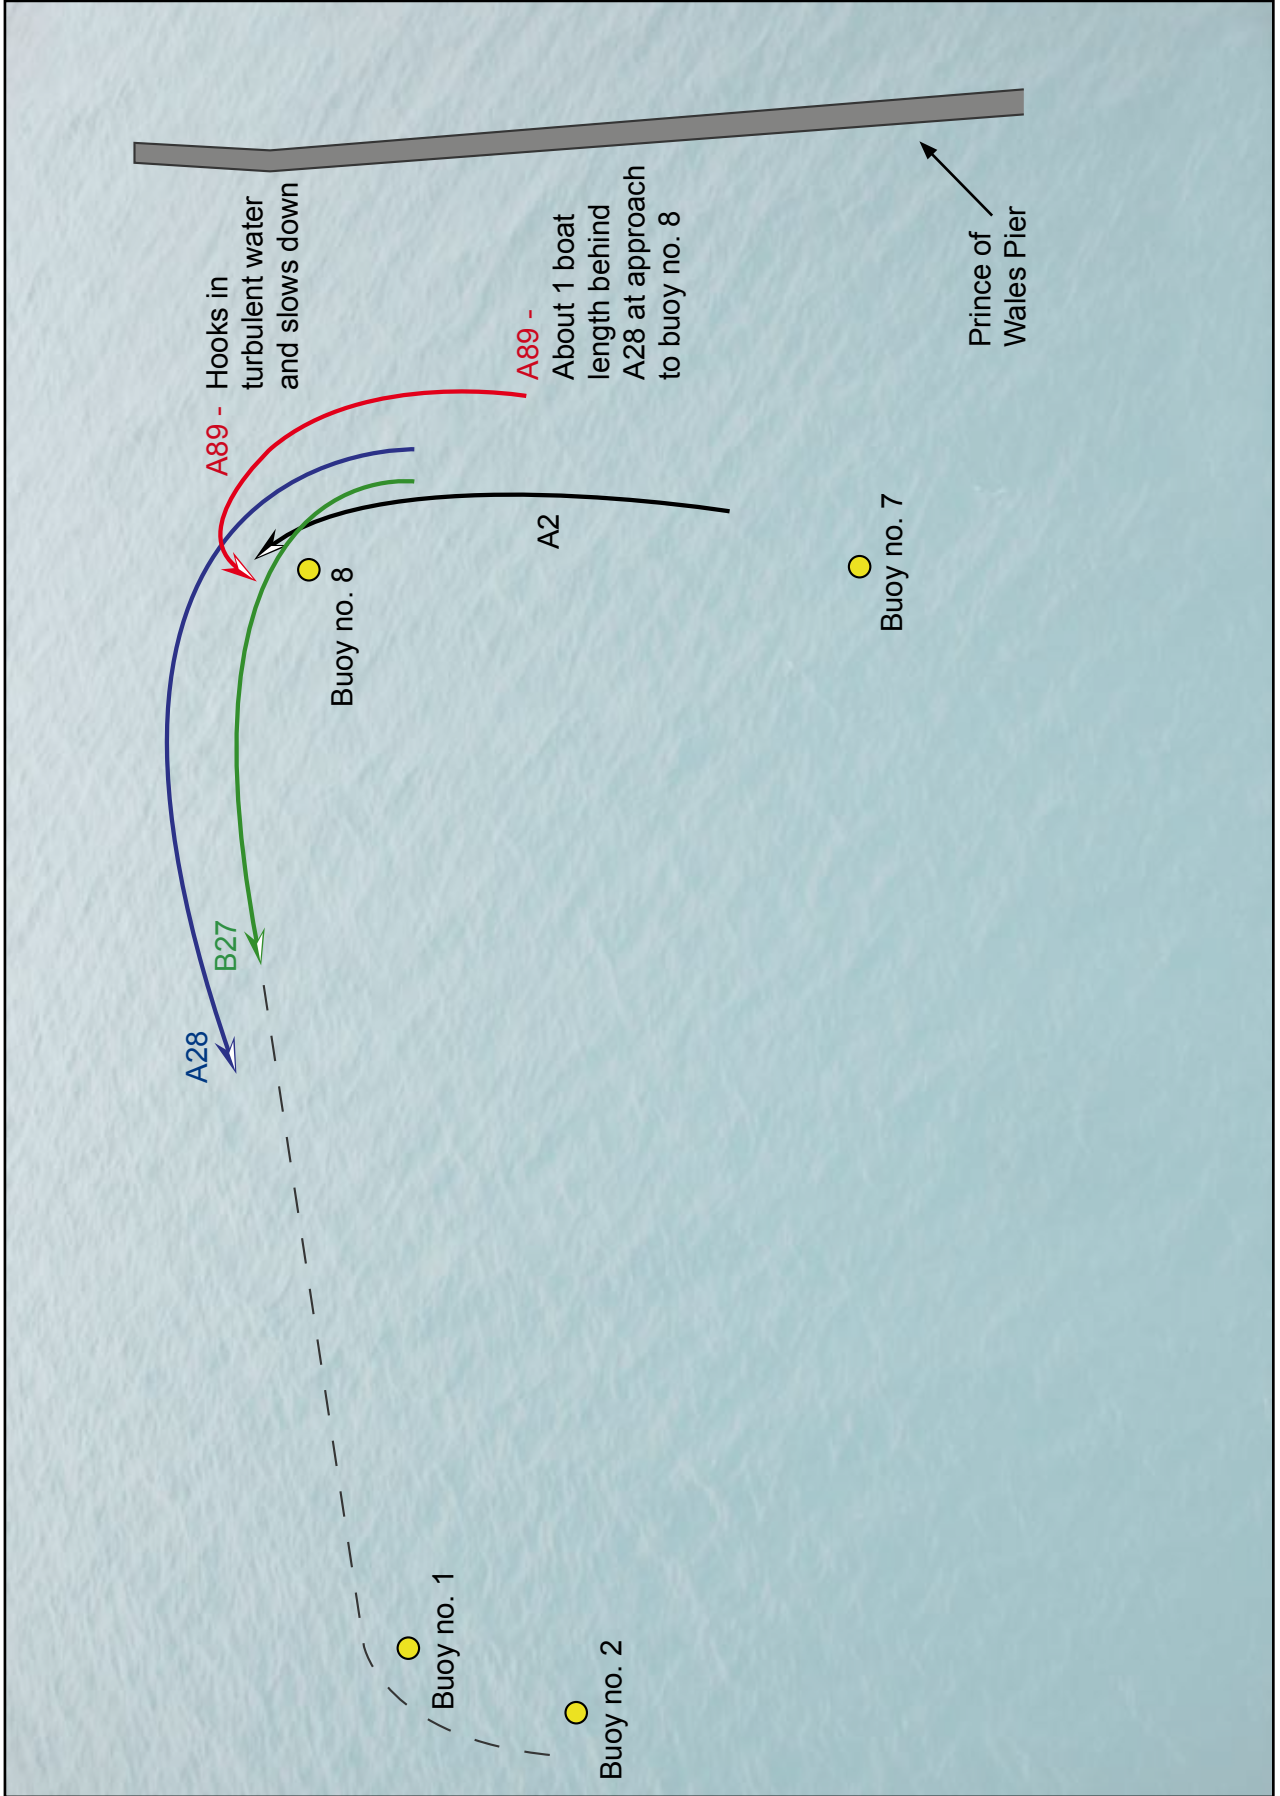
The race was started at about 1132, and the allotted 25 minutes elapsed as the leaders completed their 16<sup>th</sup> lap, and the last lap flag was flown. One of the videos of the race showed the collision and events immediately beforehand, from which it was possible to determine the courses followed by the boats (**Figure 2**). Boat B27 approached buoy no. 8 and took a tight line around the turn. Boat A28 was behind, but catching up and preparing to overtake (**Figure 3**). It followed a similar, but wider line to B27 around the turn keeping clear, but leaving it in position to overtake on the next straight. Timekeepers recorded that boat A89 was 2 seconds behind A28 and, from the video, there appears to be about one boat length between them as they approached buoy no. 8 (**Figure 4**). Boat A89 took an even wider line than A28, but during the turn, the driver attempted to cut inside of A28, in order to gain an advantage on the next straight. During this manoeuvre, A89 turned more sharply than was necessary, the bow trimmed down and the boat slowed significantly (**Figure 5**).

Courses followed by the boats before the collision

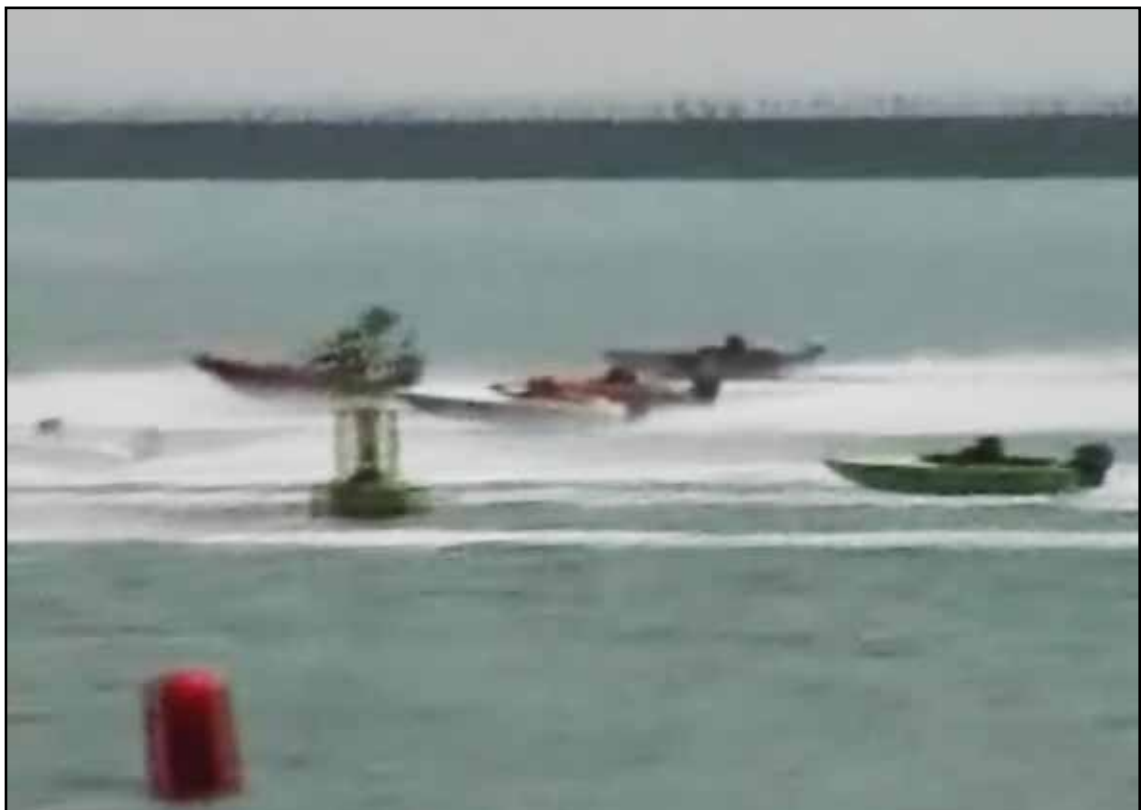
Figure 8

The race was started with all the boats in line abreast following behind the starter's boat. Speed was increased, with all the boats maintaining their positions, and when the start flag was raised they accelerated to full race speed. Although the bulk of the field was to the south of the special navigation mark, several boats passed extremely close to it on both sides, in their attempts to take the shortest route to the first turn (**Figure 8**).

Starting run passing the special navigation mark

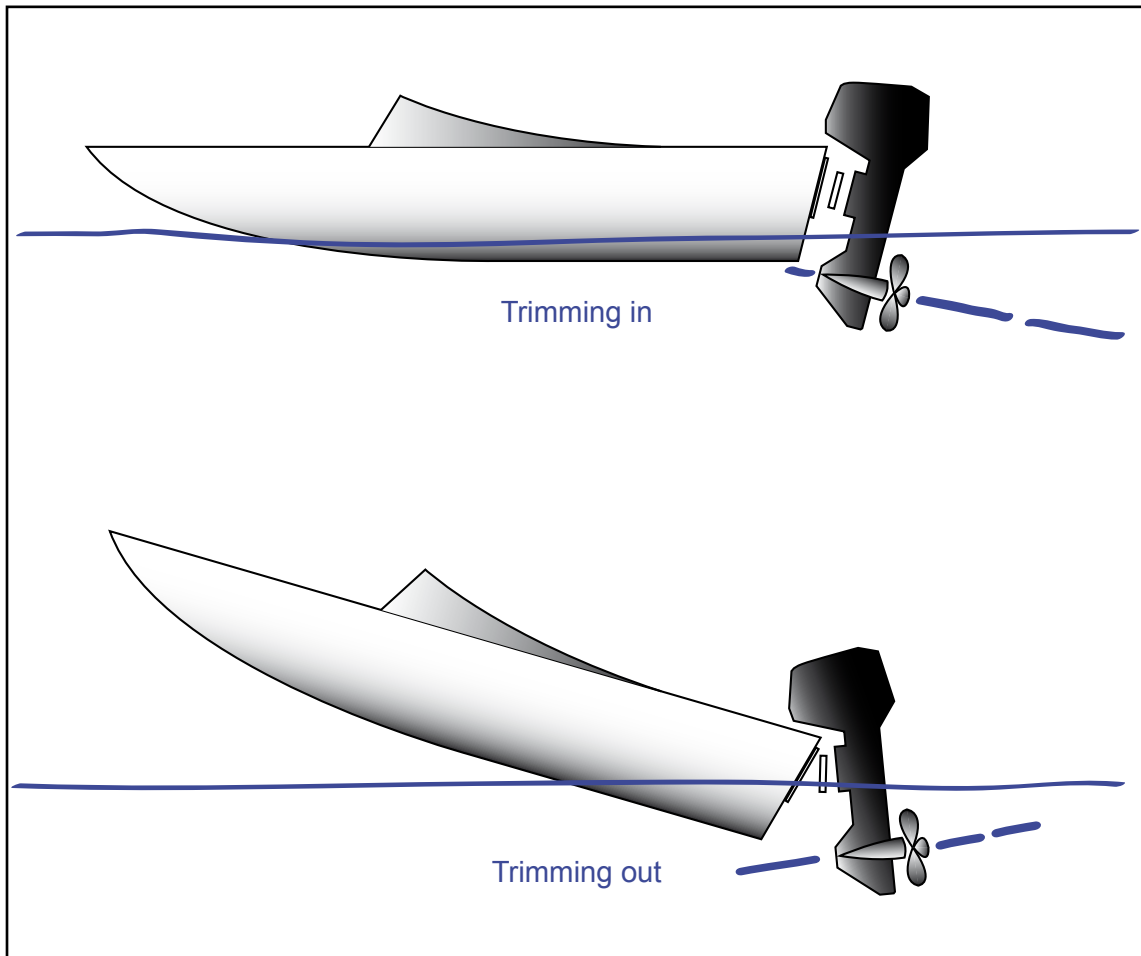
Figure 9

from the transom raises the bow, which improves the boat's ability to plane and so increases the top speed as less of the hull is in the water (**Figure 9**). However, it becomes more difficult to turn the boat in this state. Experienced racers reported that they adjust trim almost constantly during races to achieve the best balance of control and speed around the course. Both of the crews involved in this accident left their trim at an average setting to avoid additional complication during the race.

Effect of engine trimming

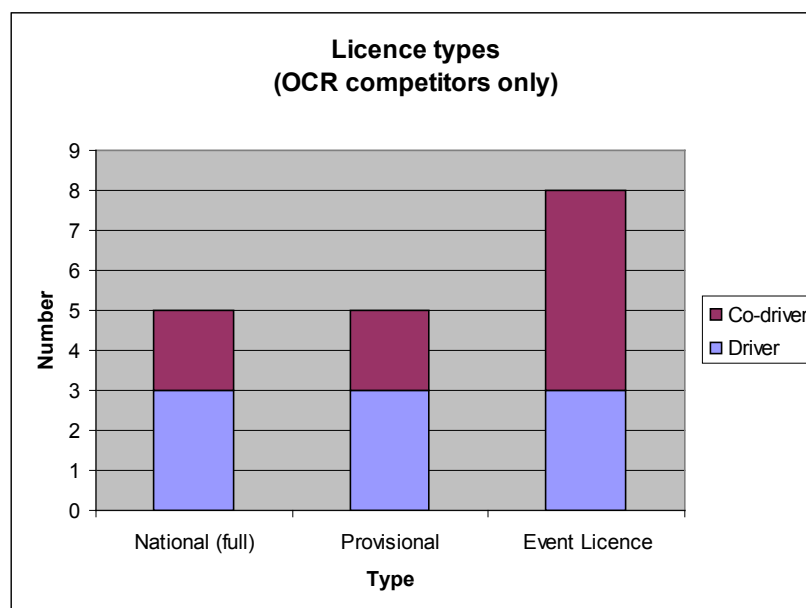
The types of licences held by the 18 competitors in the OCR classes at the Dover event are shown below (**Figure 10**).

Figure 10: Types of licence held by the competitors in the OCR Classes at the Dover Regatta. (Note: One of the co-drivers with a provisional licence had previously held a full licence, but had recently returned to the sport after an extended period and could not be issued a full licence immediately)

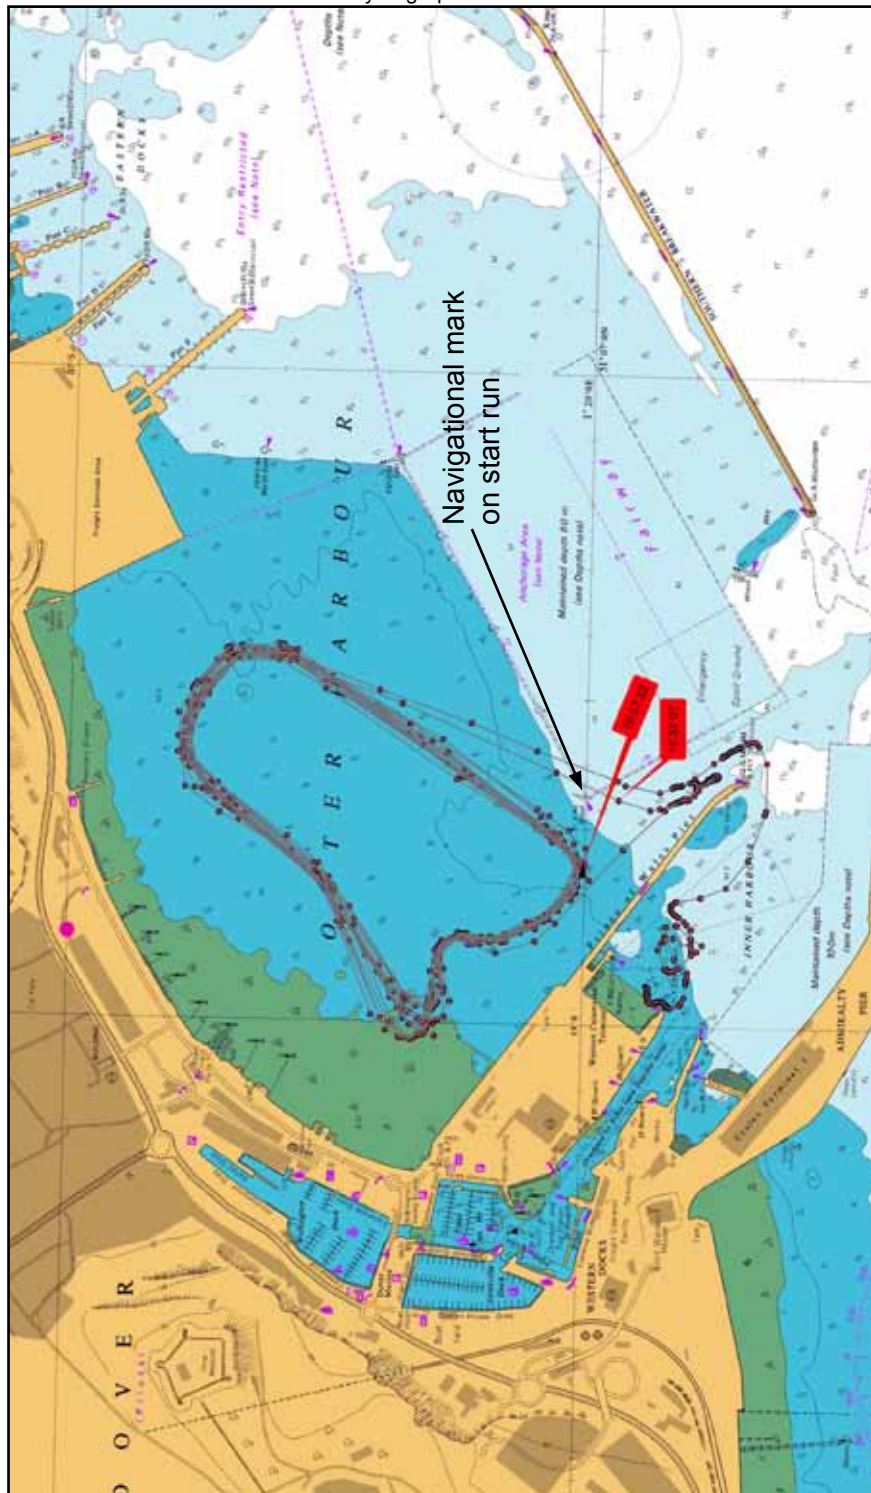
Figure 14

in the outer harbour (**Figure 14**). A representative from Dover Harbour Board sat on the Regatta Committee, and the location of the course and racing times were arranged to avoid potential conflict with commercial traffic and other craft taking part in the regatta. UKFFORC's plan for the powerboat racing events was accepted by the regatta committee and Dover Harbour Board, as they were assured that racing would be conducted in accordance with the RYA's rules, and the plan subject to RYA approval.

Chart extract with GPS data from boat A89
