Report on the investigation of  
the starboard boiler explosion resulting in  
one fatal and one serious injury on board the  
Liquid Natural Gas tanker

***Hilli***

10 October 2003

**Report No 4/2007**  
**March 2007**

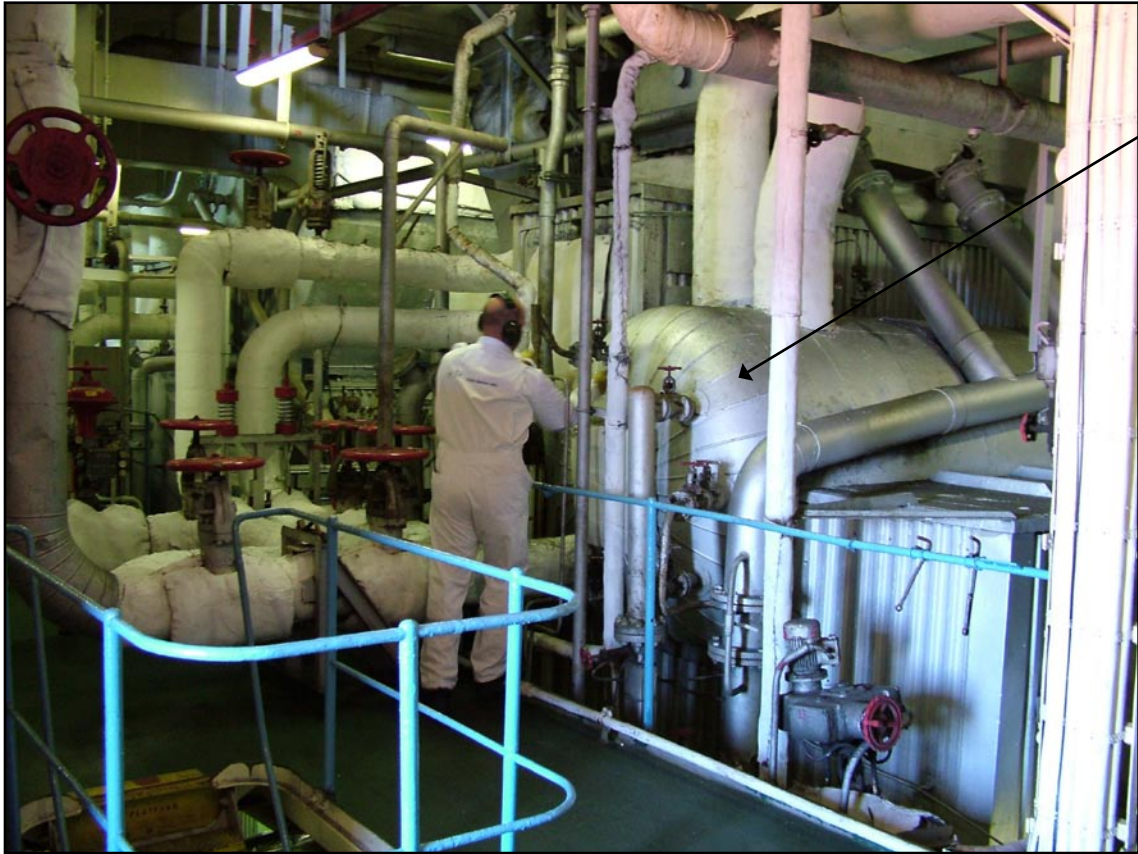
Figure 3

Forward view of the starboard boiler steam drum top plate level

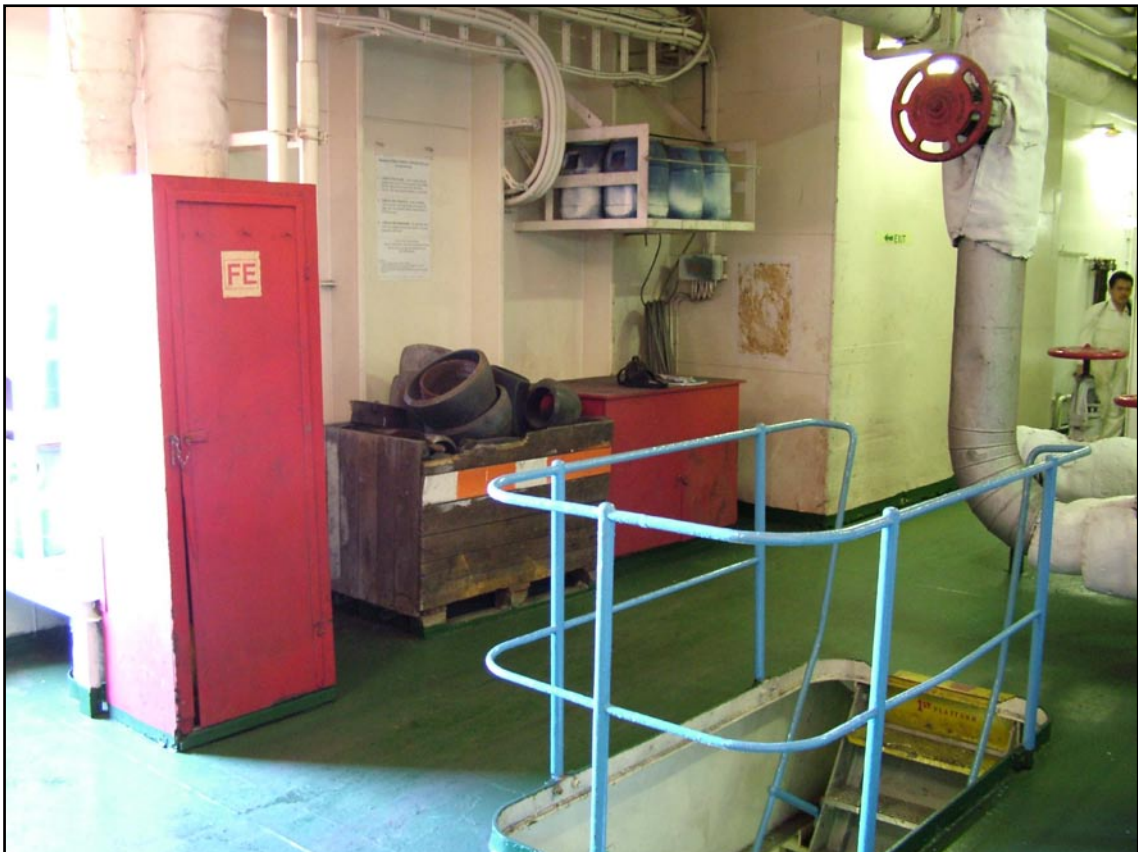
Figure 4

After view of the starboard boiler steam drum top plate level

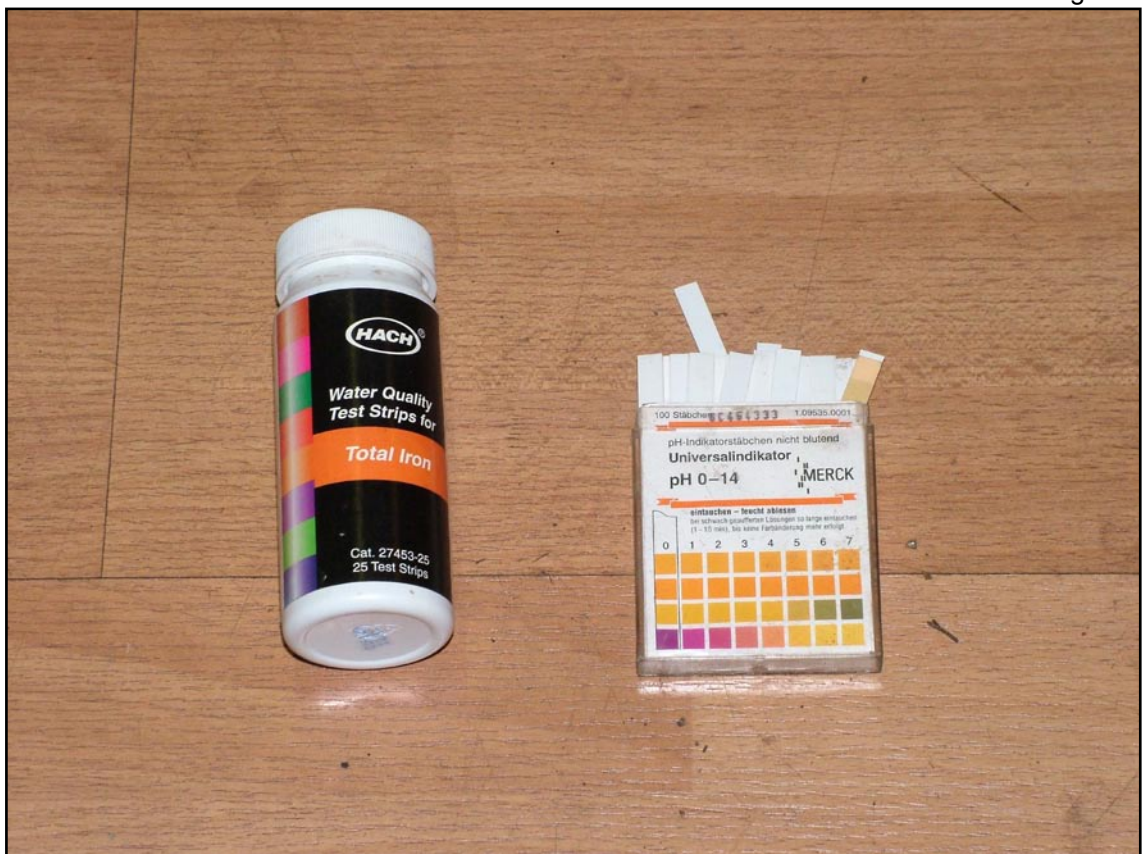
Figure 5

Fe and pH test equipment

The overseer used dissolved iron comparator strips (**Figure 5**) to give a check on the progress of the chemical clean. A constant level, rather than an increase, of dissolved iron in the cleaning fluid provided an indication that no more corrosion products were being removed from the boiler. However, this interpretation relied on the cleaning fluid being of sufficient acidity and the inhibitor being fully effective throughout the cleaning process.

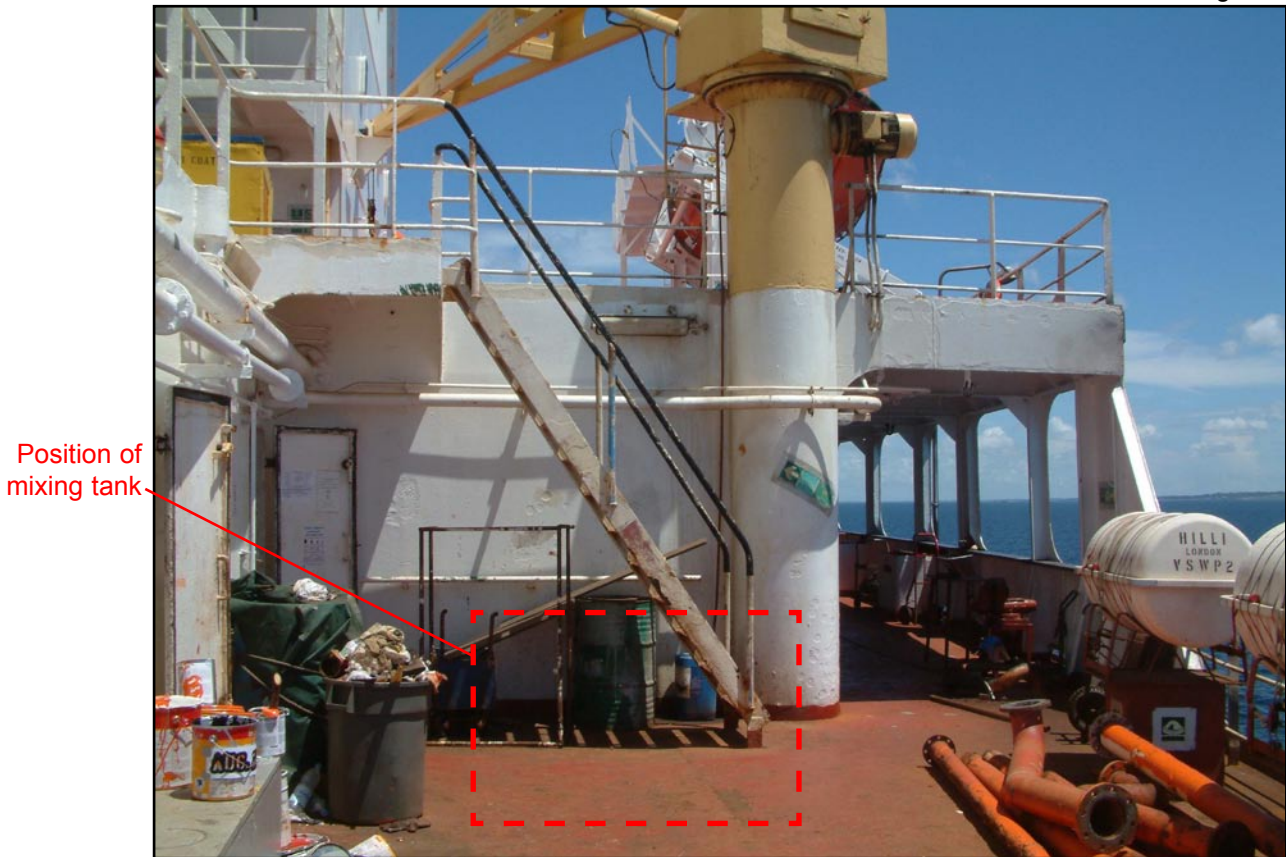
Figure 6

Position of the water/acid mixing tank on the starboard side of the main deck

A water/acid mixing tank, with a non-gastight top, was situated at the after, starboard side of the main deck approximately 5.5m above the top of the steam drum. A plastic hose connected the mixing tank to the steam drum via one of the removed safety valve flanges (**Figures 6, 11 and 12**).

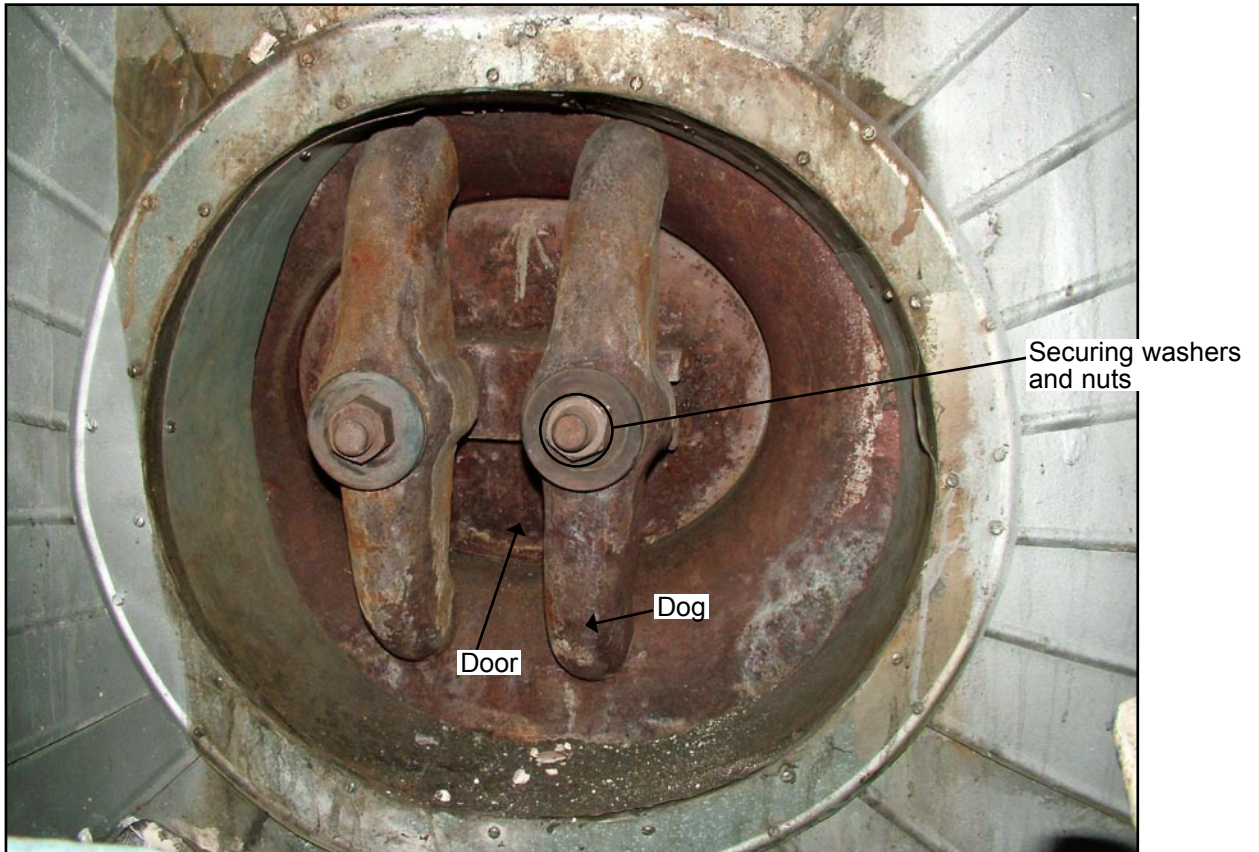
Figure 7

As Mr Walton and the overseer went to the Engine Control Room (ECR) for refreshments, two HPML workers went to the steam drum and removed the nuts and washers on the dogs, before removing the dogs themselves (**Figure 7**). At about 2152 they pushed the hinged door into the steam drum (**Figure 8**). As they forced the door inwards, they noticed a distinct suction, as the door opened and air was drawn into the steam drum. Neither of the workers noticed anything else untoward, and there were no unusual smells or vapours which aroused their suspicions. They then positioned a yellow, HPML halogen lamp on a guardrail, near to the steam drum, before going to the ECR to inform Mr Walton that the door had been opened. After that, both men went up to the main deck to take further refreshments.

Starboard boiler steam drum, door arrangement

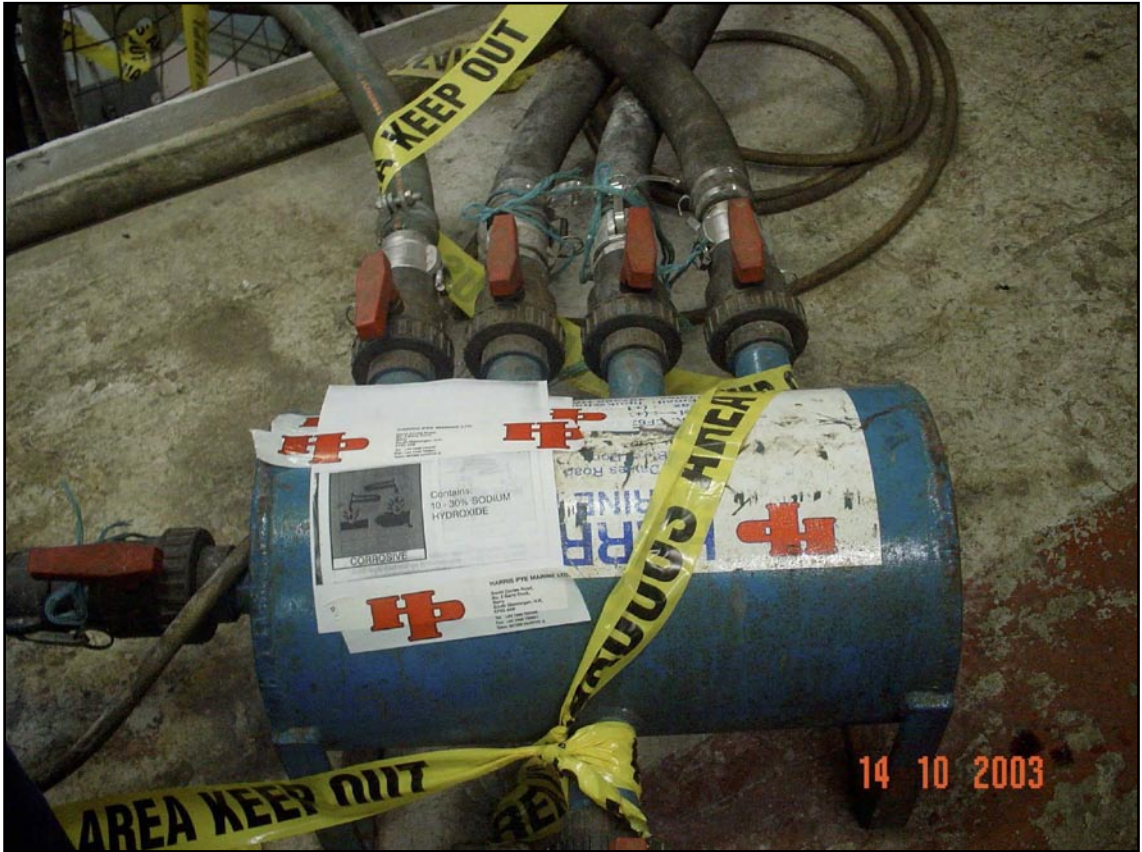
Figure 13

Reinforced 75mm flexible hoses were connected to the run down valves of the bottom water wall headers and water drum. These hoses were led to a common manifold (**Figure 13**) from where a centrifugal, air-driven pump (**Figure 14**) took a suction and returned the acid/water mix back to the mixing tank via a flow control valve. A number of ball valves were fitted to the connections to allow the system to be isolated in the event of leakage and to enable the mixture to be discharged to a shore side bowser.

Manifold and connecting hoses

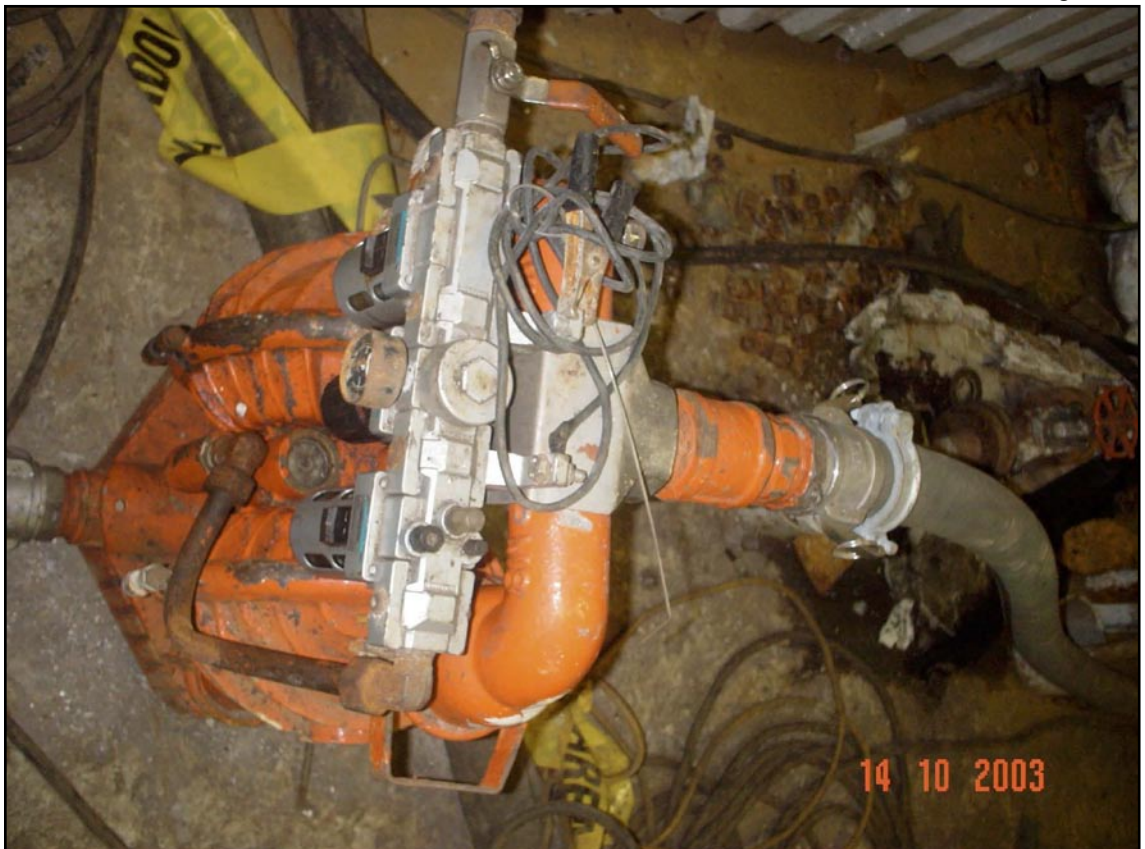
Figure 14

Air driven centrifugal circulating pump
