Report on the investigation of  
the loss of a passenger overboard from

***Hurlingham***

at Westminster Pier, on the River Thames

**Report No 12/2009**  
**June 2009**

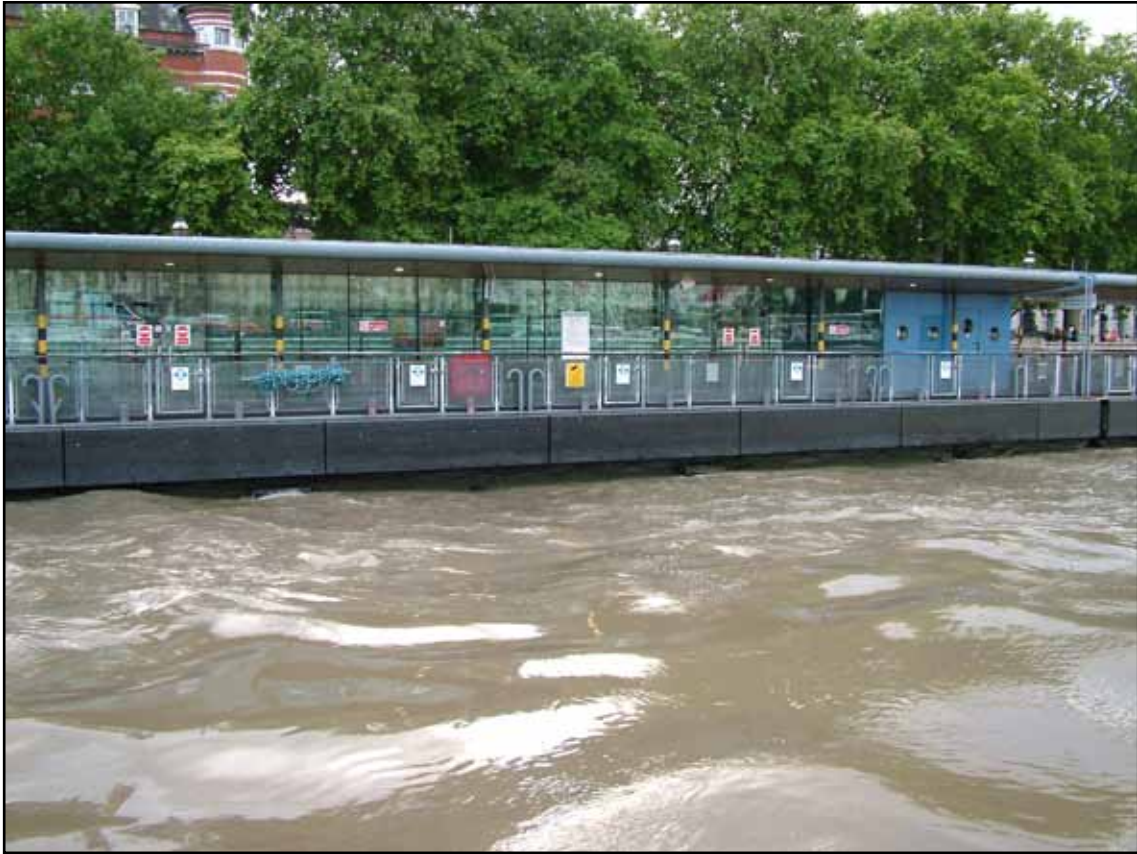
Figure 2a

The skipper brought *Hurlingham* alongside Westminster Pier (**Figures 2a and b**) and, due to the effect of turbulence from Westminster Bridge, he asked the mate to secure it with head and midships lines. The skipper left the propeller engaged in astern gear and the engine running at idle to put some tension on the mooring line and draw the boat into the pier. The layout of the boat and height of the pier made it preferable for passengers to embark using the forward entrances. These were on the turn of the bow, and it was normal practice for the boat to berth at a slight angle against the pier and for passengers to step directly from the pier onto the boat. A gangway was not routinely used, and none was used throughout that night.

Westminster Pier, viewed from the river

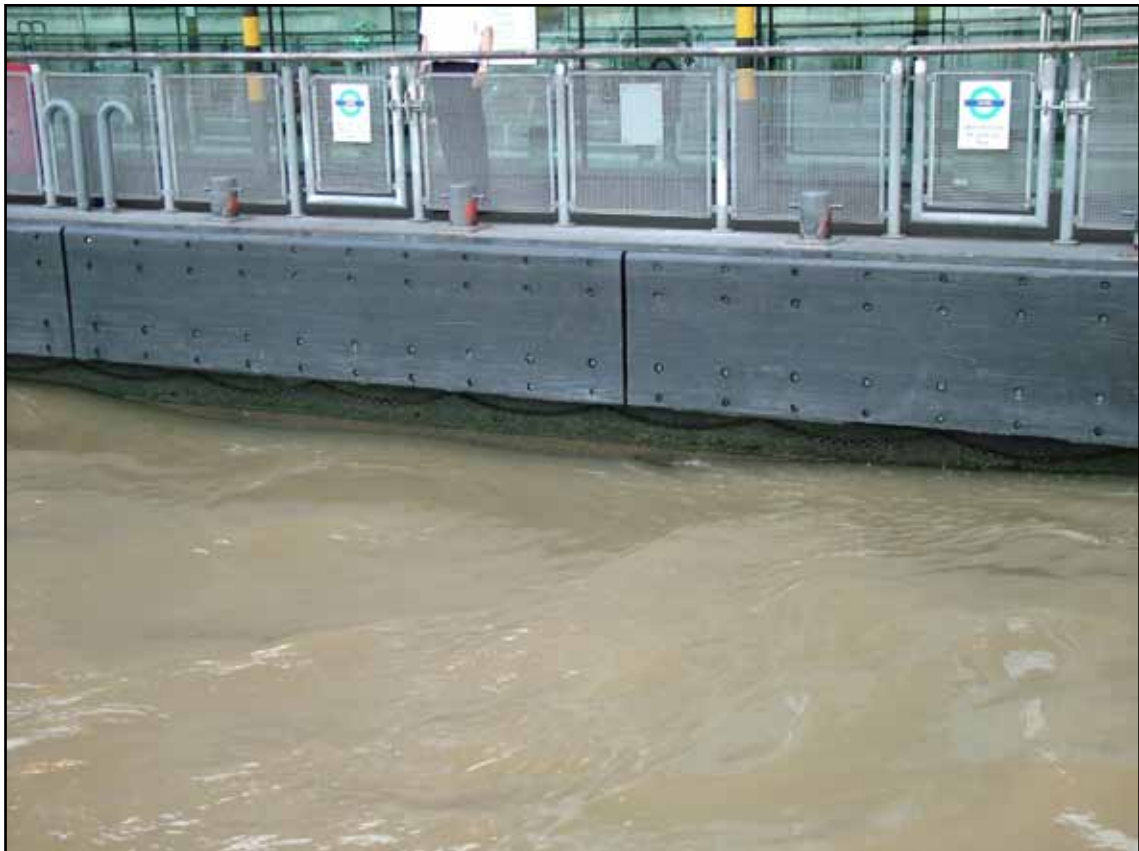
Figure 2b

Details of Westminster Pier

Westminster Pier is fitted with a substantial, black coloured, fender (**Figure 2**). The lights are fitted above the central part of the pier and provide a level of illumination typical of street lighting at a public facility. A substantial guardrail is fitted around the edge of the pontoon and inevitably casts a shadow over the outboard edge of the pontoon. The shadow is reduced when the gate is opened, but increases if passengers congregate at the guardrail.
