Report on the investigation

into the loss of the tug

Ijsselstroom

in the port of Peterhead

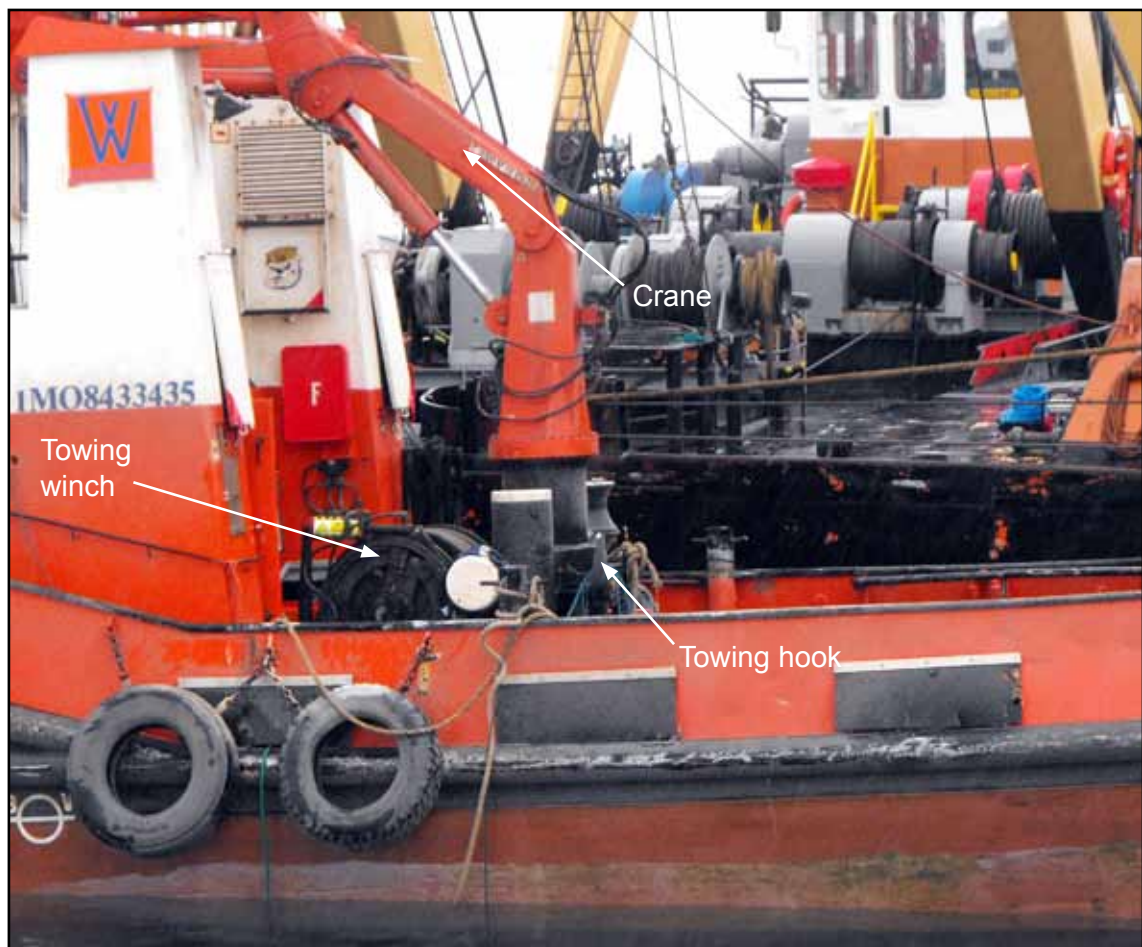
Figure 10

On deck, *IjsseIstroom* had a single drum towing winch, a quick release towing hook and a single hydraulic crane, all sited on the centre line just aft of the main accommodation (**Figure 10**).

IjsseIstroom aft deck gear

The hydraulic system of the winch brake was powered by a power take-off from the starboard shaft. If the starboard engine failed for any reason then the brake would be permanently applied. It is not known when the starboard engine stopped during *Ijsselstroom*'s capsizing at Peterhead.

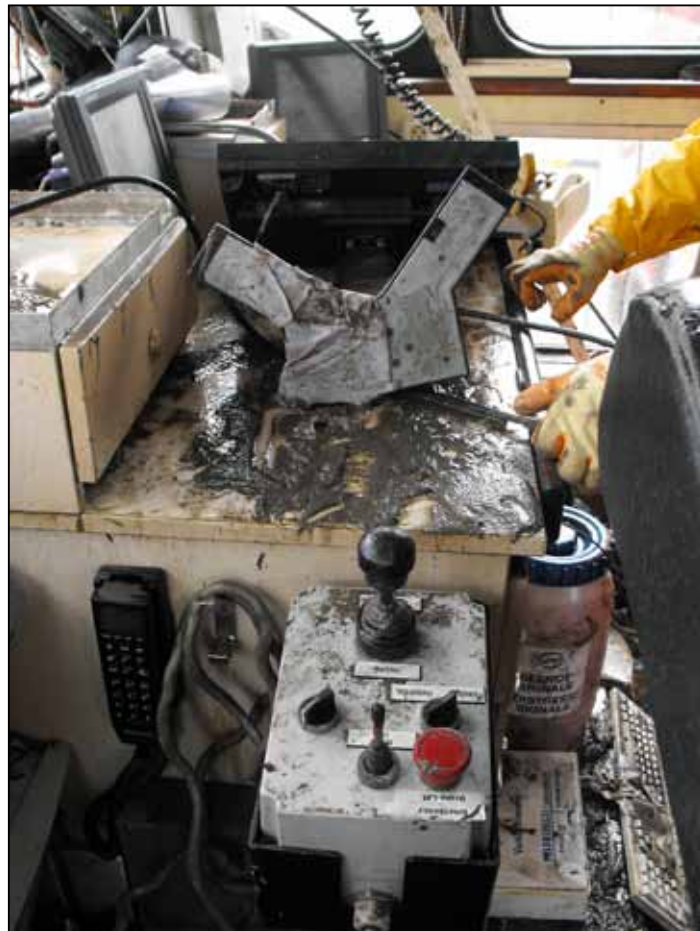
Figure 14

Winch control unit

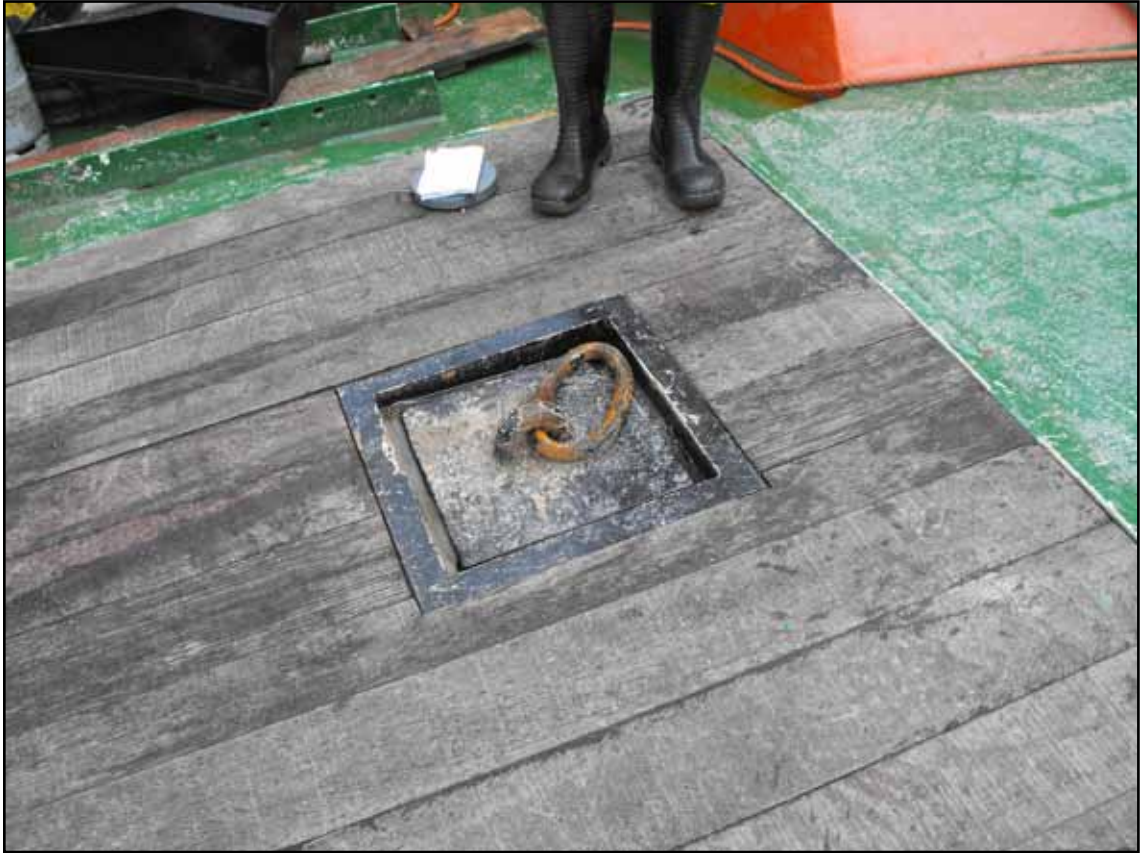
Figure 18

Ijsselstroom did not have a gob winch, centre line fairlead or H-shaped bollard, though she did have a ring through a centre line pad eye on the aft deck (**Figure 18**). However, it is not known if this had sufficient strength to support a gob rope, and it had not previously been used for this purpose. *Ijsselstroom*'s skipper never used gob ropes and felt that they would hinder his ability to handle the tug.

Centre line ring

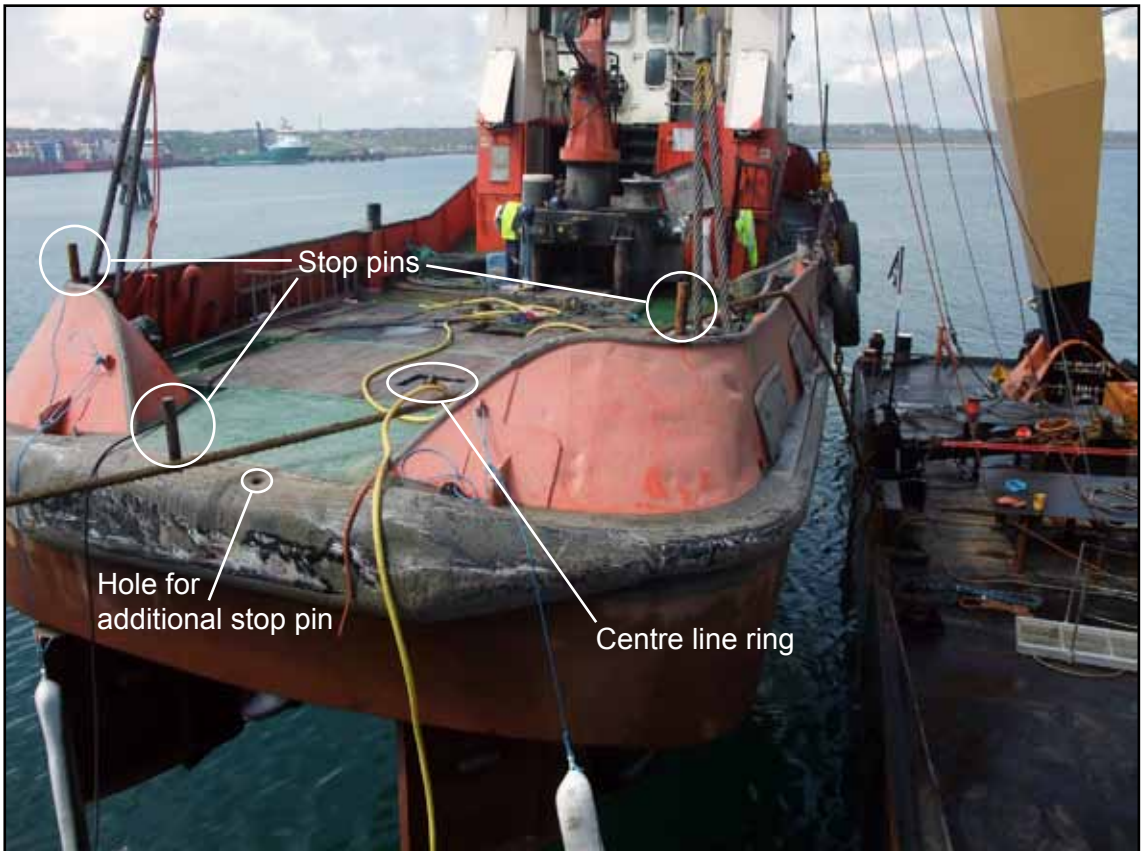
Figure 19

Another way to prevent a towing wire moving on to the tug's beam is by using stop pins. These are normally found on both quarters and either side of the centre line at the after end of the working deck. They can be fixed, removable or hydraulically raised and lowered. *Ijsselstroom* had removable pins, but none were in use for the arrival of *Tak Boa 1* because the skipper felt that the lead of the towline would be too steep to make them effective. **Figure 19** shows port and starboard quarter pins rigged and ready for use, and one removable pin fitted to port of the centre line.

Stop pins and centre line ring
