Report on the investigation of
the grounding of
HC Katia
while undergoing sea trials in the Solent
on
3 December 2003

Marine Accident Investigation Branch
First Floor
Carlton House
Carlton Place
Southampton
United Kingdom
SO15 2DZ

Report No 8/2004
July 2004

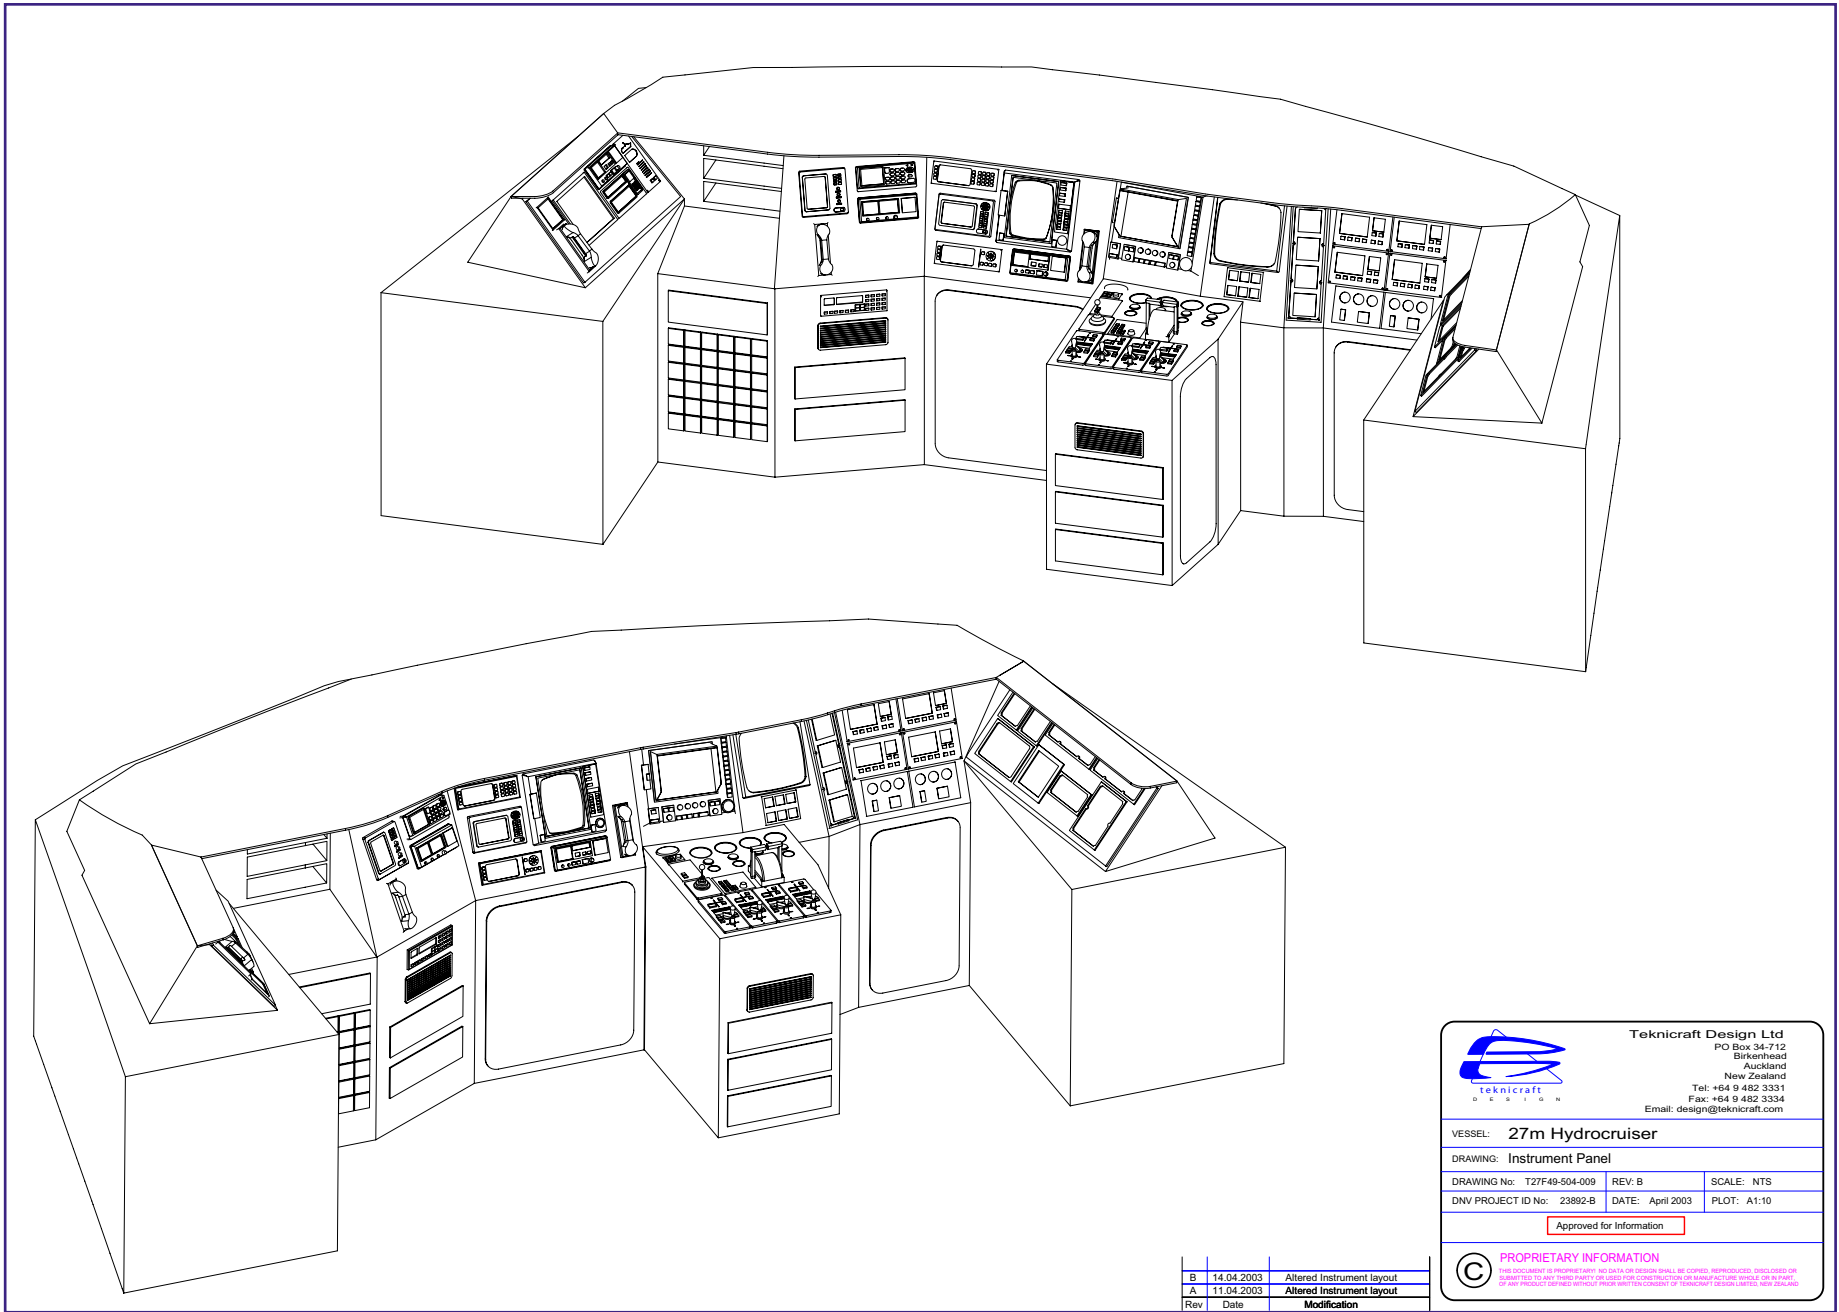
Bridge layout - general

Although outline structural plans of the bridge were submitted to the MCA, detailed bridge control layout plans were not made available before the accident, and therefore no formal approval of the bridge layout, by a flag state nautical professional, was possible.

The builder fitted decorative mouldings around the large scantling stiffeners between the bridge front windows, to conceal wiring and pipework, which restricted the visibility from the pilot's control position.
