Report on the investigation of
the fire and subsequent sinking of

Lady Candida

off Corsica

Report No 4/2008
February 2008

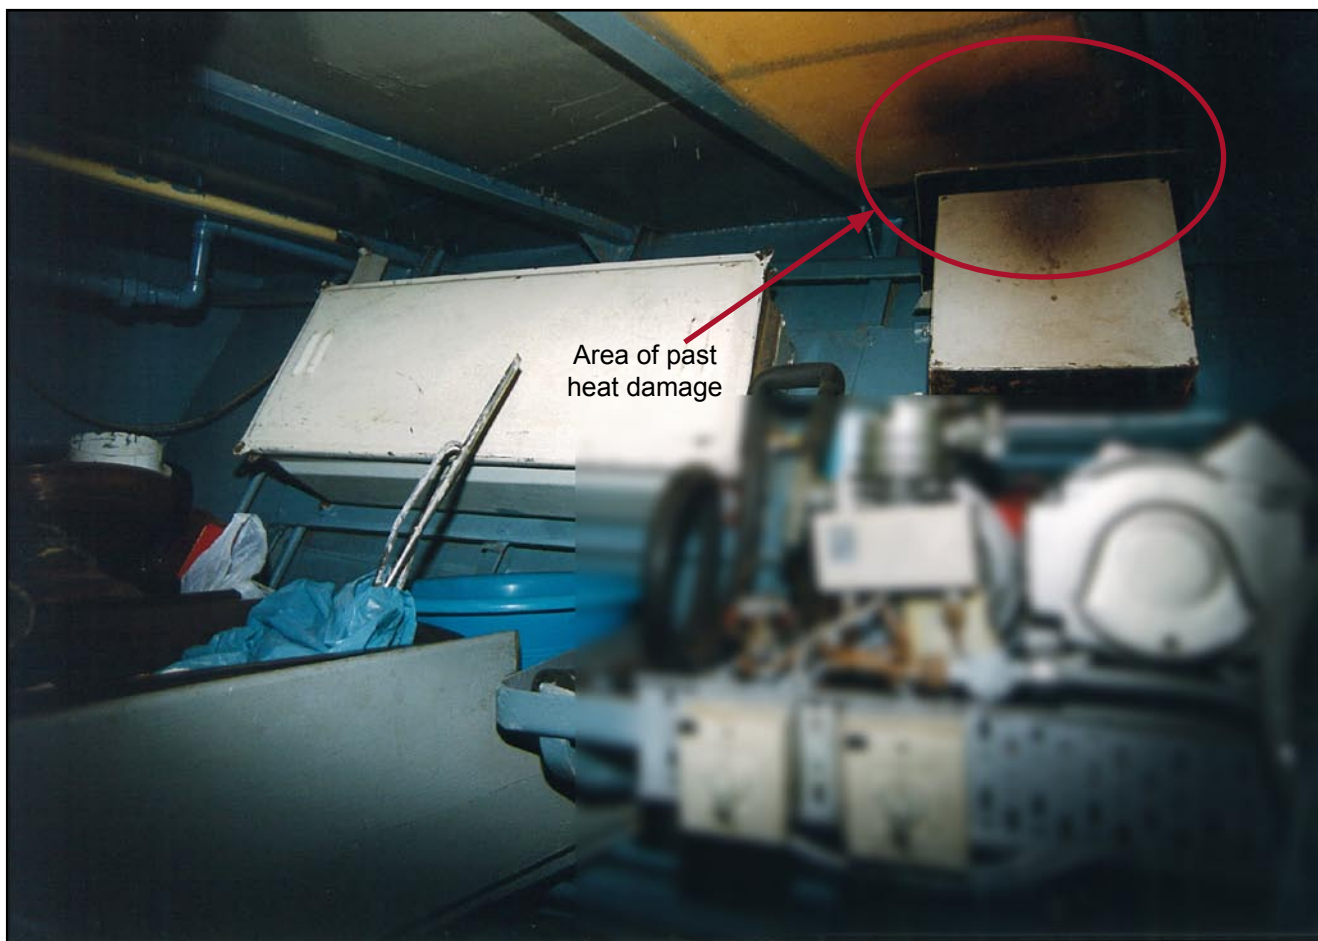
Figure 7

Internal access to the laundry was by an alleyway (**Figure 3**). At the forward end of the alleyway, a flight of three steps led to the laundry room and a crew cabin, which shared a common two-way door (**Figure 6**). The main control panels for the 110V DC windlass (**Figure 7**), which had a history of overheating, were sited behind the stairs.
