Report on the investigation into the foundering of the motor cruiser

Last Call

at Whitby

Report No 11/2008
June 2008

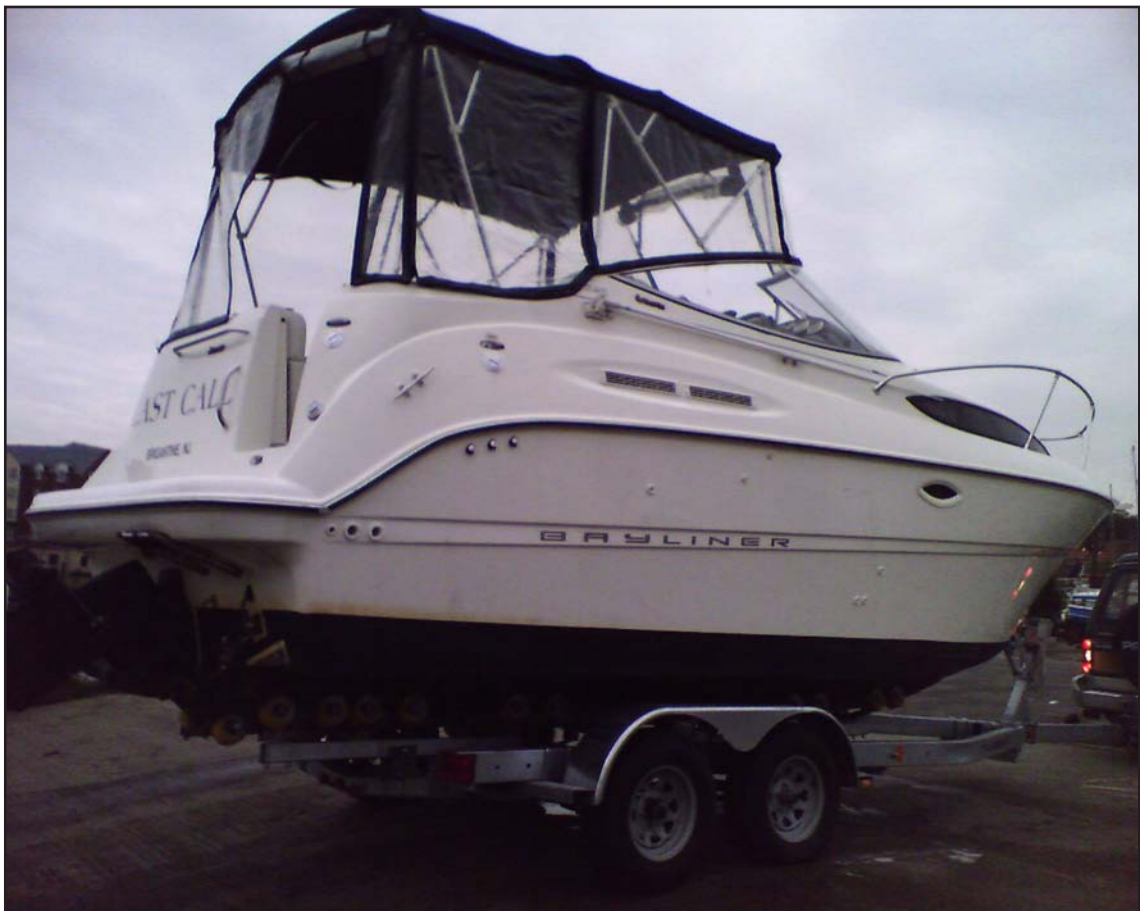
Figure 1

Last Call was imported through the Port of Liverpool. Once import duty and VAT had been paid, the vessel was released by Her Majesty's Revenue and Customs (HMRC) and delivered by road transport to Coates Marine boatyard in Whitby on 12 November 2007. On arrival at Coates Marine, *Last Call* was lifted off the transport and stowed on its own trailer in the boatyard (**Figure 1**).

Last Call after delivery to Coates Marine

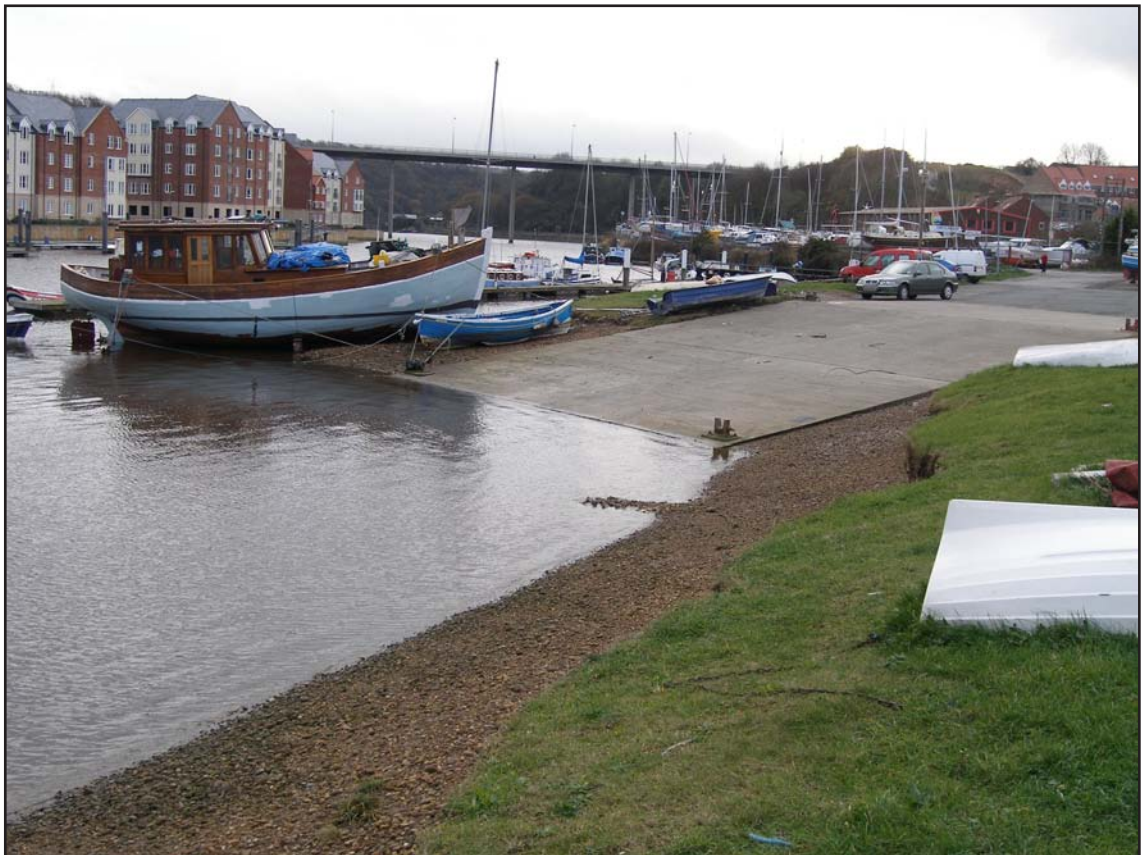
Figure 2

At 0930 on 17 November, after obtaining a launching permit from the Whitby marina supervisor, *Last Call* was launched from the trailer using the slipway operated by Scarborough Borough Council (**Figure 2**). While Jill Russell and John Carrick made arrangements at the marina office for the allocation of a suitable day mooring, *Last Call* was being manoeuvred by Andrew Carrick in the vicinity of the marina, with a friend providing crew assistance.

Launching slipway

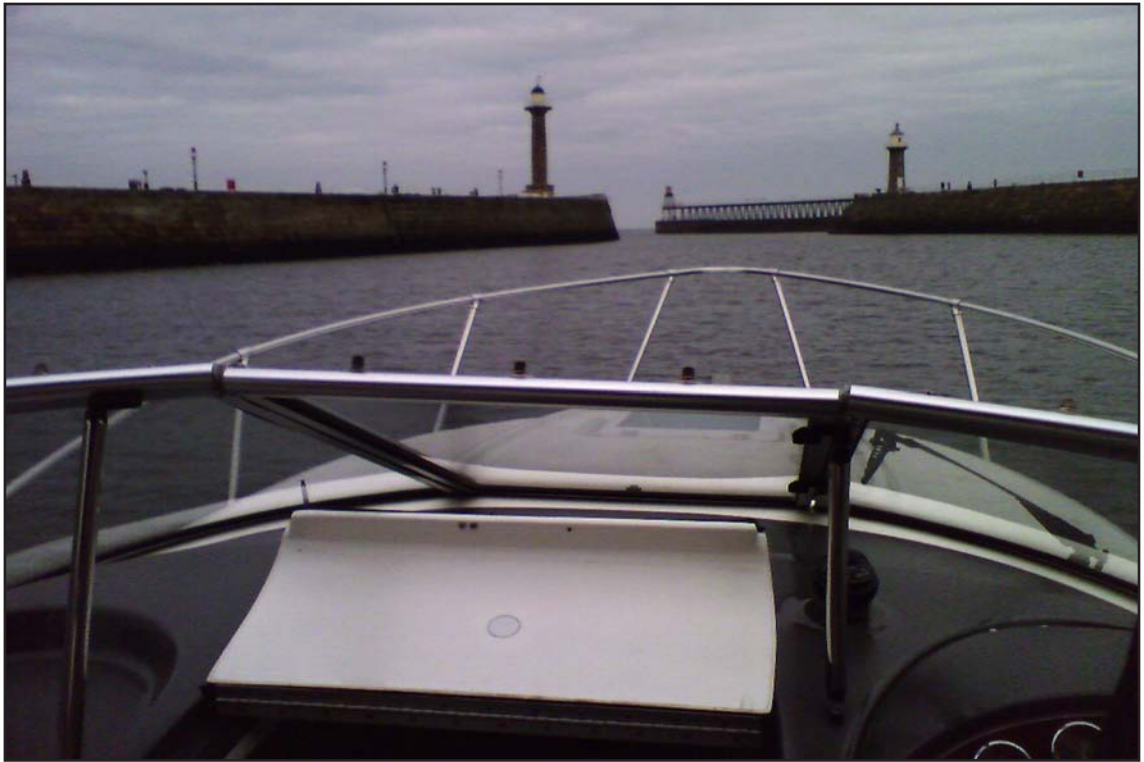
Figure 3

Last Call on passage, 17 November

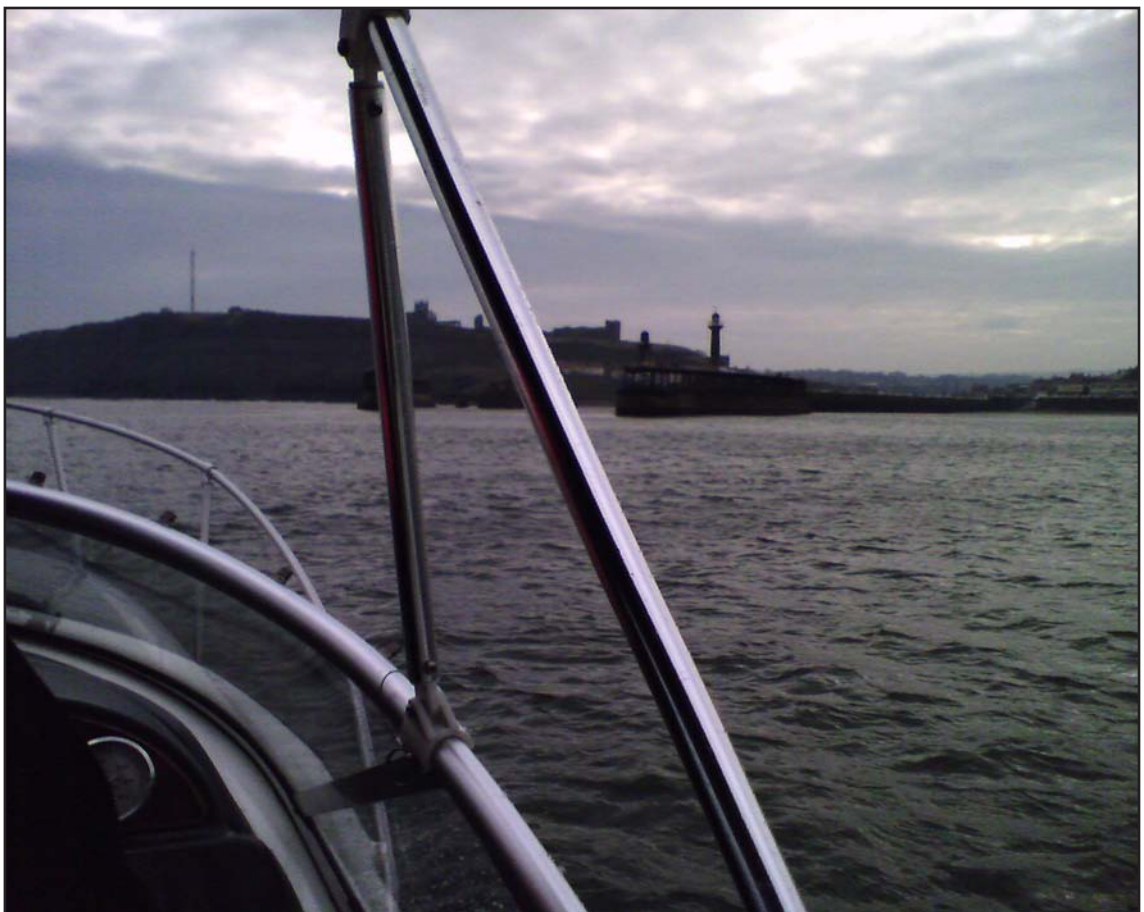
Figure 4

Last Call on passage, 17 November

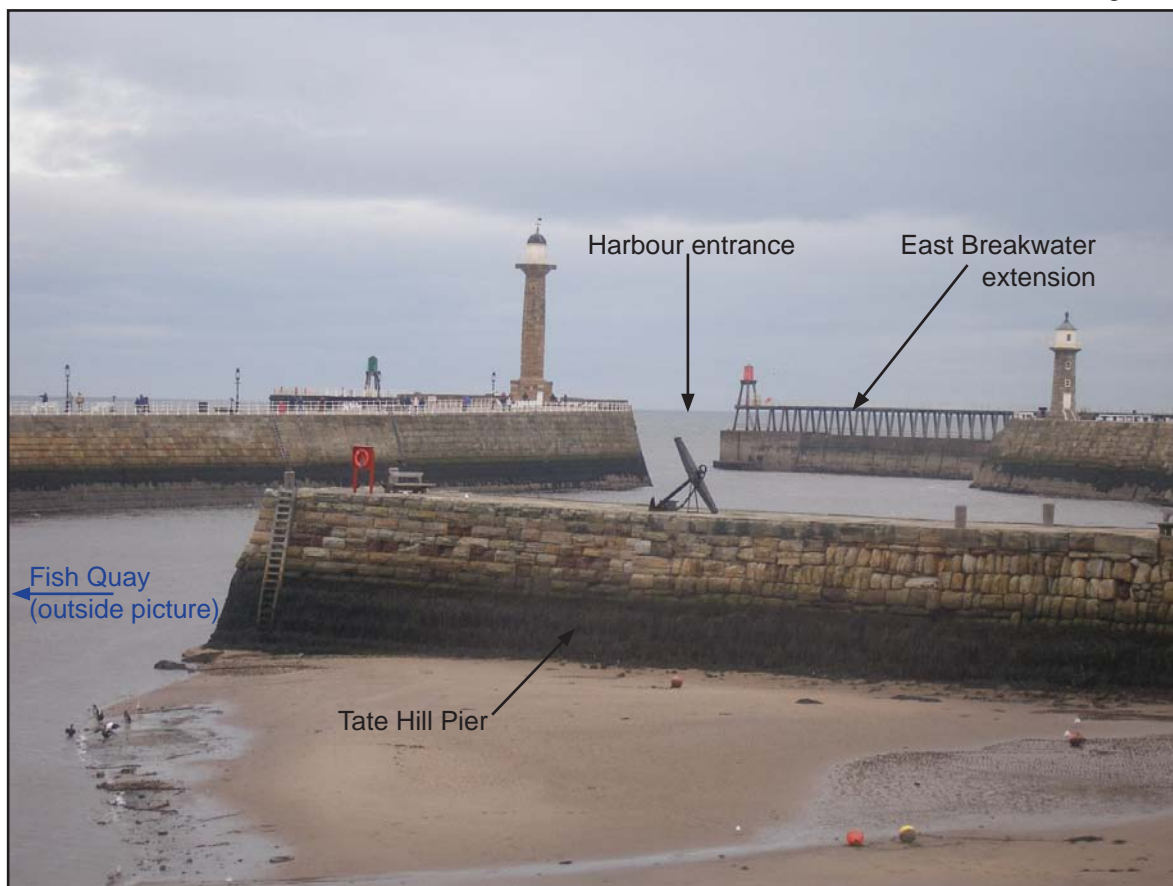
At 1211, the duty harbour watchkeeper, who was working in the vicinity of the Fish Quay, on the west side of the river, saw *Last Call* pass Tate Hill Pier, increase speed, and then head toward the harbour entrance (**Figure 5**). Concerned for the safety of the craft should it attempt to leave the harbour, he called the lifeboat station direct by mobile telephone. At 1212, immediately after the call to the lifeboat station, he informed the Whitby harbourmaster that a pleasure craft was attempting to leave the harbour. On completion of the call he collected his hand-held VHF and made his way toward the end of the west pier.

Whitby outer harbour

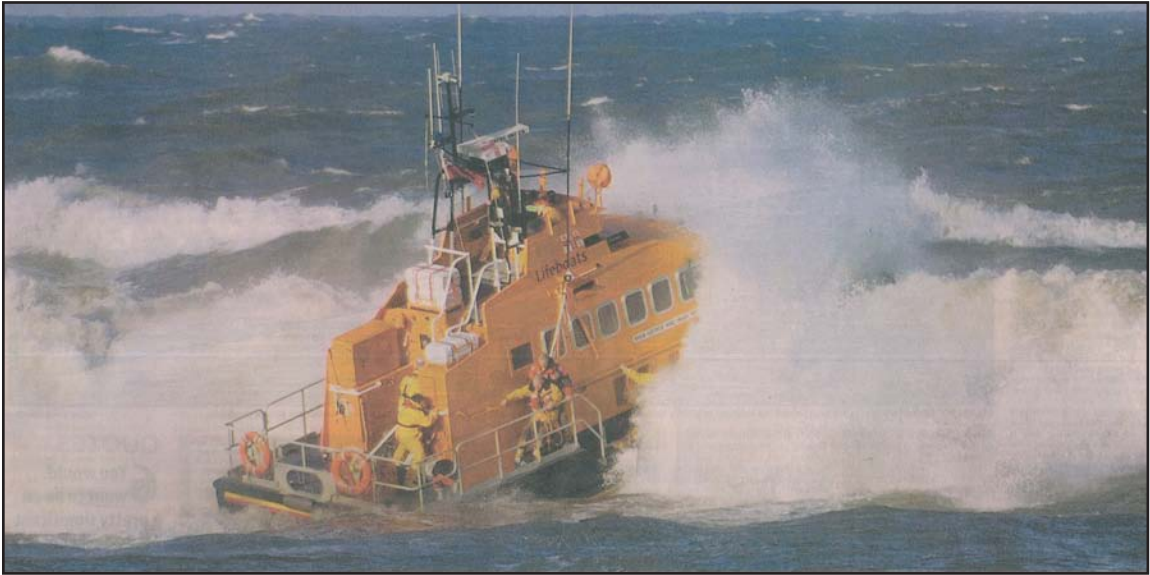
The coxswain manoeuvred the lifeboat to head into the wind and sea, and then drifted astern towards the men (**Figure 8**). During the manoeuvre, a large wave broke over the lifeboat and the two men in the water. When the seawater cleared, the person wearing the lifejacket was sighted face down in the water.

Rescue operation

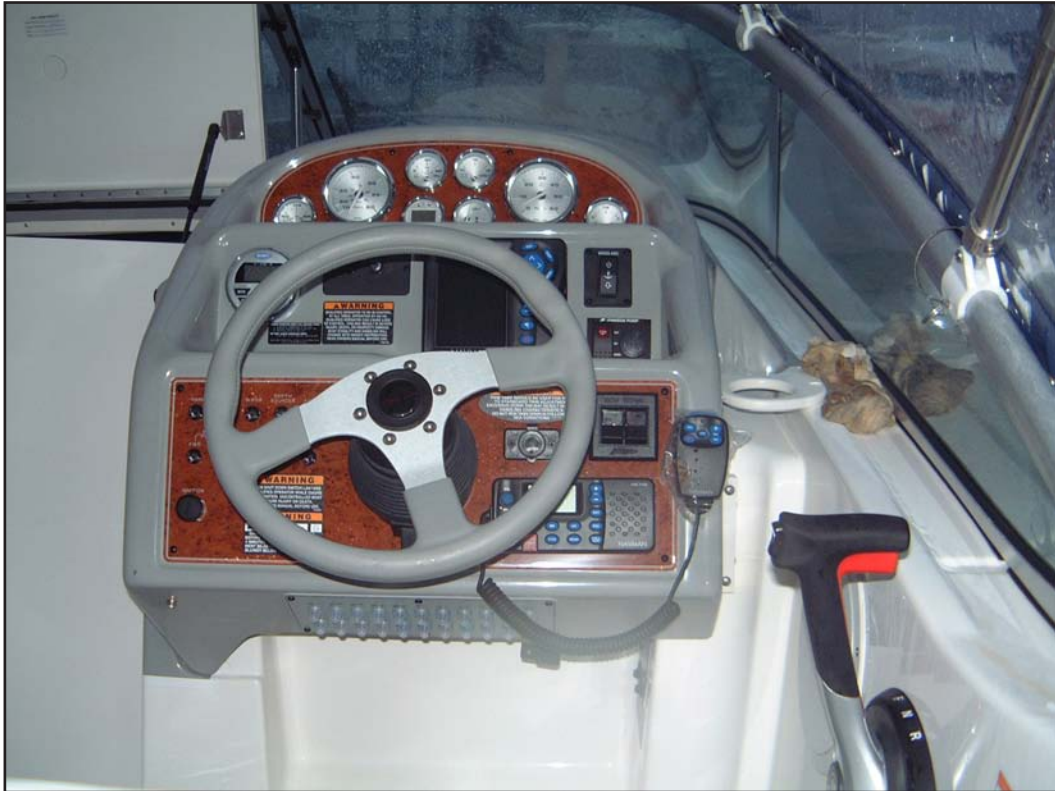
Figure 10

The helmsman's seat was positioned close to a 'tilt adjustable' steering wheel. The space available for the helmsman to stand behind the wheel was minimal. From the information available, there was no additional equipment fitted to *Last Call* over and above the manufacturer's initial specification.

245 SB - helmsman's position (similar craft)

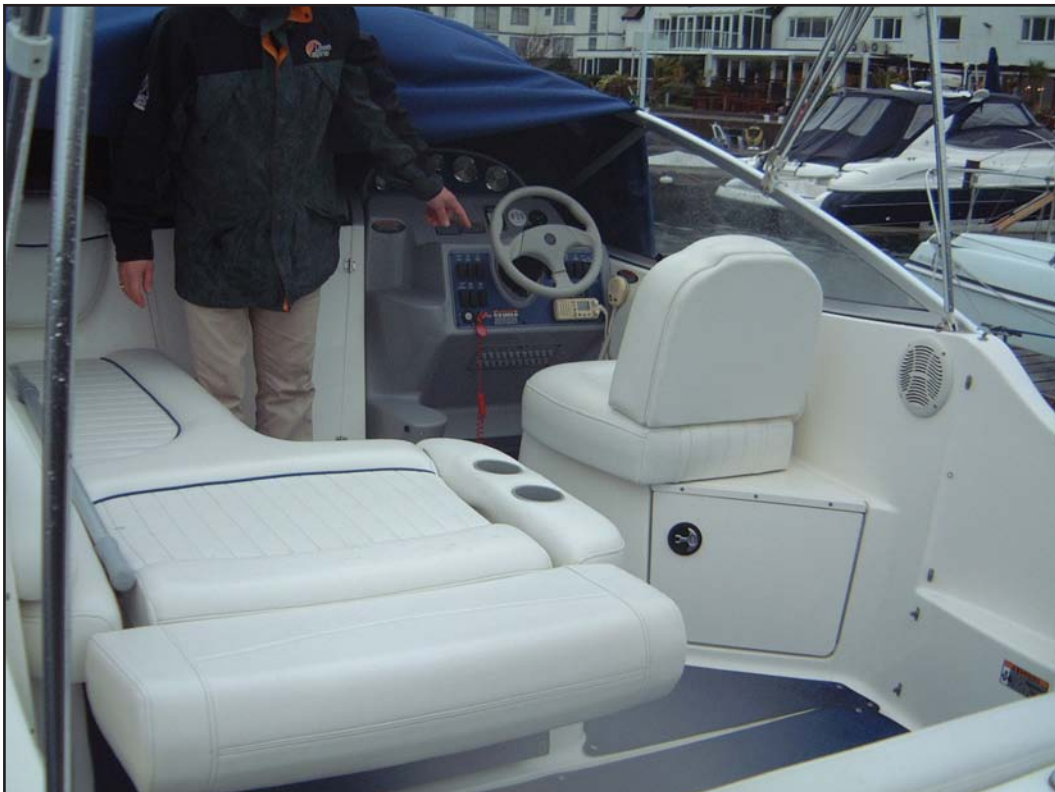
Figure 11

The cockpit layout and design is shown in **Figures 10 and 11**. The photographs were taken on board another Bayliner 245 Ciera, but show the same layout and instrumentation as that fitted to *Last Call*.

Cockpit layout (similar craft)

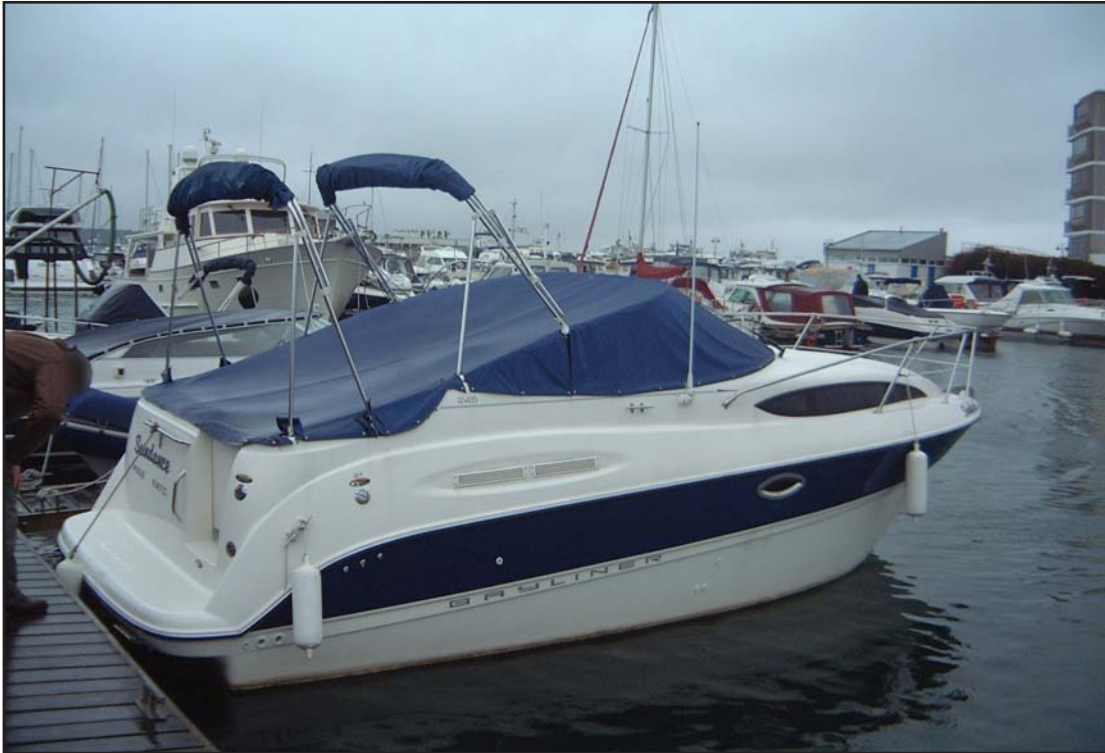
Figure 12

The two-piece canvas and vinyl cockpit canopy could be unzipped, allowing the occupants to remain protected, while the aft section was open to the elements. Access to the boat was via a transom door on the starboard side (**see Figure 12**).

Bayliner 245 SB (similar craft)

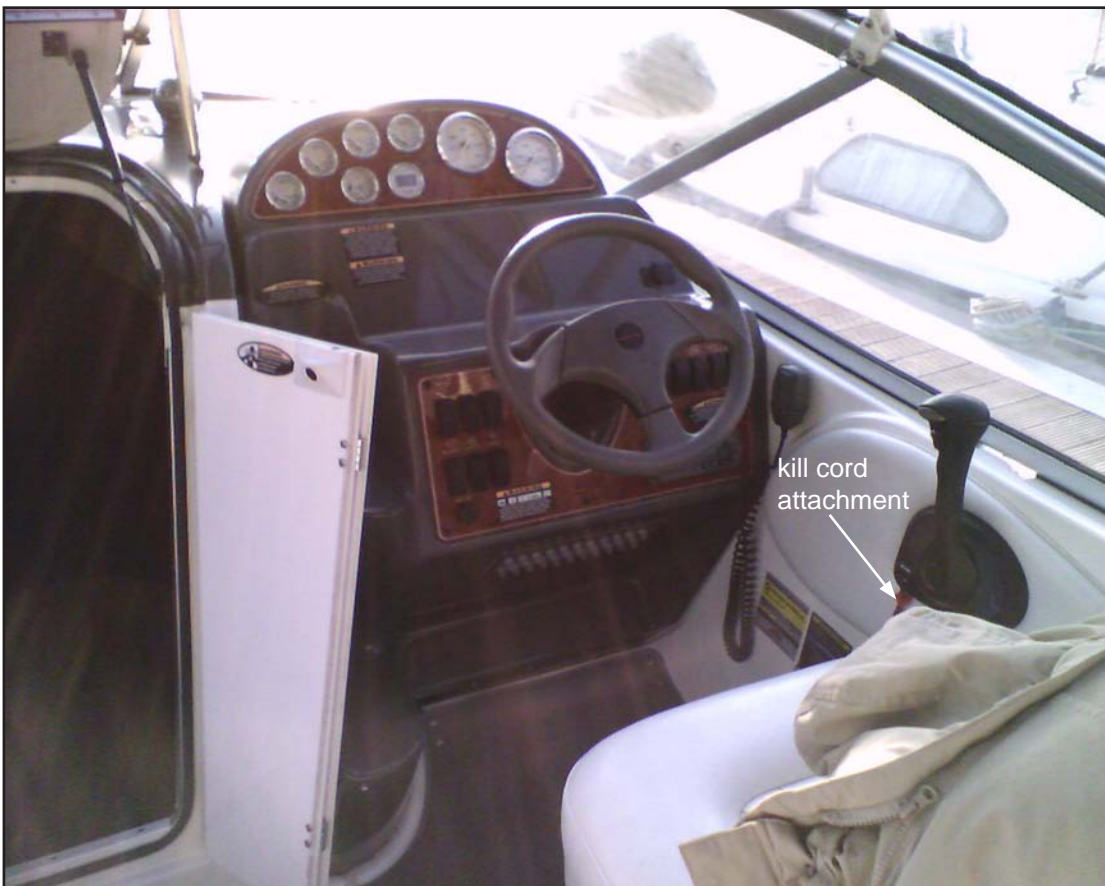
Figure 13

A kill-cord 'toggle' mechanism was fitted adjacent to the throttle lever (**see Figure 13**). Its purpose was to stop the engine if the helmsman moved away from the helm or fell overboard. By doing so, it prevented the boat from injuring third parties, and gave the helmsman an opportunity to re-board the boat if he had fallen overboard.

Last Call - helm position

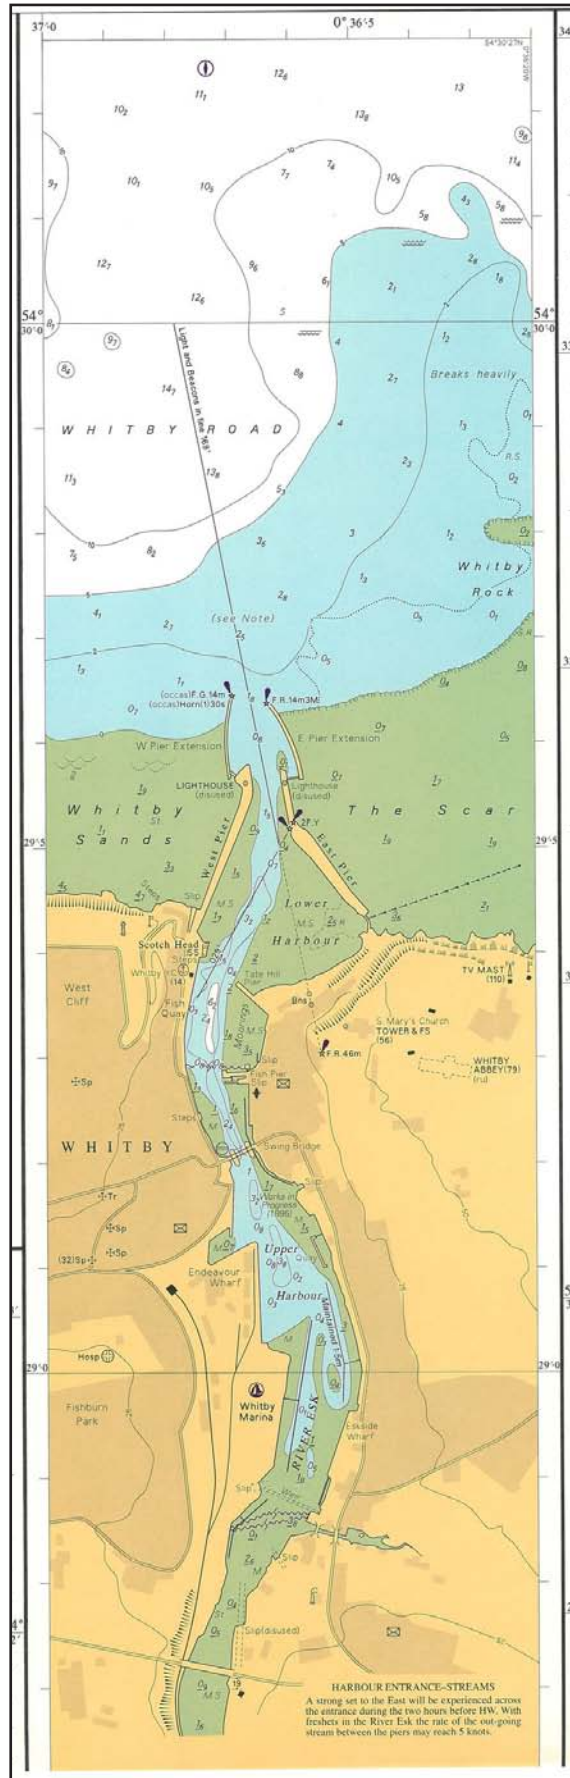
The harbour is divided into the upper and lower harbours, which are separated by a swing bridge. Whitby marina is situated at the south end of the upper harbour. An extract of BA chart 1612 showing the harbour and its approaches can be found at **Figure 15**.

Whitby harbour
