Report on the investigation of  
a fatal man overboard from the Reflex 38 yacht  
**Lion**

14.5 miles south of Selsey Bill, West Sussex

18 June 2011

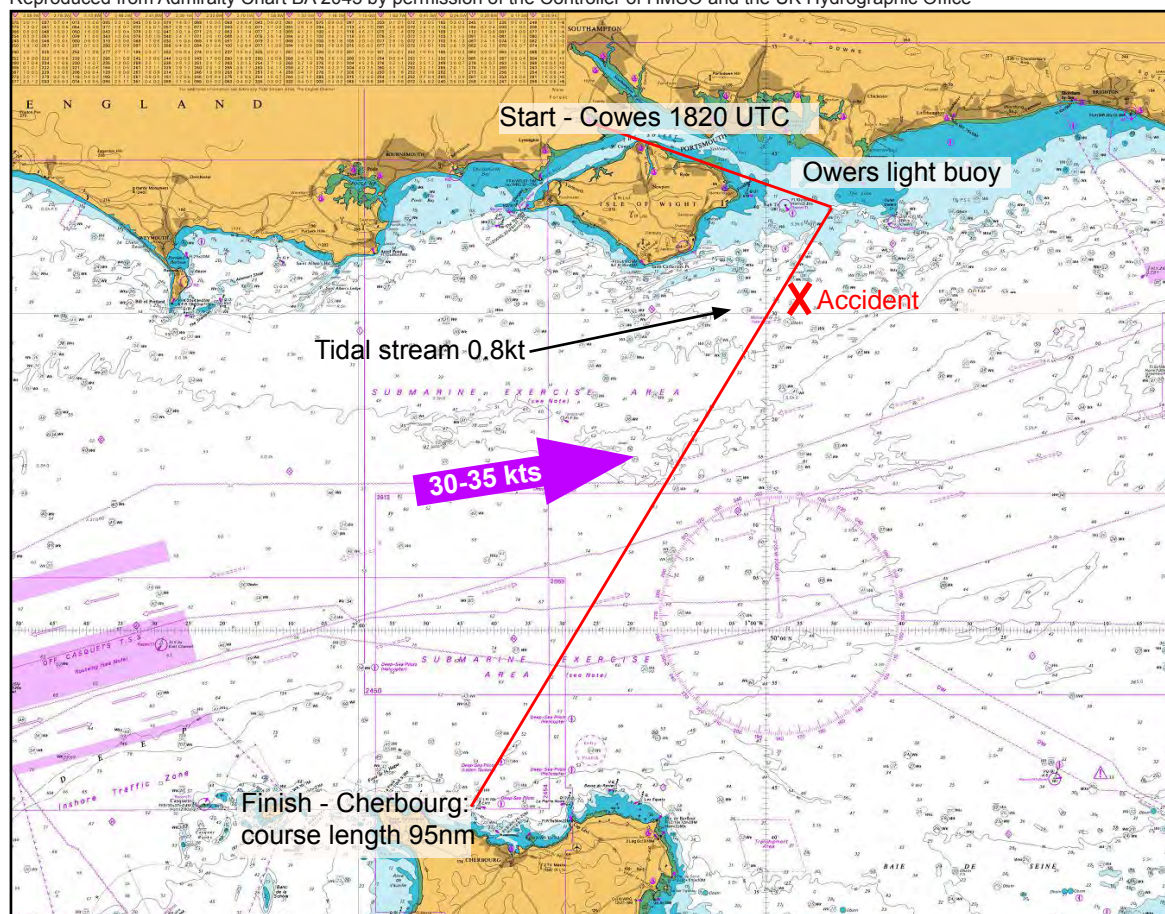
**Figure 1:** Chartlet showing Morgan Cup Race course and key events

At 1320 on 17 June, RORC's Race Committee sent details of the Morgan Cup Race course to the competitors by e-mail (**Annex C**). The course, at 95 miles long, was relatively short to take account of the difficult conditions expected. A chartlet showing the course is at **Figure 1**.

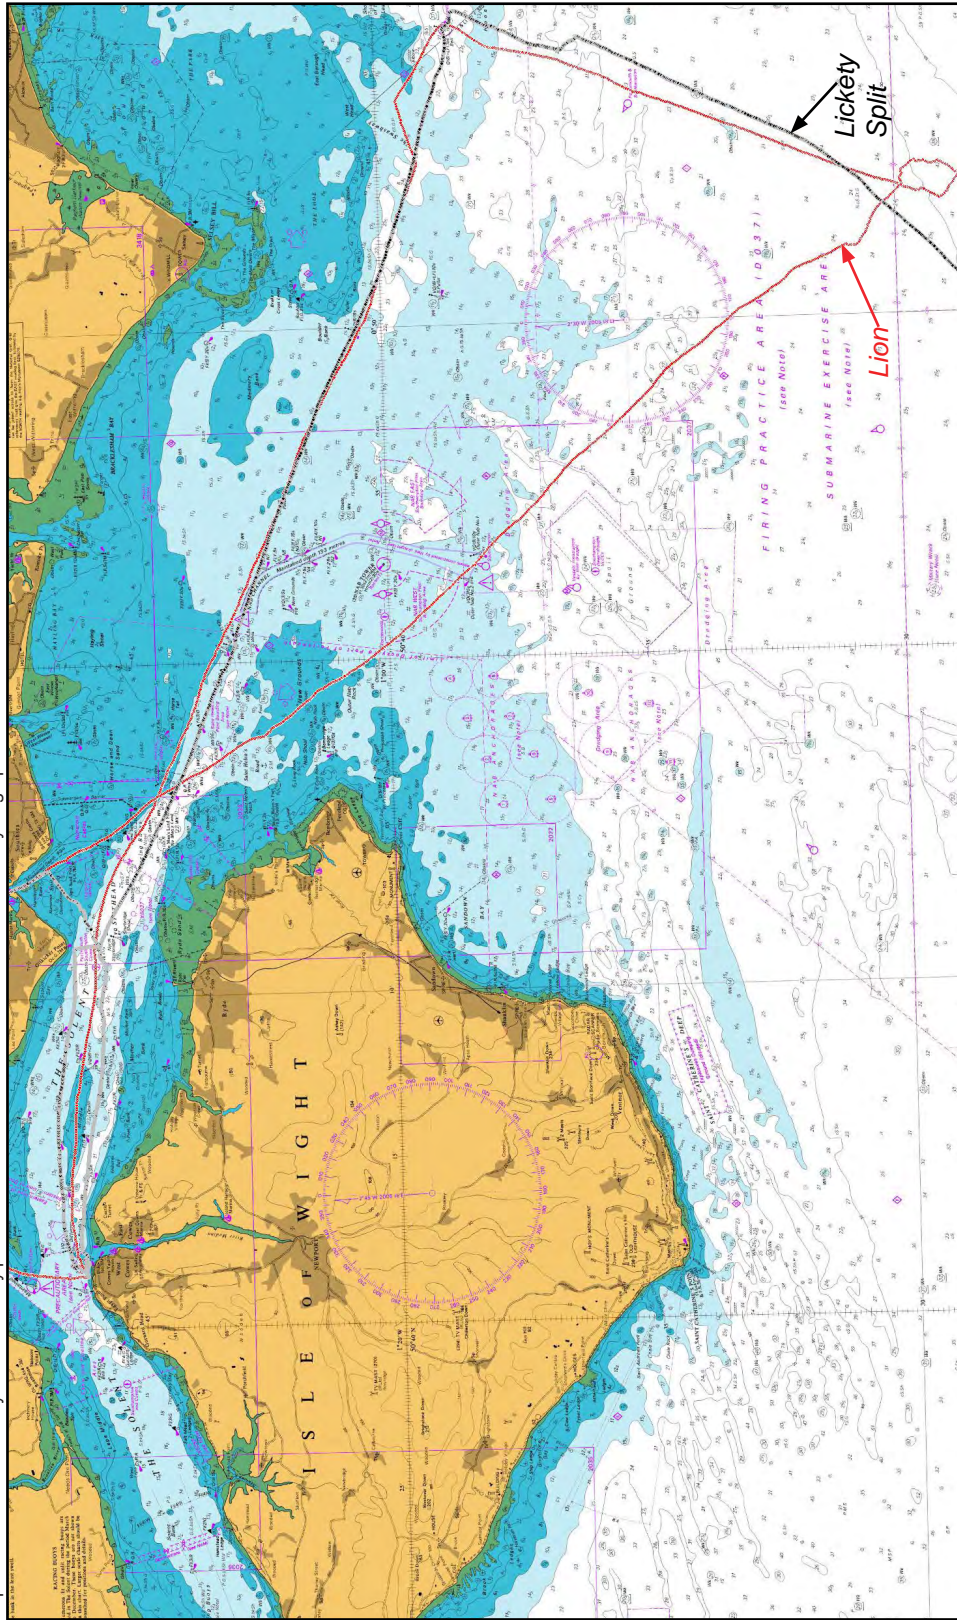
Figure 2: Chartlet showing AIS/GPS tracks for *Lion* and *Lickety Split*

The early stages of *Lion's* race were uneventful as the yacht progressed east along The Solent close-hauled at speeds over the ground (SOG) of between 6.4 and 8 knots (**Figure 2**). At about 2025, the helmsman felt that with the No.3 genoa the boat was under-powered. The skipper agreed, and the sail was replaced with the No.2 genoa; the No.3 genoa was then taken into the cabin for repairs to the luff.

*Lion*'s combined Automatic Identification System (AIS) and GPS tracks up to the accident and the return leg to Portsmouth are at **Figure 2**. The figure also shows the AIS track for *Lickety Split*.

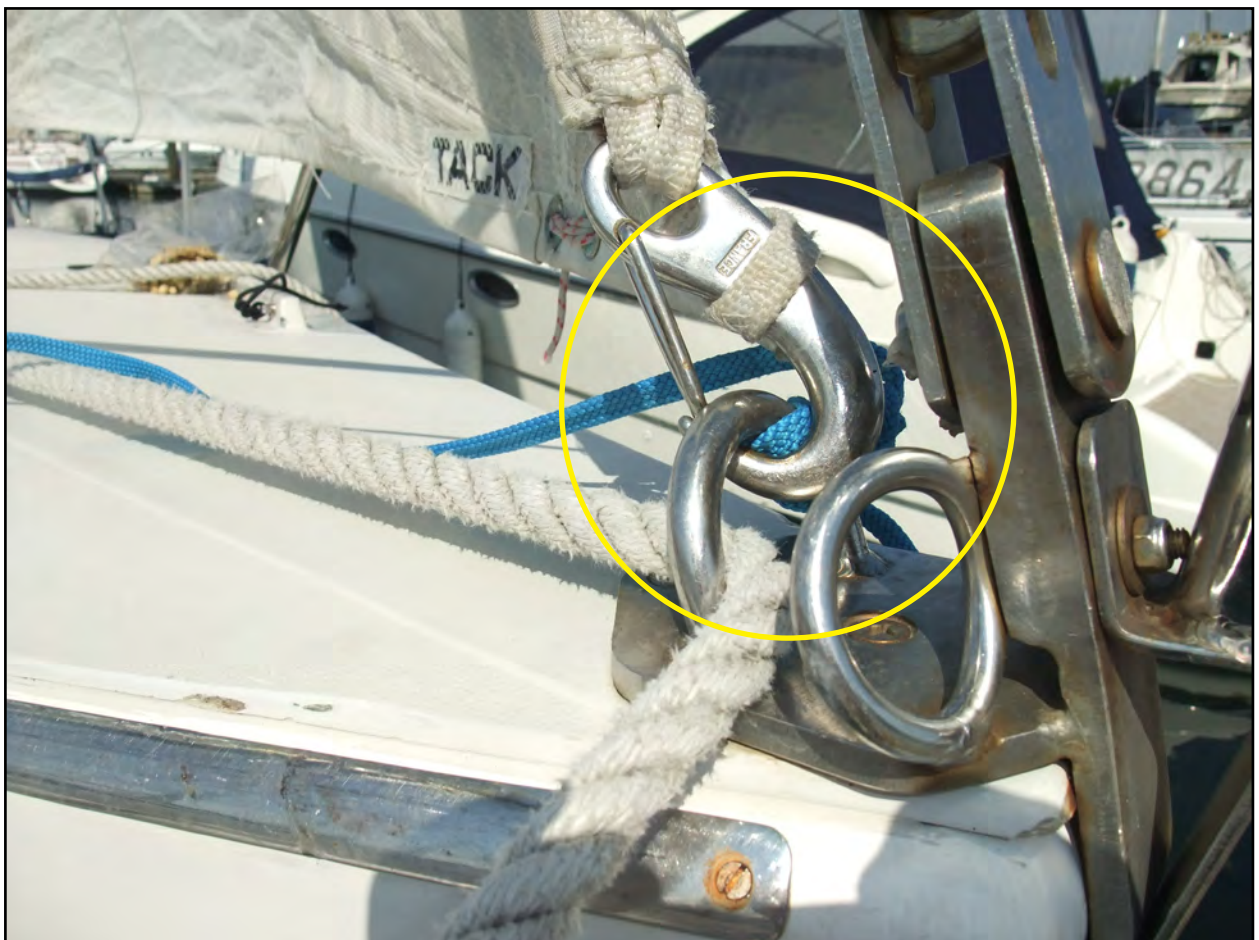
**Figure 4:** Genoa tack connected to the forward pad eye

The helmsman then heard the skipper instruct the bow and mast men to lash the No.1 genoa on the deck. The sail was secured to the port guard wires and supporting stanchions using light “bungy” straps and two sail ties (**Figure 3**) while the tack remained clipped to the forward pad eye (**Figure 4**). Soon afterwards the helmsman instructed that the first reef in the mainsail should be taken in. Once the mainsail had been reefed, the skipper told the helmsman that he was content with the new sail configuration.

At 0027, the helmsman felt the yacht's handling characteristics change. At the same time, he noticed that the No.1 genoa had slipped from its lashings and was streaming down the port side of the yacht. However, the tack remained secured to the forward pad eye, which prevented the sail from floating away. The skipper called the bow and mast men to the deck to help recover the sail if required. Meanwhile the helmsman concentrated on maintaining a steady course to assist the recovery operation. As the mast man entered the cockpit he noted the wind speed indicator was reading 38 knots. The yacht was heeling to port with her toerail dipping into the water.

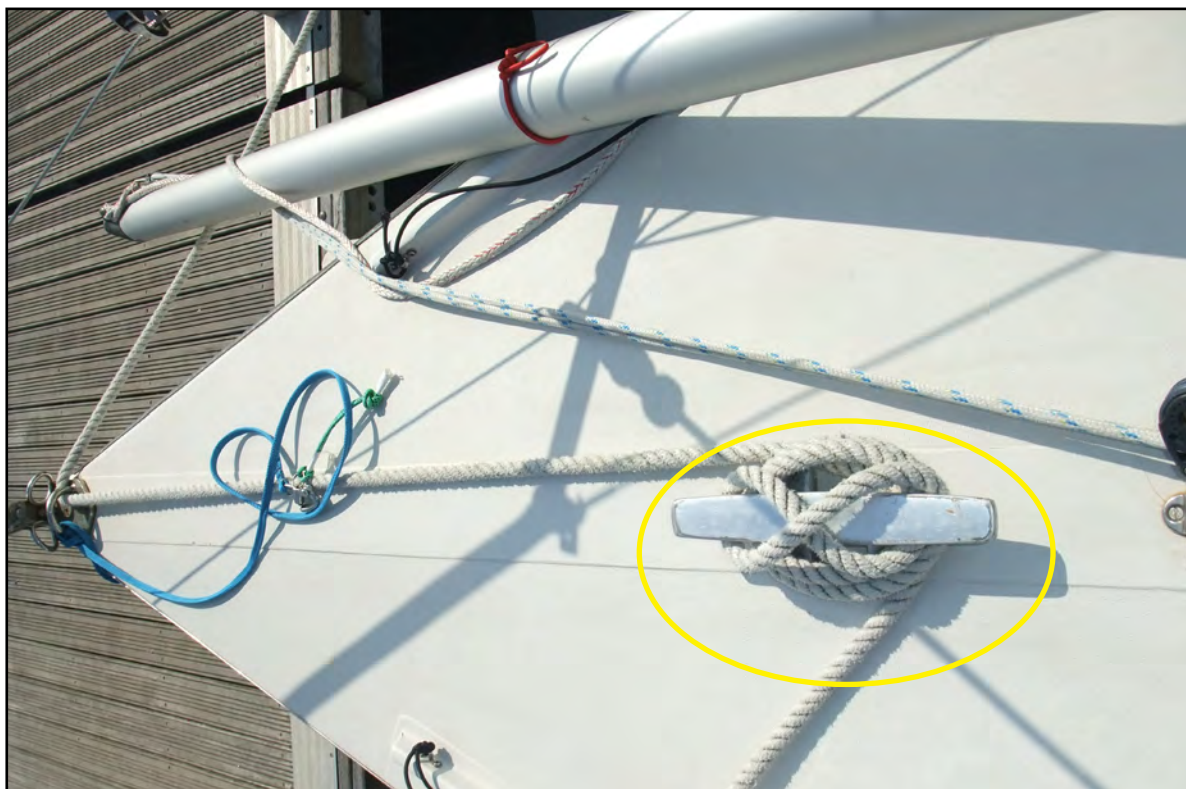
**Figure 5:** Position of the forward centreline cleat

As the skipper recovered the sail from the water it was passed along the starboard side by trimmers 1 and 2, and the navigator guided it down the companionway and into the cabin. When all of the sail was recovered on board, the skipper disconnected the tack from the forward pad eye. He then transferred his tether from the port to the starboard jackline in preparation to return to the cockpit along the high, starboard side, as was his usual practice. Almost immediately, the sail snagged and the skipper called “stop”. Trimmer 1 then saw him lie on the deck, on his stomach, facing forward and to starboard of the centreline. It is likely that the sail had snagged on the forward centreline cleat (**Figure 5**) and the skipper was attempting to free it. After a short time, the skipper called “OK” and the sail continued to be passed along the starboard side, partly over the coach roof and down the companionway into the cabin.

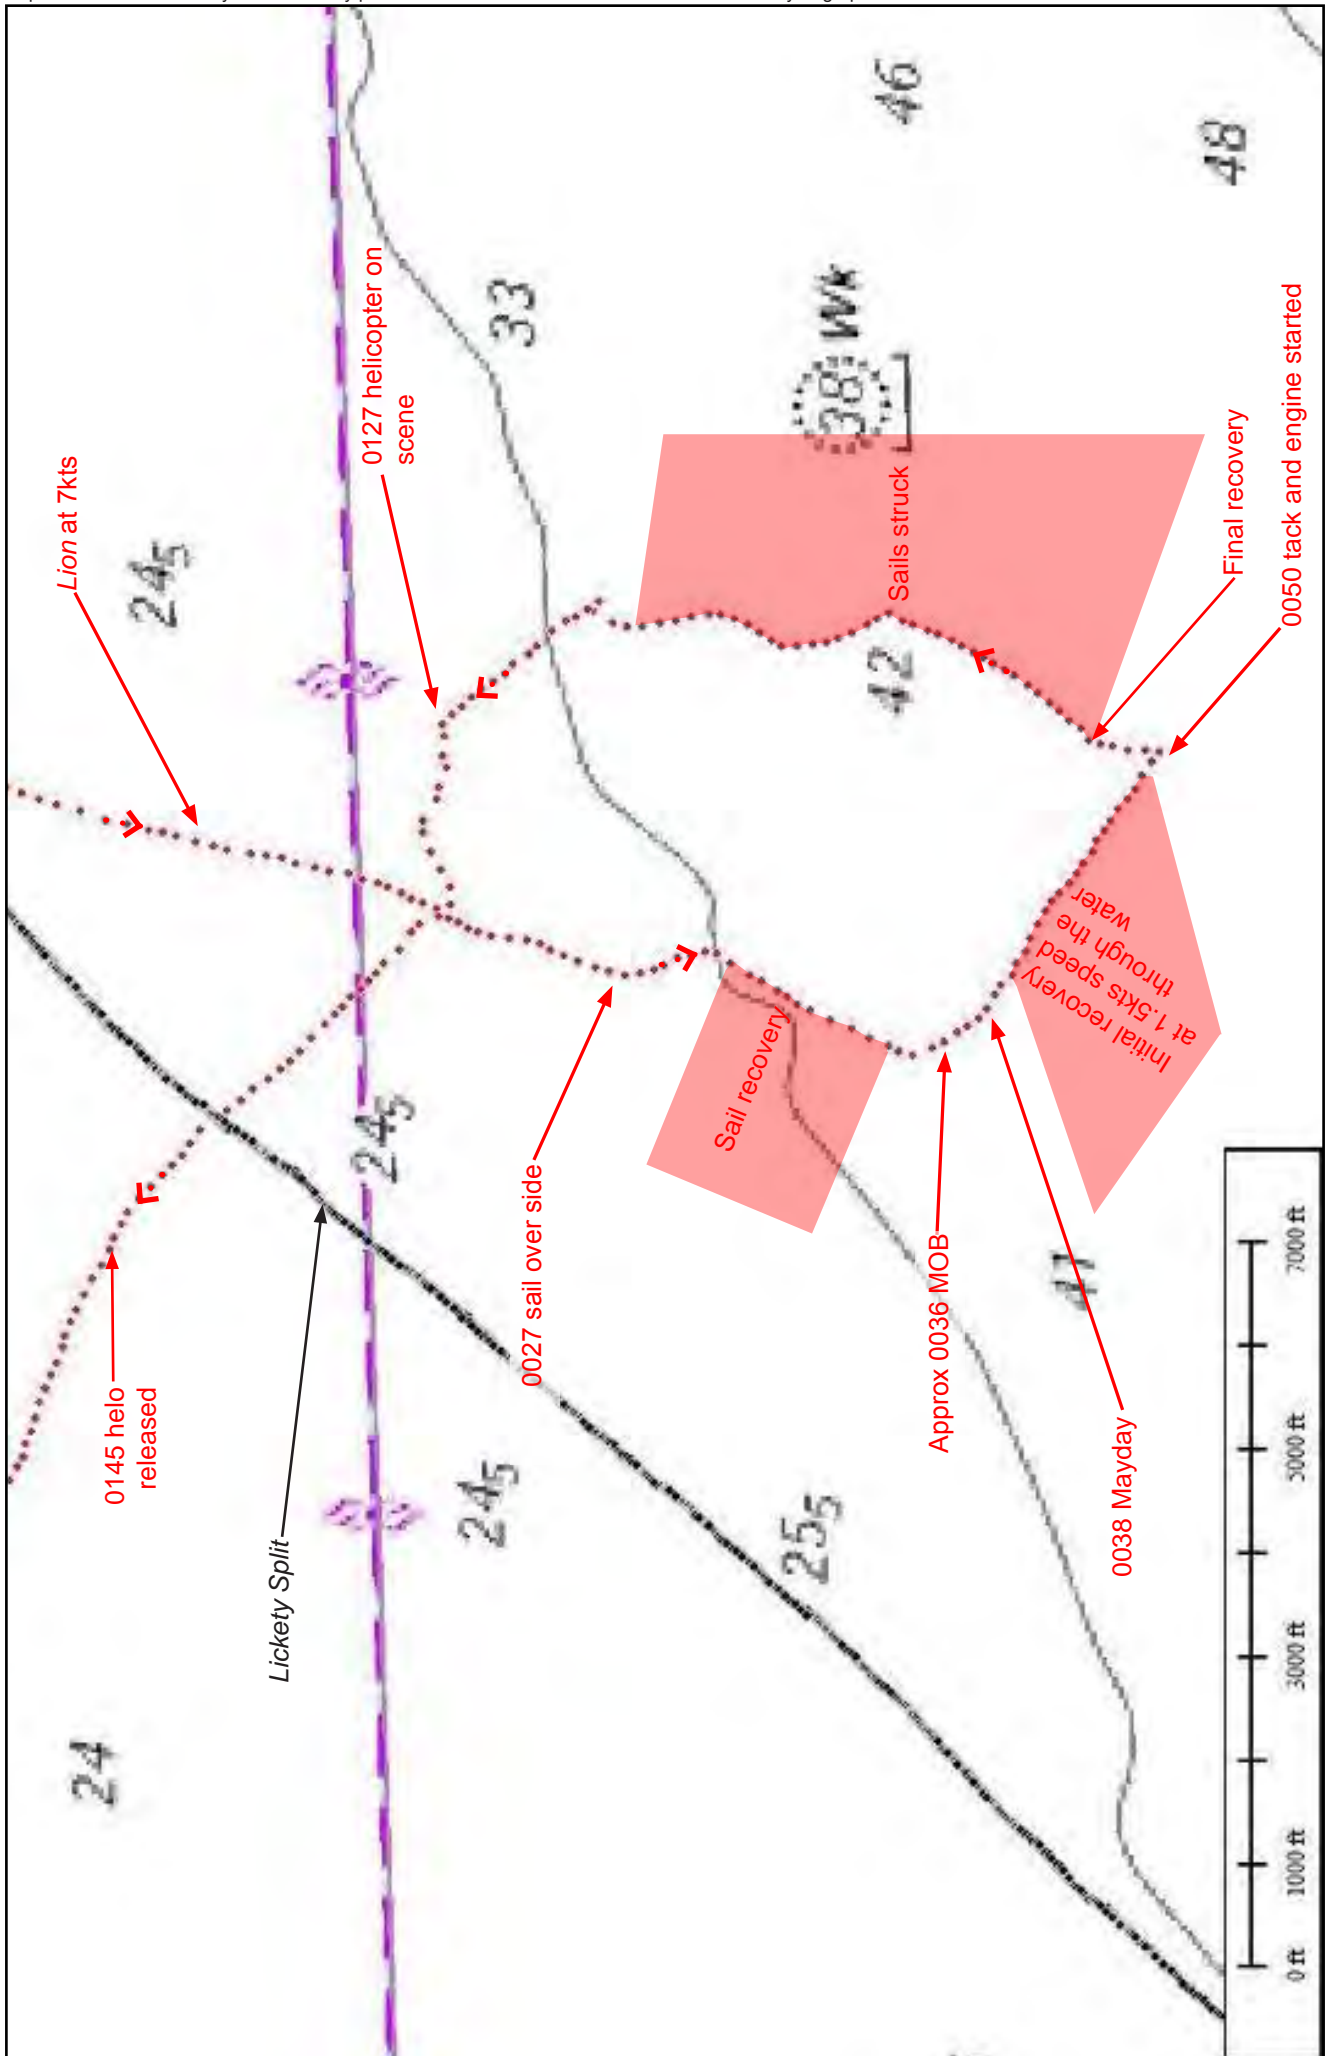
Figure 6: Detailed AIS track showing key events

To assist in the recovery, the helmsman instructed the general duties man to release the mainsheet, which had the effect of immediately slowing *Lion* down from 4.5 knots to 1.5 knots through the water, with a course over ground (COG) of approximately 135° True (T) (**Figure 6**).

A more detailed AIS track for *Lion*, showing the specific stages of the accident and actions taken, is at **Figure 6**.

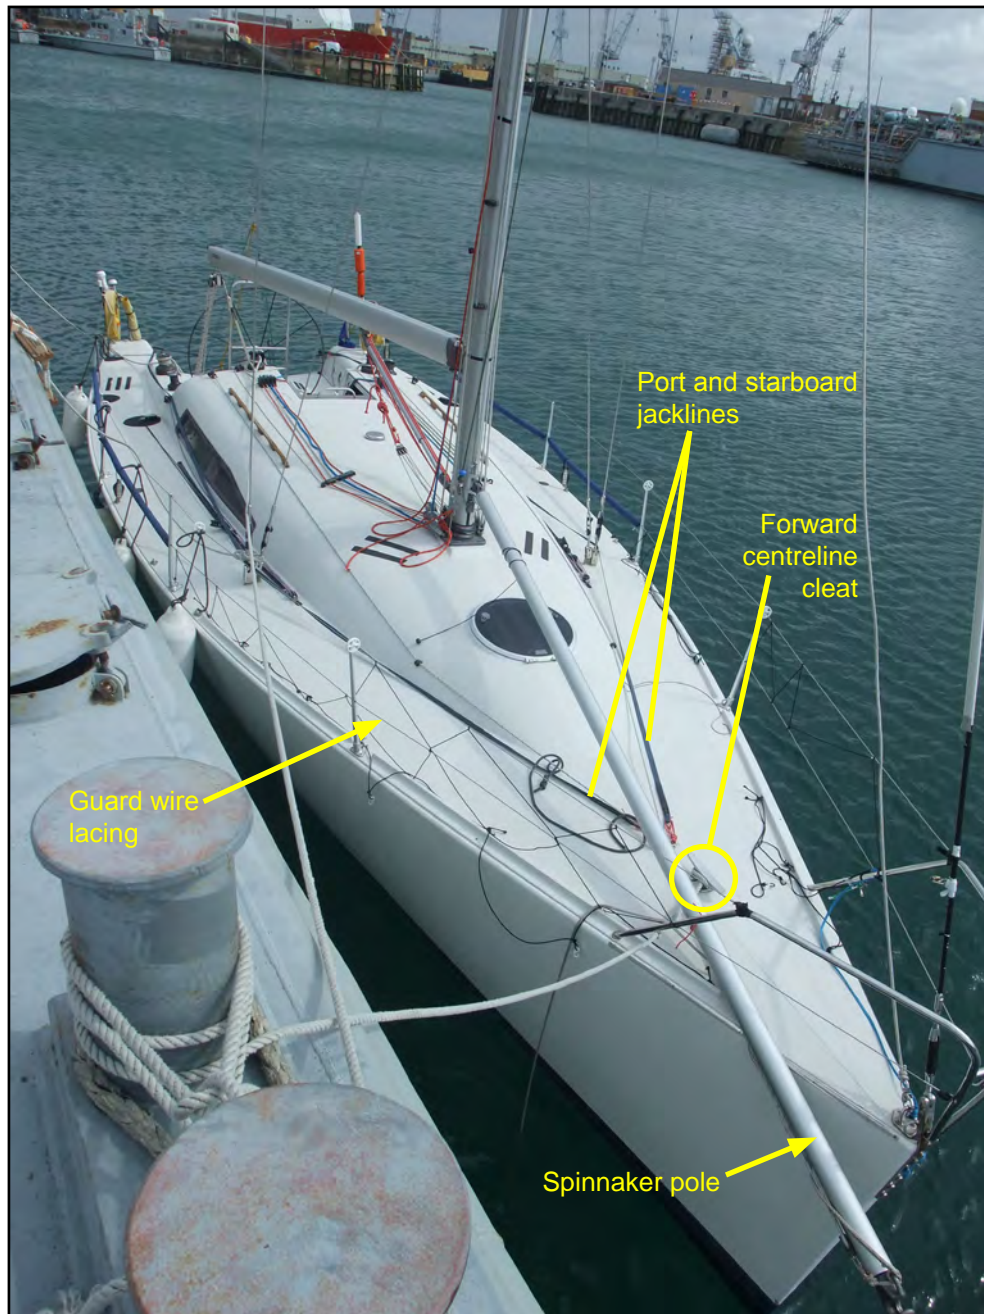
**Figure 9:** Deck layout

The port and starboard webbing jacklines were individually secured to the transom aft and to a forward common deck fitting positioned just aft of the cleat on the foredeck. On inspection, following the accident, the jacklines and fastenings were found to be in good condition.

The deck layout is shown at **Figure 9**.

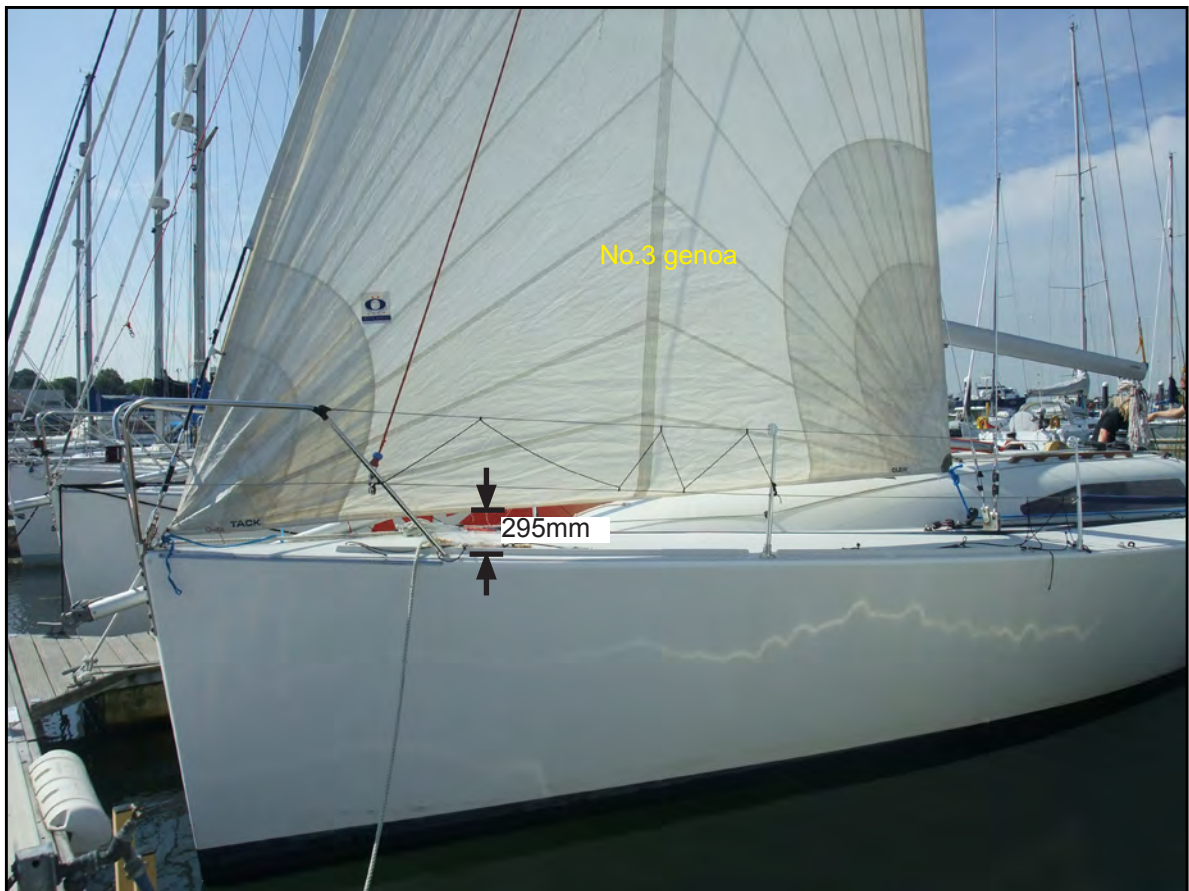
**Figure 11:** Gap between the foot of No.3 genoa and the deck

The gap between the foot of the No.3 genoa, the sail in use at the time of the accident, and the deck was 295mm (**Figure 11**).

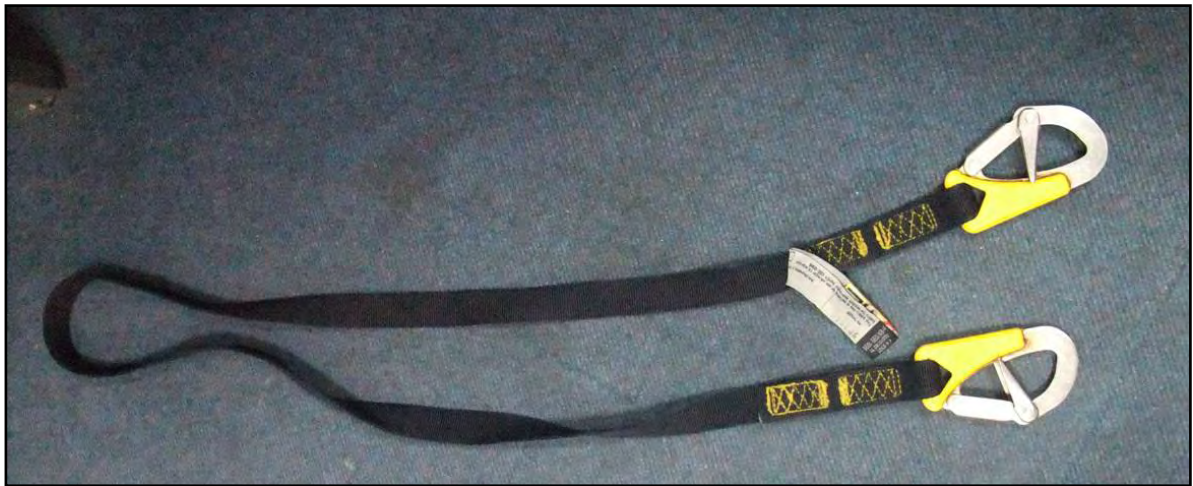
**Figure 14:** Two-hook tether

There are two main types of tether: the two-hook and the three-hook versions. The three-hook tether has an additional, short tether, complete with hook, stitched to the main tether at approximately the mid-point. The configurations are at **Figures 14** and **15** respectively.
