Report on the investigation of
two accidents during berthing and unberthing
of

Logos II

St Helier, Jersey

Report No 1/2008
January 2008

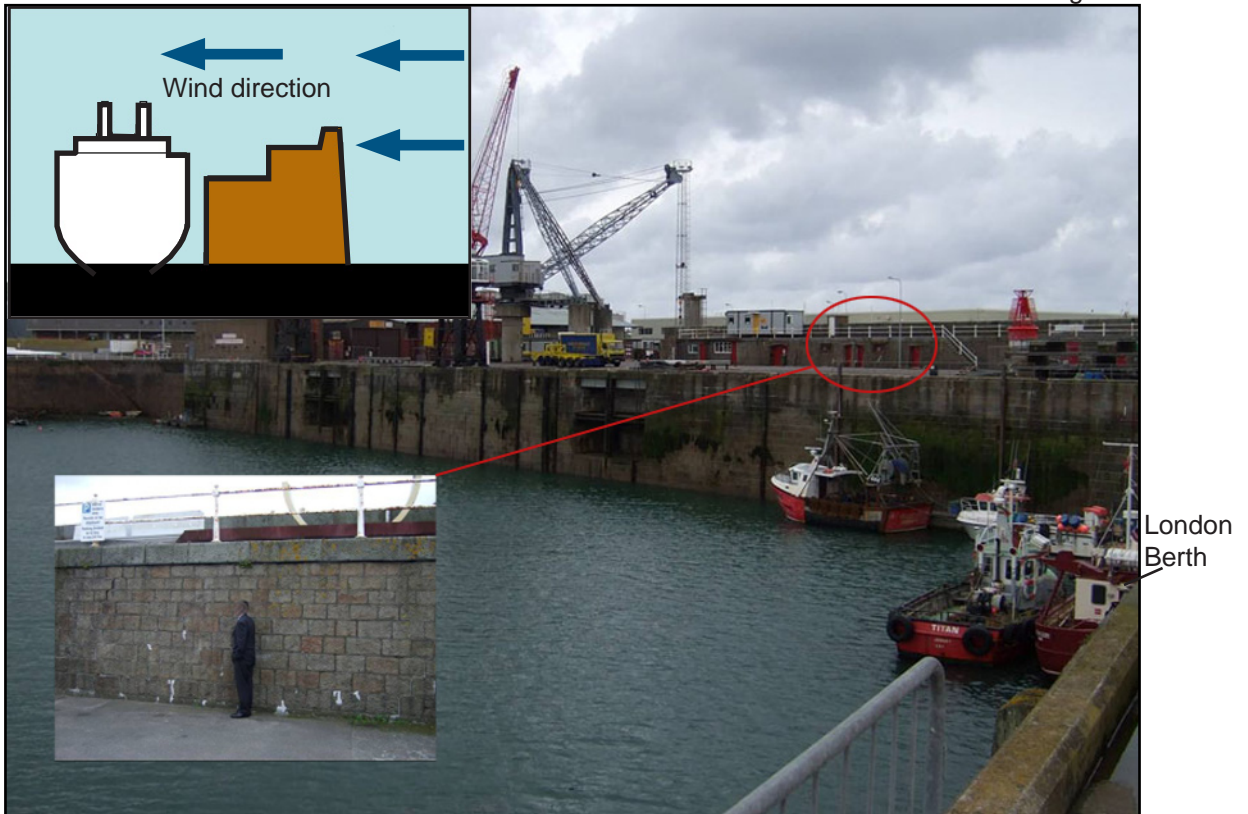
Figure 2

Victoria Pier

Before *Ronez* sailed, the DHM called the port control to arrange for three small boats moored on the western cross pontoon on Victoria Pier (**Figure 2**) to be moved by the duty officer, as he considered that they could potentially hinder the berthing of *Logos II*. Two other small boats moored alongside each other at the south end of London Berth (**Figure 3**) were not considered to be at risk. Using the VHF radio, the DHM also provided a briefing to the skippers of the tugs *Titan* and *Marineco Toomai* on his intended berthing plan.

The inner harbour of St Helier is entered through Albert Pier head and Victoria Pier head (**Figure 1**). On entering the inner harbour, Victoria Pier is located to the south. It is 135 metres in length and is used mainly for general cargo operations and the discharge of cement. The largest ship to use this berth was *Logos II*, in September 2005, although it is occasionally used by vessels of up to 90 metres LOA. A small fixed floating pontoon used by small boats is sited at the western end of the pier. The unusually high harbour walls (**Figure 2**) provide good shelter from strong winds, particularly from the south.

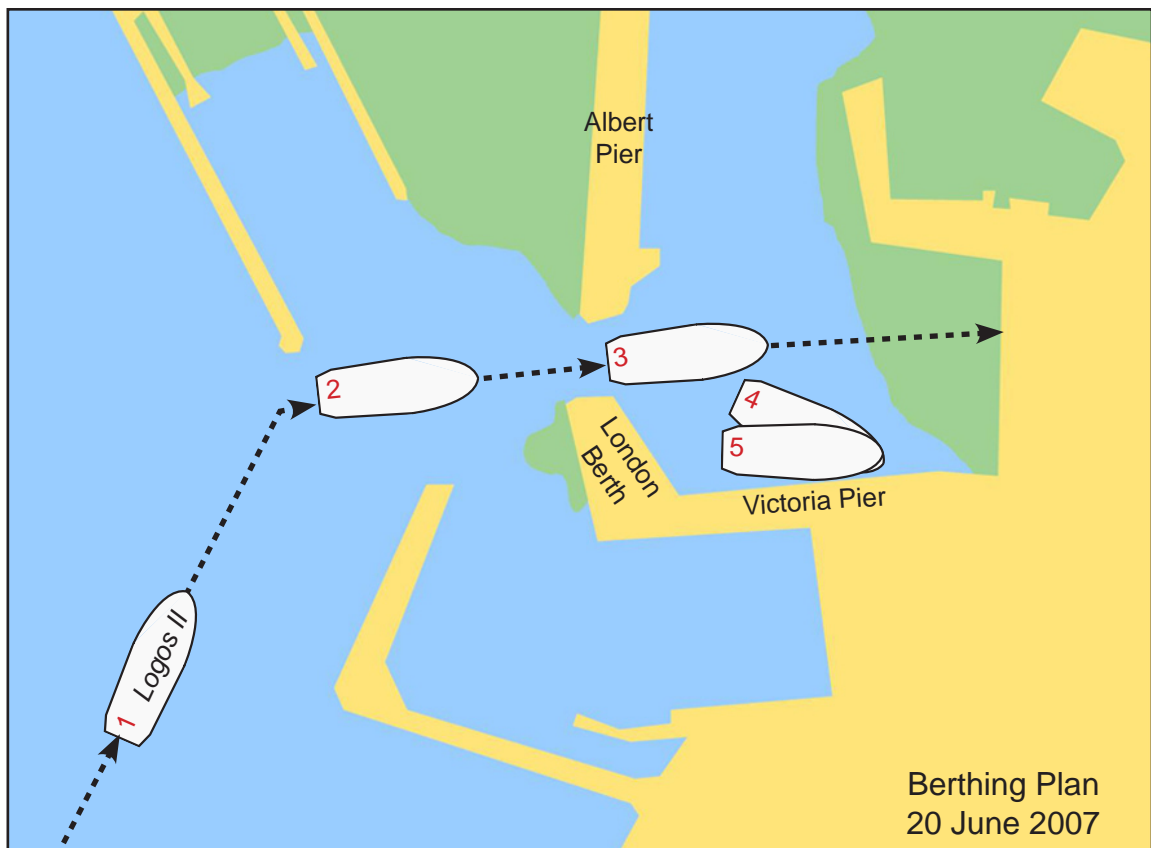
Figure 3

Diagram of the berthing plan of *Logos II*

The master and pilot then exchanged information. The master gave the DHM a pilot card (**Annex A**) and advised him that *Logos II* had two inward turning controllable pitch propellers with a single rudder amidships. The master also highlighted that the vessel's stern was easily influenced by the wind. The DHM then briefed the master that the vessel would enter and stop in the inner harbour where she would be met by *Titan* and *Marineco Toomai*. The intention was to position *Marineco Toomai* on the port quarter to hold the stern up against the fresh southerly breeze, and for *Titan* to push the bow towards the quay. Once sufficient lines were made fast forward, the stern would be pushed in with the assistance of the tug aft (**Figure 3**).

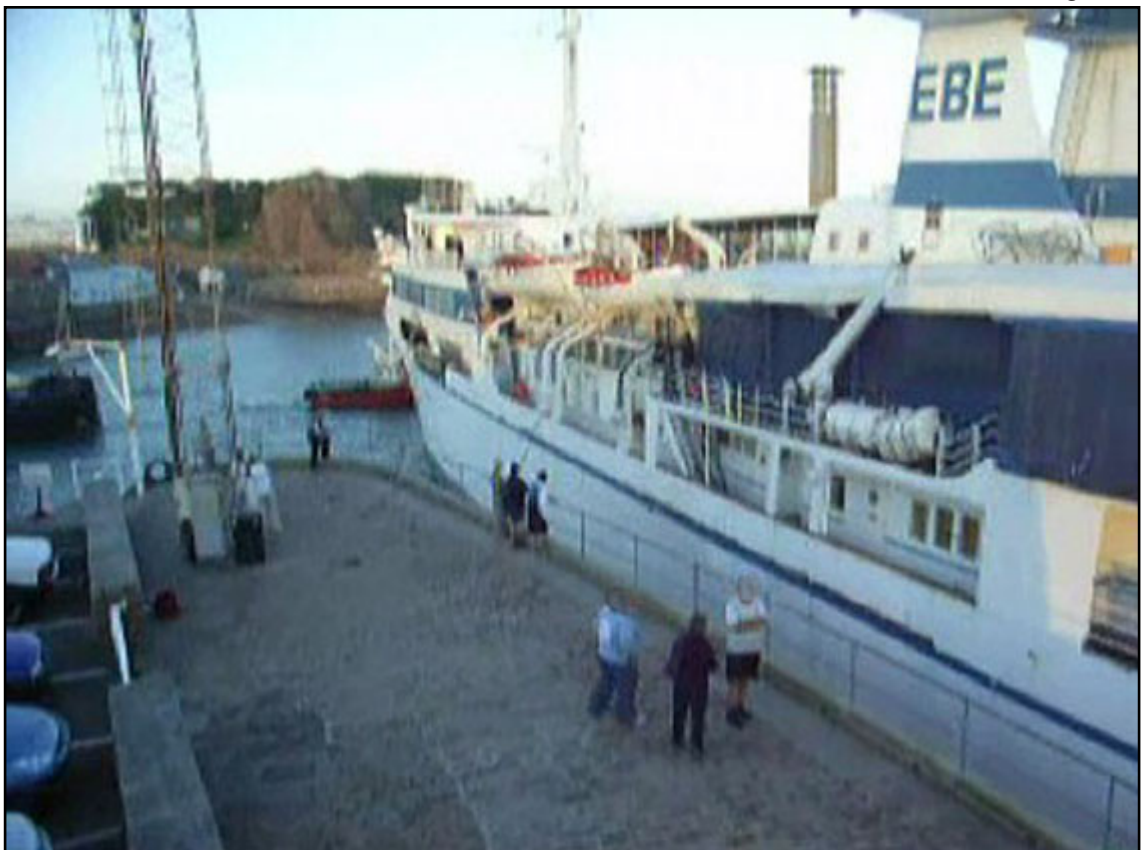
Figure 4

Logos II weighed anchor at 2008 and the master handed the con to the DHM. The vessel proceeded at full ahead manoeuvring speed of 7 knots and, after the passage through Small Road, she executed the turn towards the inner harbour without difficulty. During the transit through the inner pier heads, on which a large crowd had gathered to greet the ship and was cheering loudly, the DHM instructed *Titan* to: 'get on the bow as soon as possible and start pushing us down south'. The skipper of *Titan* immediately complied with this instruction (**Figure 4**), and soon after, the port quarter of *Logos II* began to swing towards Albert Pier head. The DHM was able to check the swing of the port quarter by the use of ahead power and port helm.

Titan pushing *Logos II* on entry through the pier heads (image captured from video)

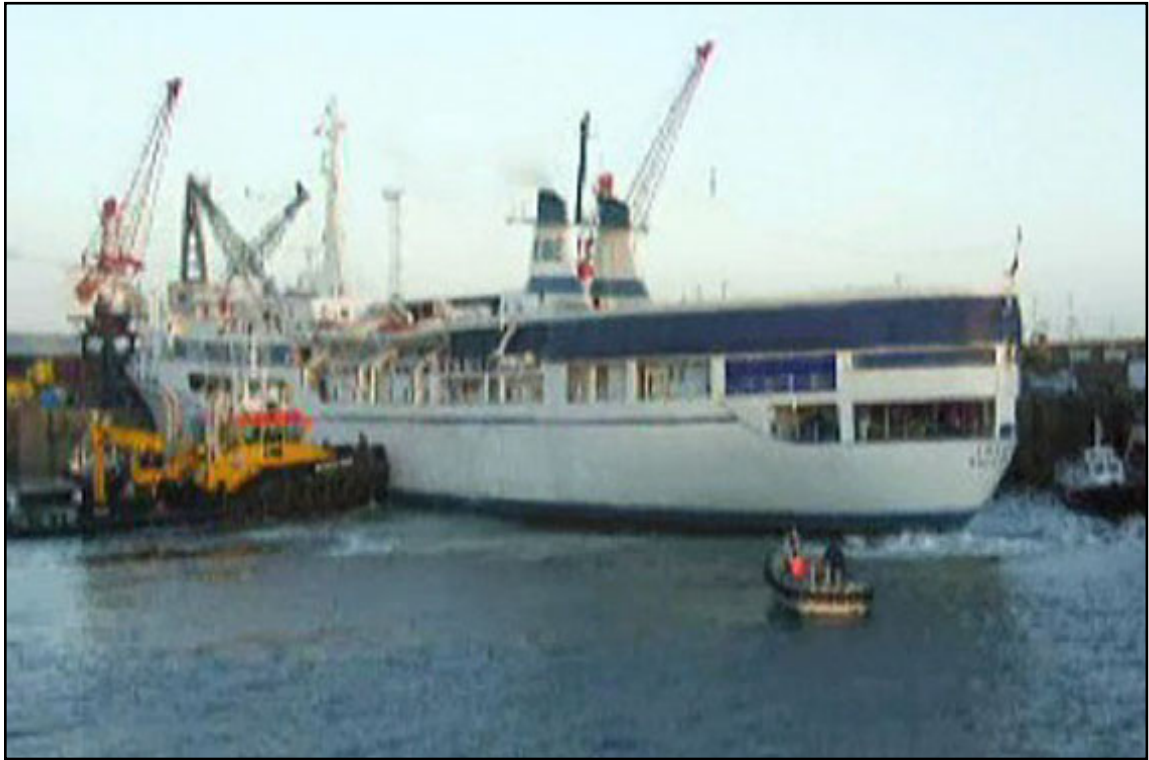
Figure 5

On clearing the pier heads, *Marineco Toomai* took up a position just aft of amidships (**Figure 5**) on the port side of *Logos II*. At 2043, the DHM instructed both tugs to push the vessel towards Victoria Pier. His instruction to *Marineco Toomai* was: 'can you push easy on the stern, we will to push her bodily down' [sic]. The DHM looked over the port side on several occasions as *Logos II* closed Victoria Pier, but was unable to accurately determine the position of *Marineco Toomai* due to obstructions in his line of site. He assumed she was in her assigned station; he did not check directly with the tug and was not informed otherwise. Soon after, *Halcyon*, a harbour work boat which had been requested by the DHM to standby to assist, positioned herself on the port quarter of *Logos II* and also started to push (**Figure 6**). This action was not requested or seen by the DHM.

Marineco Toomai pushing from amidships (image captured from video)

After *Logos II* had stopped in the inner harbour, she was pushed bodily towards Victoria Pier by *Titan*, which was positioned on the port bow, *Marineco Toomai*, positioned just aft of amidships (**Figure 5**), and by *Halcyon* on the port quarter (**Figure 6**). As she neared the berth with her bow canted towards the quay as intended, it is highly likely that the speed of approach increased as the vessel came into the lee of the harbour wall (**Figure 2**), and the effect of the fresh southerly breeze was lost. The influence of *Halcyon* would have been minimal due to her size.

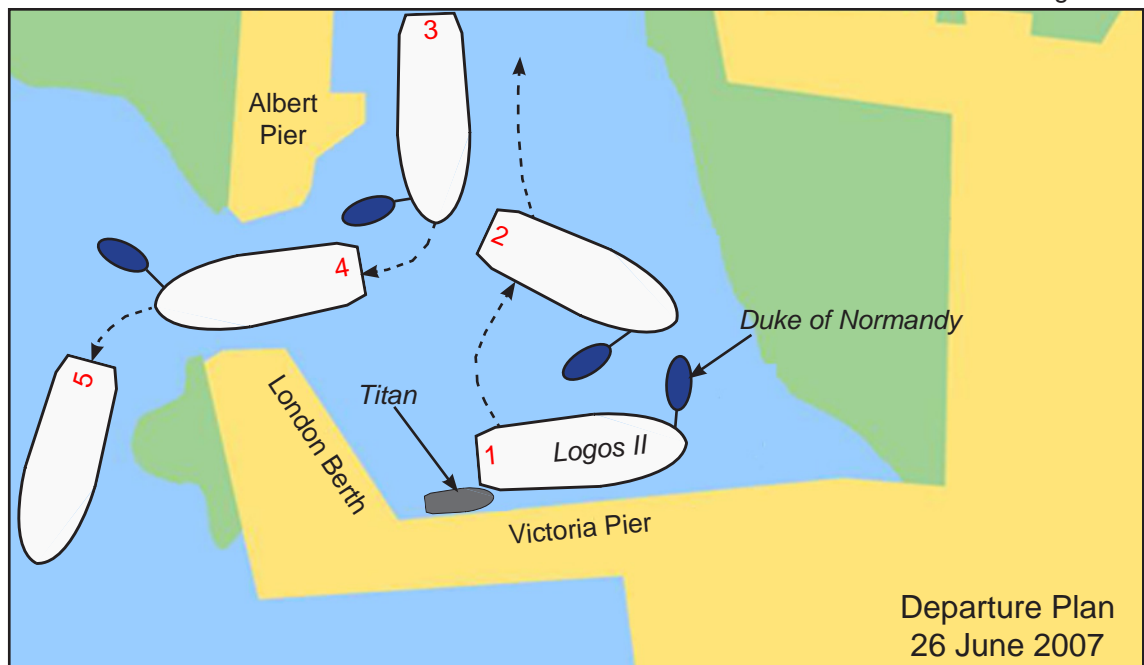
Figure 10

The nominated pilot for *Logos II*'s departure from St Helier on 26 June 2007 was the Assistant Harbour Master (AHM) responsible for fisheries and enforcement within the port. He boarded the vessel on 25 June 2007 to advise the master to advance the planned time of departure which was scheduled for 1600 the following day. This coincided with the predicted time of high water and, as the wind was forecast to strengthen from the north west, the AHM was aware that the harbour walls would provide better protection from the wind if the ship sailed at a lower state of tide. The master accepted the pilot's advice and agreed to sail at 1100. The pilot also briefed the master on the departure plan which involved the use of the tugs, *Titan* and *Duke of Normandy* (**Figure 10**).

Diagram of the departure plan of *Logos II*

The advancement of the time of departure in view of the height of tide and forecast wind conditions indicated the departure was well considered by the pilot. Indeed, the intended plan (**Figure 10**) worked well until the vessel approached the gap between the pier heads. Given the difficulty experienced by the AHM to turn *Logos II* away from Victoria Pier head, which was probably due to the poor manoeuvring characteristics of the vessel, his instruction to *Duke of Normandy* to pull the bow to the north was logical. It was unfortunate that the tow line parted as the tug attempted to manoeuvre on to the starboard bow of *Logos II*.
