Report on the investigation of  
the grounding of  
***mv Maersk Kendal***  
on Monggok Sebarok reef  
in the Singapore Strait  
on 16 September 2009

Marine Accident Investigation Branch  
Mountbatten House  
Grosvenor Square  
Southampton  
United Kingdom  
SO15 2JU

**Report No 2/2010**  
**March 2010**

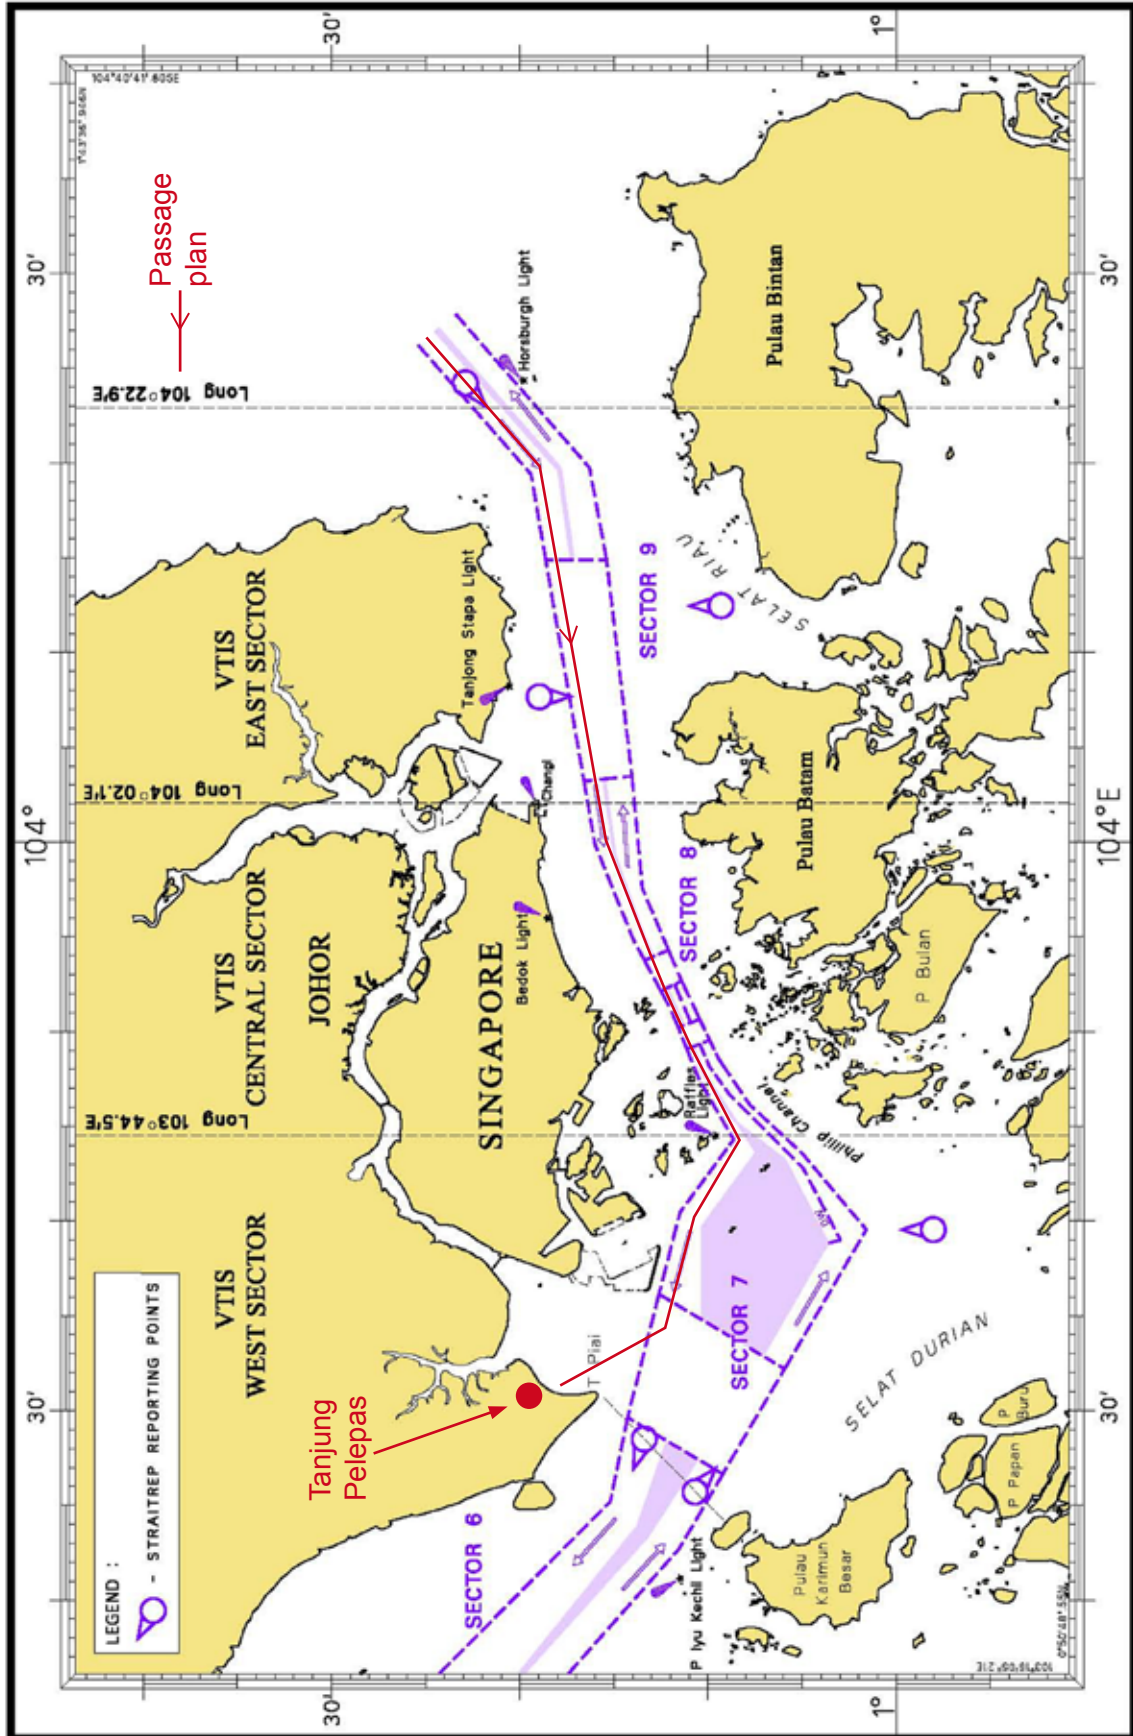
Figure 1

*Maersk Kendal* entered the eastern Singapore Strait Traffic Separation Scheme (TSS) at about 0515. As the vessel passed Horsburgh Light, at 0530, the chief officer reported in to Singapore Vessel Traffic Information System (VTIS) sector 9 (**Figure 1**) on VHF radio channel 14. This report was required by STRAITREP, a mandatory reporting scheme for vessels transiting the Malacca and Singapore Straits.

Singapore Strait - VTIS operational areas

Singapore VTIS was established by MPA as the competent authority to monitor vessel traffic in the TSS of the Singapore Strait. Sectors 7, 8 and 9 are controlled by Singapore VTIS (**Figure 1**). They provide information to ships about specific and critical situations which could cause conflicting traffic movements and other information concerning the safety of navigation.

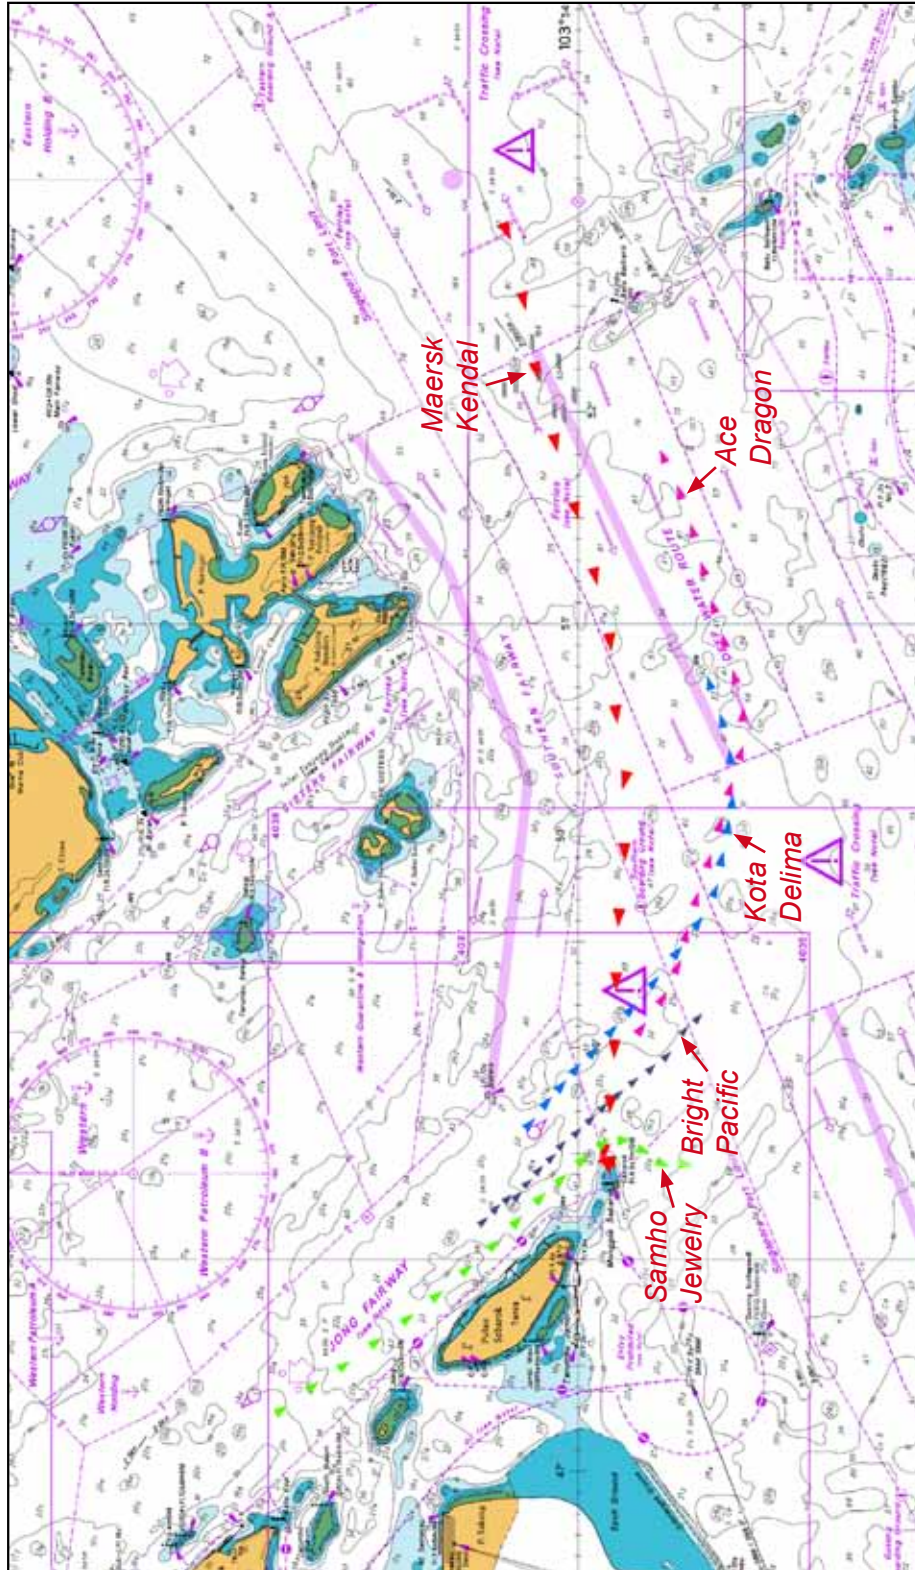
Figure 7

The complete plot of all vessels from 0700 to 0716 is at **Figure 7**.

Overview of plot of all vessels between 0700 and 0716

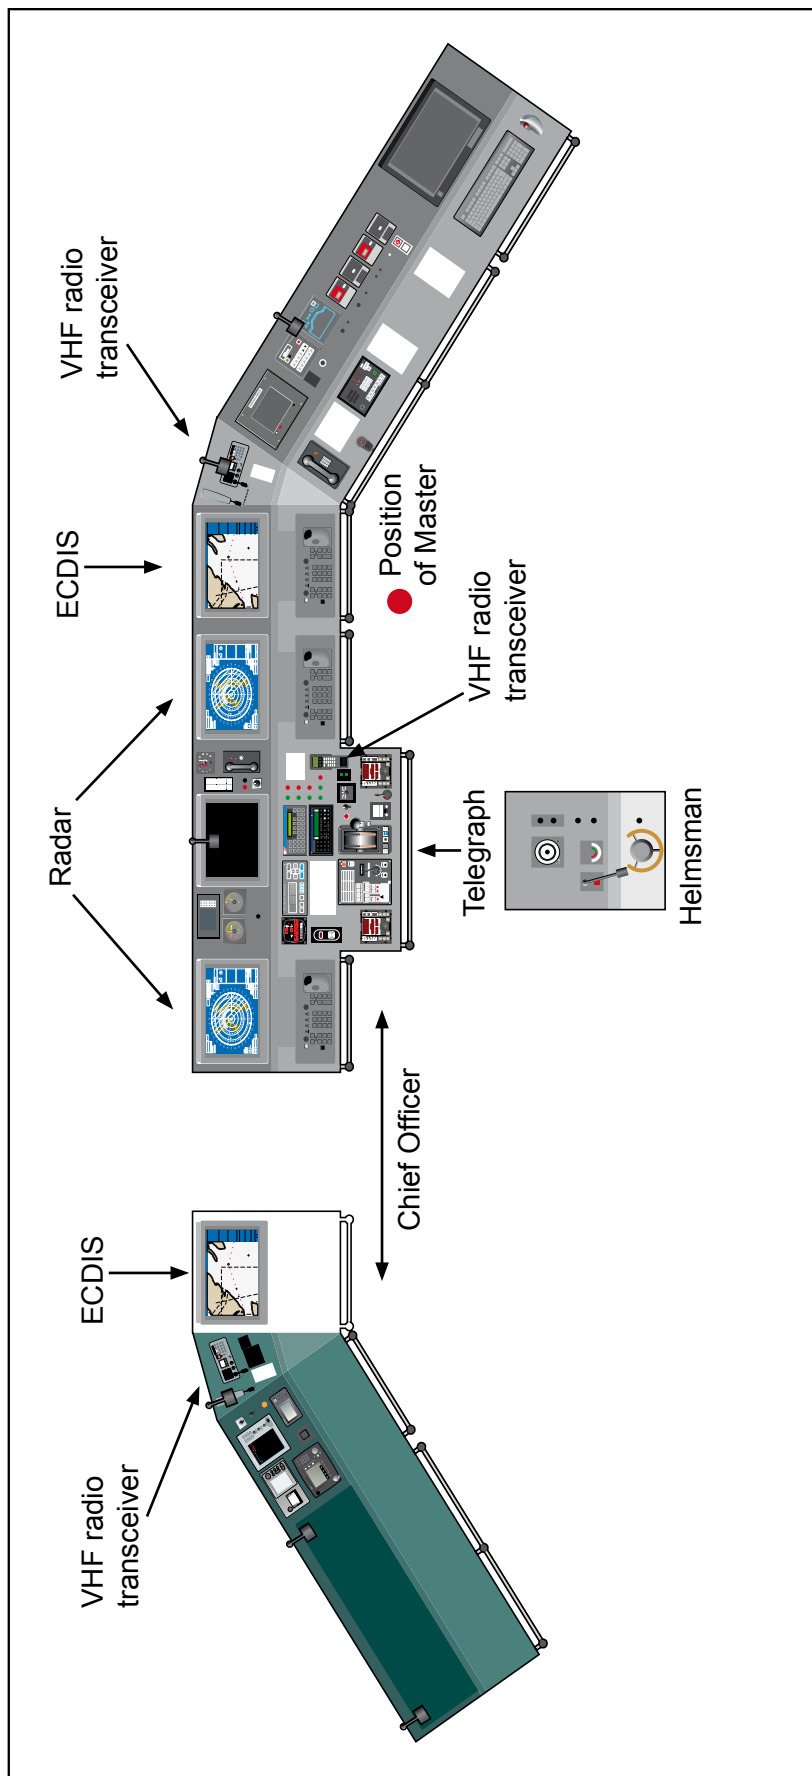
Figure 10

Bridge equipment layout

The master was predominantly positioned at the starboard radar and ECDIS displays (**Figure 10**). The engine telegraph was located on his inboard side. This was his usual position from which he had an unrestricted view of the conning display unit. At the time of grounding, the starboard ECDIS display was on a 1:5000 scale (**Figure 11**).

Although the master started to slow the vessel's speed at 0650 to full ahead manoeuvring, this was in preparation for arrival at Tanjung Pelepas pilot station rather than to slow down for navigational and collision avoidance considerations. The timing of telegraph movements to half ahead and then slow ahead (**Annex A**), suggest that he was prompted by VTIS to slow down rather than as a result of his own assessment of the situation. The telegraph movement to half ahead had no effect, and the vessel's speed over the ground was recorded as 19 knots at 0710 (**Figure 4**). It was only when the telegraph was brought back from half ahead to slow ahead that the load down programme was overridden and the engine speed started to reduce significantly. Furthermore, neither he nor the chief officer monitored the vessel's speed, although this could have been easily obtained from the ECDIS, ARPA, AIS or the conning unit display (**Figure 10**).
