Report on the investigation of the fatal injury of a crew member
and the serious injury of a second crew member
in heavy weather on board the UK registered container ship

Maersk Kithira

23 September 2008

Report No 9/2009
April 2009

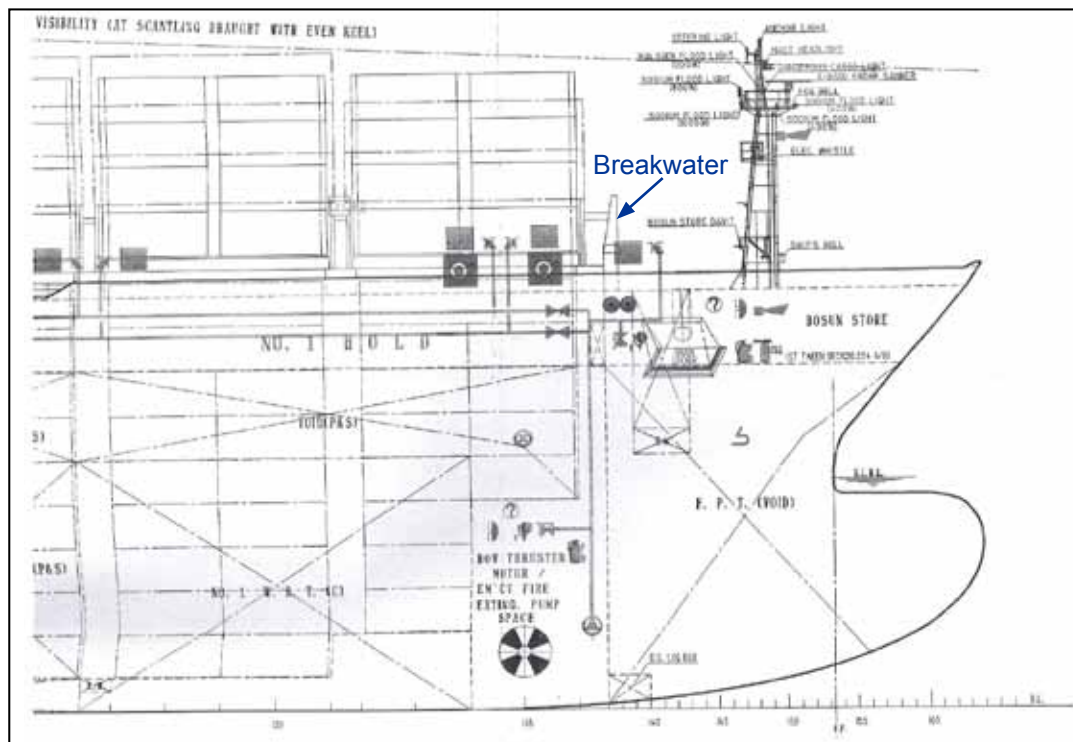
Figure 1a

Profile of *Maersk Kithira*

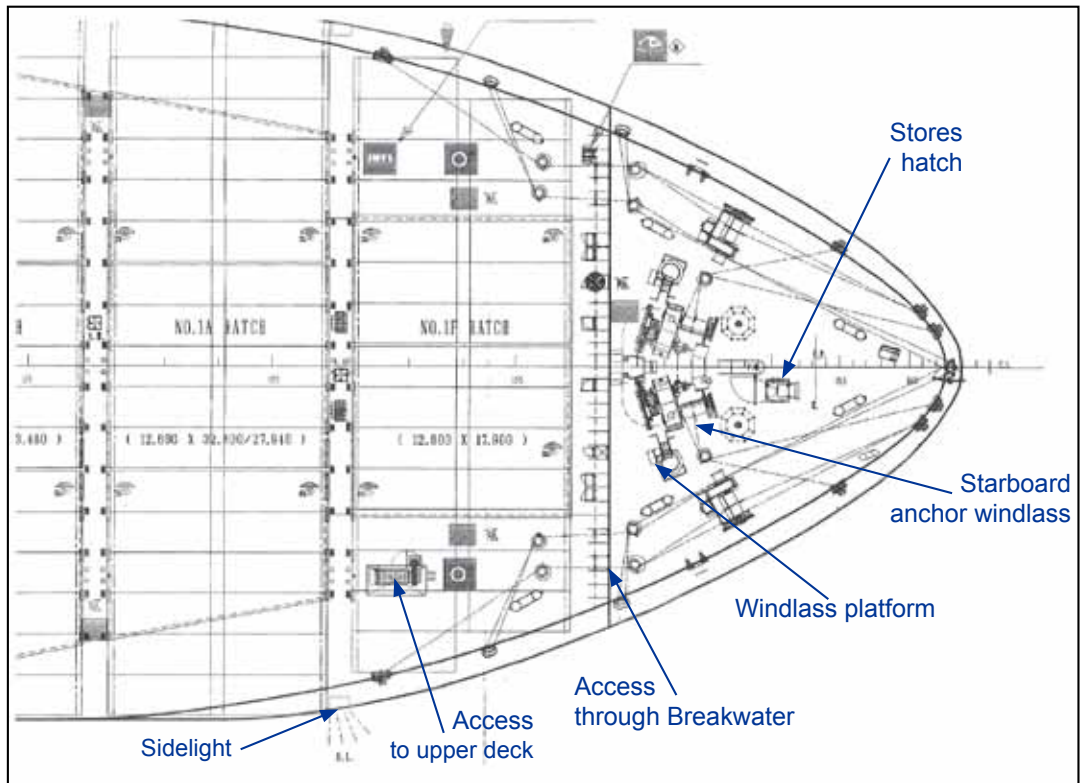
Figure 1b

On arrival at the bosun's store (**Figure 1**), the chief officer and chief engineer found that the deck was wet, and that water was entering through the forecandle deck stores hatch cover seal. Shortly afterwards, at 2007, they reported to the bridge by telephone what had been found.

Plan of Forecastle - *Maersk Kithira*
