Report on the investigations of
heavy weather damage
on board the container ship
Maersk Newport
50 miles west of Guernsey
on 10 November 2008
and fire
alongside at the container berth in Algeciras, Spain
on 15 November 2008

Report No 13/2009
June 2009

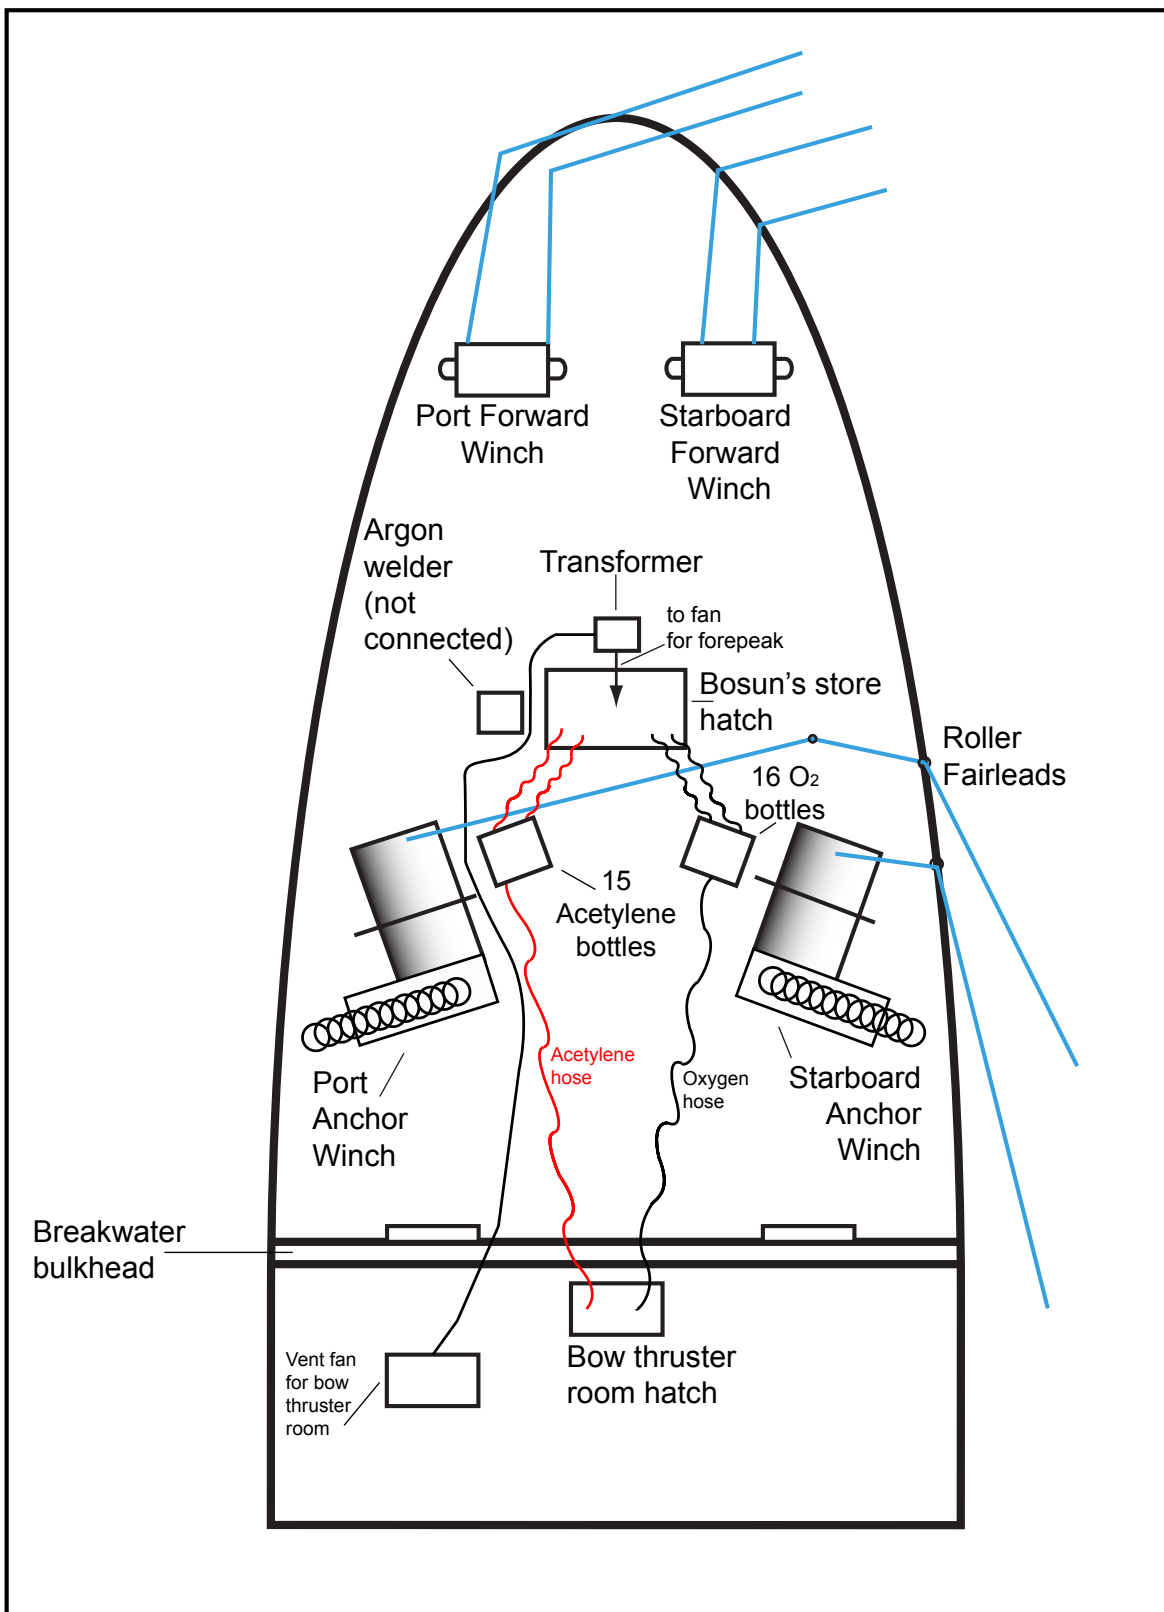
At about 0055 the burning stopped in both the forepeak and the bow thruster room. The blowtorch gas valves were shut, but the gas bottle valves were left open as the contractors started to grind off the rough, burnt edges of hull plating.

Diagrammatic layout of the contractor's equipment and forward mooring arrangements

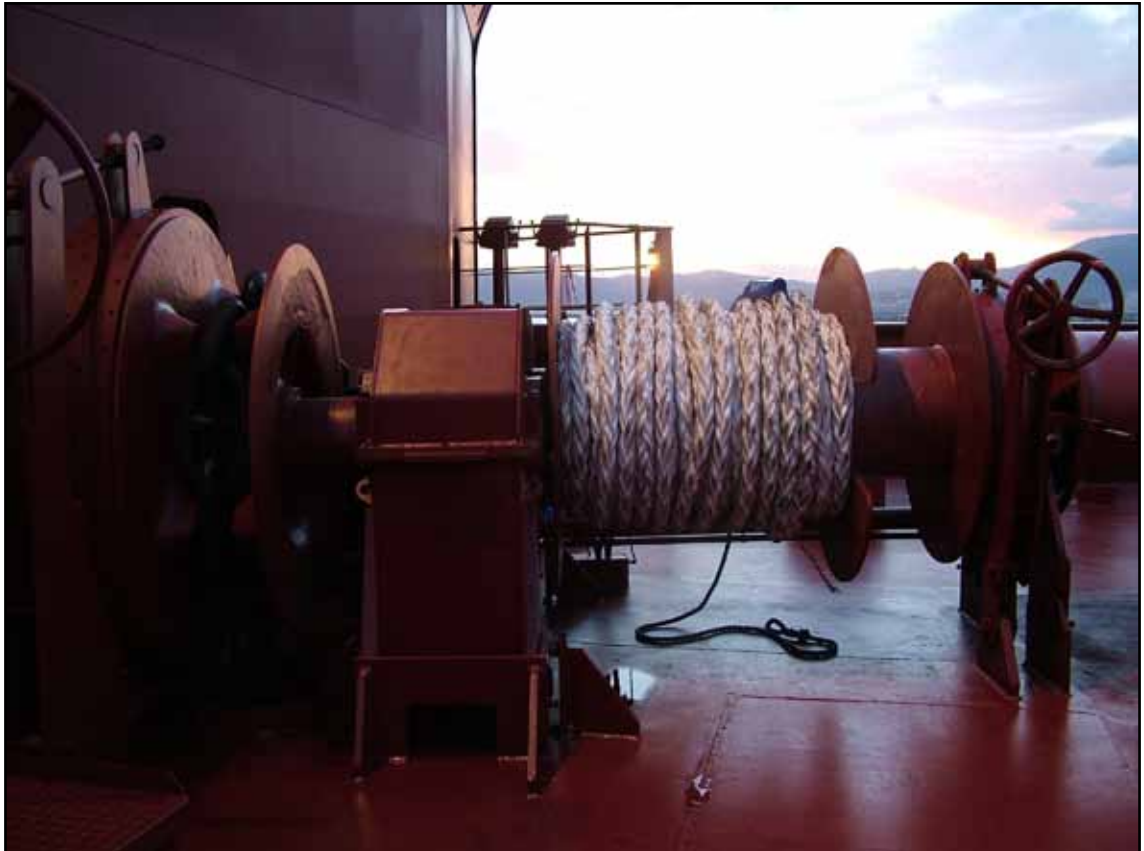
Figure 22

Maersk Newport was fitted with two, type 2 AMW 120/76 K3 R, twin drum windlass winches on the forecandle (Figure 22). The winches were designed and manufactured in 2008 by KGW Marine GmbH based in Schwerin in Germany.

General view of the port windlass winch

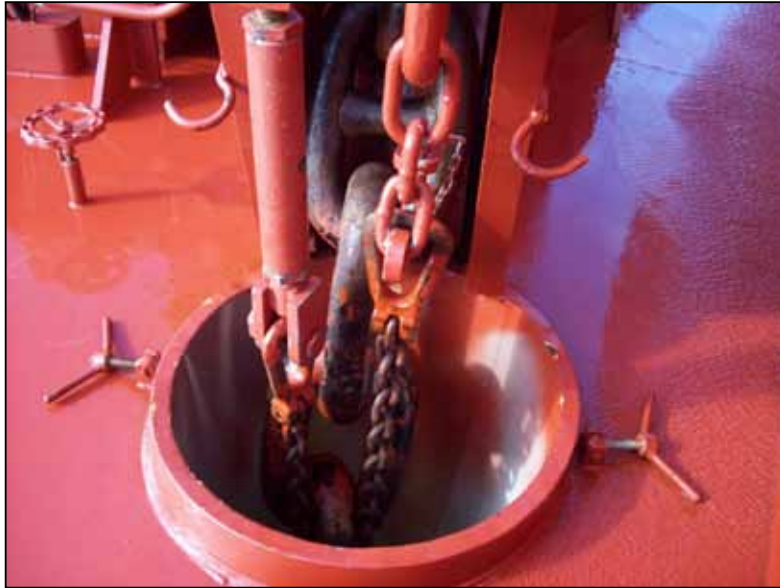
Figure 23

The lashing was passed through the anchor chain and was secured to a quick release Senhouse slip. The moveable part of the slip link was secured by an 83mm long, slightly tapered pin which passed through the tongue of the slip (**Figures 23 and 24**). The chain lashing was then tensioned by a bottle screw adjuster.

Chain lashing arrangement

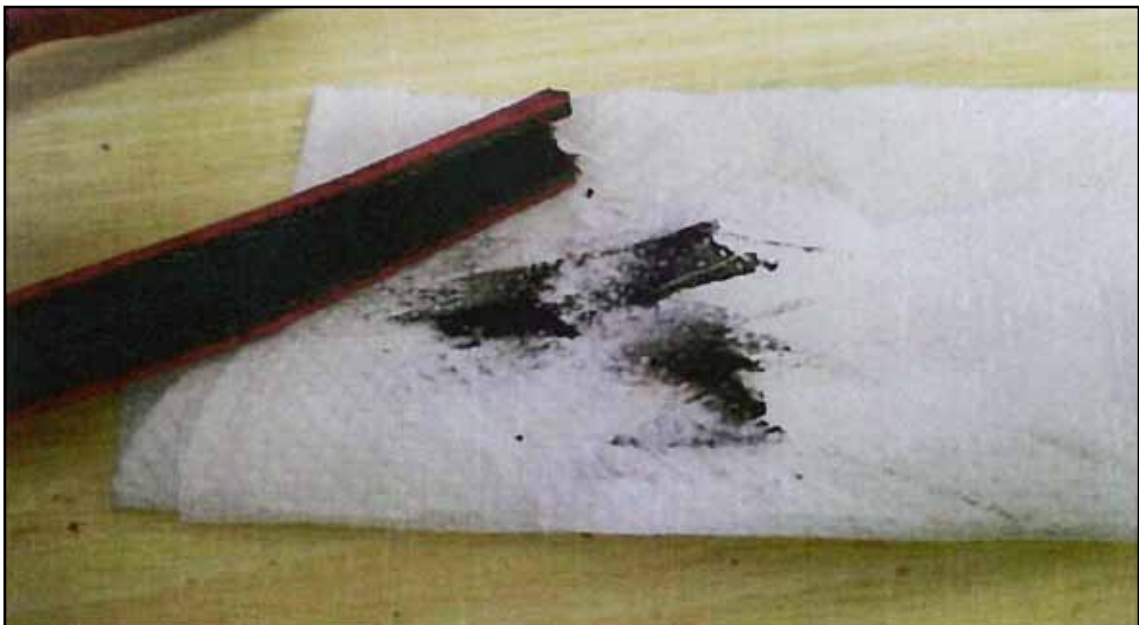
Figure 27

The flame front which precedes the flame can exceed the pressure test of the acetylene hose and cause it to fail, with the result that the flame will become exposed. A flashback is typically evidenced by carbon deposits on the inside of the hose walls – **Figure 27**.

Carbon deposits on the inside of an acetylene hose -
typical indications of a flashback
