Part 1 – Merchant Vessels

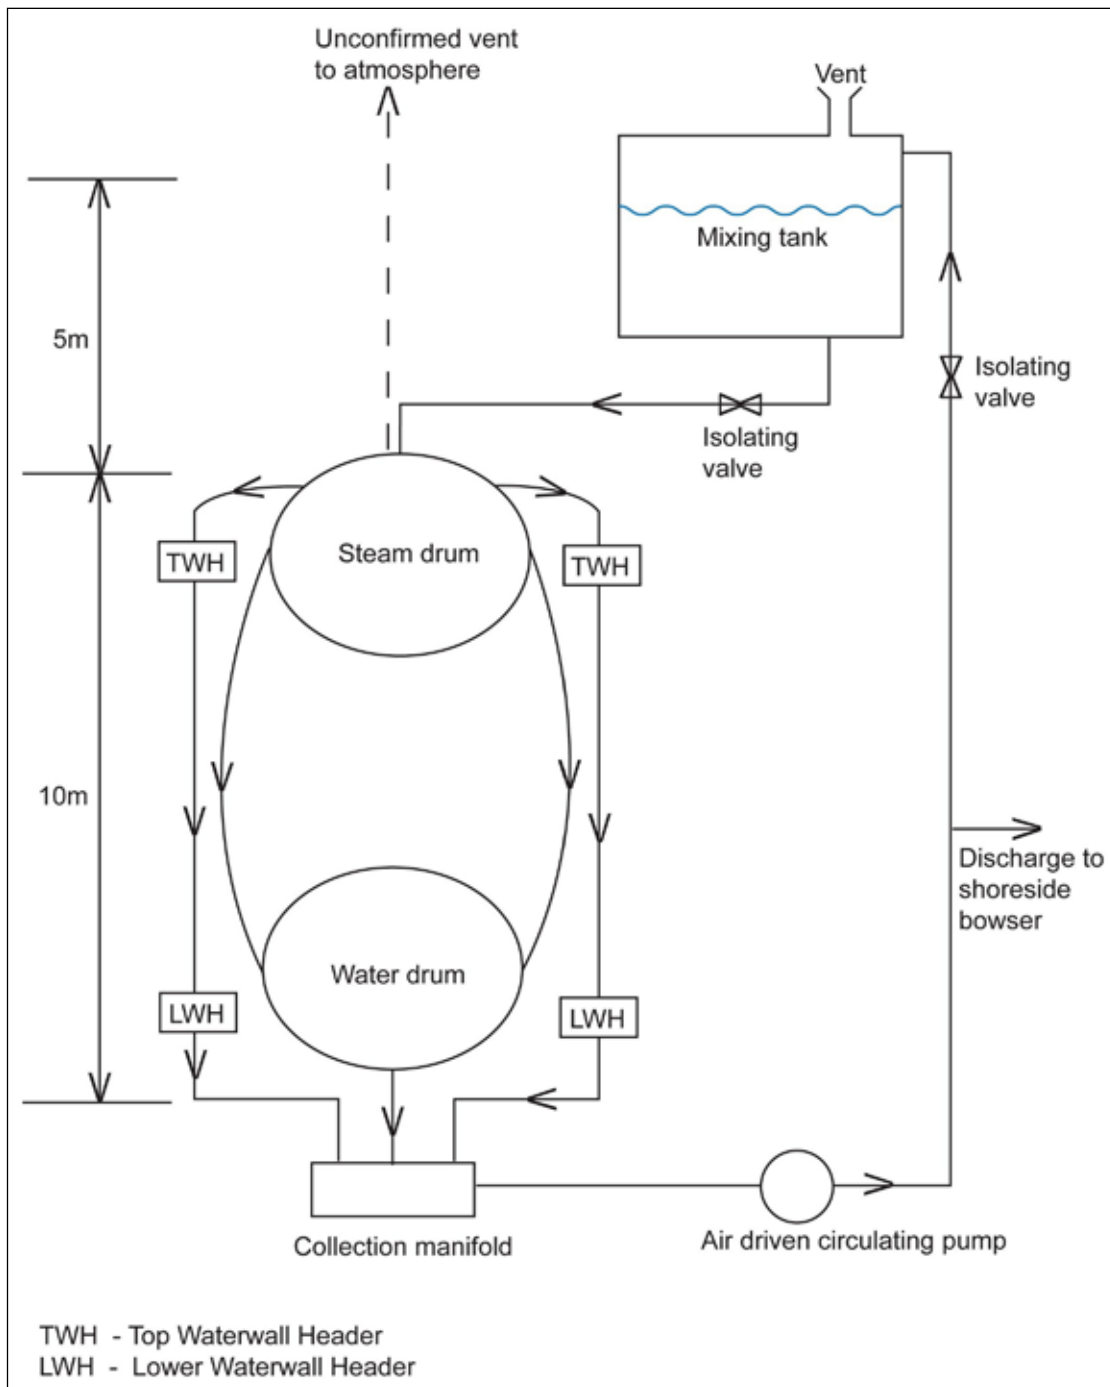
Figure 1

After completing shipyard-sponsored safety training, which included Permit to Work and entry into confined space routines, the cleaning expert set up his equipment. The final cleaning configuration is shown in the schematic at Figure 1.

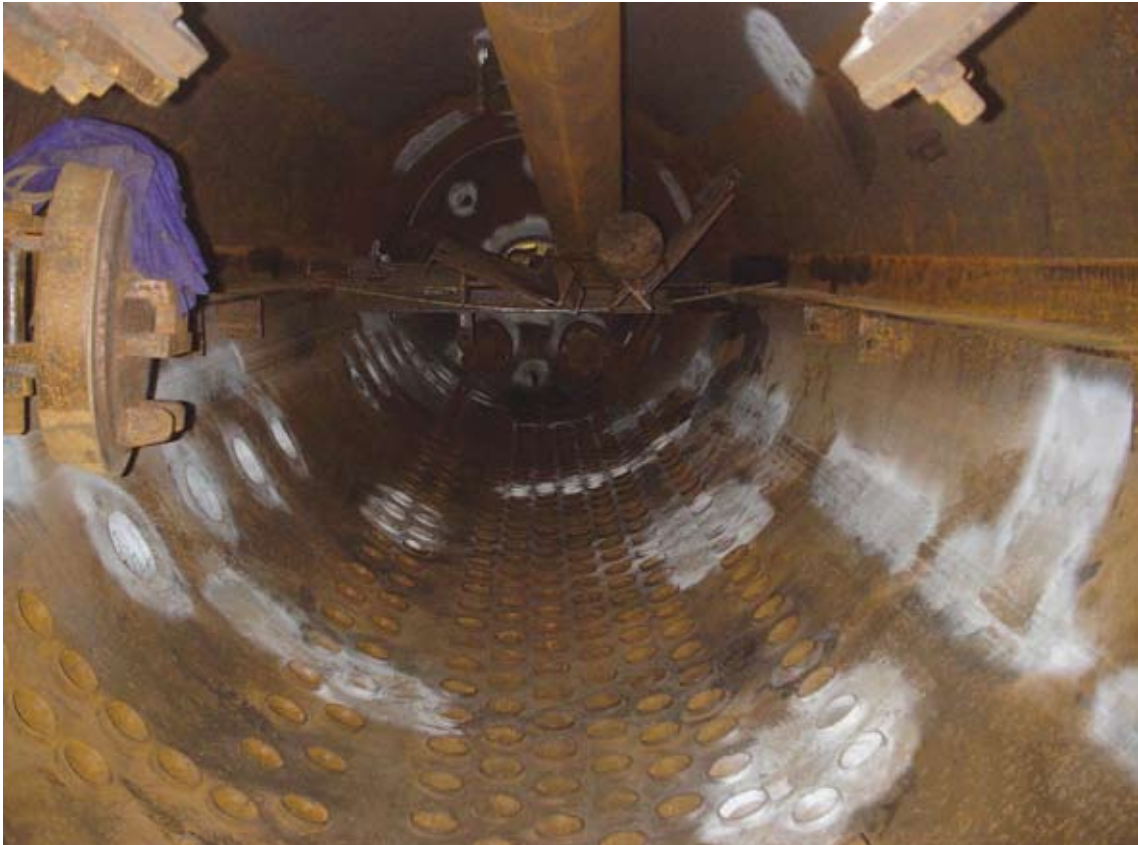
Figure 2

By 2100 things had rapidly changed. Tests indicated that the boiler steel was being attacked by the sulphamic acid. The UK expert was rather sceptical about the interpretation of the test results because he had expected to circulate the water/acid mixture for a few more hours. However, he agreed to stop circulating the water/acid mixture and reconfigured the system to pump the mixture into a shore-side bowser. In the meantime, he asked the repair contractor to arrange for the after door of the starboard boiler steam drum to be opened (Figure 2) so that the internal surfaces of the boiler could be inspected.

At about 2145 the steam drum door was opened, and as the contractors pushed the door into the drum there was a noticeable suction as the seal was broken. The workers also moved a non-intrinsically safe halogen lamp to a handrail near to the steam drum.

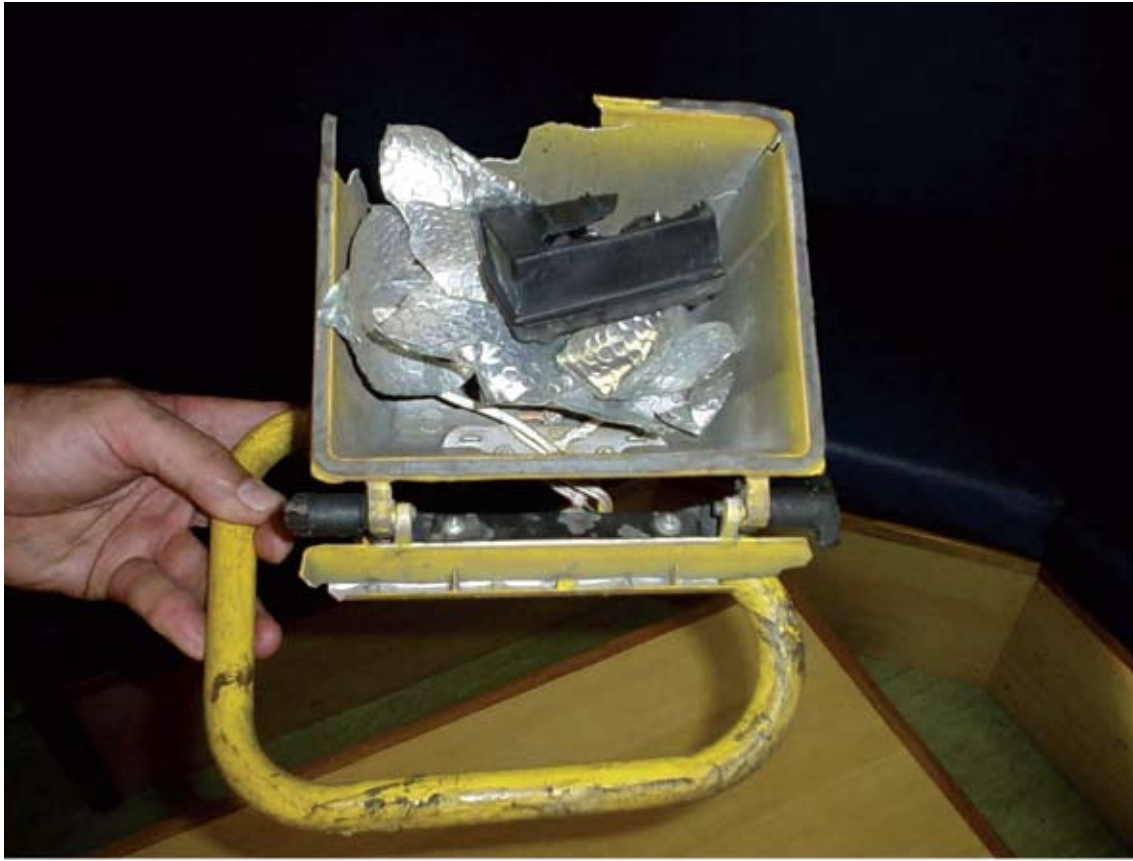
Figure 4

At 2200 both of the cleaning experts approached the steam drum door (Figure 3). No tests were conducted to check the steam drum atmosphere for either toxic or flammable gases. The UK expert picked up the halogen lamp (Figure 4) and placed it just inside the steam drum. The Danish expert saw a small flame or spark, and an explosion immediately followed.

The UK expert was thrown backwards about 4.5 metres; he was found to be unconscious and had suffered a number of fractures and severe burns. Sadly he failed to recover from his injuries and died 9 days later. The Danish expert was also burnt, but less severely. There was no fire or severe damage to either paintwork or structure.

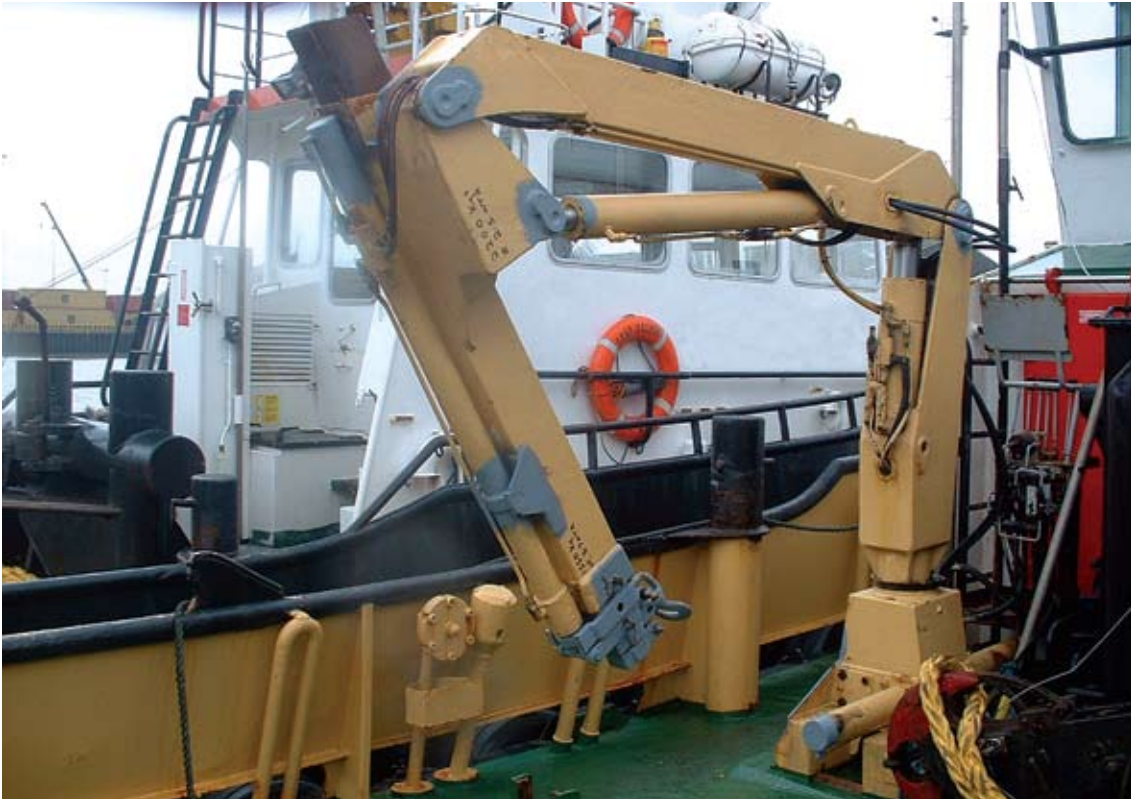
Telescopic folding jib

The engineering supervisor heard the shout and rushed to operate the controls to retract the telescopic section. He then freed the injured engineer and laid him on the deck. Meanwhile, the crew from another tug, moored alongside, jumped on board to assist. The alarm was raised immediately, and port paramedics were quickly on scene. The injured engineer was stabilised before he was flown to hospital. Sadly, although attempts were made to save his lower leg, it had to be amputated below the knee.

A subsequent inspection was unable to identify any significant fault with the crane or its controls. It is believed the injured engineer might have inadvertently moved the jib controls as he climbed down from the operator's position.

1. Treat hydraulically powered equipment with care and respect. It is extremely powerful and can inflict terrible injuries, as demonstrated by this accident.
2. Since 24 November 2006, equipment such as the crane in this accident must comply with the Merchant Shipping PUWER¹ and LOLER² regulations. As an employer, ensure you are aware of these requirements for work equipment and lifting equipment.

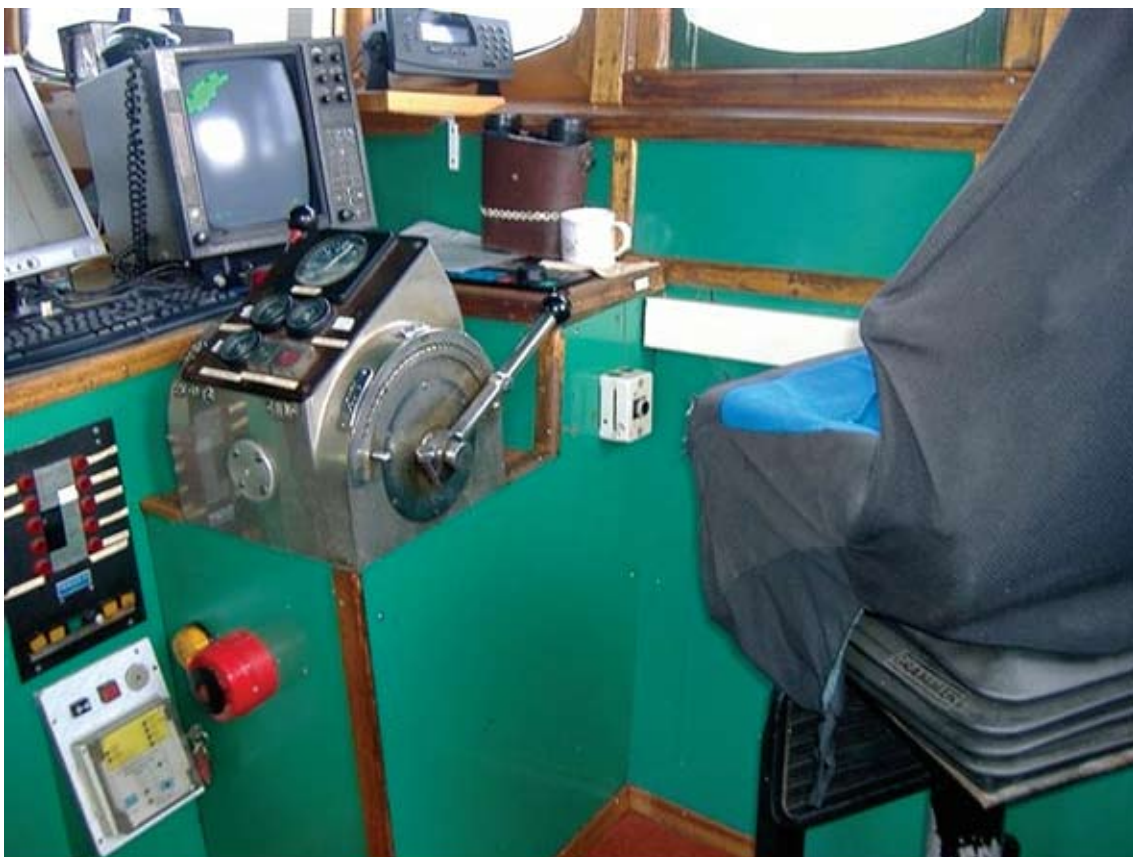
Operating panel at master's seat, looking to port

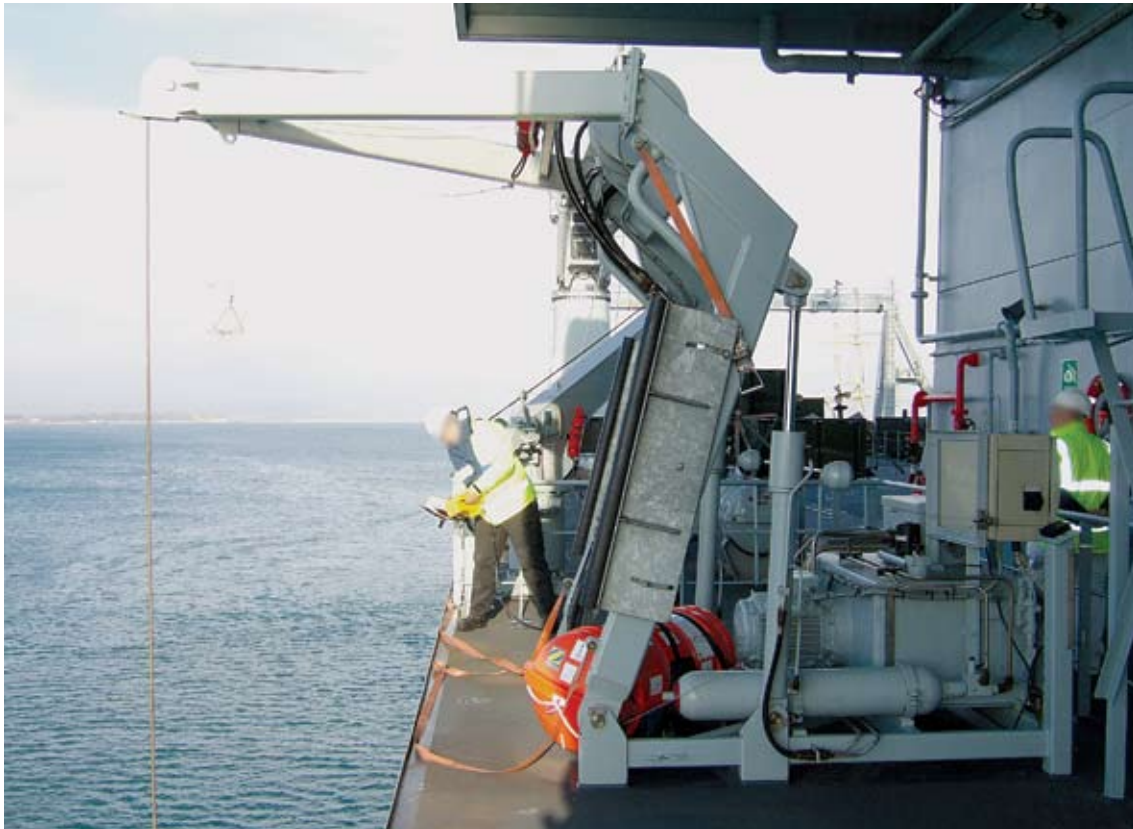
Figure 1 – FRC davit

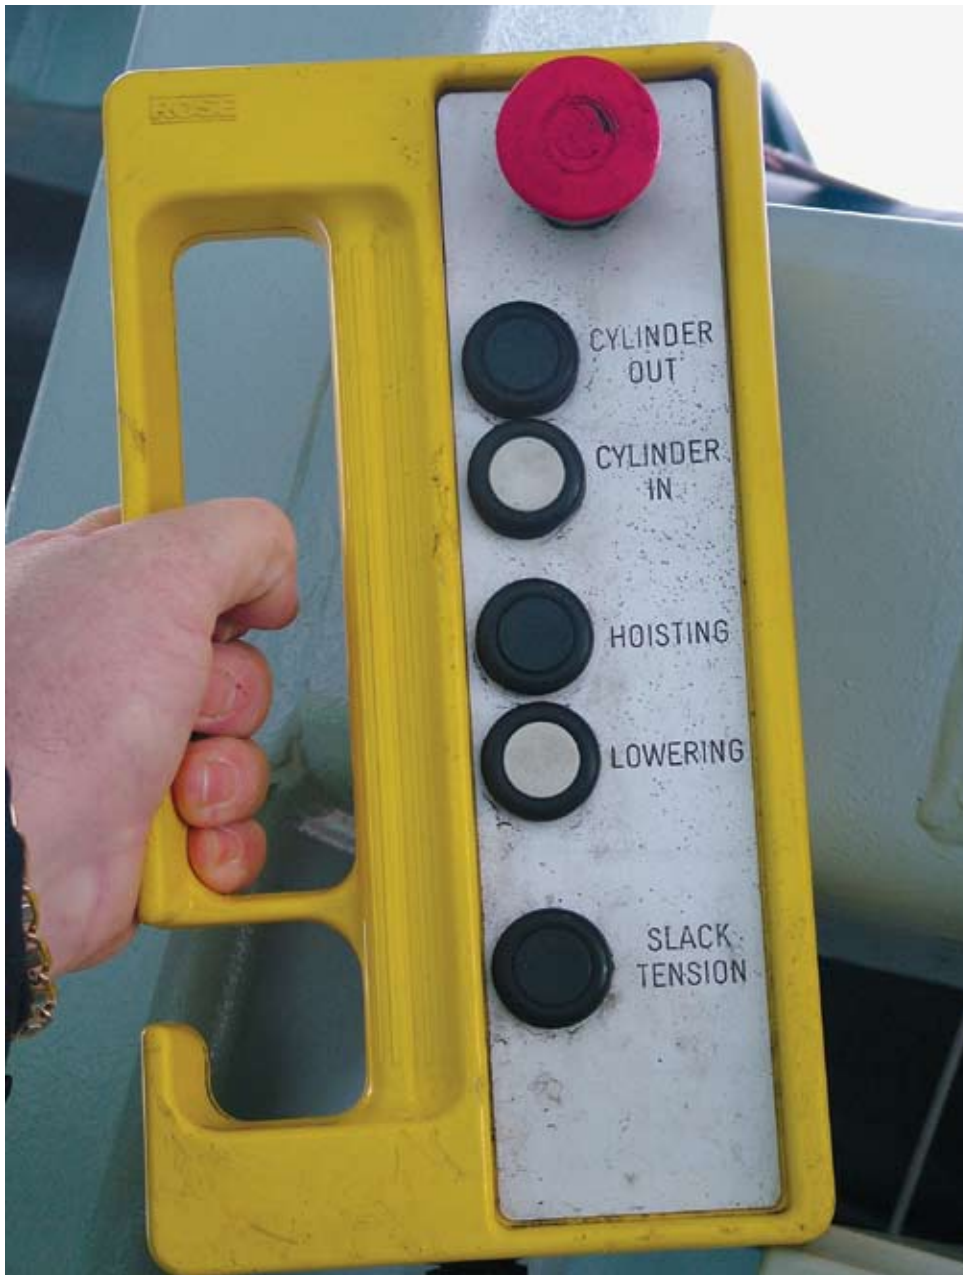
Figure 3 – FRC winch controller

Still restrained by the fall wire, the FRC turned to port, away from the ship, and listed heavily to starboard. The crew jumped clear of the boat as it was pulled on its side through the water.

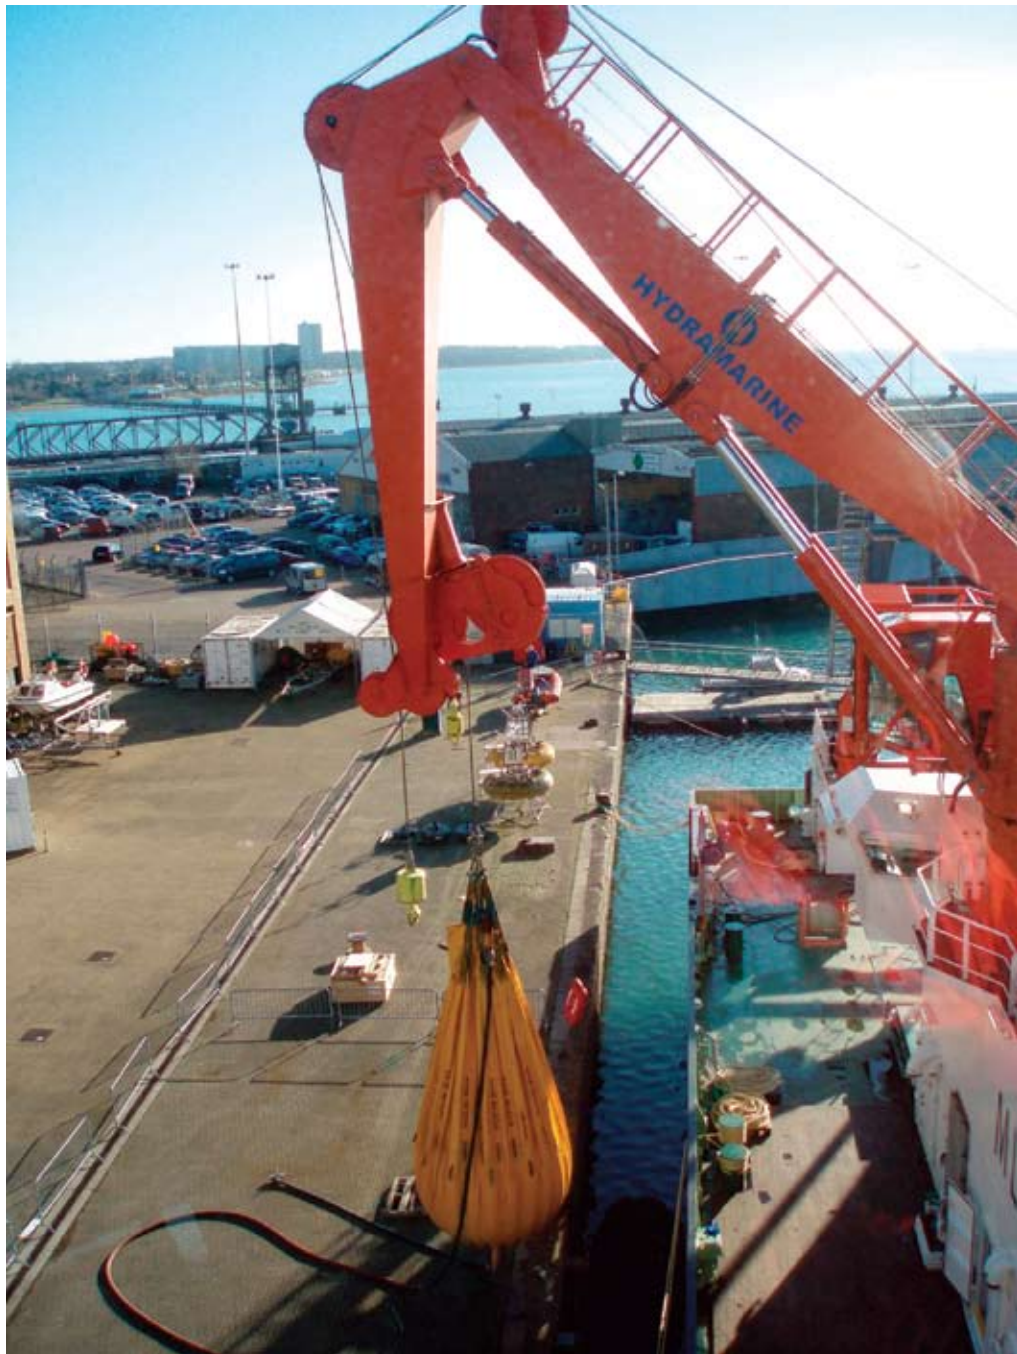
Figure 1 – View of set-up for test process

A “hard eye” was spliced at the end of the rope, but it was found that the water-bag load cell shackle pin would not pass through the eye. After some discussion, it was agreed between the ship’s staff and the contractor to remove the “hard eye” and connect the rope to the load cell shackle using a bowline knot (Figure 1).

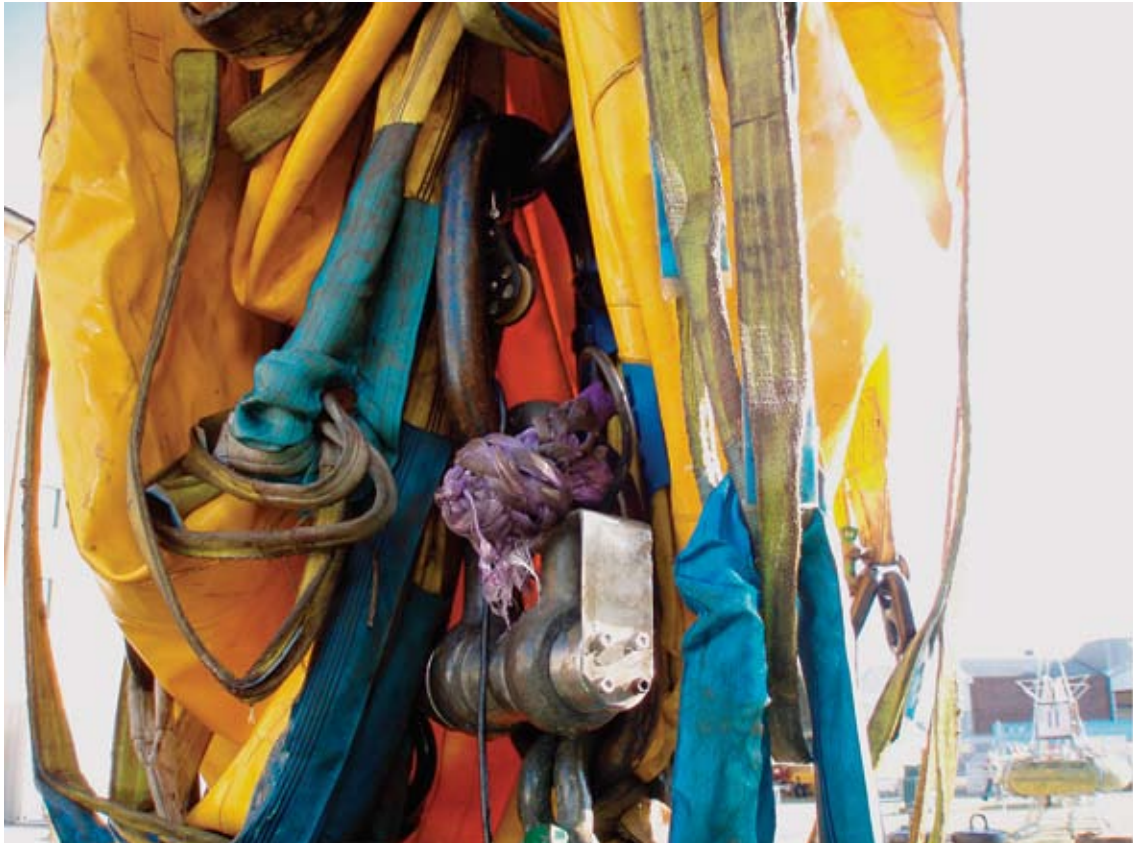
Figure 2 – View showing knot attachment to shackle

The water-bag was lifted from the jetty and partially filled with fresh water. At a load of about 10 tonnes (Figure 2) the sheaves were inspected for any structural change – none was found. More water was added to the water-bag but, soon afterwards, the rope failed and the water-bag fell onto the edge of the quay. Fortunately no-one was injured and there was no damage to the vessel or equipment.
