Report on the investigation
of a hazardous diving incident
involving

MV Norma

in the Dover Strait

Report No 3/2009
January 2009

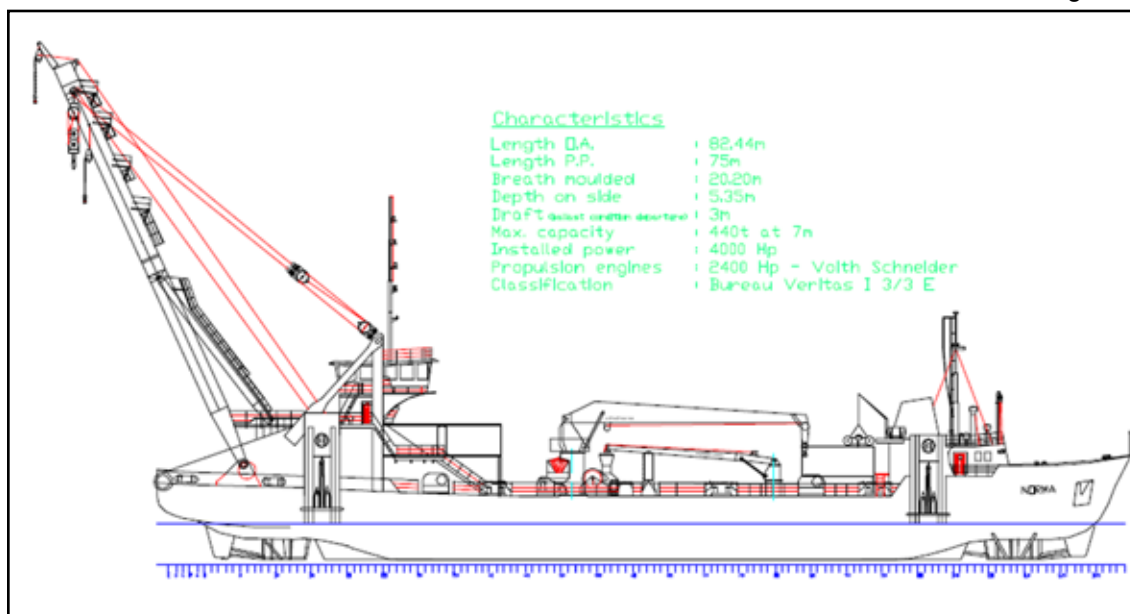
Profile plan of *Norma*

Norma was built in 1969 as a stone dumping barge for use in the construction of dykes in the Netherlands. She was later sold and converted to a self-propelled crane barge and fitted with a heavy lift crane (**Figure 9**). The vessel's core activity was marine heavy-lifting, but she was also involved in other marine related activities and had previously been used as a diving platform in conjunction with lifting and salvage operations. A record of the vessel's history since 2005 is at **Annex C**. Immediately before the incident, *Norma* had sailed from Zeebrugge, Belgium on 16 June and arrived in Newhaven the following day. The vessel was managed by Scaldis Salvage and Marine Contractors N.V.
