Report on the investigation of
the grounding of
Ovit
in the Dover Strait
on 18 September 2013

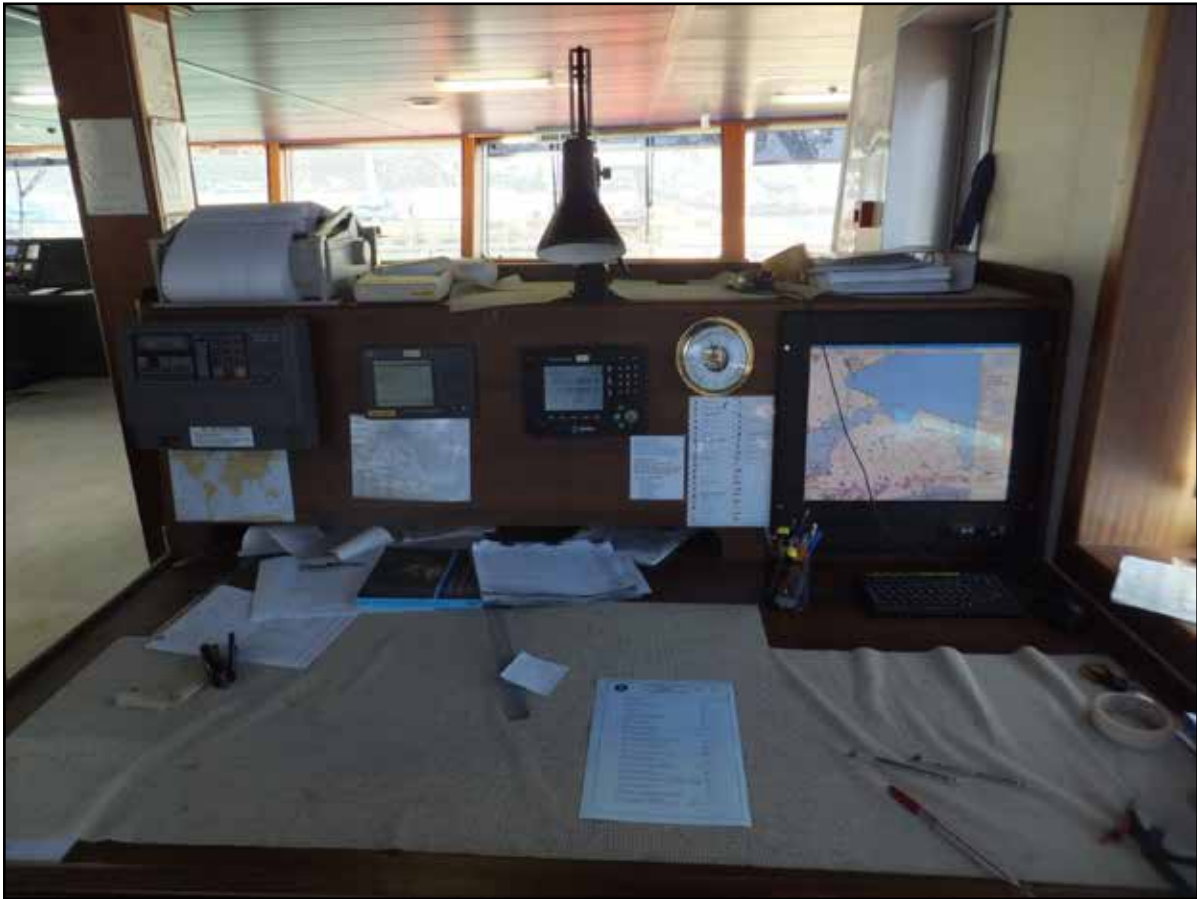
Figure 7: ECDIS planning terminal

The system comprised a planning terminal on the starboard side of the bridge by the chart table (**Figure 7**) and a monitoring terminal on the port side bridge console (**Figure 8**). Both computers were connected in a local area network and each system was supported by an independent, uninterrupted power supply.

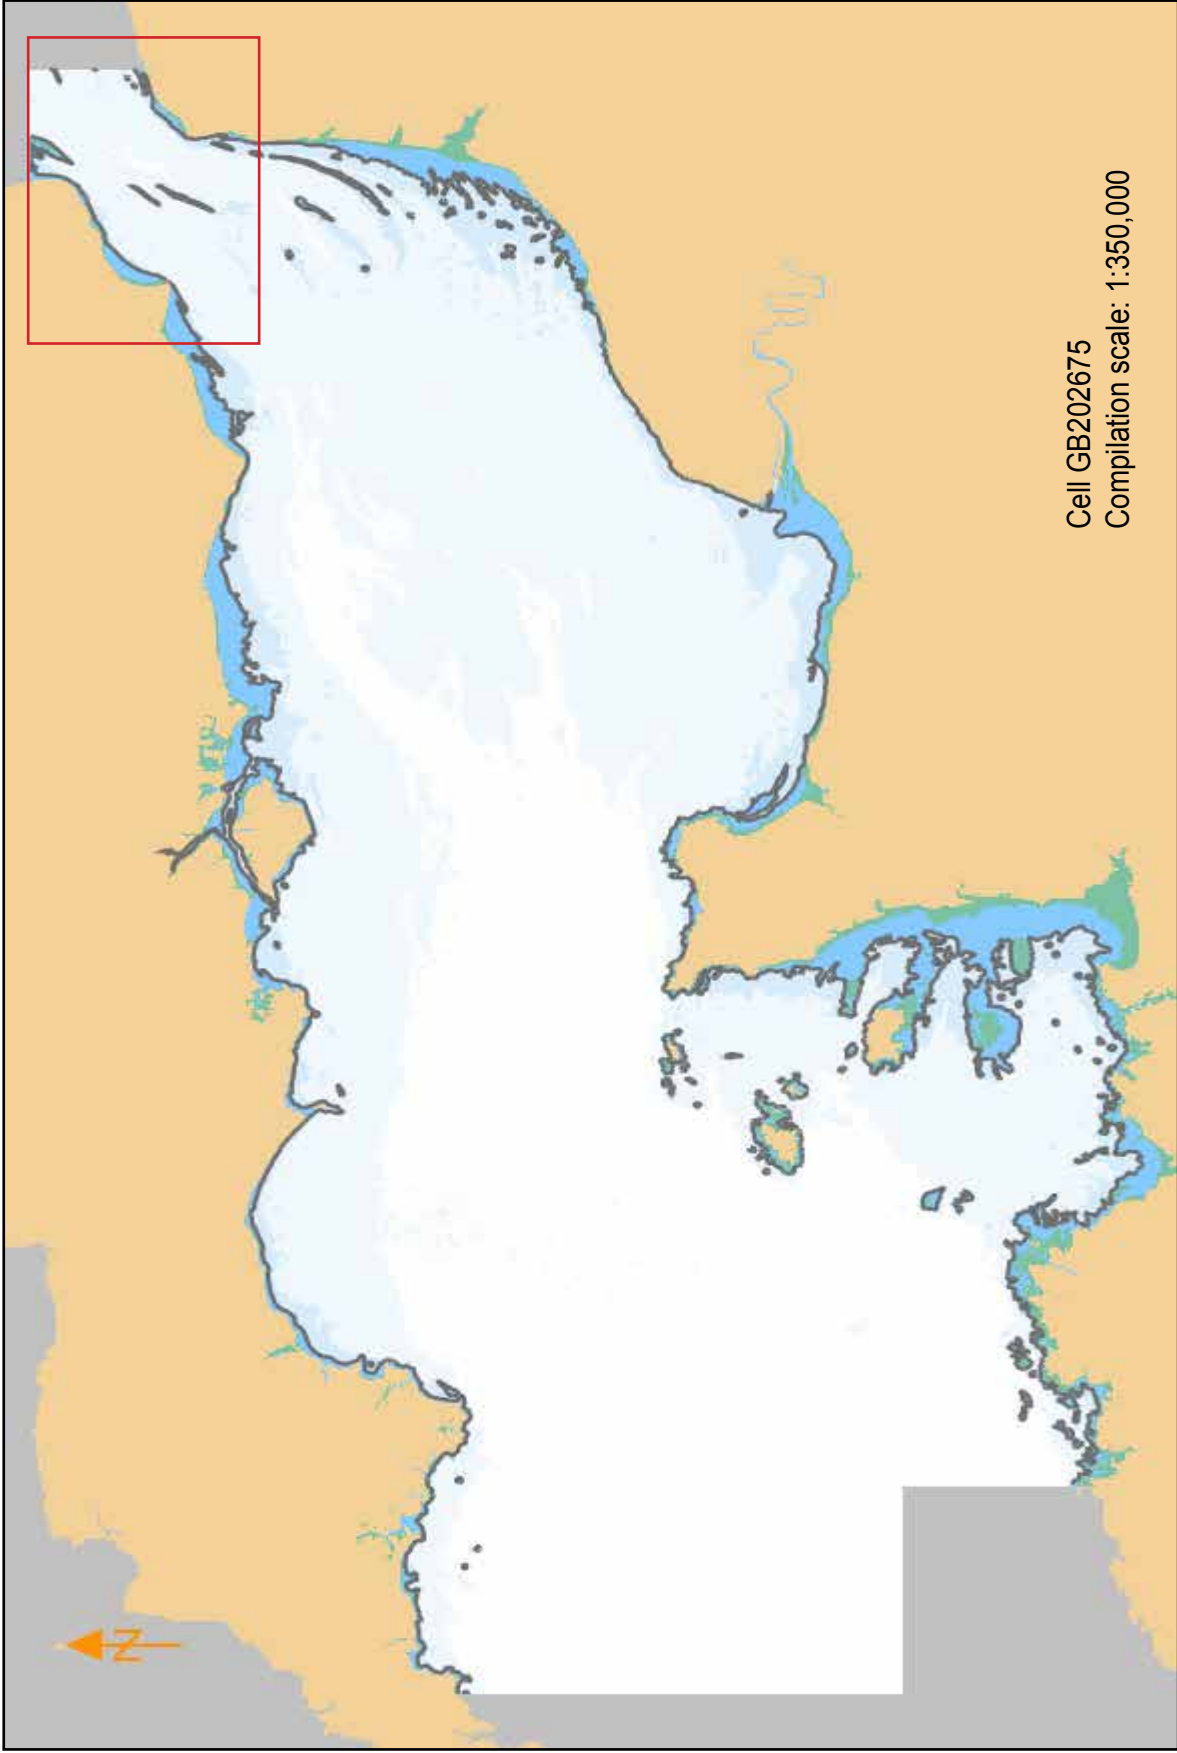
Figure 15: Area coverage of ENC cell 202675

During the Dover Strait passage, the ENC in use was GB202657 which was a 'general' chart on a scale of 1:350,000 (**Figure 15**). In coastal waters, this scale of chart would only be effective for planning purposes. ENC, GB401892 on a scale of 1:45,000 (**Figure 16**), which was suitable for coastal navigation, was available on board but it was not in use. The ECDIS 'auto-load' feature, which would have automatically selected the best scale chart, was switched off.
